Cessna Run Abandoned Mine Drainage Treatment System Project Technical Report

Introduction

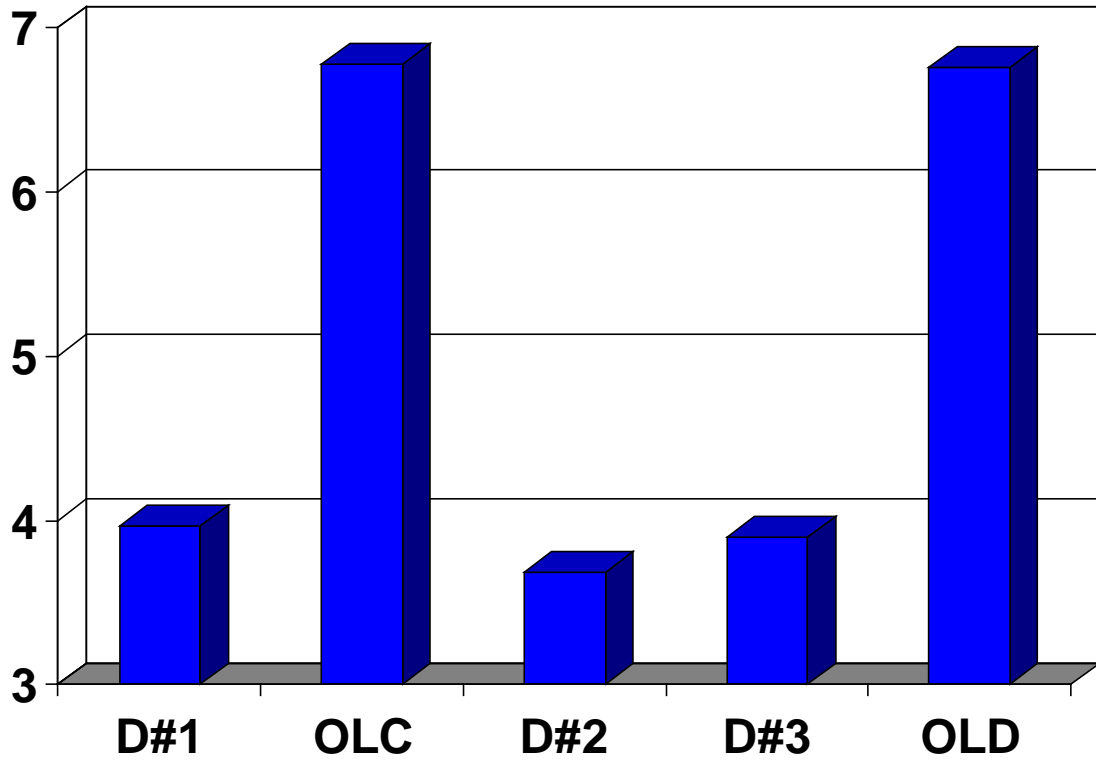
Figure 2. The influent and effluent pH values of the two Phase I Cessna Run treatment systems.

The three Phase I discharges contribute on average a total of 134 lbs/day of acidity, 9.18 lbs/day of aluminum and 39.19 lbs/day of manganese loading to Cessna Run. After treatment, the acidity concentration of the discharge water was totally eliminated and 50.98 lbs/day of alkalinity were added. In addition, aluminum and manganese loadings have been reduced 65% and 52% respectively (Table 1 and Figure 3, 4 and 5). Metal concentration reductions are great, but not ideal because of the amount of land available for sedimentation due to stream and wetland constraints.

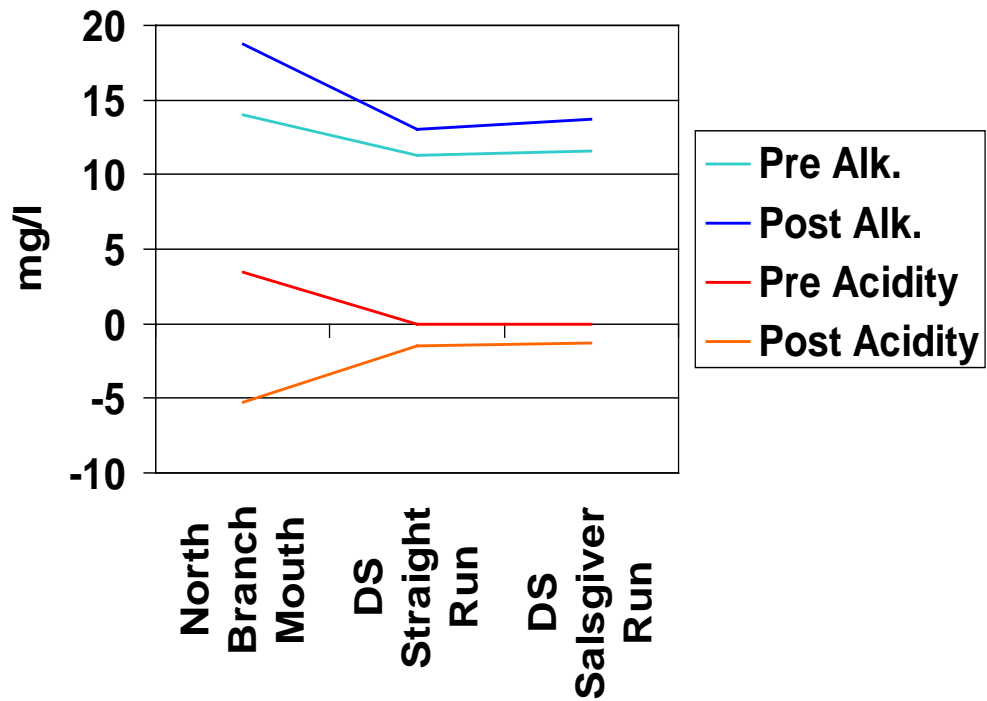
Figure 5. The alkalinity and acidity concentrations at selected sites in the Cessna Run watershed pre and post Phase I AMD treatment system construction.

The water quality of Cessna Run improved throughout its length post construction of the Phase I system. This improvement was obviously most noticeable on the North Branch just before its confluence with Straight Run (Figure 5 and 6). The alkalinity concentration was increased 34% while the acidity concentration was reduced 251%. Similar improvements were documented for aluminum and manganese concentrations which were reduced 66% and 27% respectively.

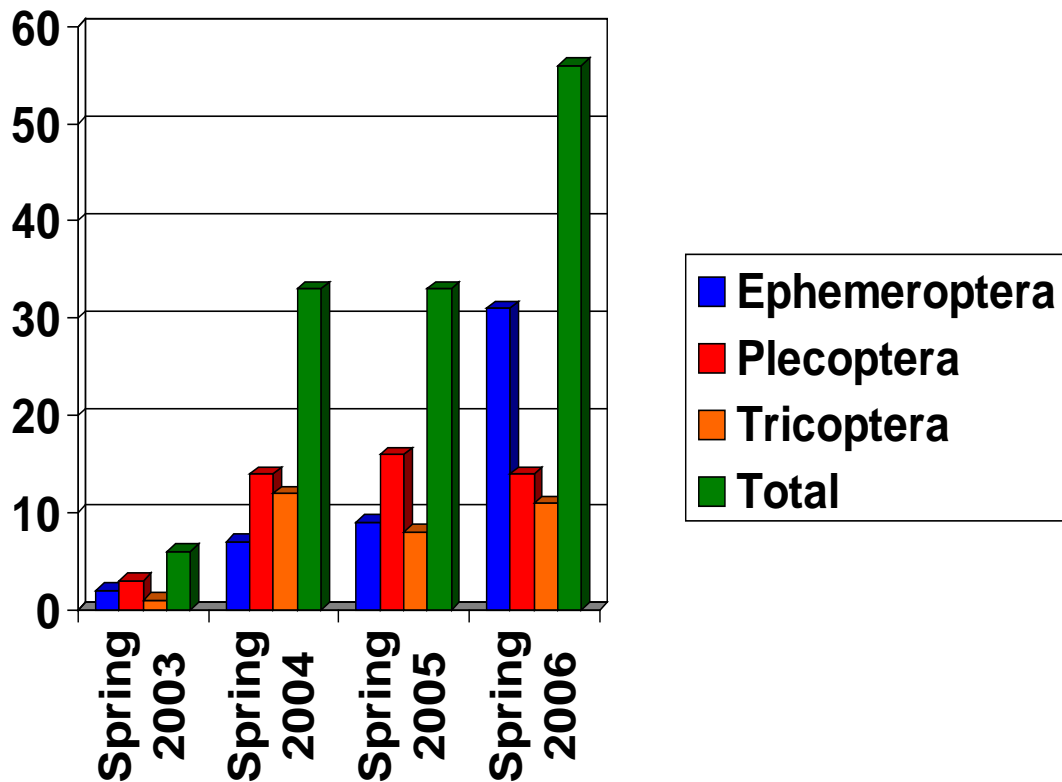
Figure 7. The EPT Taxa numbers at the mouth of Cessna Run. Notice the great improvement in the 2006 sample, post Phase I construction.

The macroinvertebrate community of Cessna Run has been the greatest responder to the construction of the Phase I systems. Every May, starting in 2003, the Ken Sink Chapter of Trout Unlimited completes a macroinvertebrate sample at Cessna Run before its confluence with Little Mahoning Creek, approximately 1.5 miles downstream of the Phase I systems. The 2006 sample, collected six months after the Phase I systems were placed online, shows great improvement in the EPT (Ephemeroptera (mayflies), Plecoptera (stoneflies) and Tricoptera (caddisflies)) Taxa, generally considered the three most pollution sensitive Orders of stream macroinvertebrates. Those improvements are illustrated in Figure 7 and 8.

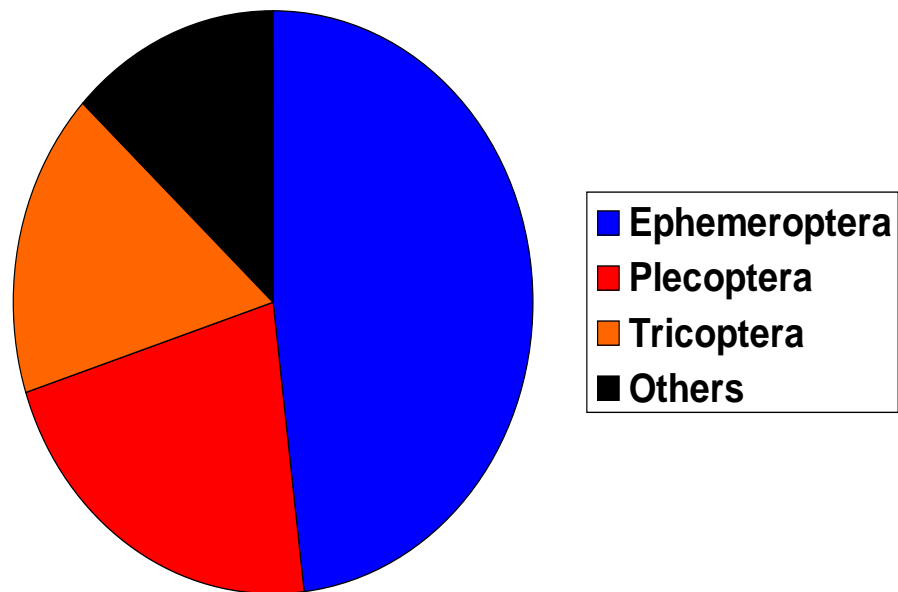
Figure 9. The composition of the macroinvertebrate community at the mouth of Cessna Run in spring 2005. The EPT Taxa constitute 87% of the sample. Ephemeroptera (mayflies) constitute 48% of the sample.

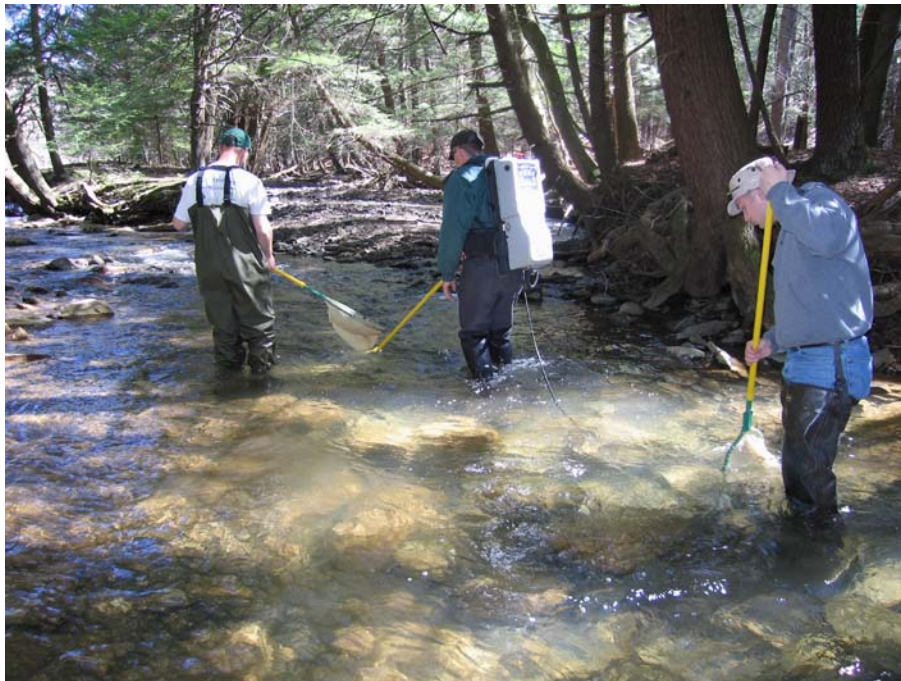
Figure 10. Nick Pinizzotto and Ben Wright of the WPC electroshocking Cessna Run near its confluence with Salsgiver Run.

On April 19, 2006 the Western Pennsylvania Conservancy assisted the Indiana County Conservation District with a fish electroshocking study of Cessna Run between the entries of Straight Run and Salsgiver Run (Figure 10). One hundred fourteen total fish comprising seven different fish species were collected. A majority (70%) of those were blacknose dace (28%), creek chub (25%) and a field unidentifiable shiner species (17%). Other species collected were white sucker (9%) and smallmouth bass (3%).
