## Watershed will scrub away Aultman Run iron

## "SR286 Passive Treatment System Constructed"

# Aultsmans Run Watershed Assessment

# Aultmans Run Water Quality Database

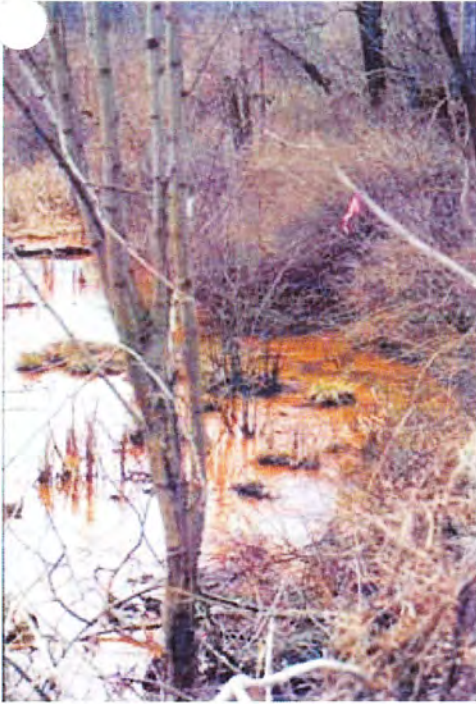
Iron pollution turns water orange before it flows into Aultman run.

The plants that will be installed by the groups will remove the 11,000 pounds of iron that enter the stream each year. Healthy streams are usually free of iron.

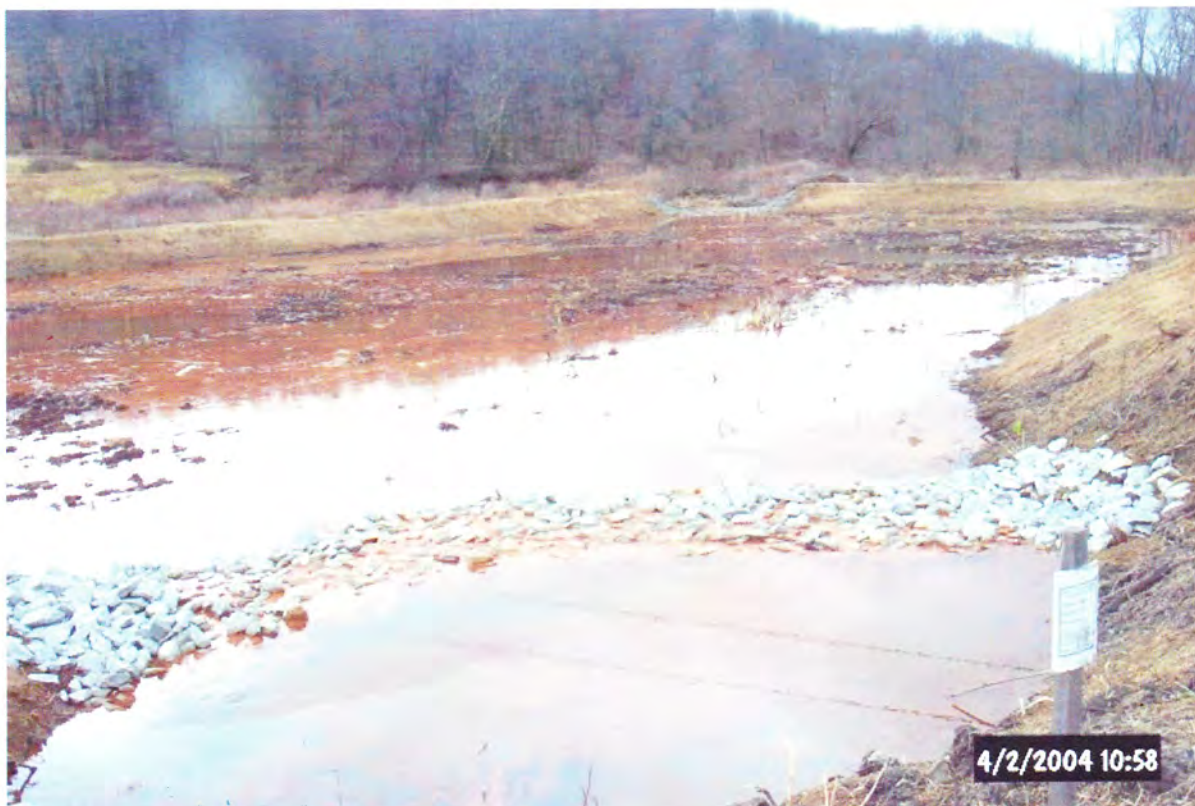
(Aultman, PA) - Through a public-private partnership effort, the first passive treatment system in the Aultmans Run Watershed has been constructed and is successfully treating an alkaline, iron-bearing mine discharge known as the SR 286 Discharge. For the first time in over 75 years, this abandoned mine discharge will no longer flow untreated into Aultmans Run.

The forebay collects the discharge and equally distributes the flow to the wetland. The wetland has a large surface area to maximize the oxidation, precipitation, and accumulation of iron. In order to provide a high wetland plant diversity to increase habitat value, the wetland has small elevation variations, known as microtopographical relief. The innovative design also incorporates a 4,000-SF existing, degraded wetland to provide additional treatment area.

a moderate iron concentration (17 mg/L) and a maximum flow of 200 gpm. During low-flow conditions, the discharge is the major source of water to the stream. Due to this pollution, aquatic organisms within Aultmans Run have been impacted.

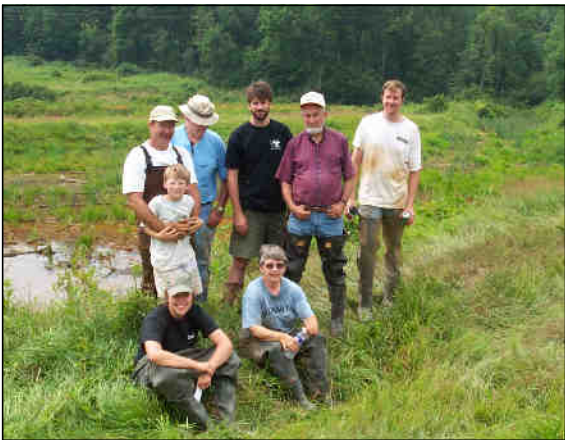
### Wetland Planting in the Aultmans Run Watershed

On the cool, overcast Saturday of July 17, **Bob Beran** and **Maggie Allio** of **Beran Environmental Services** and **Shaun Busler** of **Stream Restoration Incorporated** met with about a half dozen volunteers at the SR286 Passive Treatment System in Center Township, Indiana County, to plant an aerobic wetland. The volunteers, from the **Aultman Watershed Association for Restoring the Environment (AWARE)**, diligently worked for four hours planting hundreds of plants and reconfiguring a portion of the wetland. **Thanks to Brian Okey, Michael Poage, Carol Cummins, Carl Trout, and Harry Charles of AWARE** for making a difference in their watershed! Only native species were planted including: smart weed, three-way sedge, spatterdock, and burreed. The work on the 17th helped to quickly es-

tablish plant growth, which helps to treat the water that has been severely degraded due to an abandoned mine. In addition, the volunteers added new species of plants to those that had naturally established themselves within the wetland to create diversity.

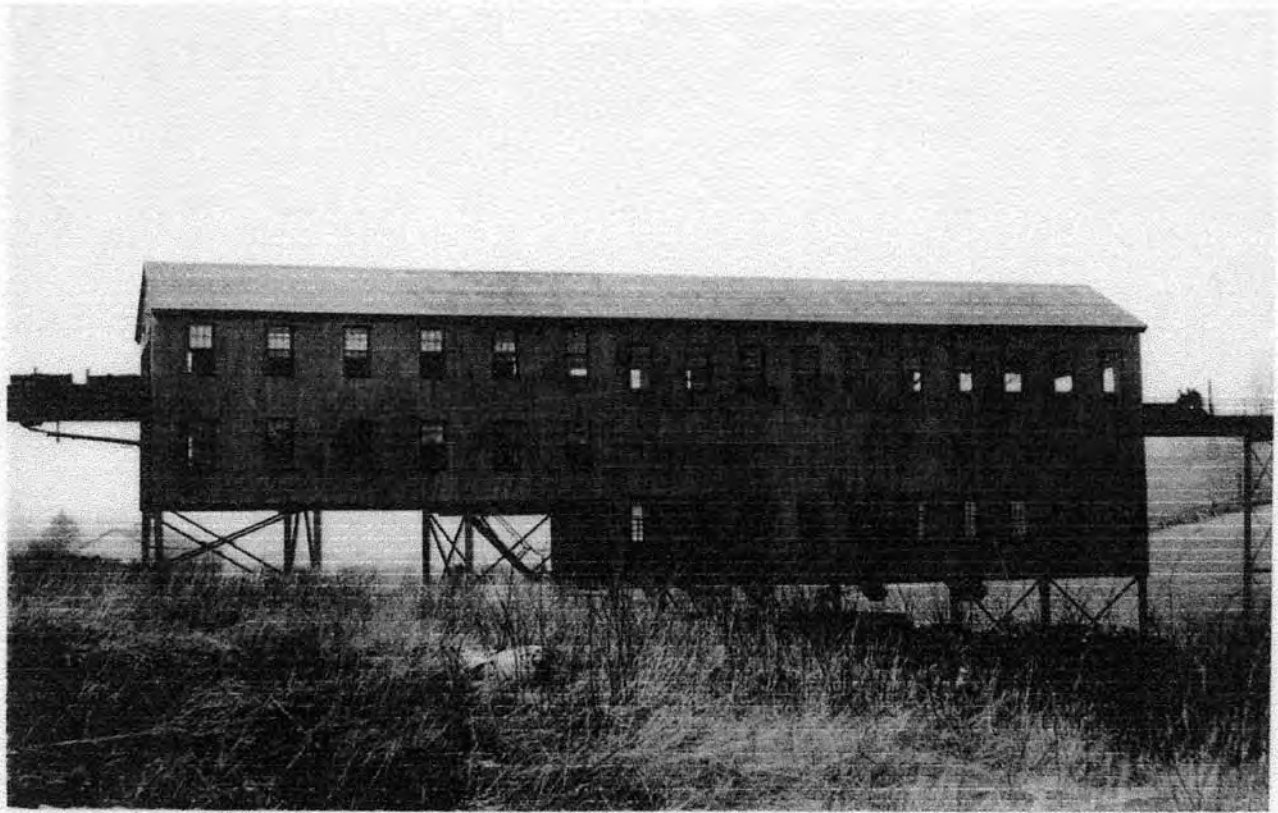
## AULTMAN TIPPLE

Coal CLEANED, dumped into RAILROAD CARS and ON for delivery.  
LOCATED ON outskirts of town (AULTMAN) AND NEAR RAILROAD AND ROUTE 80.
