Laurel Run Watershed Initiative
HARBISON WALKER RESTORATION AREA
MINE DRAINAGE ABATEMENT

PHASE I

HARBISON WALKER RESTORATION AREA
MINE DRAINAGE ABATEMENT

DISCHARGES 12, 13, 14

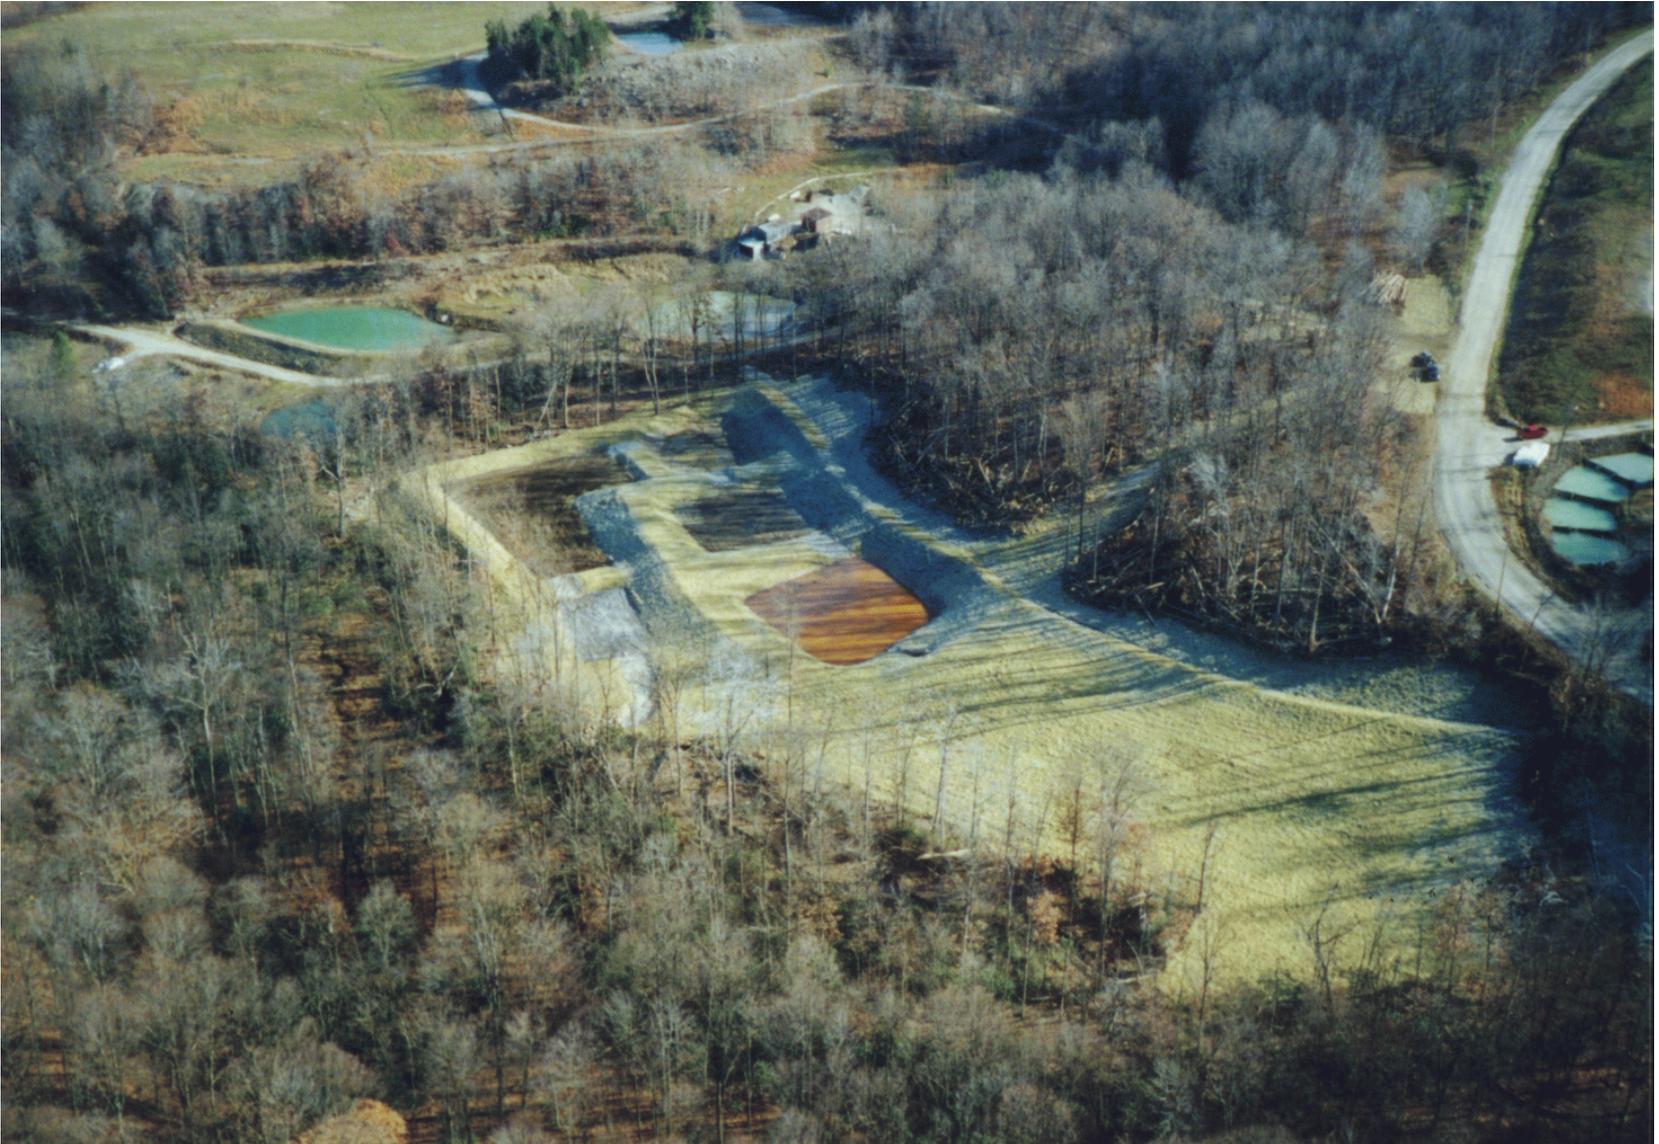
Aerial view of passive treatment system for Phase I constructed in 5 weeks 10/11/99 through 11/17/99 taken one day after construction. (Photo take 11/18/99 by Ron Horansky, MCI, PA DEP, Greensburg, DMO)

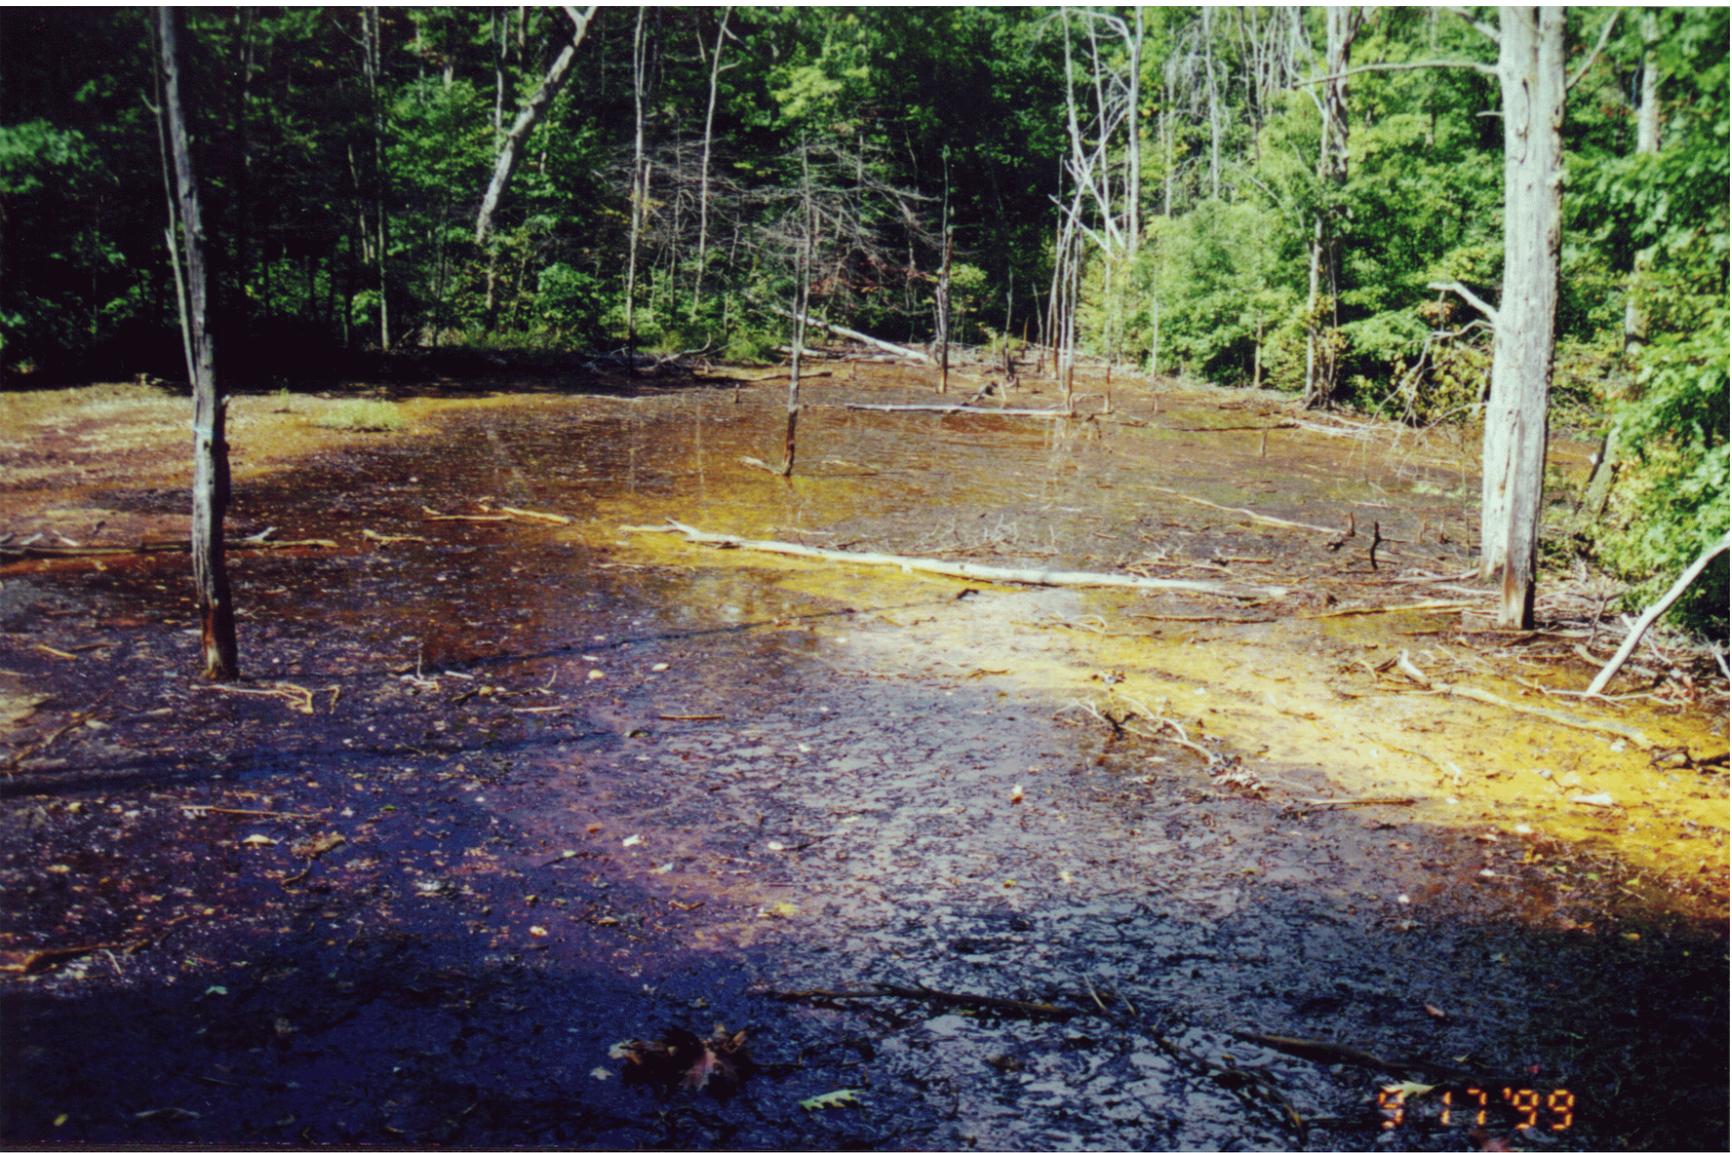
Effects of abandoned mine drainage at Harbison Walker Restoration Area, Ohio State Park, Stewart To Fayette County, PA. (SRI 9/17/99)

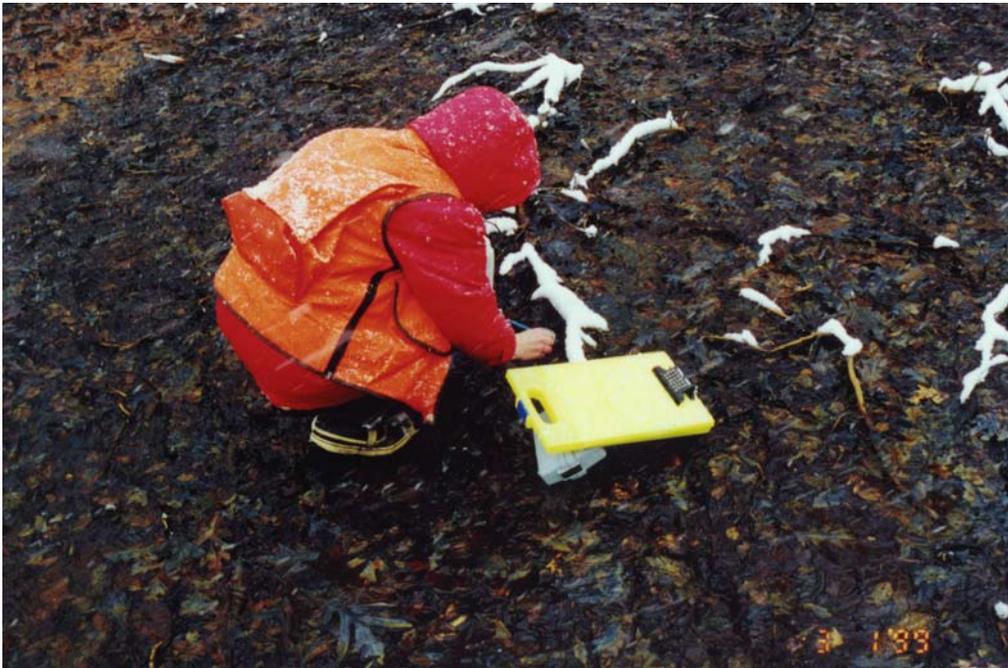
Sampling diffuse flow of discharges 12 and 13 prior to passive treatment system installation. (3/1/99)

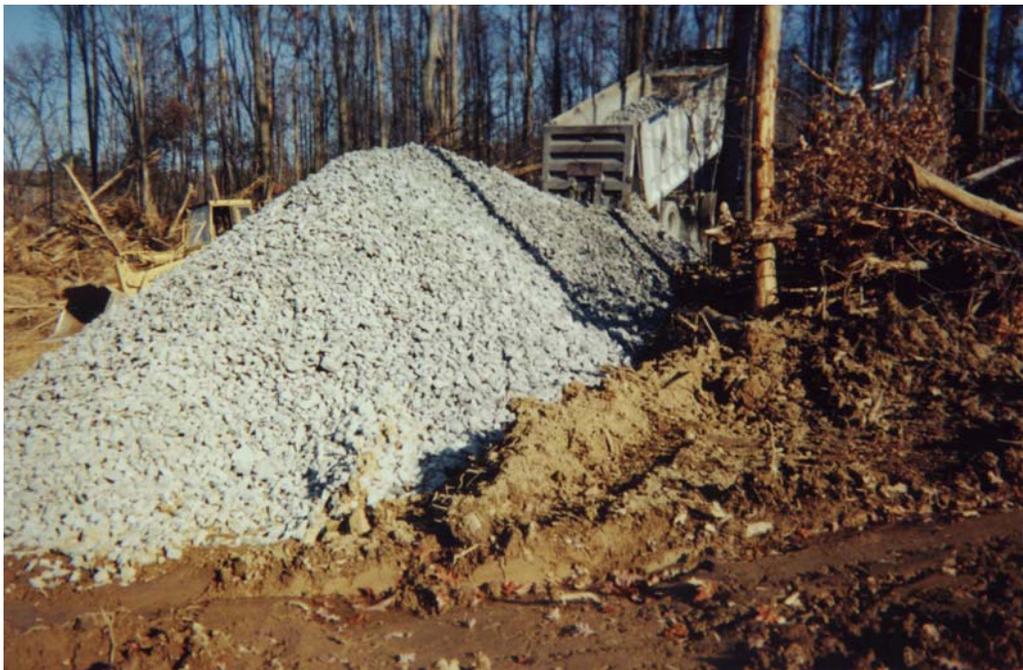
AASHTO #1 limestone used in the construction of the ALD and VFP. (10/29/99)

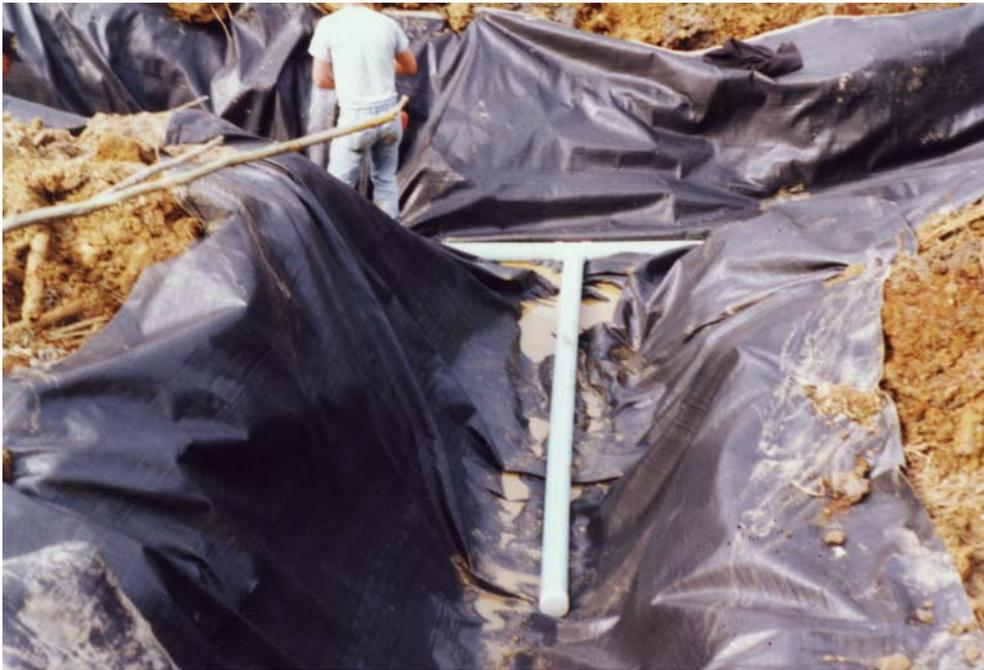
4 inch, perforated SDR 35 pipe in collection system. One of two laterals shown. (10/11/99)

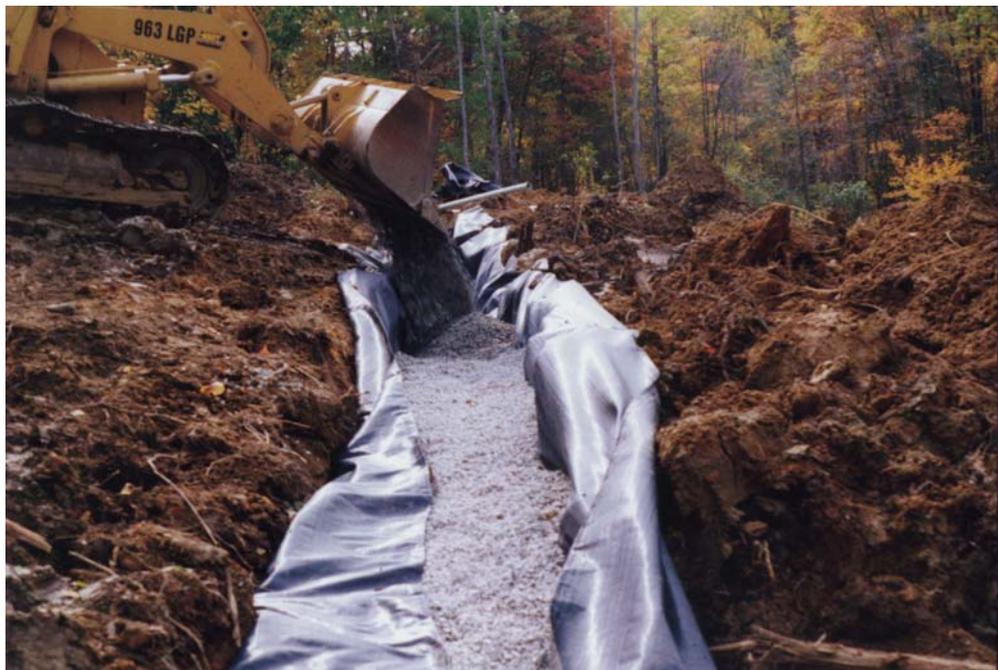
Placing of sandstone aggregate in collection ditch. (10/11/99)

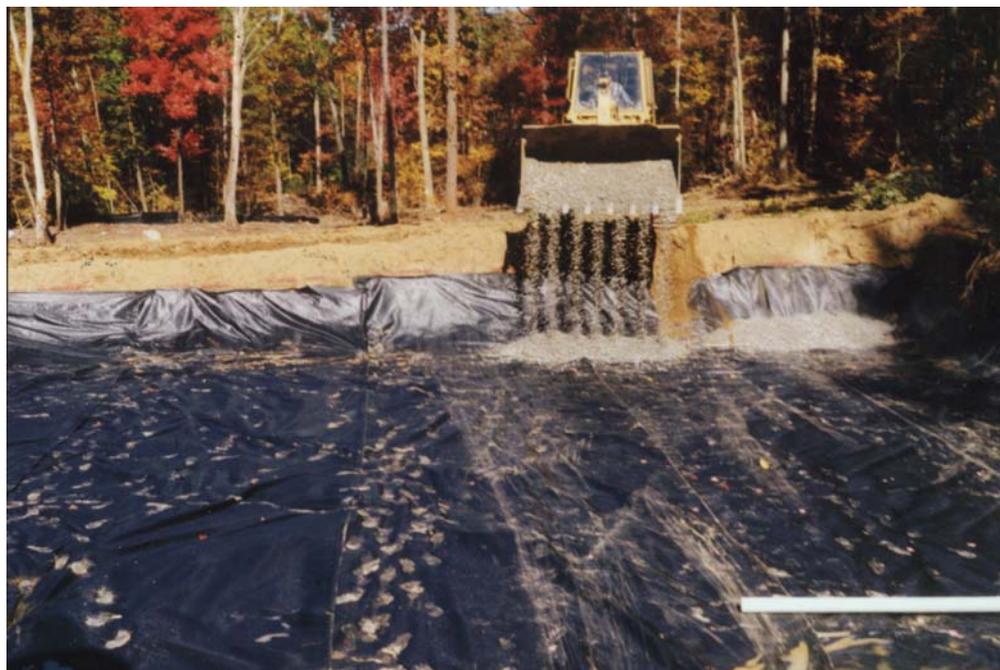
Sandstone aggregate being placed to bed pipe for outlet manifold in Anoxic Limestone Drain. (10/1999)

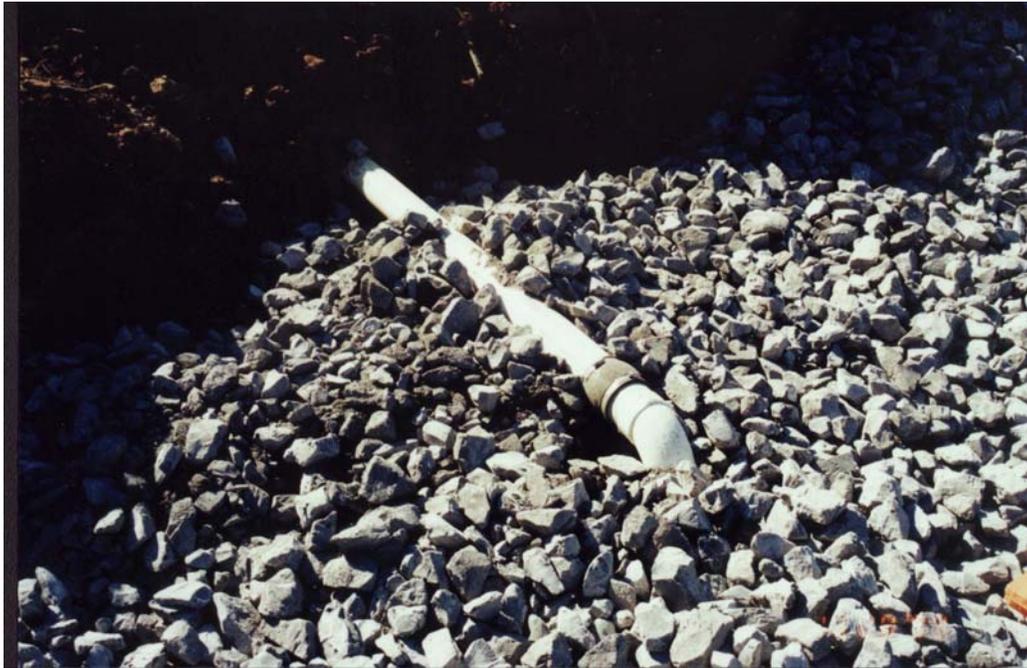
Influent pipe from Anoxic Collection System to Anoxic Limestone Drain. (10/28/99)

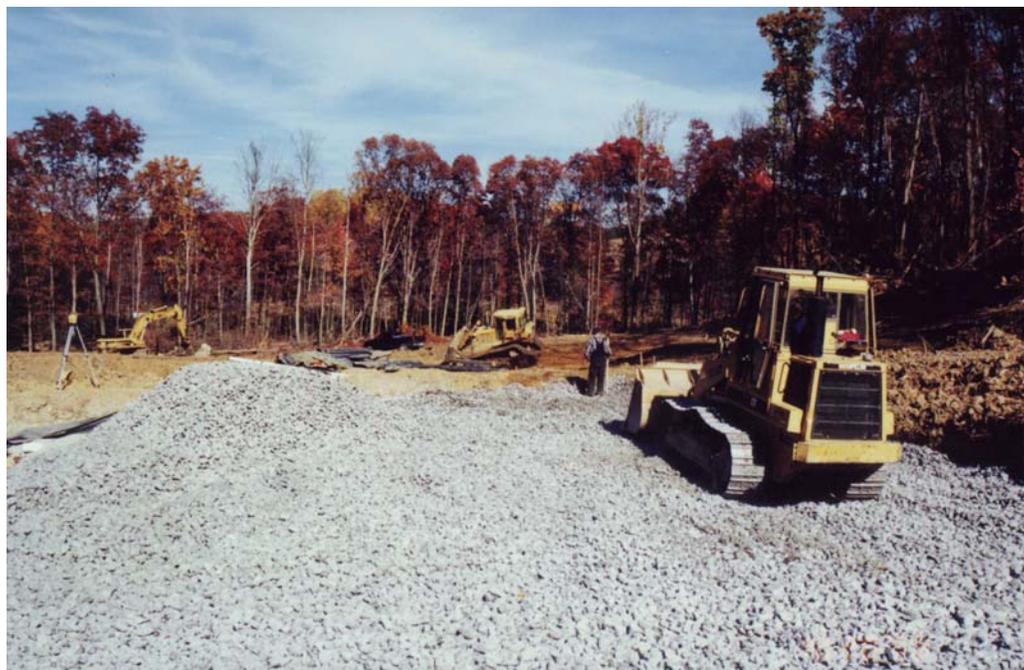
Construction of Anoxic Limestone Drain (670 tons), part of the Phase I passive treatment system. (10/28/99)

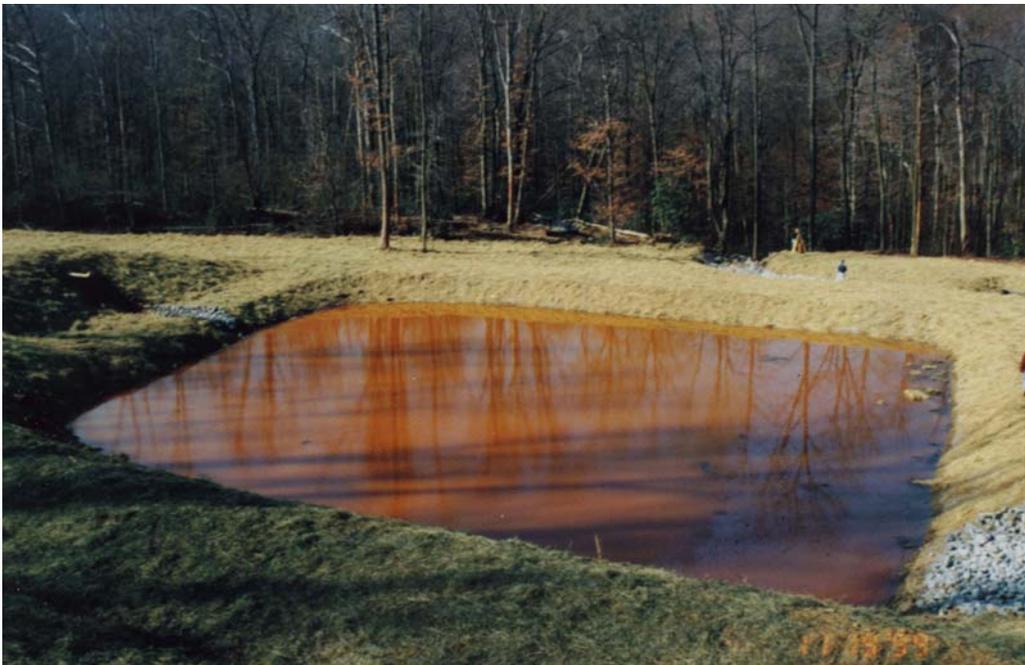
Below: Iron accumulation within Settling Pond #1
and surveying of passive treatment system.
(11/19/99)

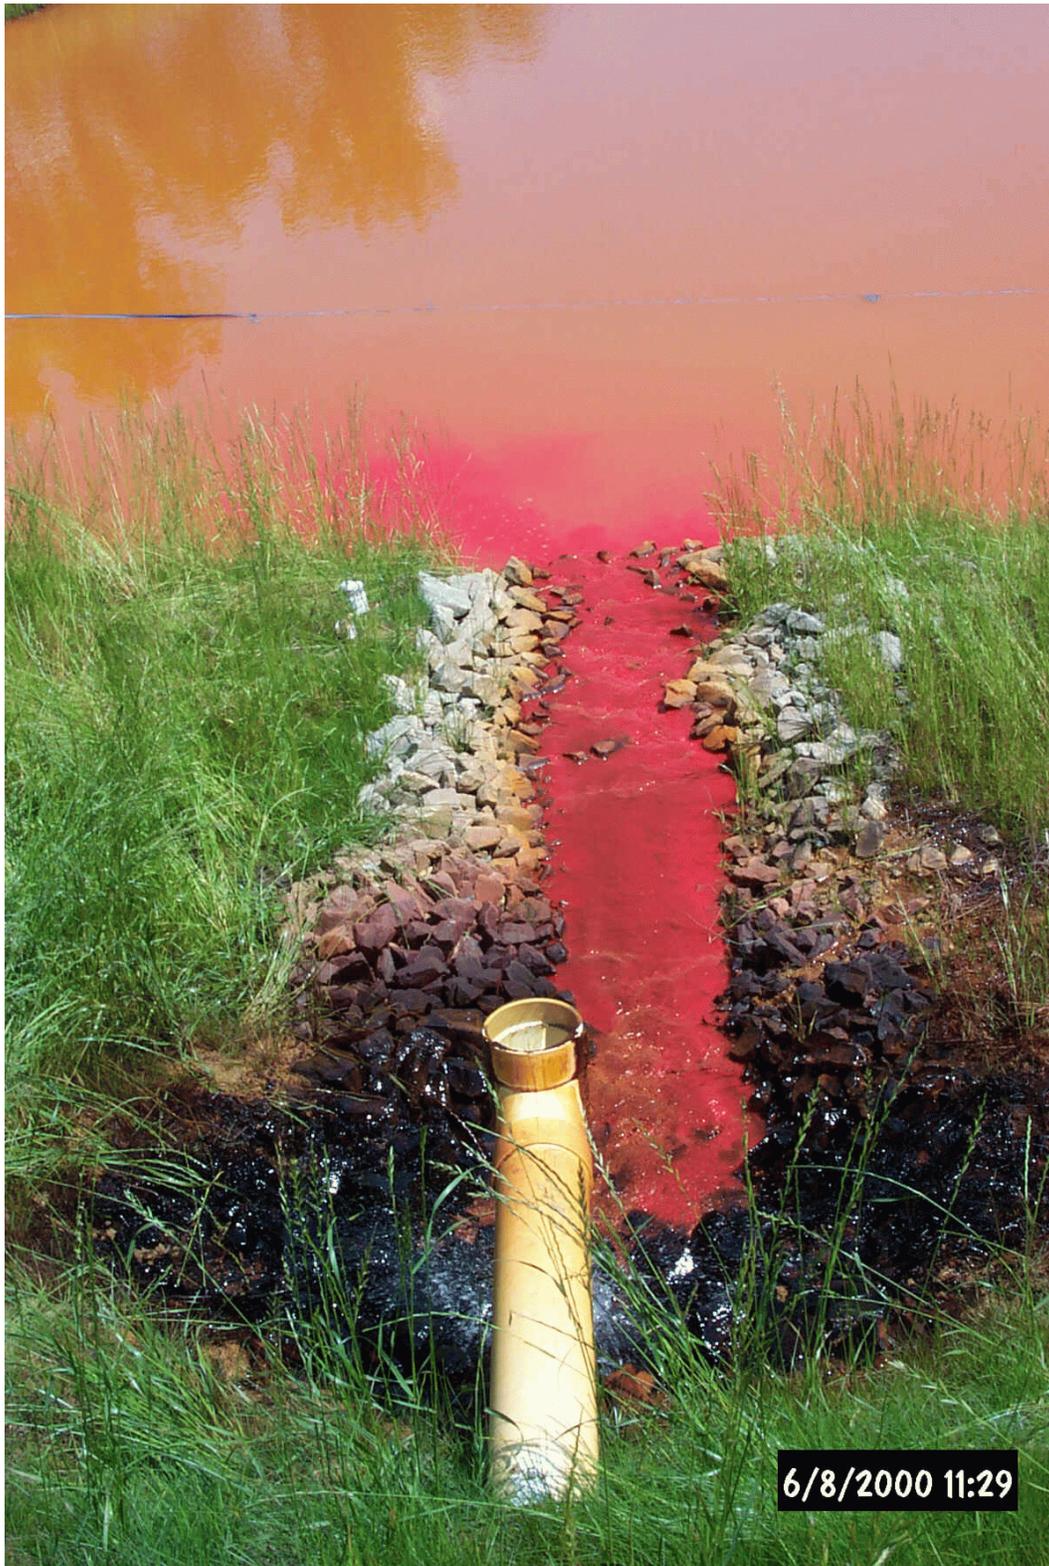
Beginning of dye test of Settling Pond #1 examining water distribution patterns.

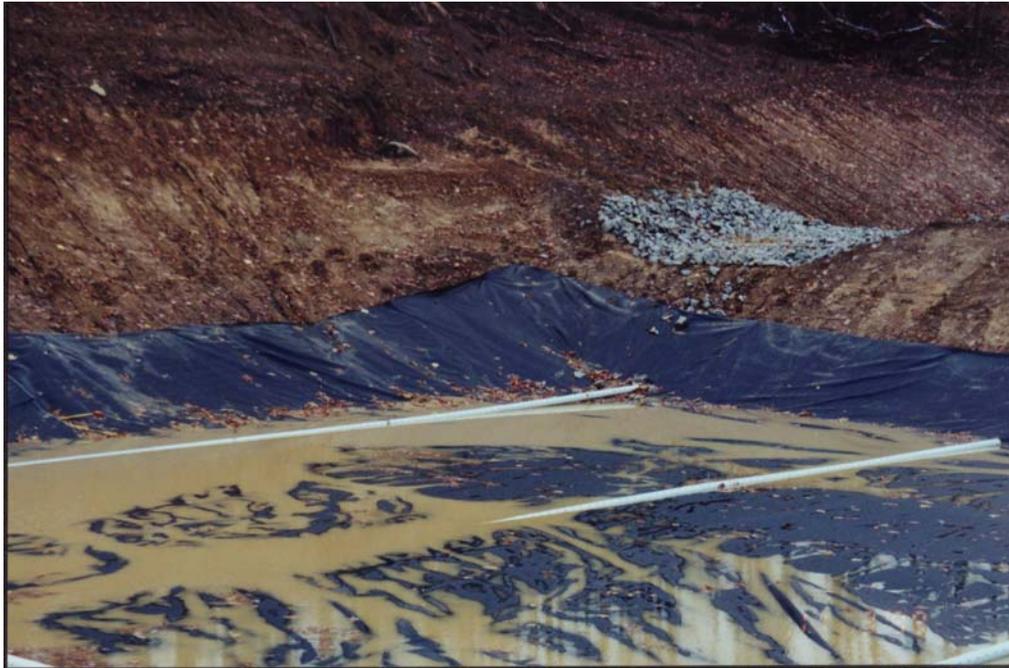
Underdrain of Vertical Flow Pond before addition of limestone and compost. (11/3/99)

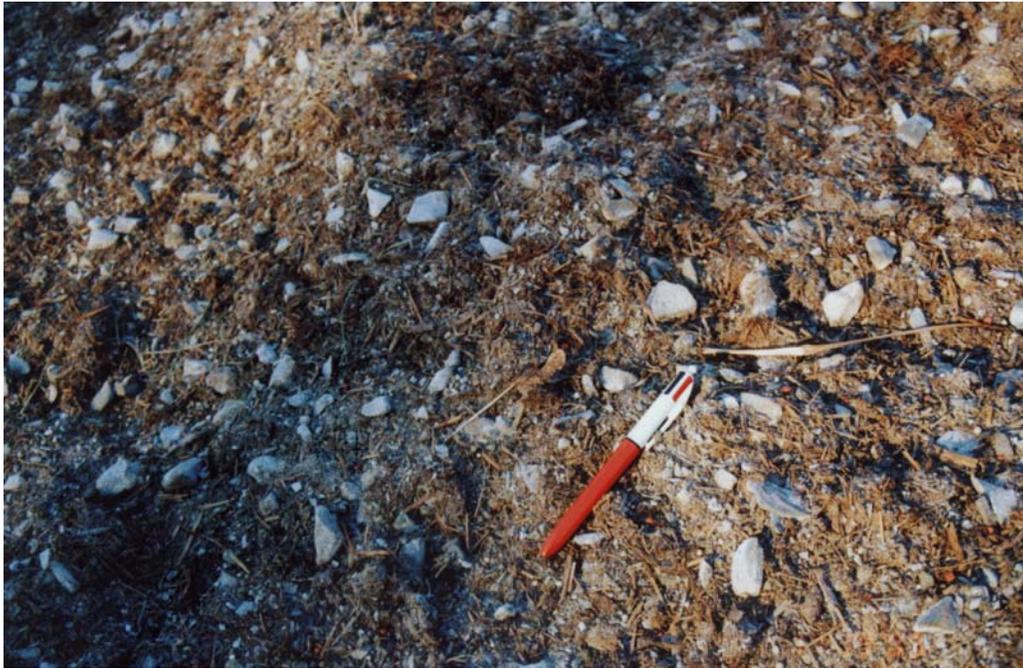
Spent mushroom compost and limestone aggregate mixture overlying 600 tons of limestone in Vertical Flow Pond. (11/19/99)

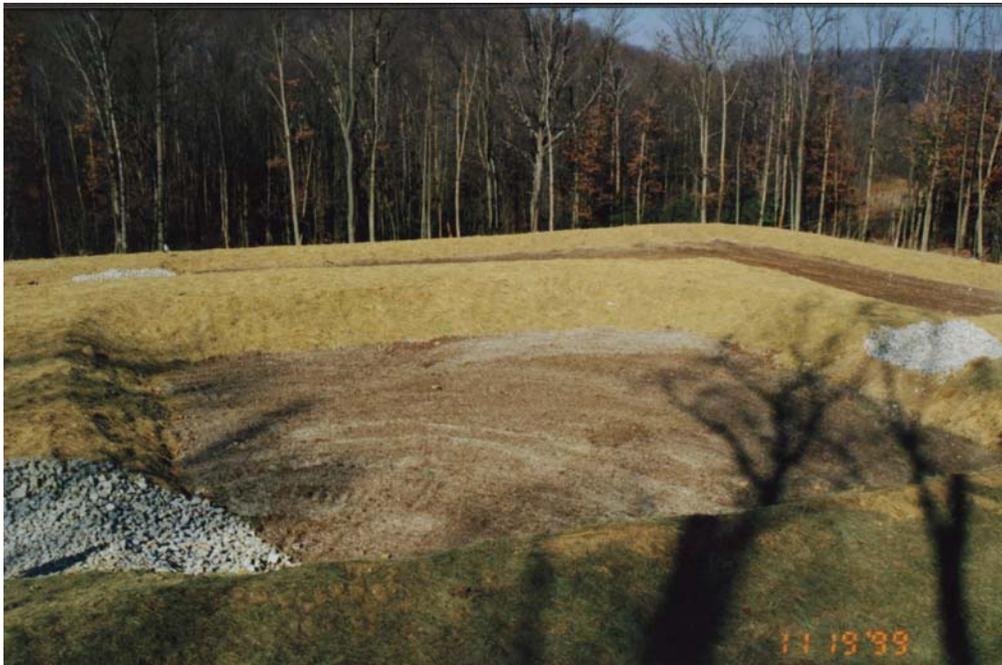
Completed Vertical Flow Pond with 600 tons of AASHTO#1 overlain by mixture containing 36 tons of spent mushroom compost, 71 tons of AASHTO #57, 69 tons of AASHTO #10 aggregate. (11/19/99)

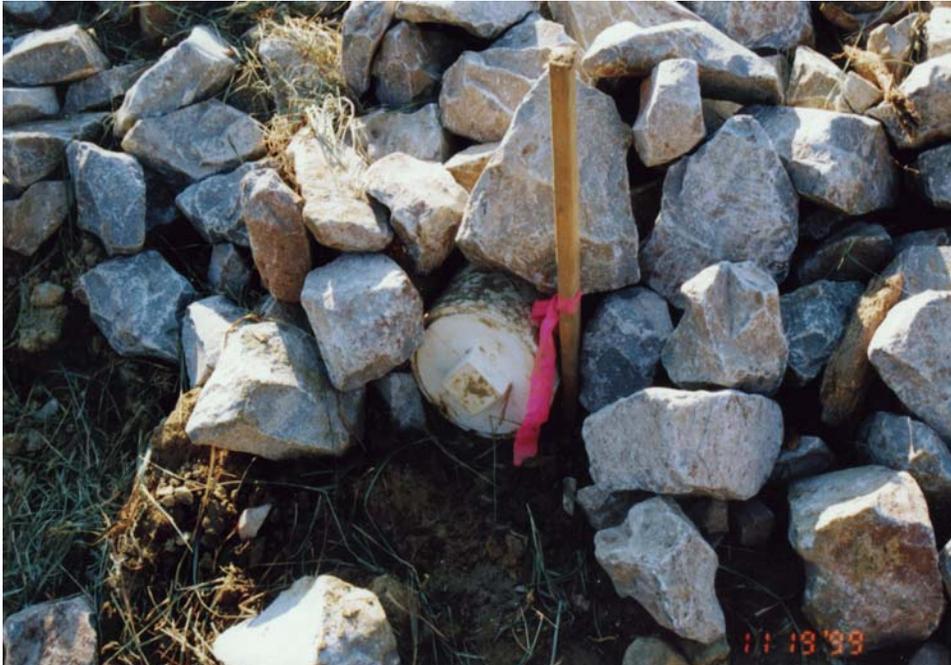
6" Bottom flush pipe for Vertical Flow Pond. (11/19/99)

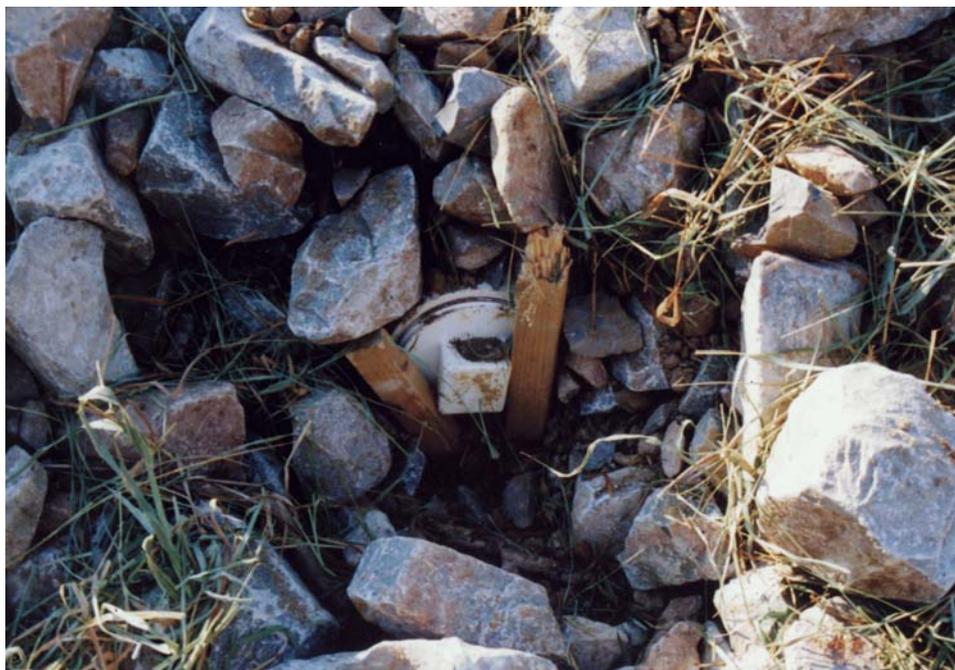
4" Alternate discharge pipe for Vertical Flow Pond. (11/19/99)

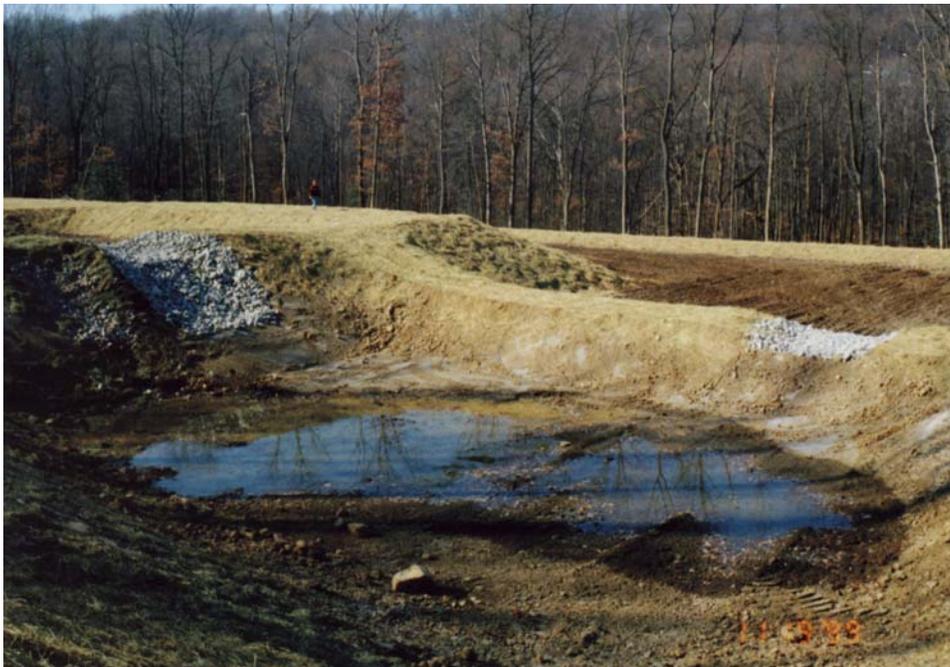
Settling Pond #2 before water began flowing through the passive treatment system. (11/19/99)

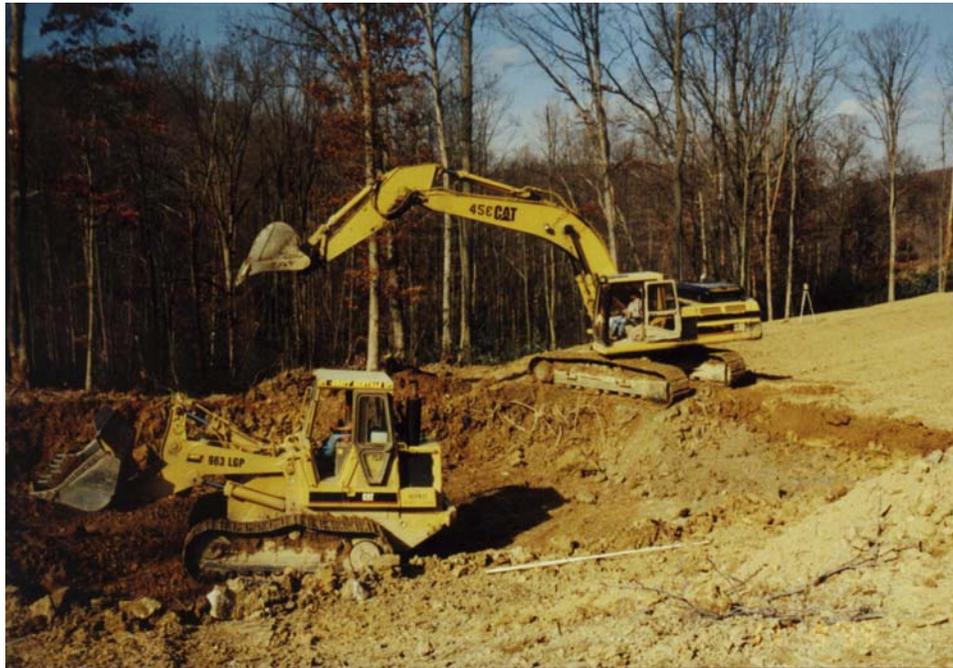
Construction of 500 ton Horizontal Flow Limestone Bed.
(11/9/99)

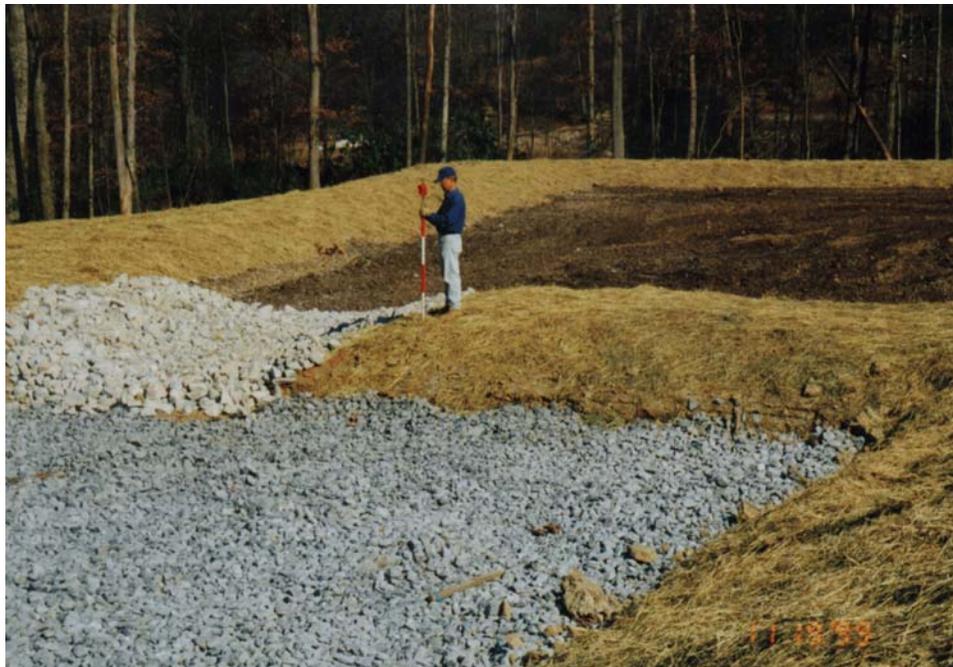
Spillway from 11,000 SF Wetland to Horizontal Flow Limestone Bed containing 500 ton of AASHTO #1 aggregate. Rodman surveying for "As-Builts." (11/19/99)

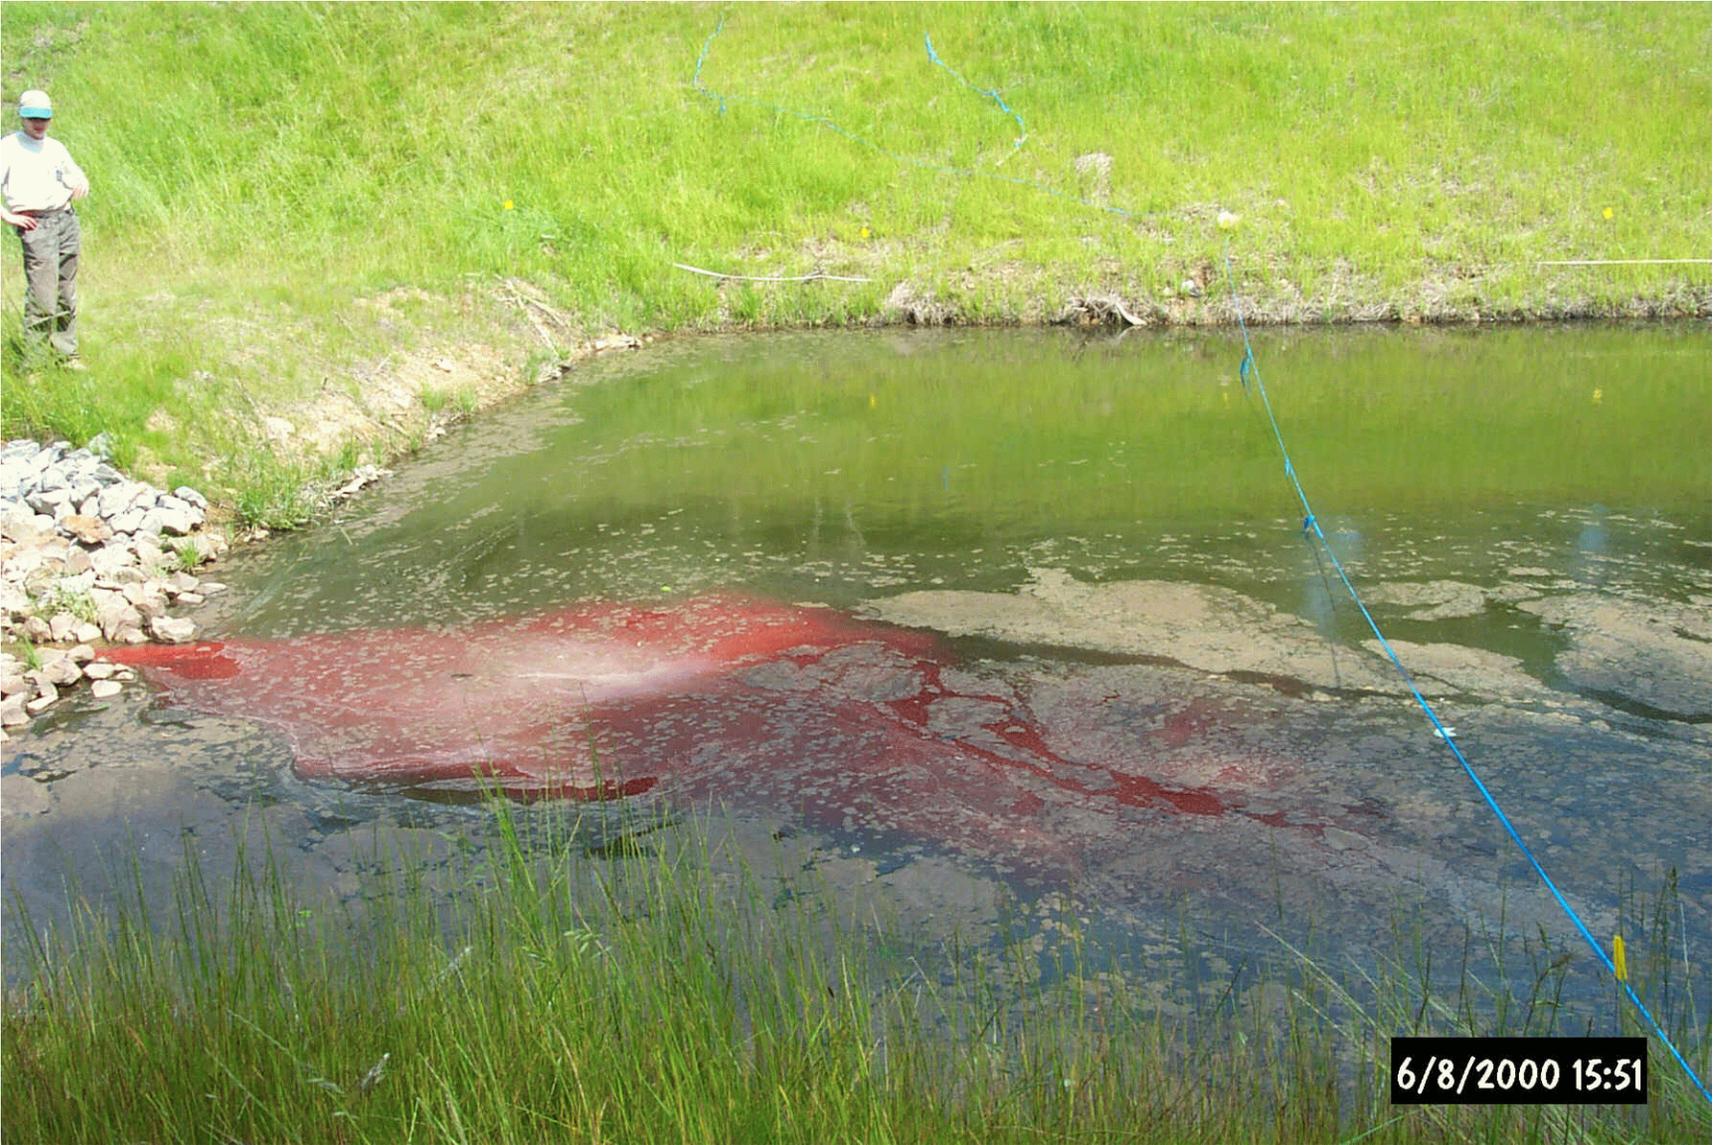
rcy Peart, Stream Restoration, Inc., looking over dye quickly moving through the HFLB.

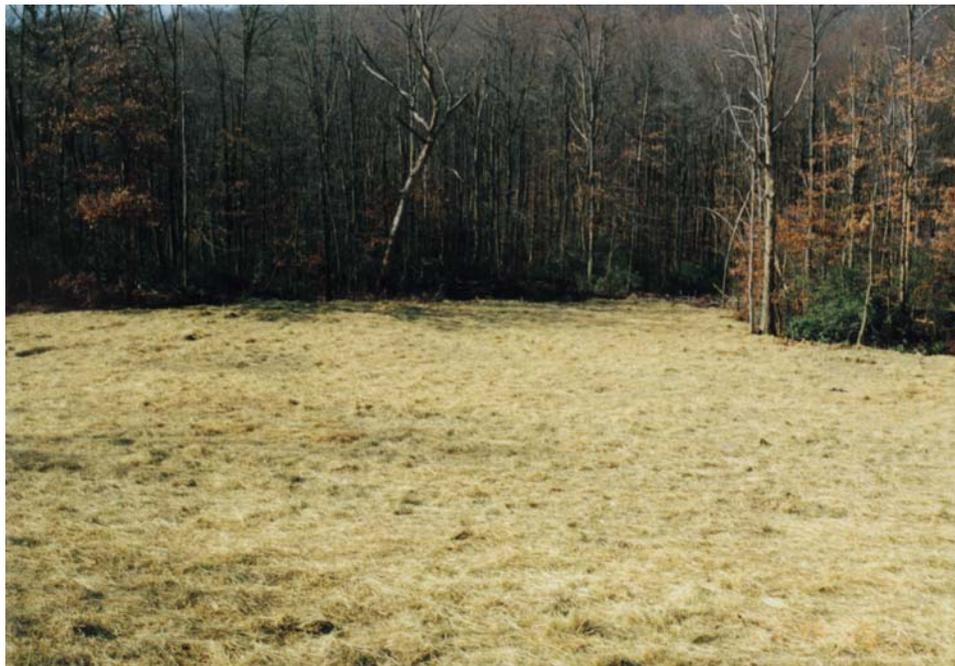
Revegetation: seed, fertilizer, lime, and mulch in former iron precipitate coated dead area. (11/19/99)

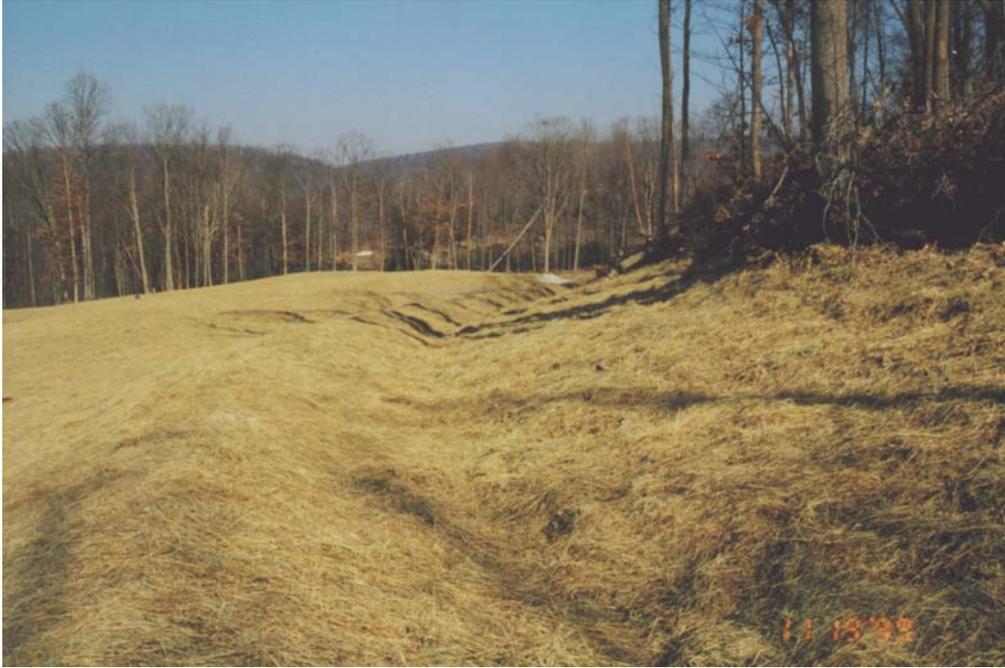
Above: Diversion ditch (looking northerly) preventing surface water runoff from entering the passive treatment system. (11/19/99)

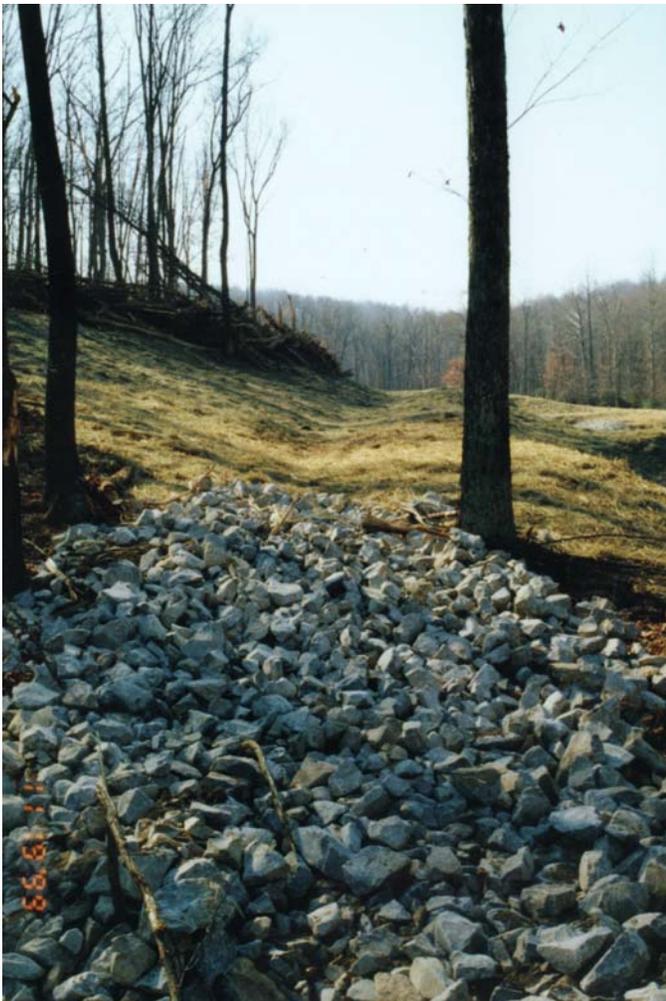
Left: Energy dissipator/level spreader at end of upland diversion ditch. (11/19/99)

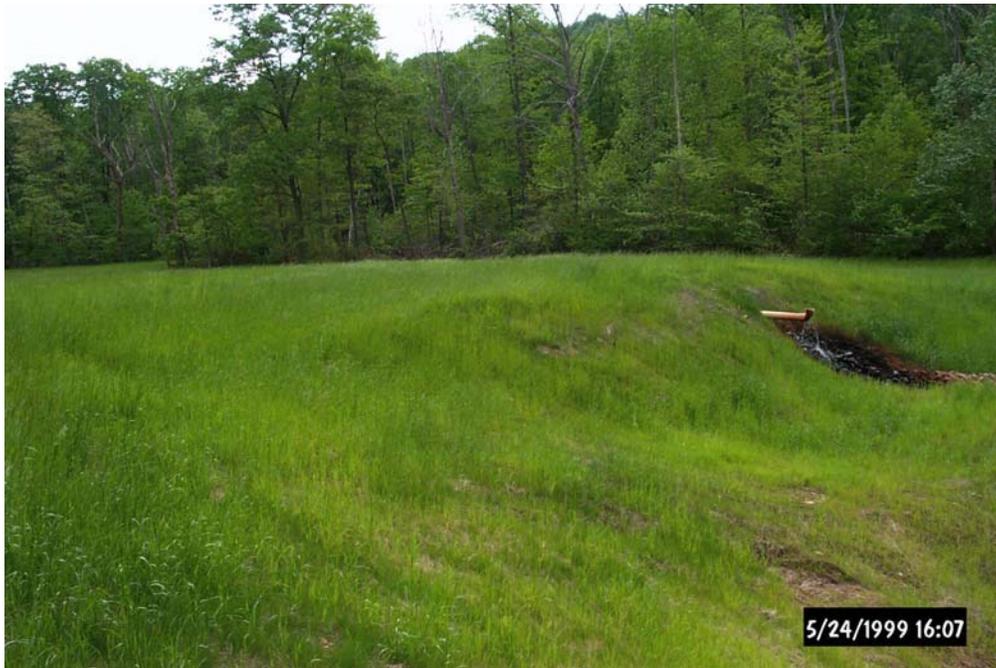
Successful revegetation above Anoxic Limestone Drain six months after seeding.

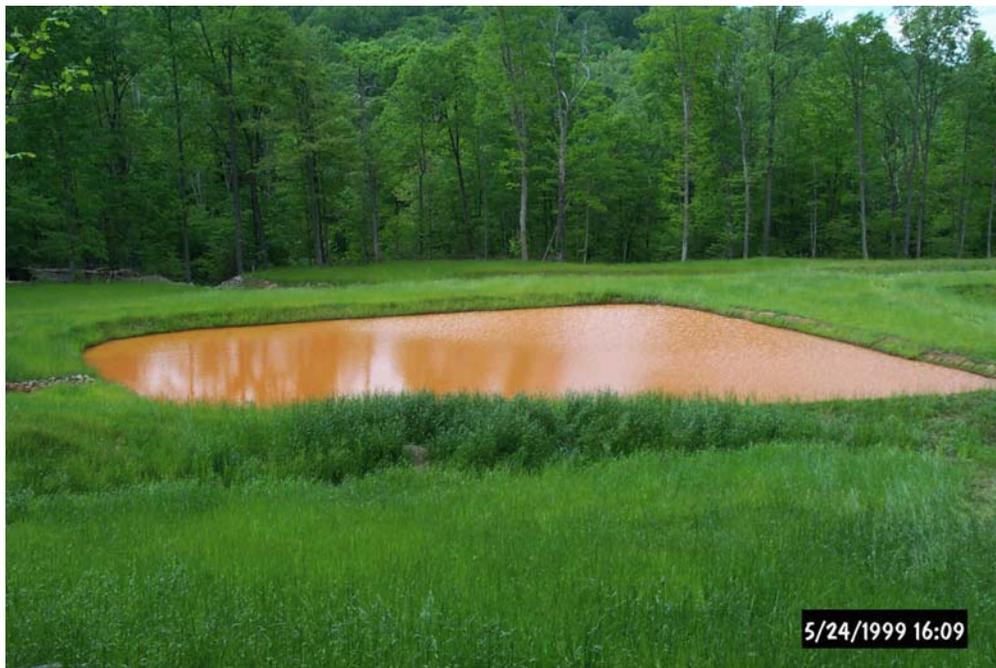
Iron solids in settling pond #1.

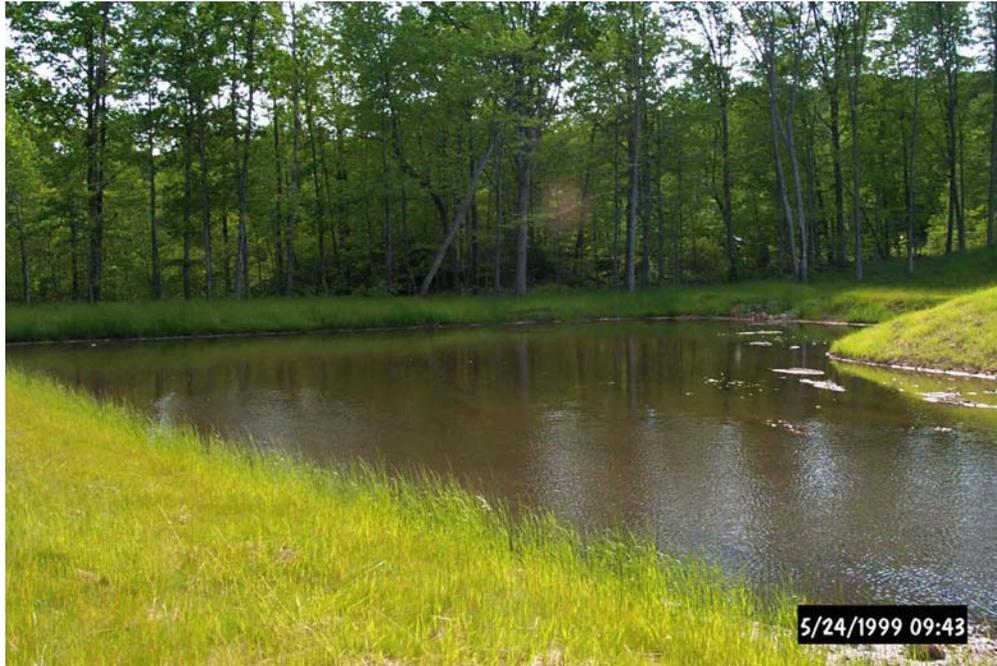
Successful revegetation after 6 months looking towards wetland before planting.
