BC19 & BC19B REMEDIATION PROJECT FINAL REPORT

**Public Private Partnership Effort
Marion Township, Butler County, PA**

Re: Final Report for Project # NW20377
Growing Greener – Environmental Stewardship and Watershed Protection Grant
ME#3521010
BC19 & BC19B Remediation Project, Blacks Creek in Slippery Rock Creek Watershed
Marion Township, Butler County, PA

Final Report

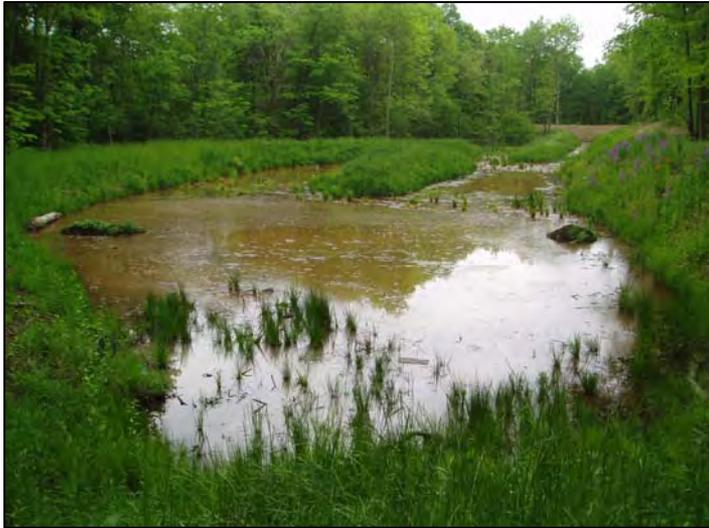
Photo 1: Treatment Wetland of the BC19/19B Remediation Project, Photopoint 1 (6-4-05)

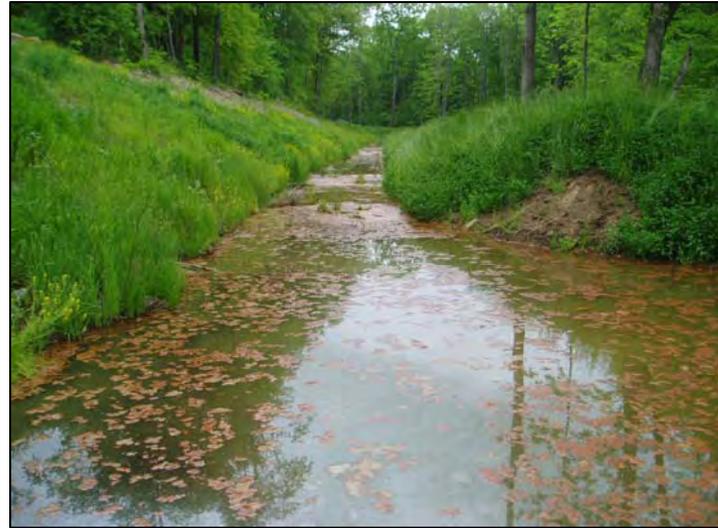
Photo 2: Plunge pool below BC19B discharge, Photopoint 6 (6-4-05)

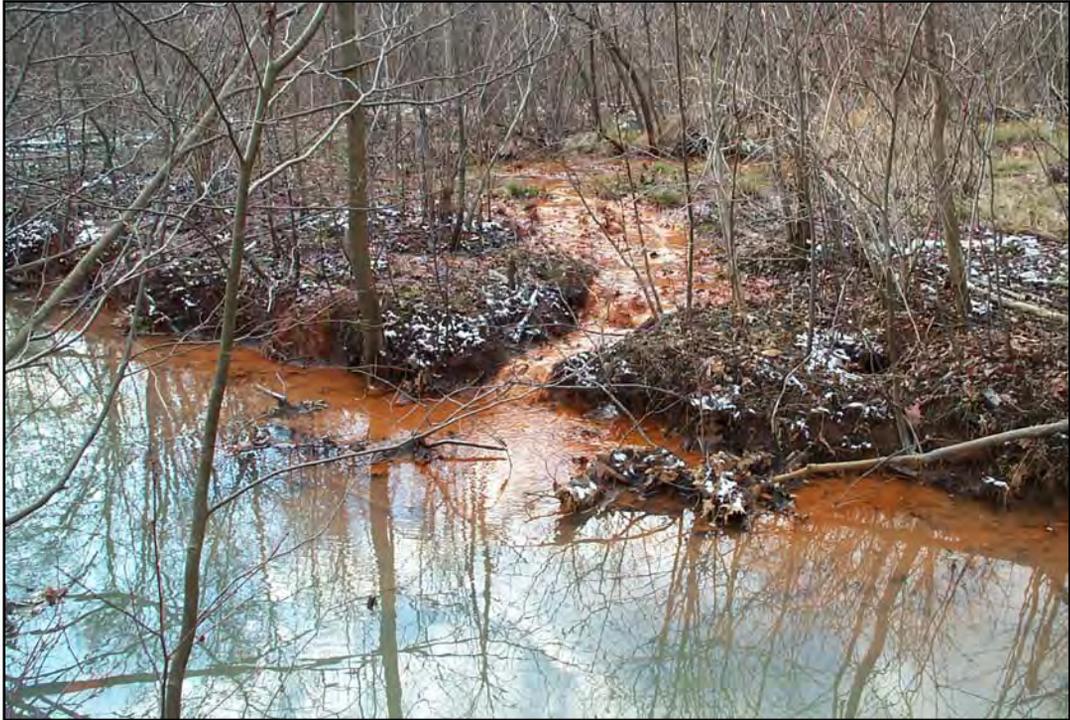
BC 19 discharge entering Blacks Creek. This discharge produces approximately 3,200 lbs/yr of iron and 1,000 lbs/yr of manganese.

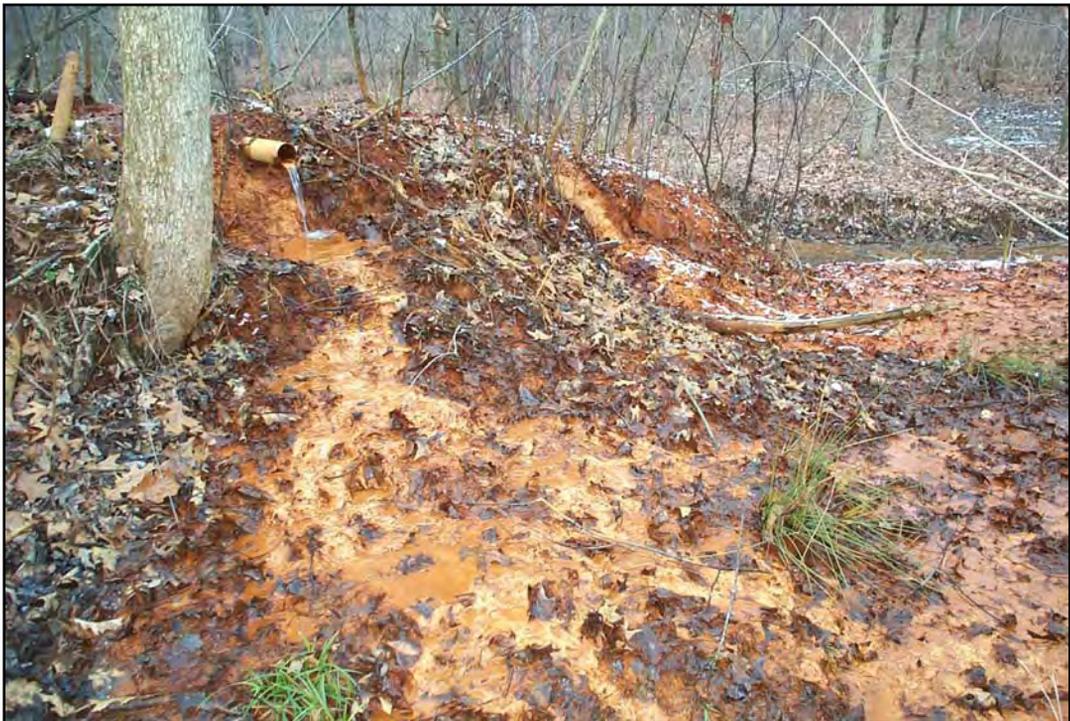
BC 19B discharge. This discharge produces approximately 3,100 lbs/yr of iron and 900 lbs/yr of manganese. Blacks Creek is visible in the background.

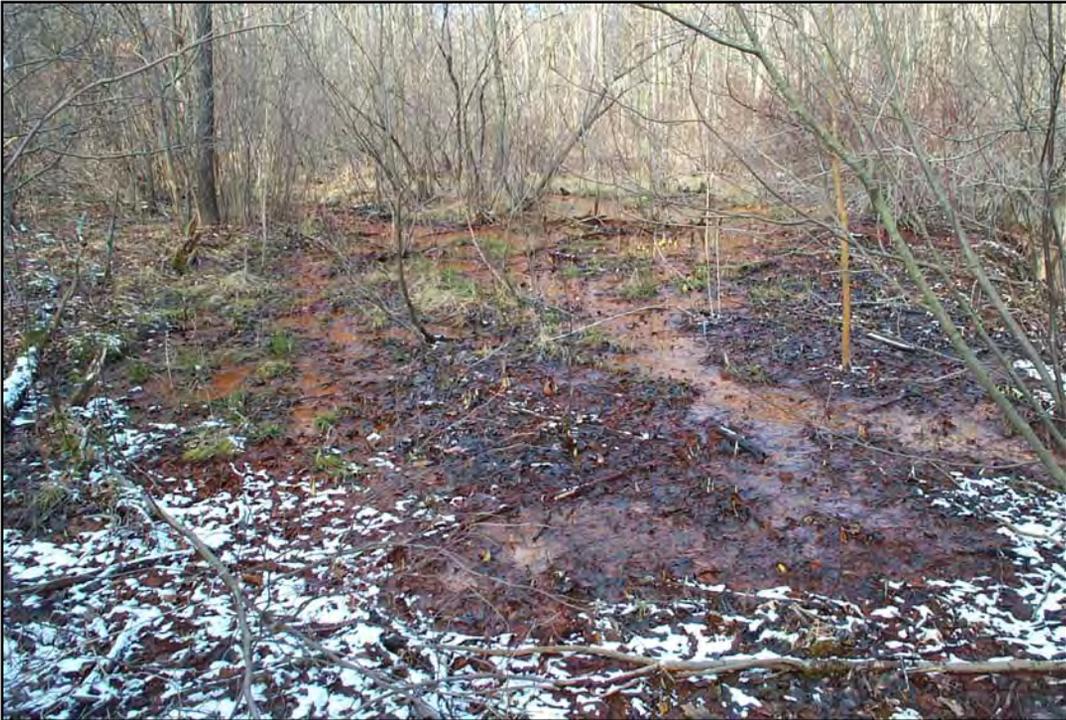
The flows from the BC 19 discharge pass through a portion of this degraded wetland before entering Blacks Creek.

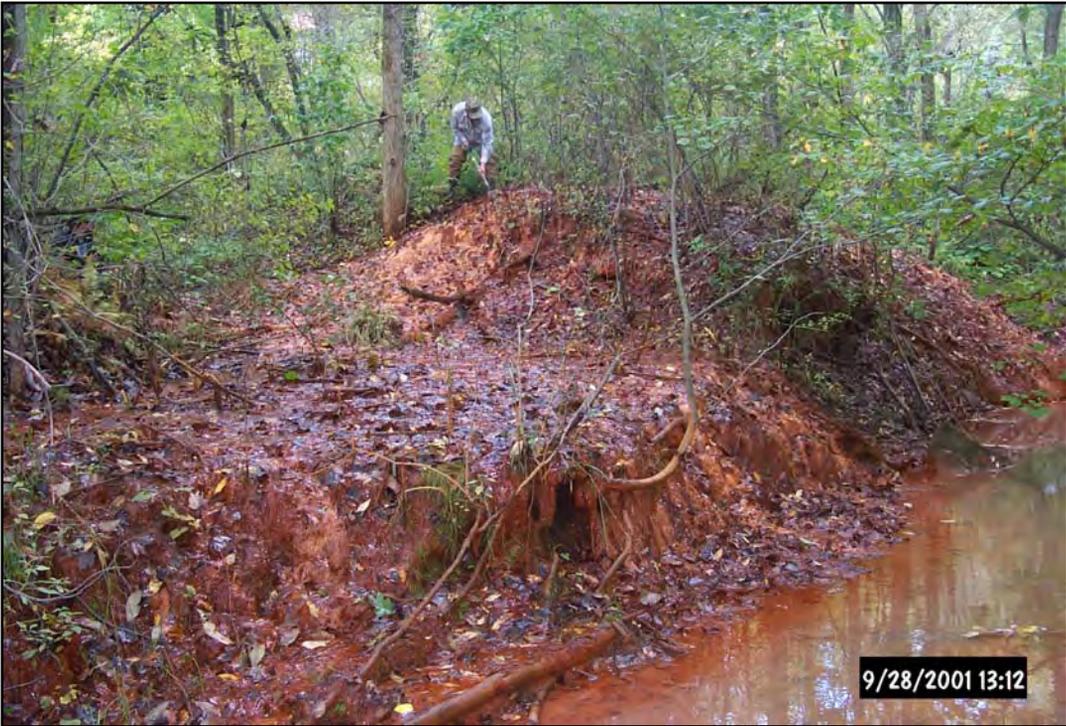
Tim Gillen, PA DEP Knox DMO, installing a pipe to measure flow from the upwelling of abandoned oil well BC19B.

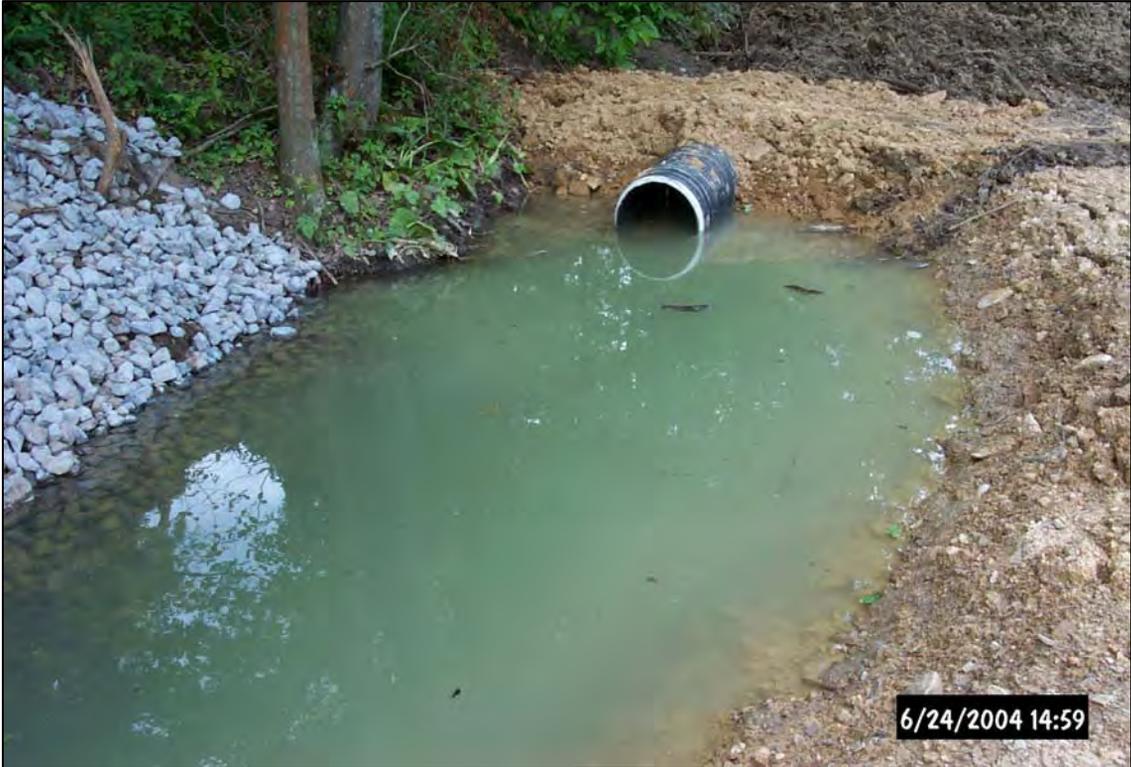
Plunge pool and culvert for diversion of surface flows from passive treatment system.

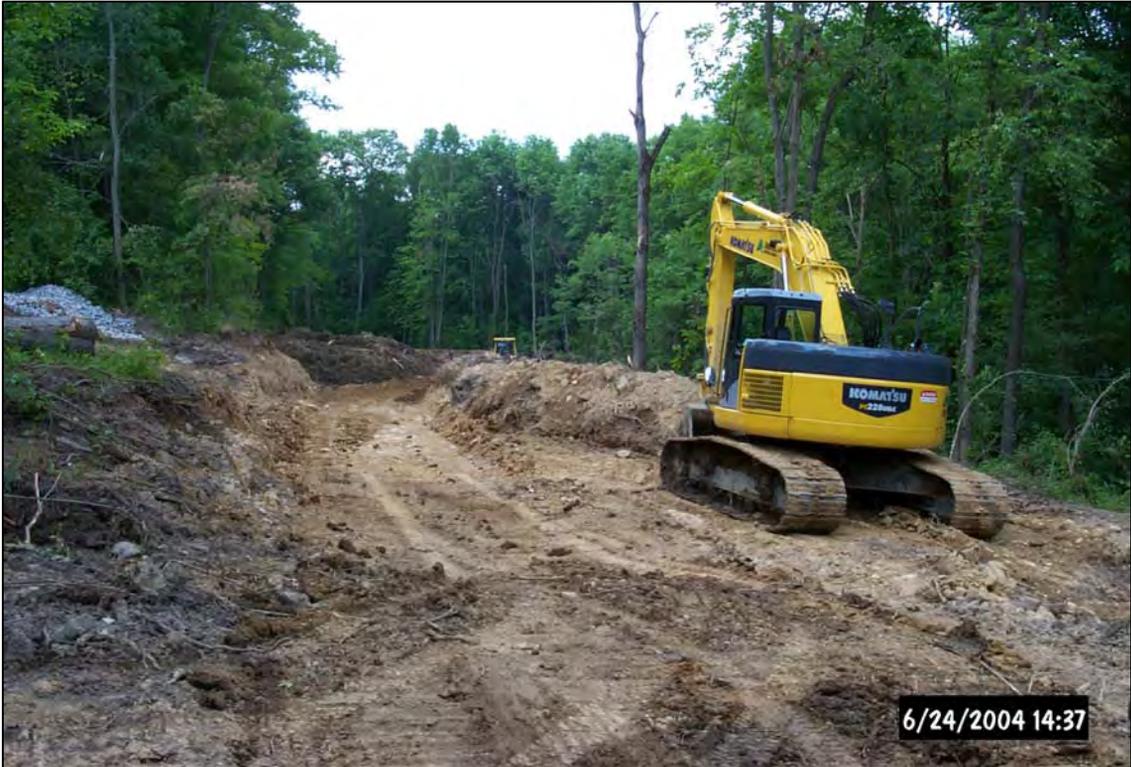
Early earth moving with excavator in the area of the BC19B discharge.

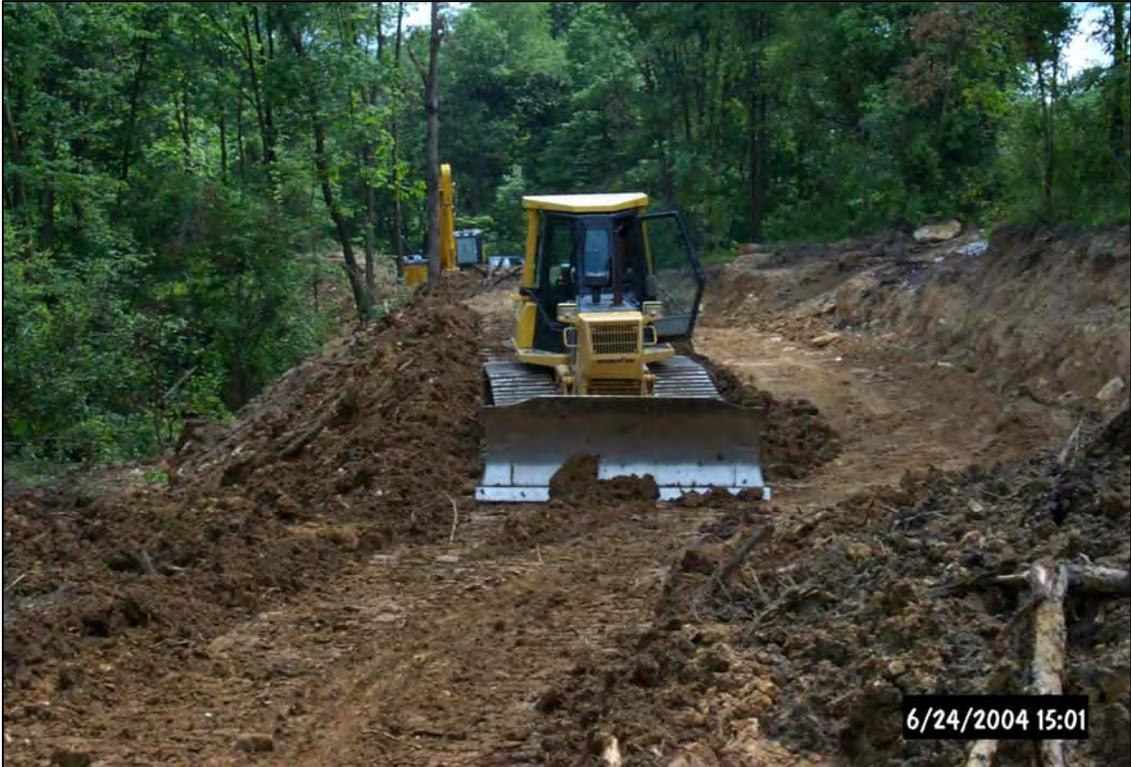
Early earth moving with bulldozer in area of the bioswale and berm.

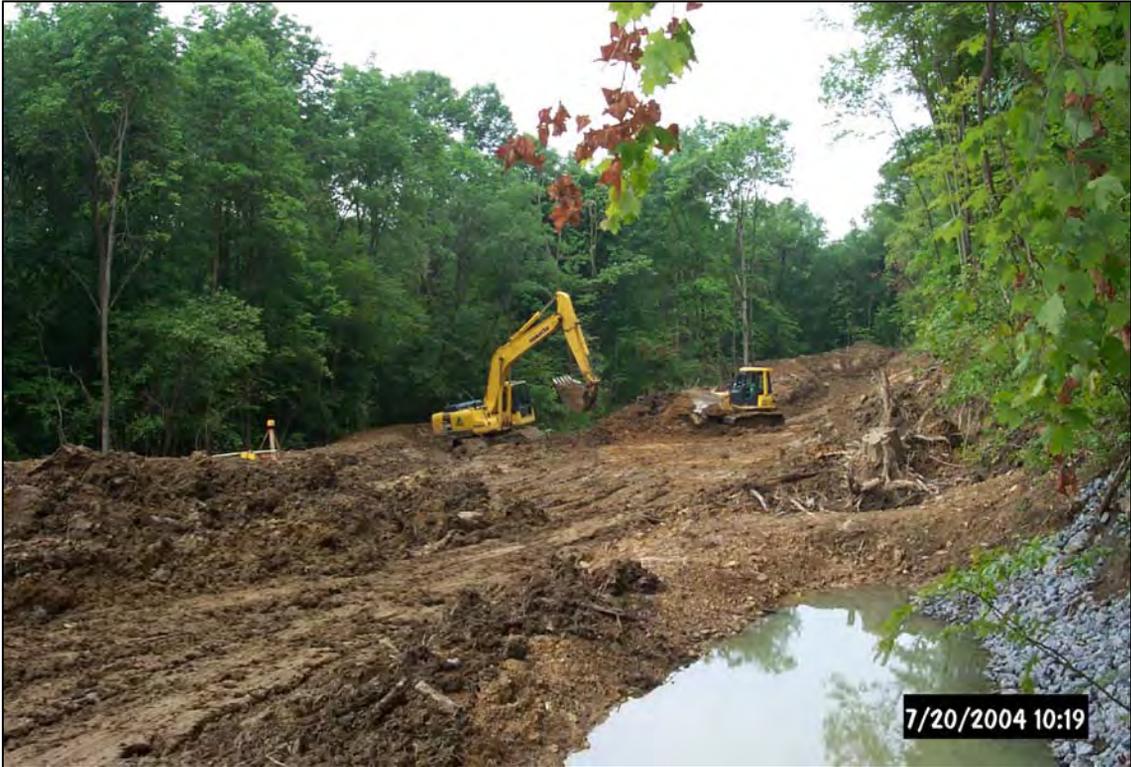
Plunge pool for surface water diversion in foreground. In background, earth moving with bulldozer and excavator in the area near the wetland outlet and berm of the bioswale.

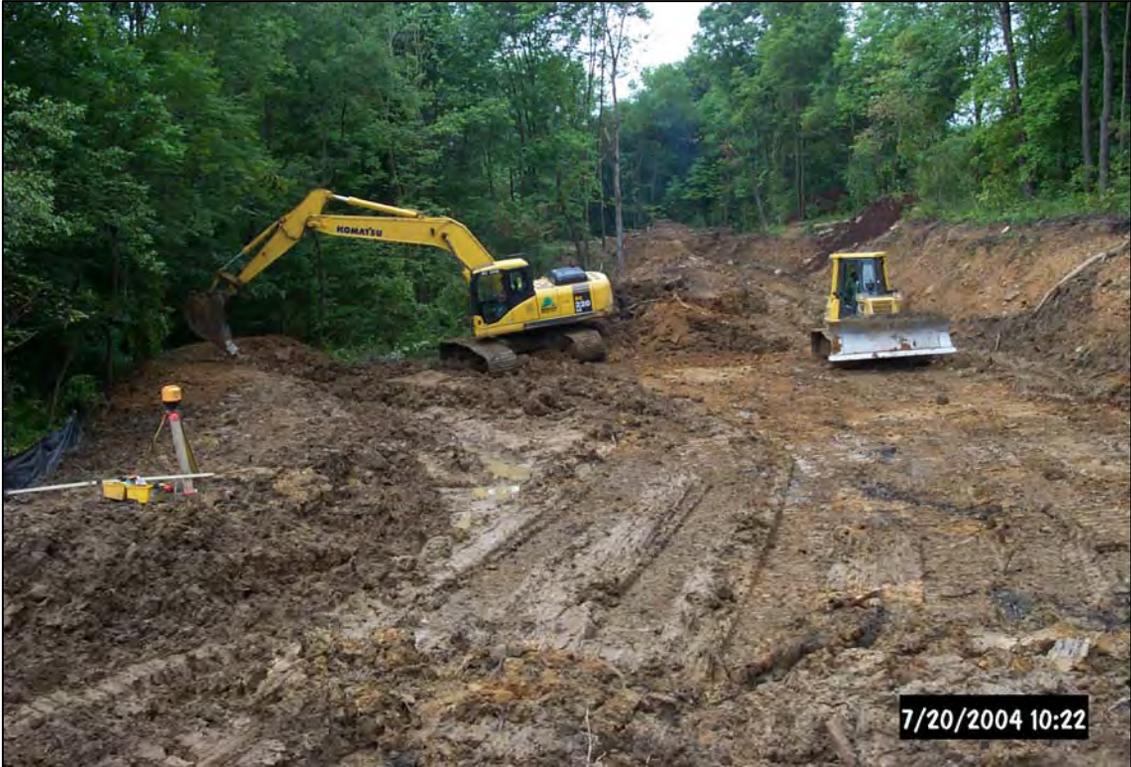
Wetland basin and berm construction near outlet and end of bioswale. Laser level and stadia rod utilized to maintain grades throughout construction.

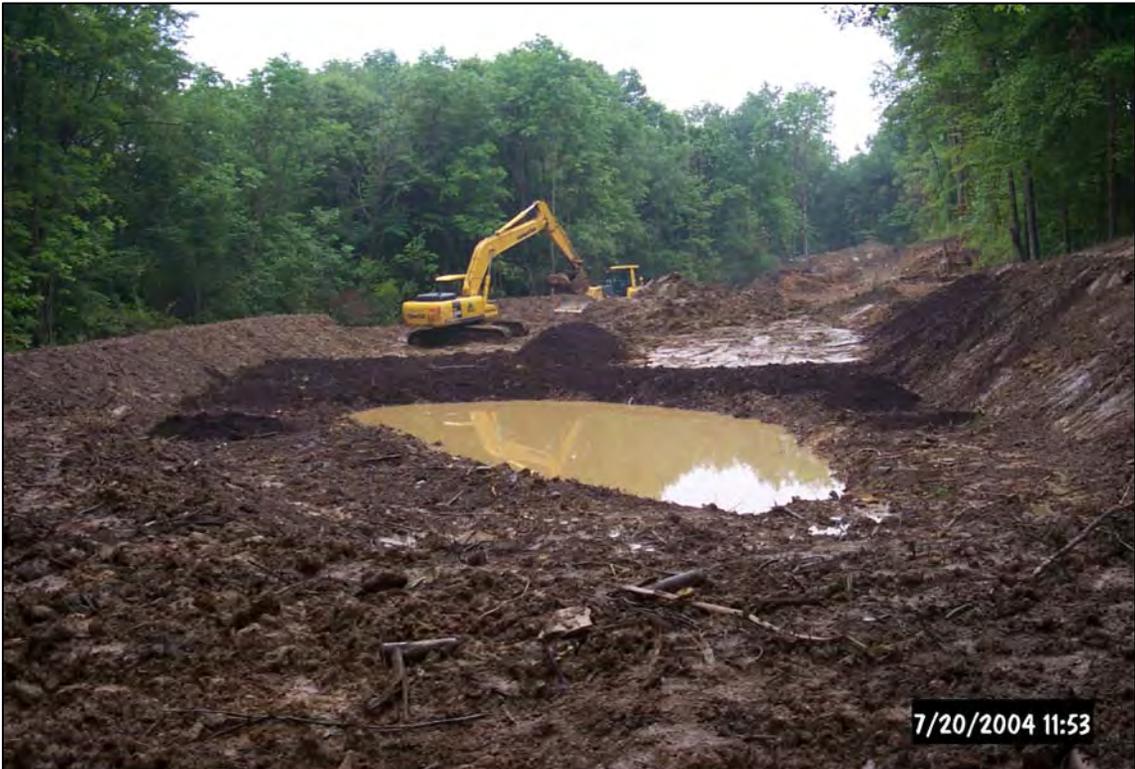
Excavator constructing berm in the area of the BC19 discharge to direct flows to the drop structure visible in the foreground.

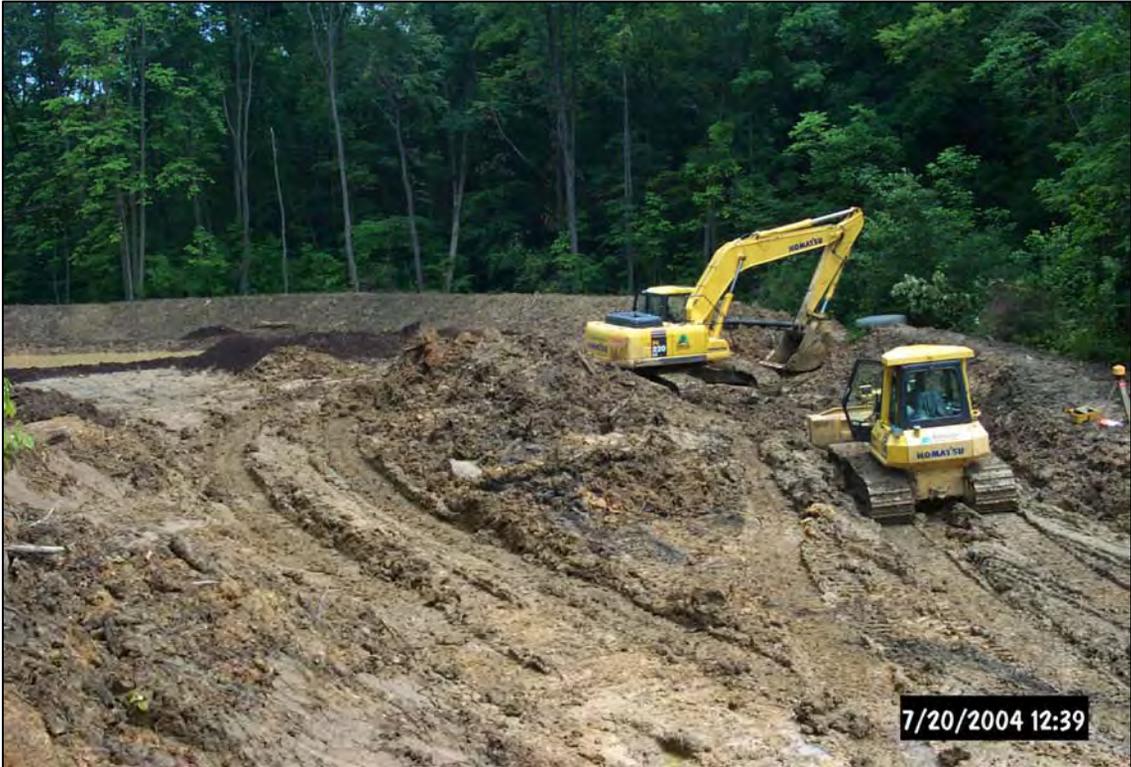
Continued construction of wetland basin and berms in the area of the BC19B discharge.

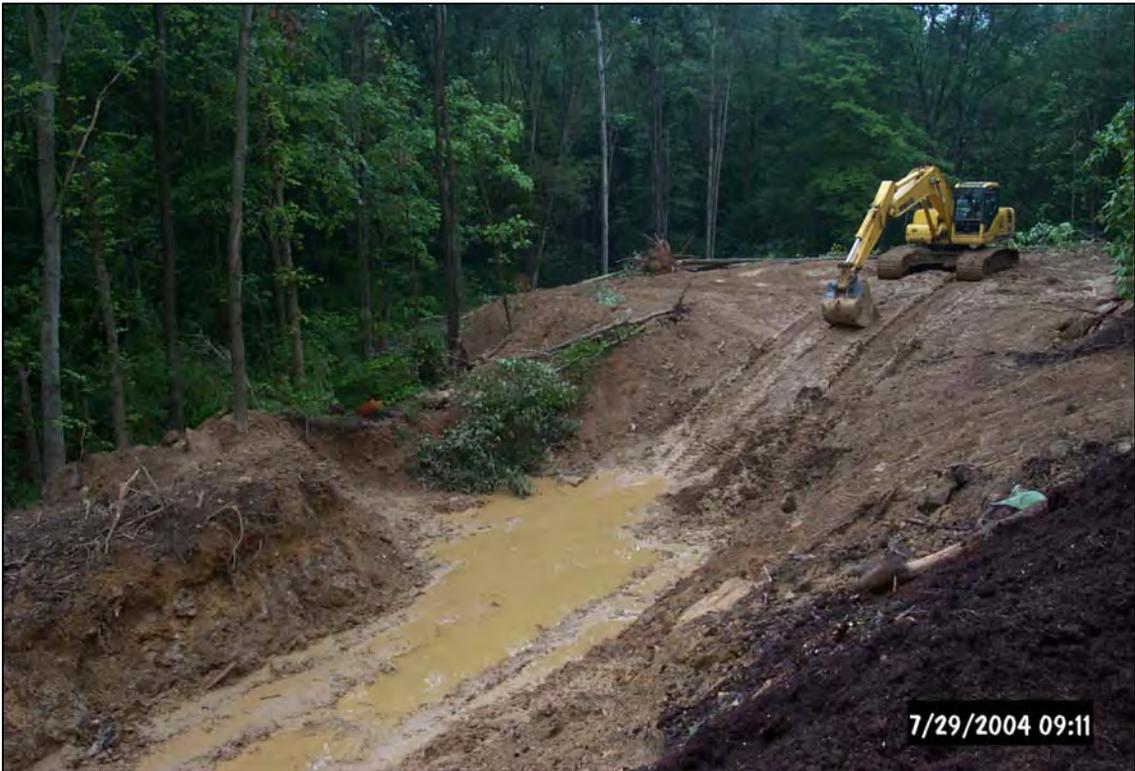
Excavator grading slope south near the drop structure for the BC19B discharge.

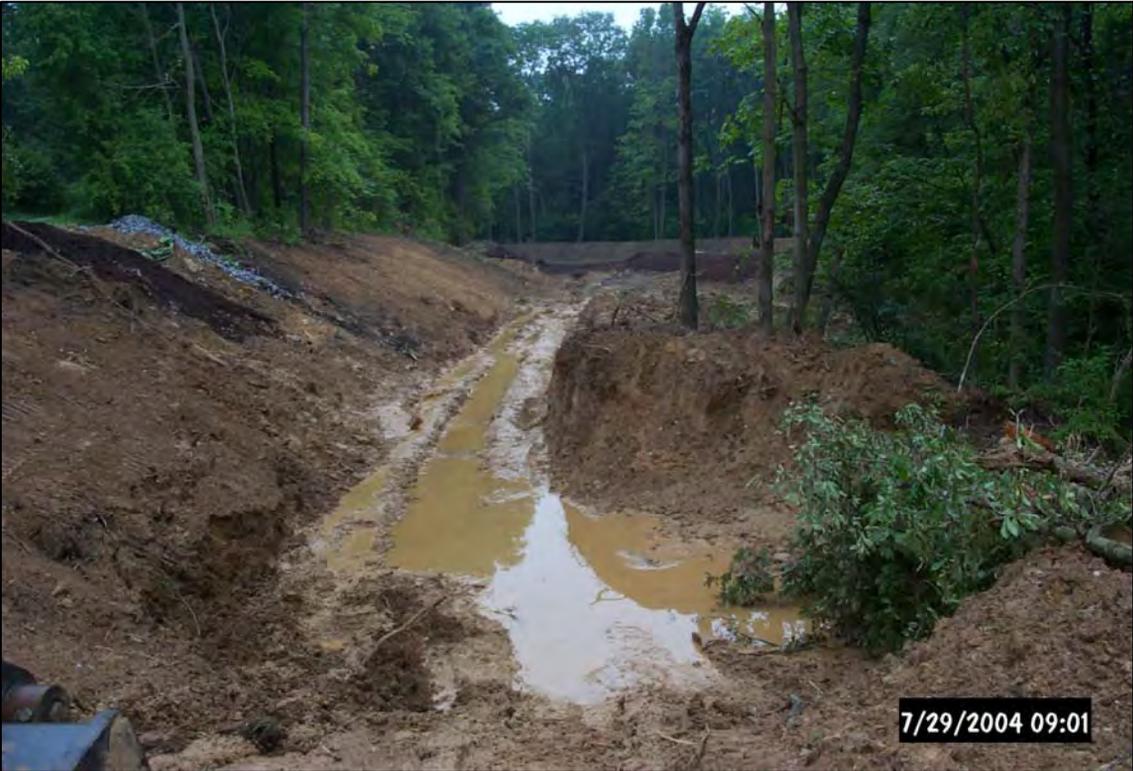
Plunge pool near the BC19B discharge and the bioswale conveying flows to the main basin of the treatment wetland.

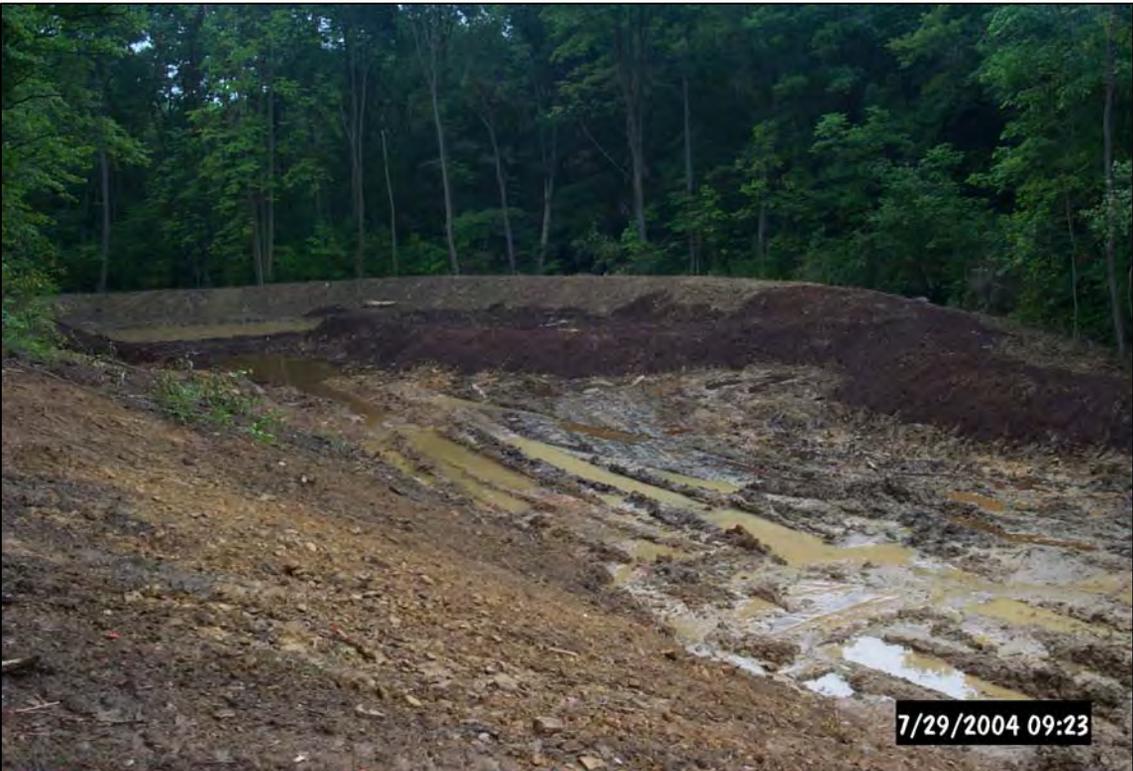
Main basin of treatment wetland.

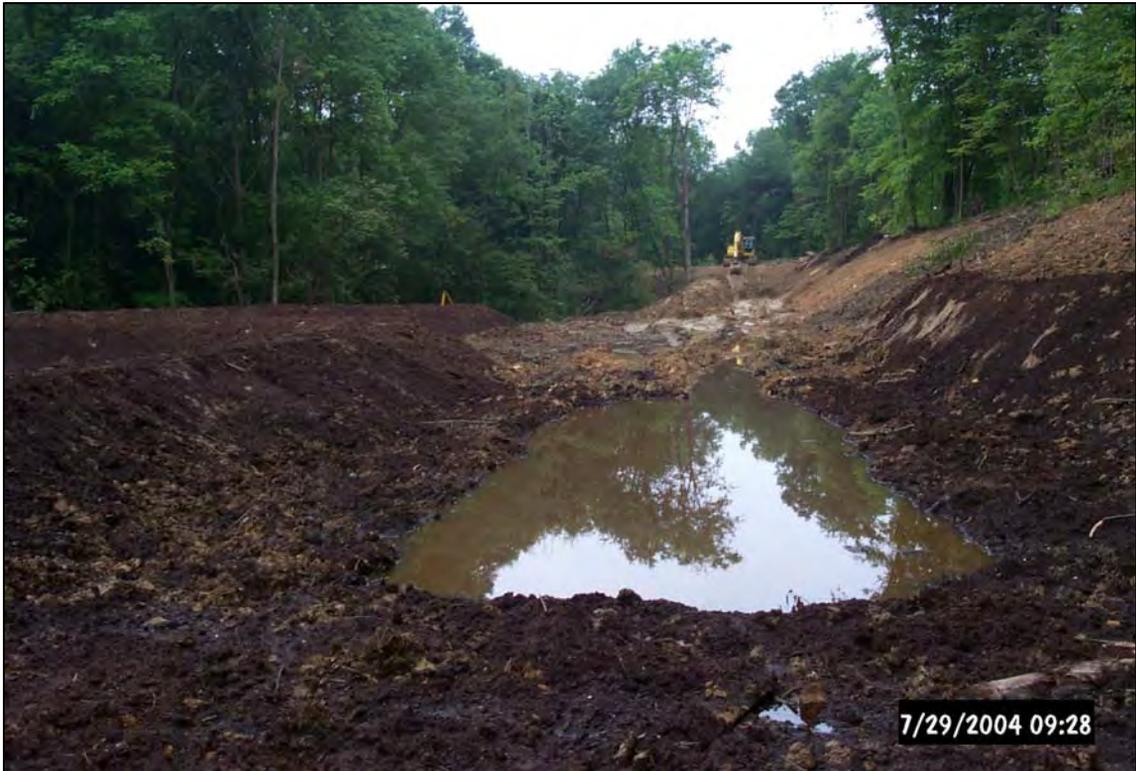
Plunge pool in the main basin of the treatment wetland near the end of the bioswale that conveys flows from the BC19B discharge.

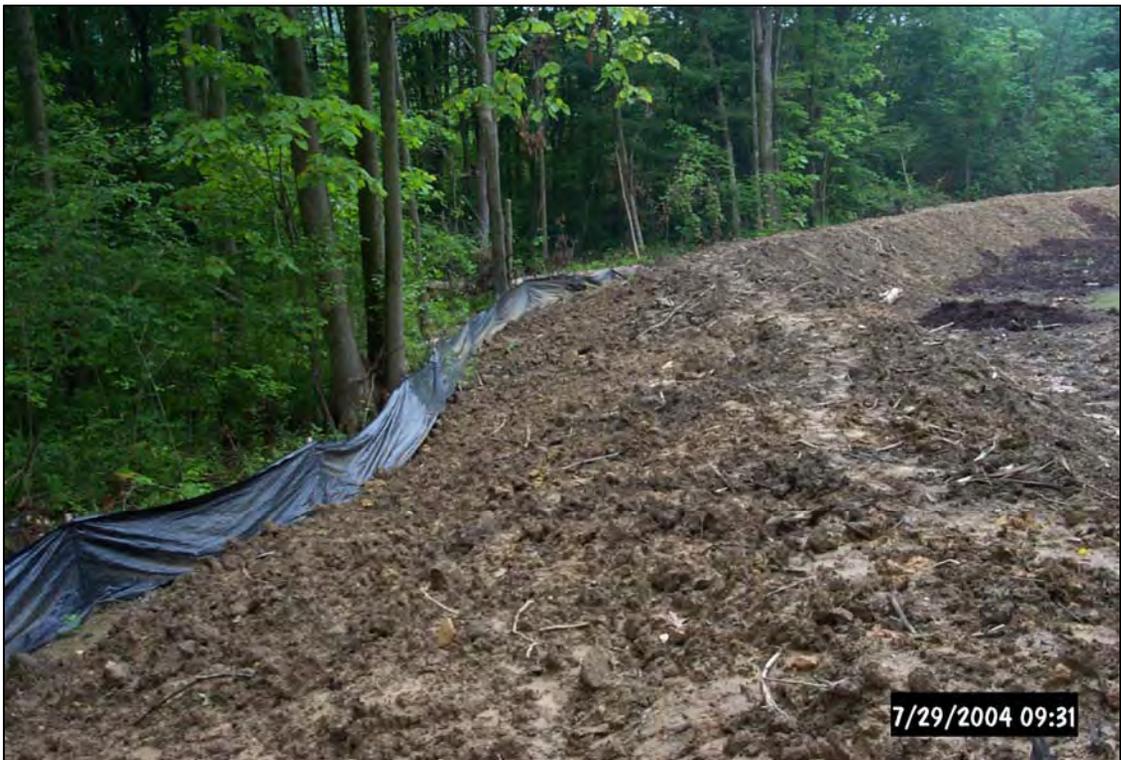
Silt fence located between the outside berm of the treatment wetland and the riparian buffer left adjacent to Blacks Creek.

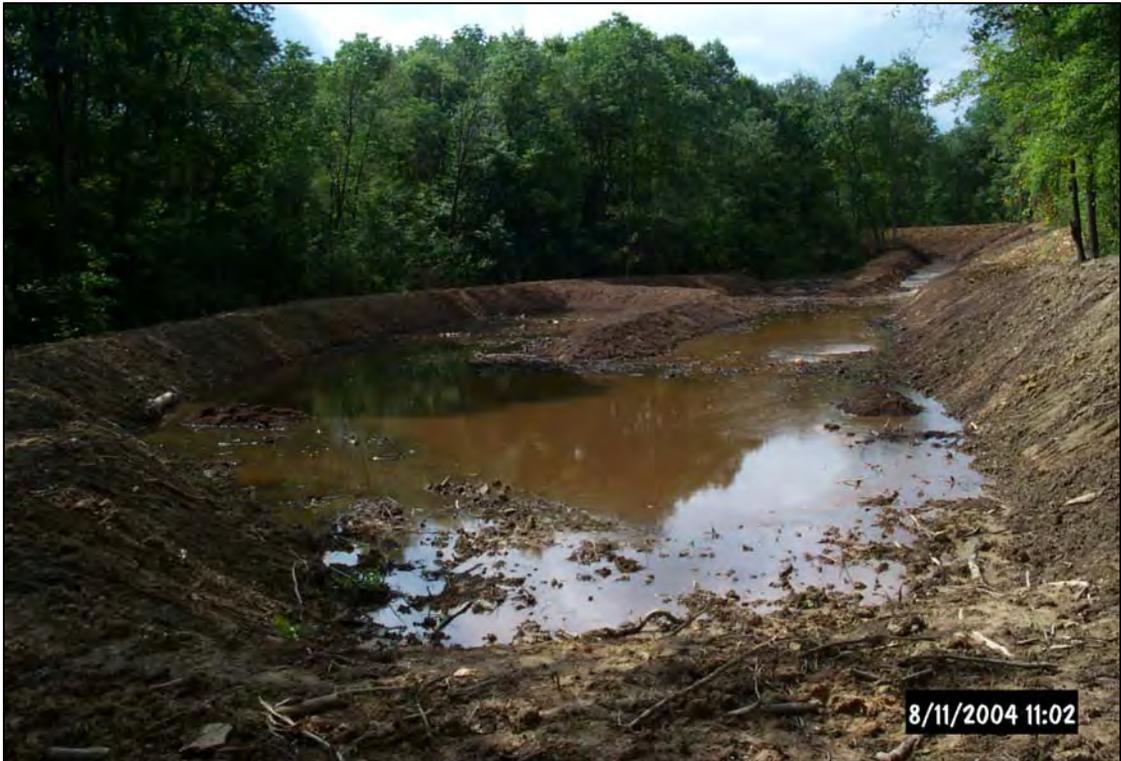
Main basin of treatment wetland. Facing south from the northern end..

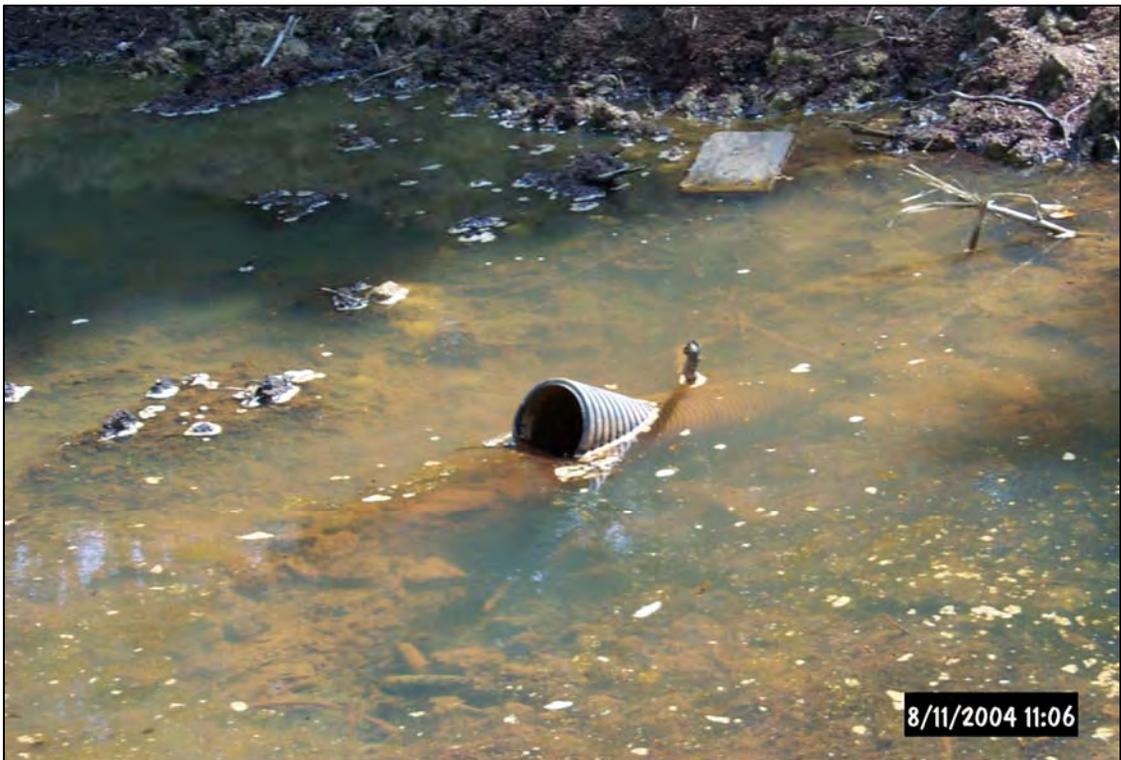
Area of the BC19 discharge within the treatment wetland.

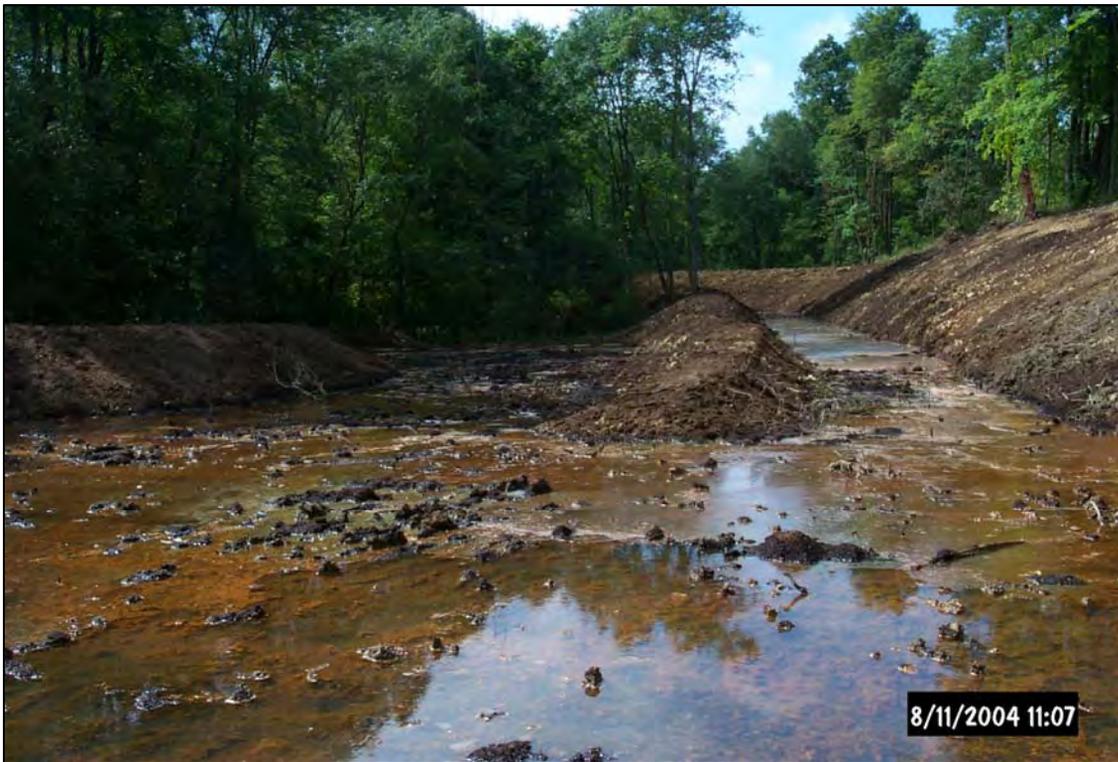
Main basin of treatment wetland. Facing south toward outlet and bioswale..

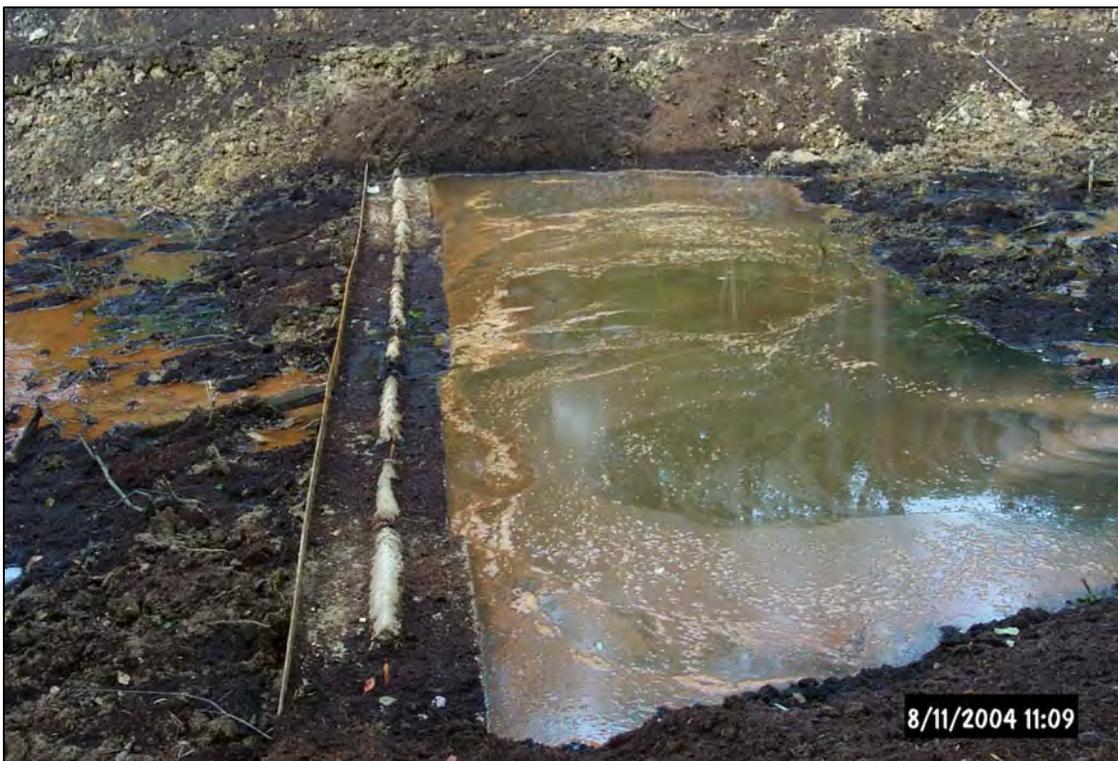
Drop structure and level spreader. The level spreader maintains consistent water levels within the main basin of the treatment wetland and creates an aerating sheet flow to the lower portion of the treatment wetland. This and other drop structures slow water velocities and allow for accumulation of metal precipitates.

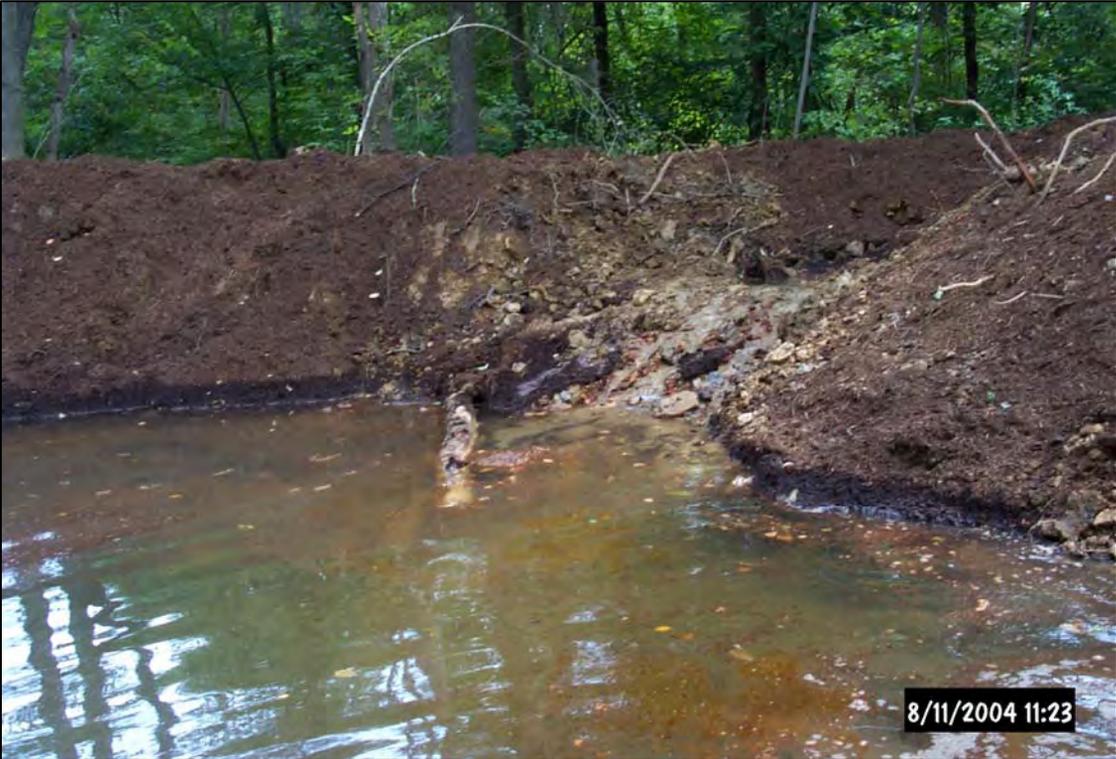
BC19B discharge entering drop structure of the treatment wetland.

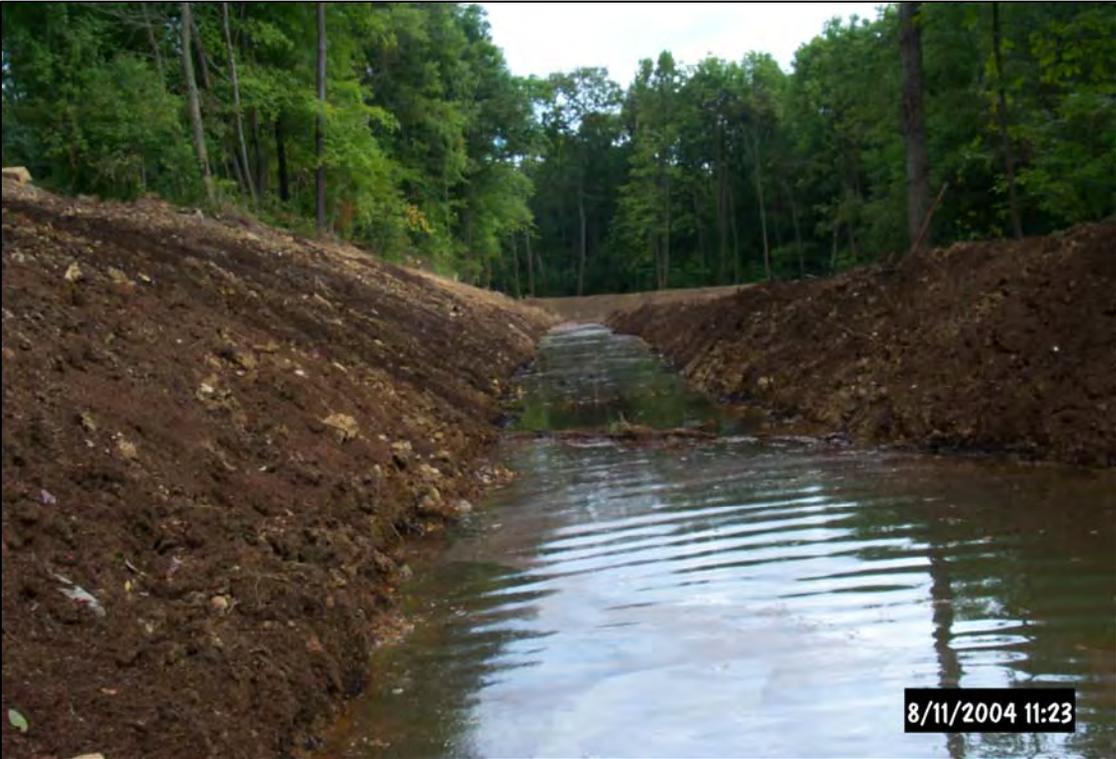
Bioswale conveying flows from the BC19B discharge to the main basin of the treatment wetland.
