Fox Run Restoration Project - Phase I

**Yellow Creek Watershed
Jackson Township
Mercer County, Pennsylvania**

Re: Final Report
ME# 352997; Project # NW-20194
Fox Run Restoration Area – Phase I
Jackson Township, Mercer County, PA
870102/01 FR-trans 87

FOX RUN Restoration Area - PHASE 1: FINAL REPORT
Jackson Township, Mercer County, PA

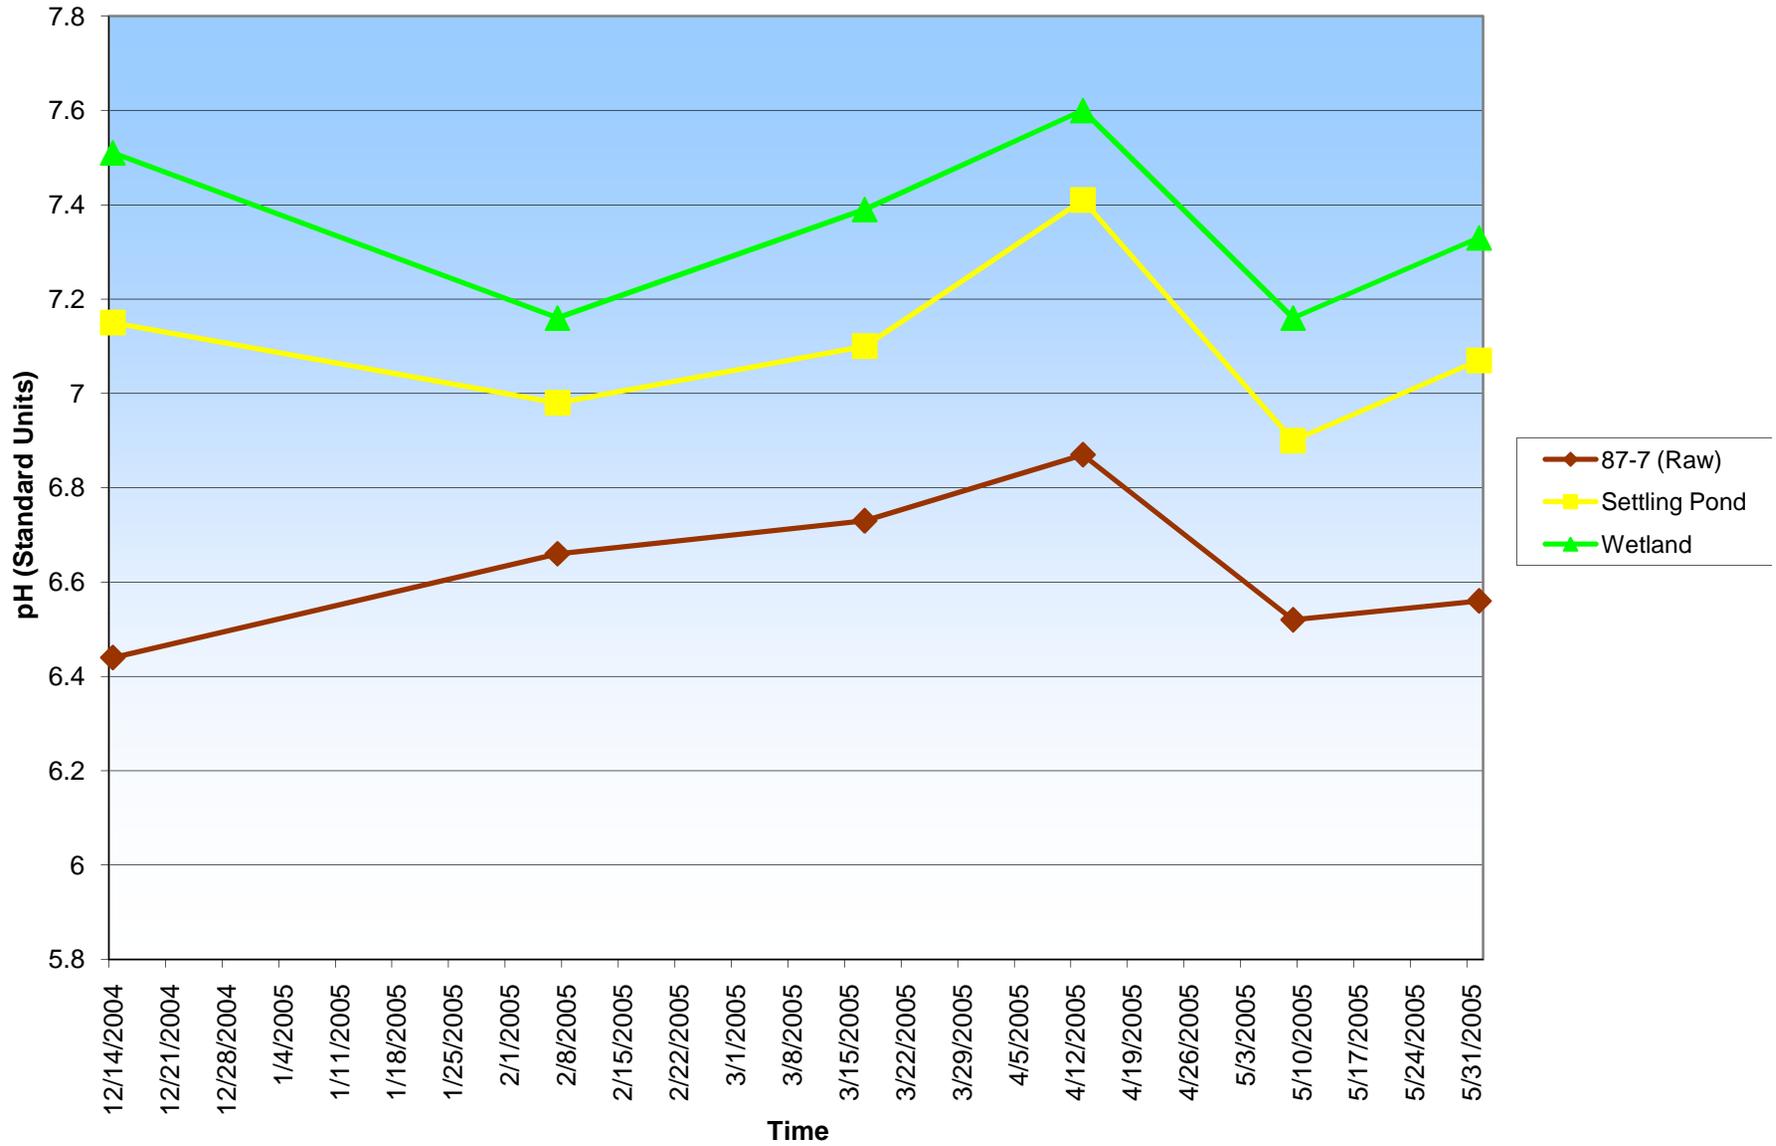
Figure 6.

Comparison of pH Throughout the Fox Run Phase I Passive Treatment System Over Time

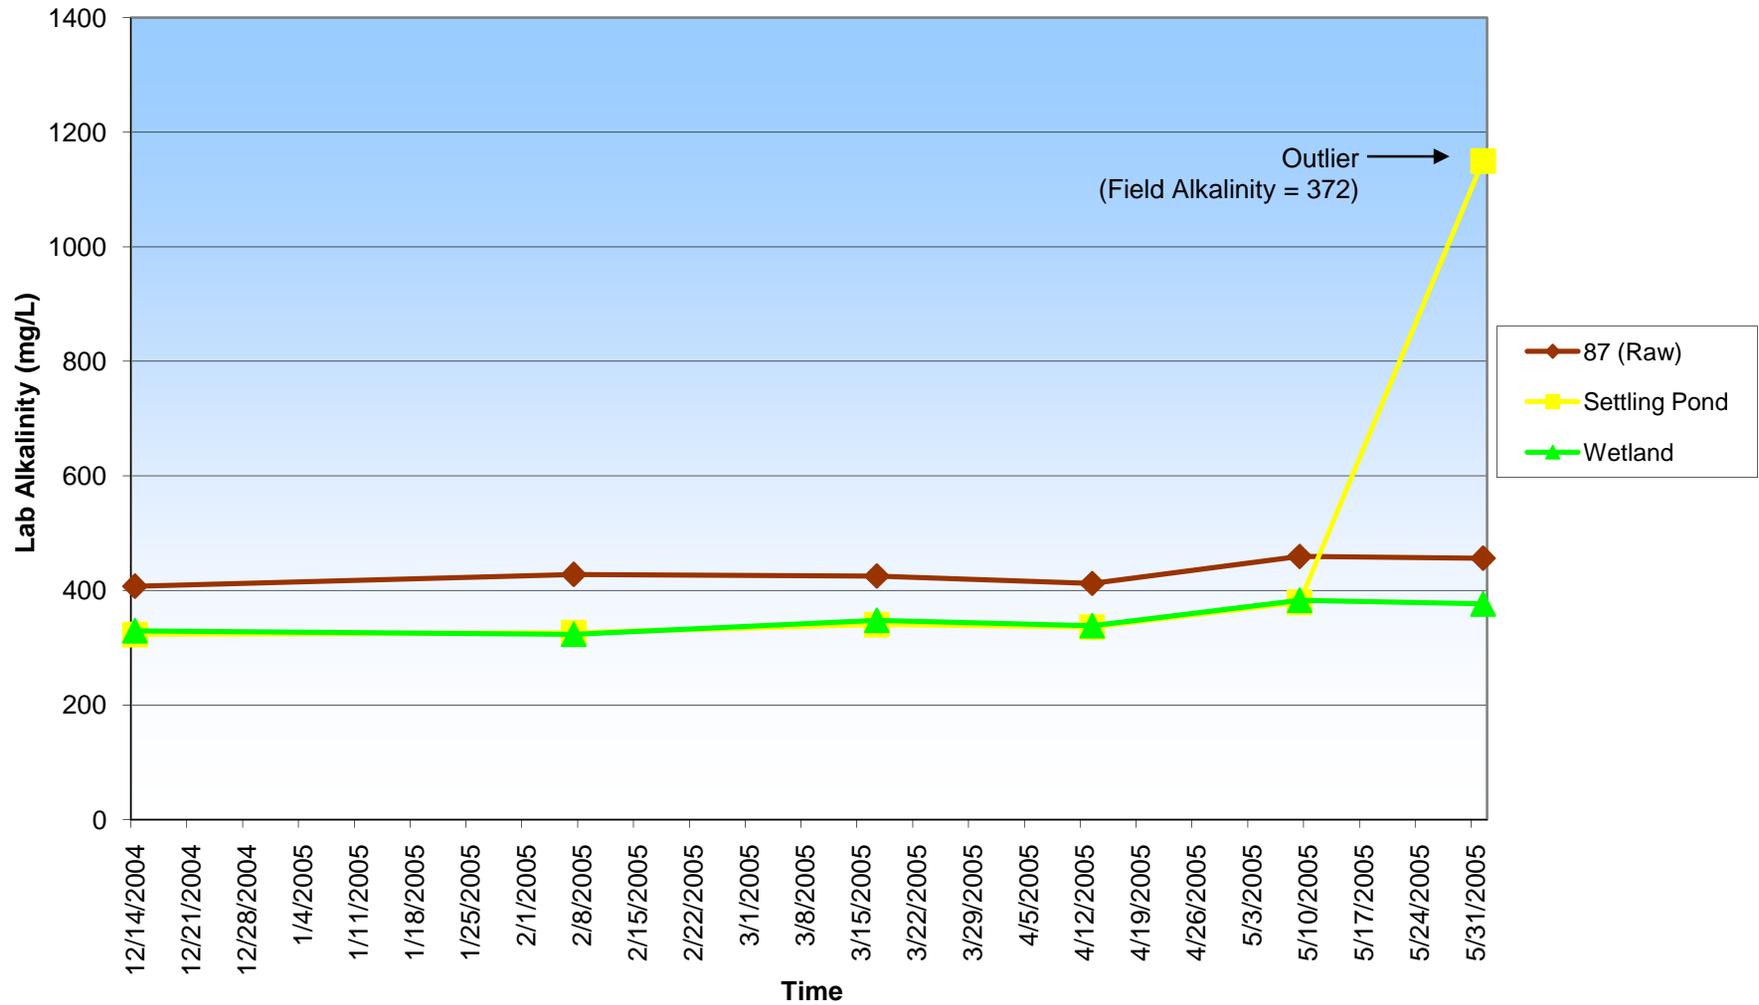
Figure 7.

Comparison of Lab Alkalinity Through Fox Run Phase I Passive Treatment System Over Time

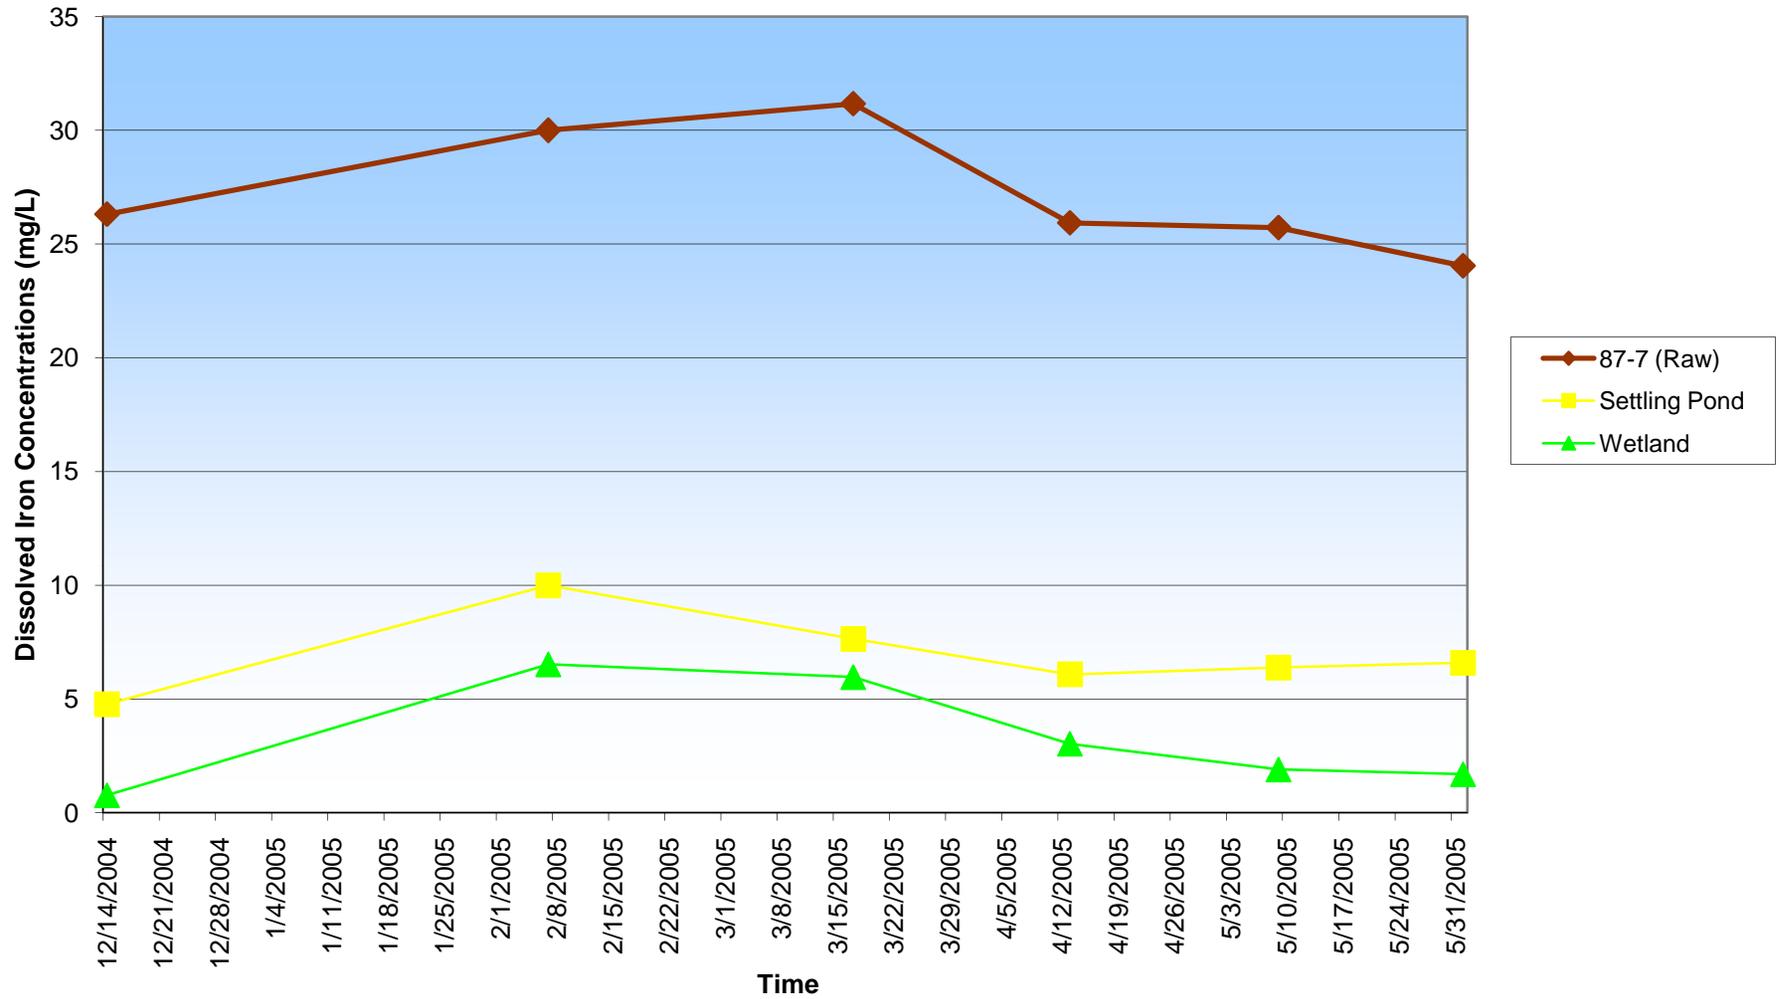
Figure 8.

Comparison of Dissolved Iron Concentrations Through the Fox Run Phase I Passive Treatment System Over Time

Comparing only the concentration of the raw water at discharge 87-7 with the final effluent of the system, approximately 80% of the iron is being retained within the passive treatment system. Based upon the pre-construction monitoring for discharge 87-7, the estimated iron loading to be retained in the passive system was 1,500 lbs per year. Using average pre-construction flow data and post-construction concentration, the estimate has been increased by over 2.5x to approximately 4,000 lbs per year. As about 9 other degraded seeps were encountered and captured by the passive system, which is a typical occurrence during construction in a discharge zone, the actual amount of iron solids retained probably exceeds more than 4,000 lbs per year.

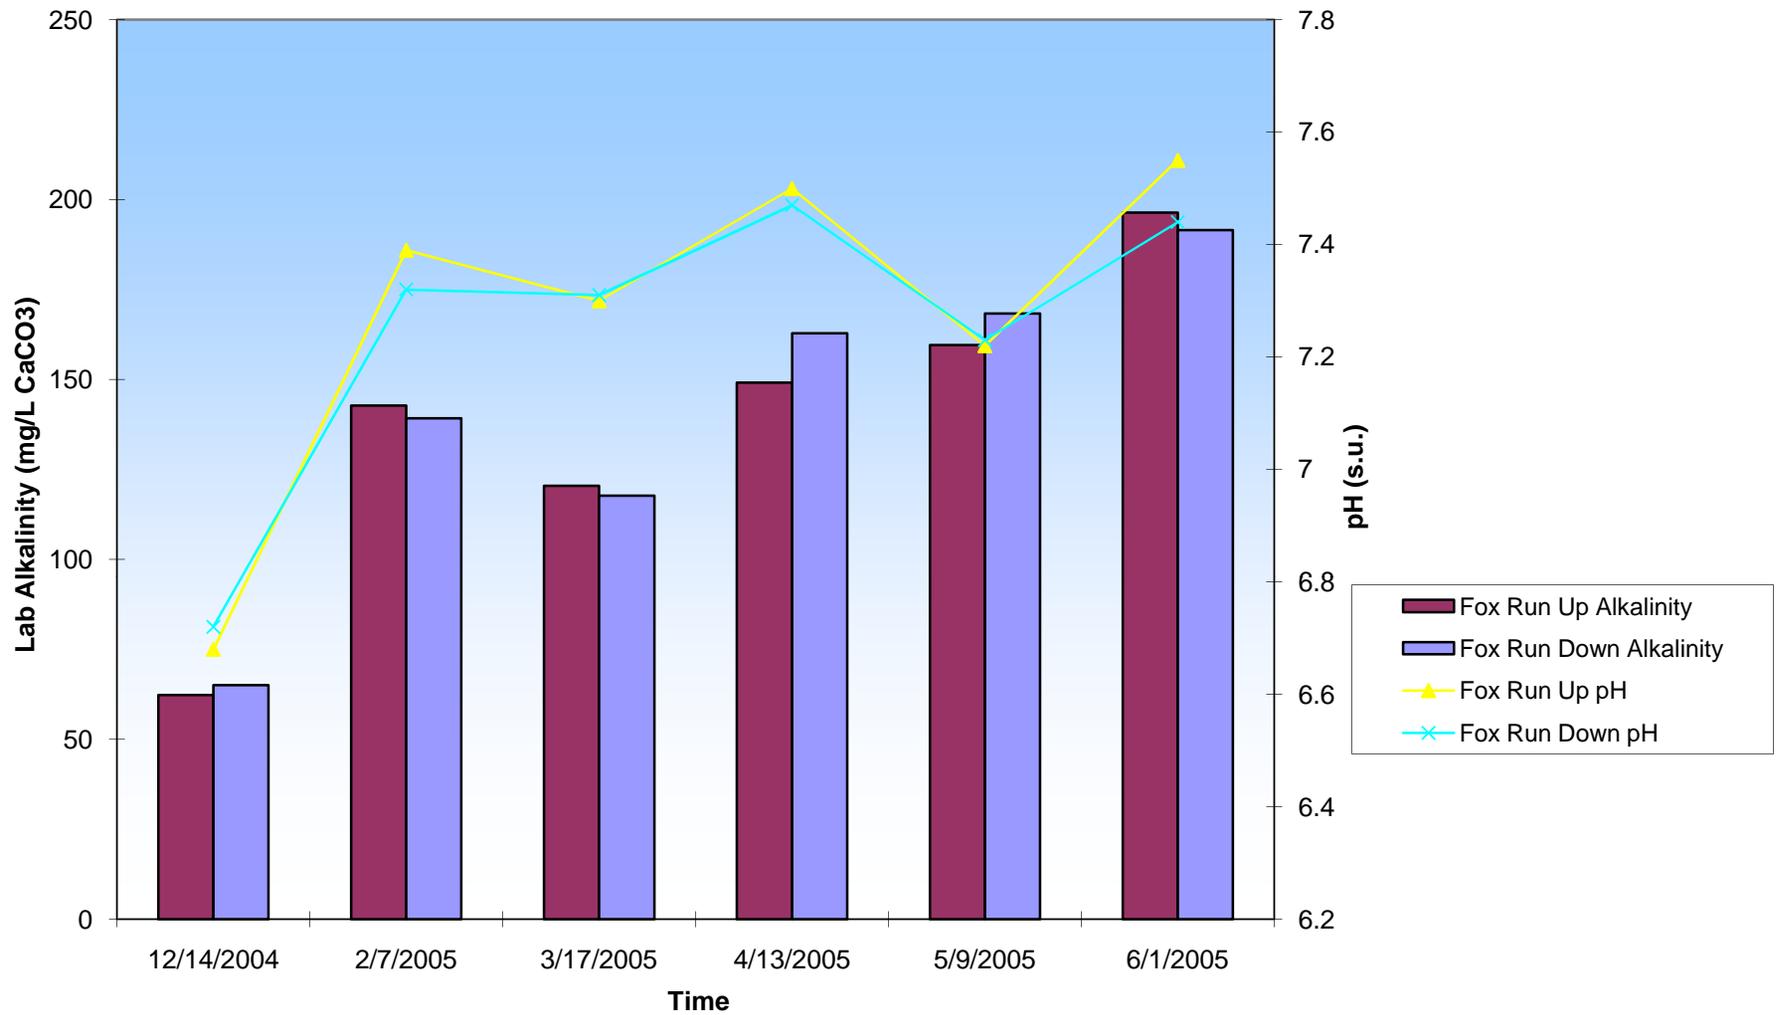
Figure 9.

Comparison of pH and Alkalinity of Fox Run Upstream and Downstream of Phase I Passive Treatment System

Even though the constructed wetland is expected to take a year or so to mature, since placement of the Phase 1 passive system online, Fox Run is no longer being significantly impacted by the degraded drainage from 87-7. In fact, the upstream water quality is very similar to the downstream water quality currently monitored at the SR0062 bridge about 200 feet downstream of the 87-7 confluence with Fox Run. Future monitoring will determine the long-term impact of Phase 1.

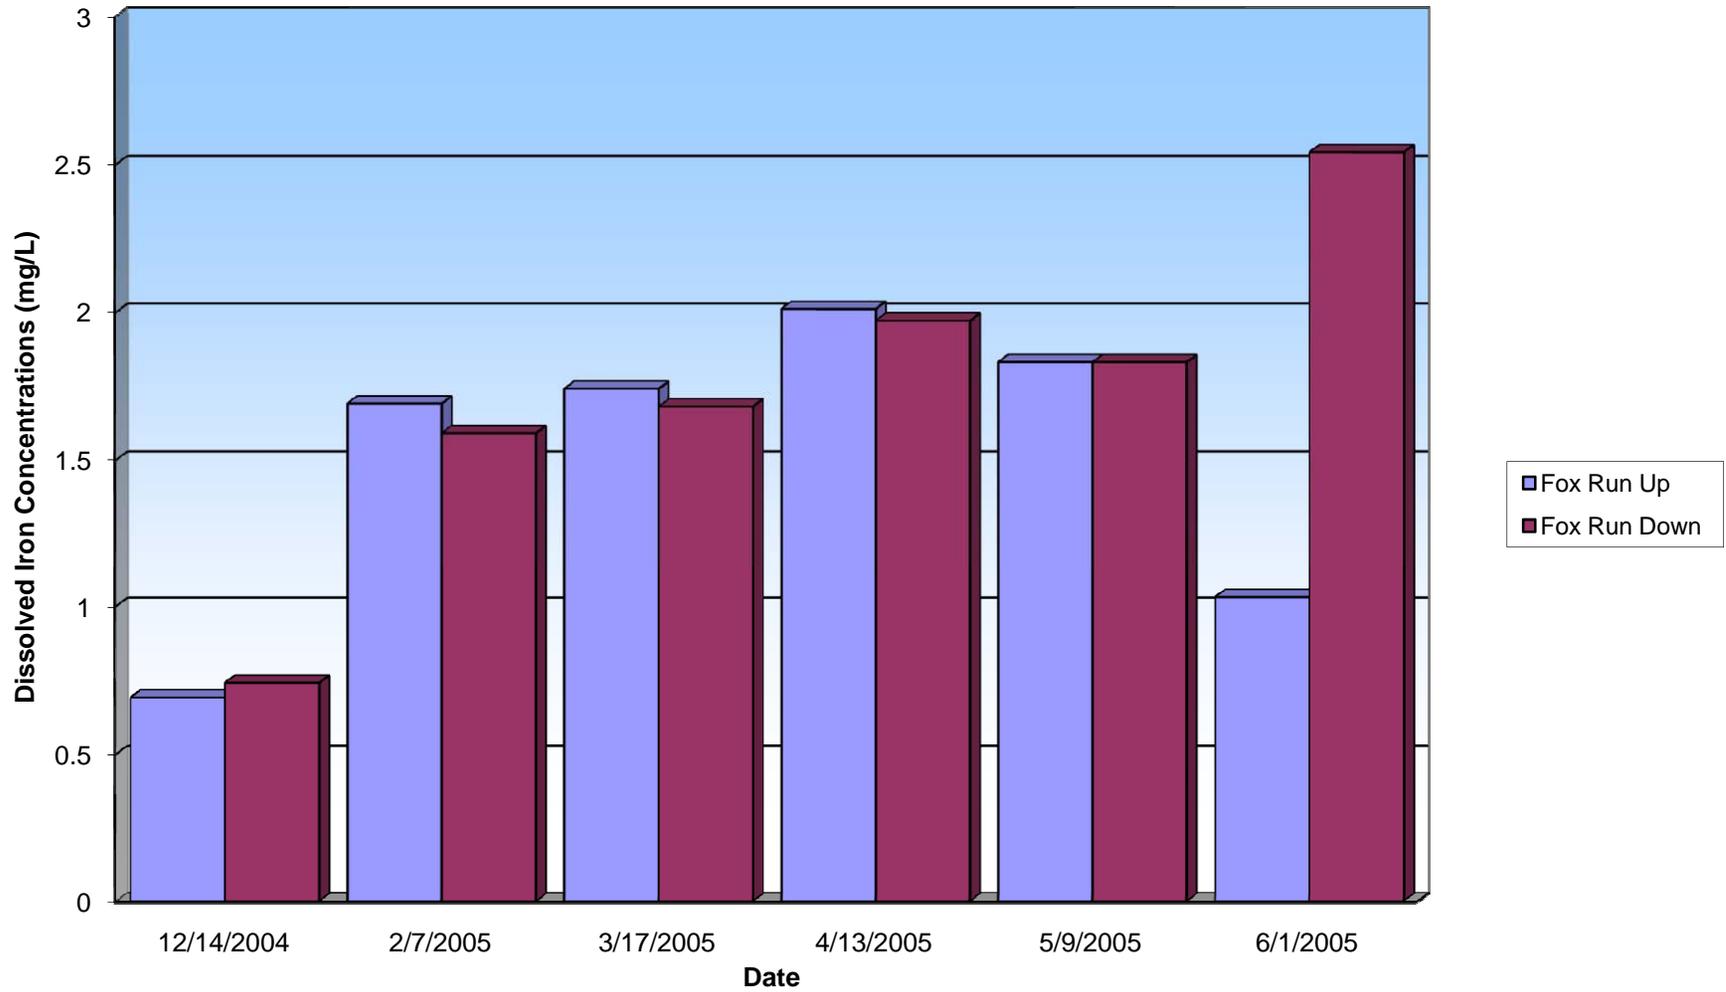
Figure 10.

Comparison of Dissolved Iron Concentrations Upstream and Downstream of Passive Treatment Systems

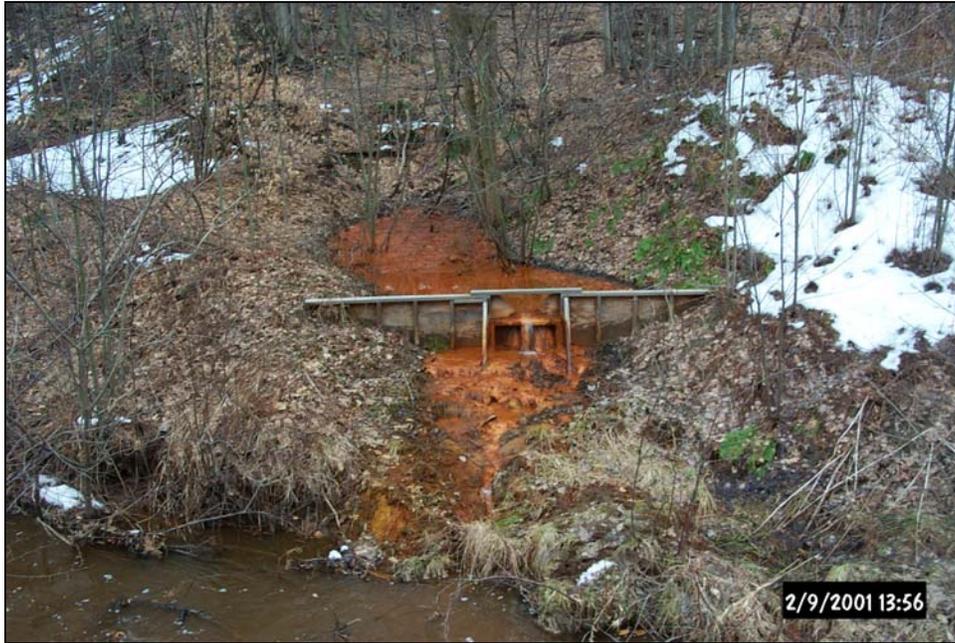
This is the main discharge (87-7) at Fox Run Phase 1. The weir in the picture was installed during the initial assessment of Fox Run conducted by the Mercer County Conservation District (ca. 1999). The proximity of Fox Run (seen in foreground) was problematic.

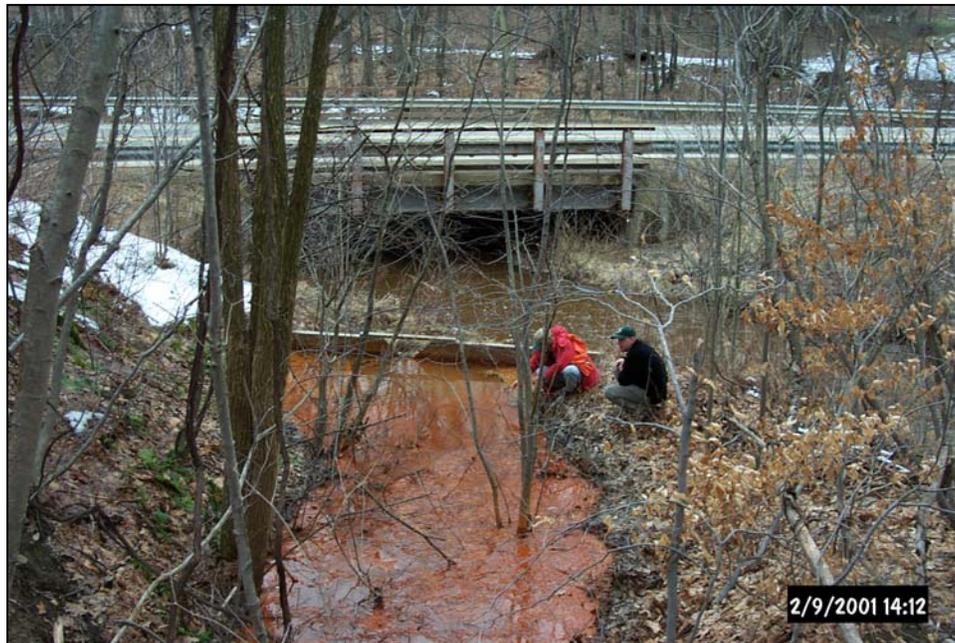
Margaret Dunn and Shawn Hedglin test water quality and determine flow rate of 87-7 and identify available construction area to determine feasibility of installing a passive treatment system. Notice the proximity of Fox Run and State Route 62 to the site in the background.

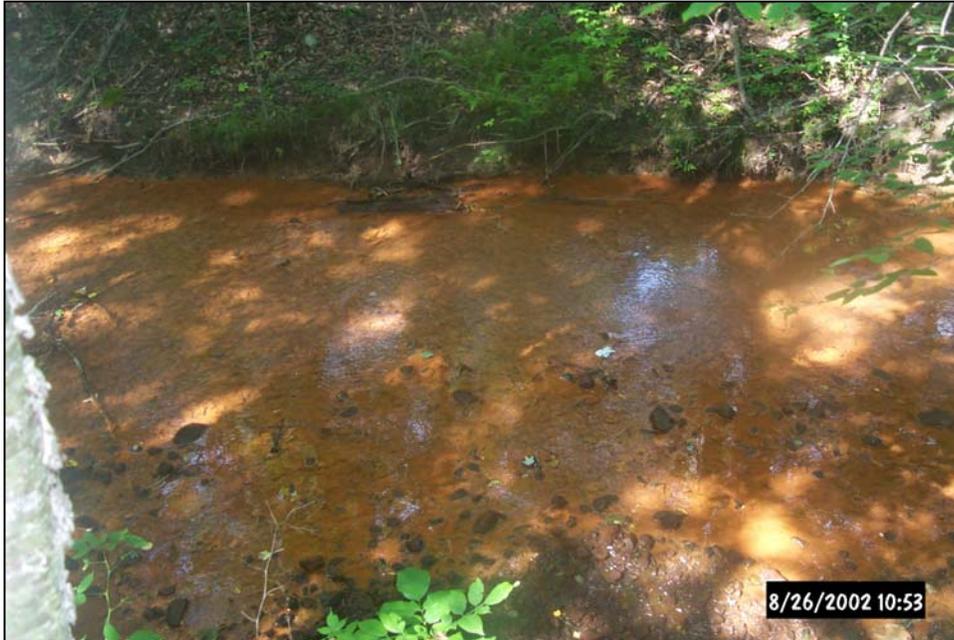
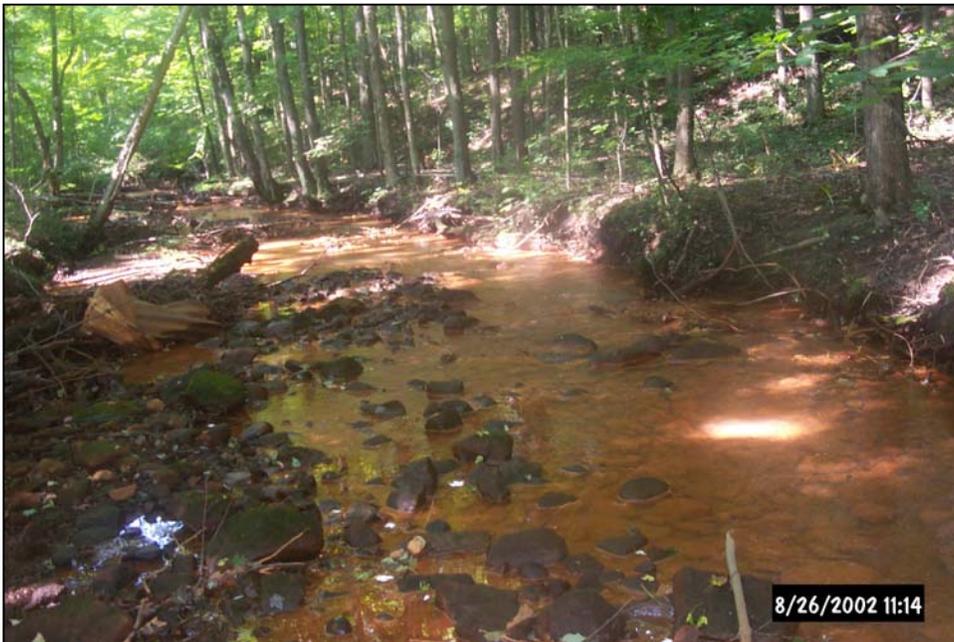
These are photographs of Fox Run taken directly downstream from discharge 87-7. The iron precipitate completely covers the substrate making it difficult for aquatic life to survive.

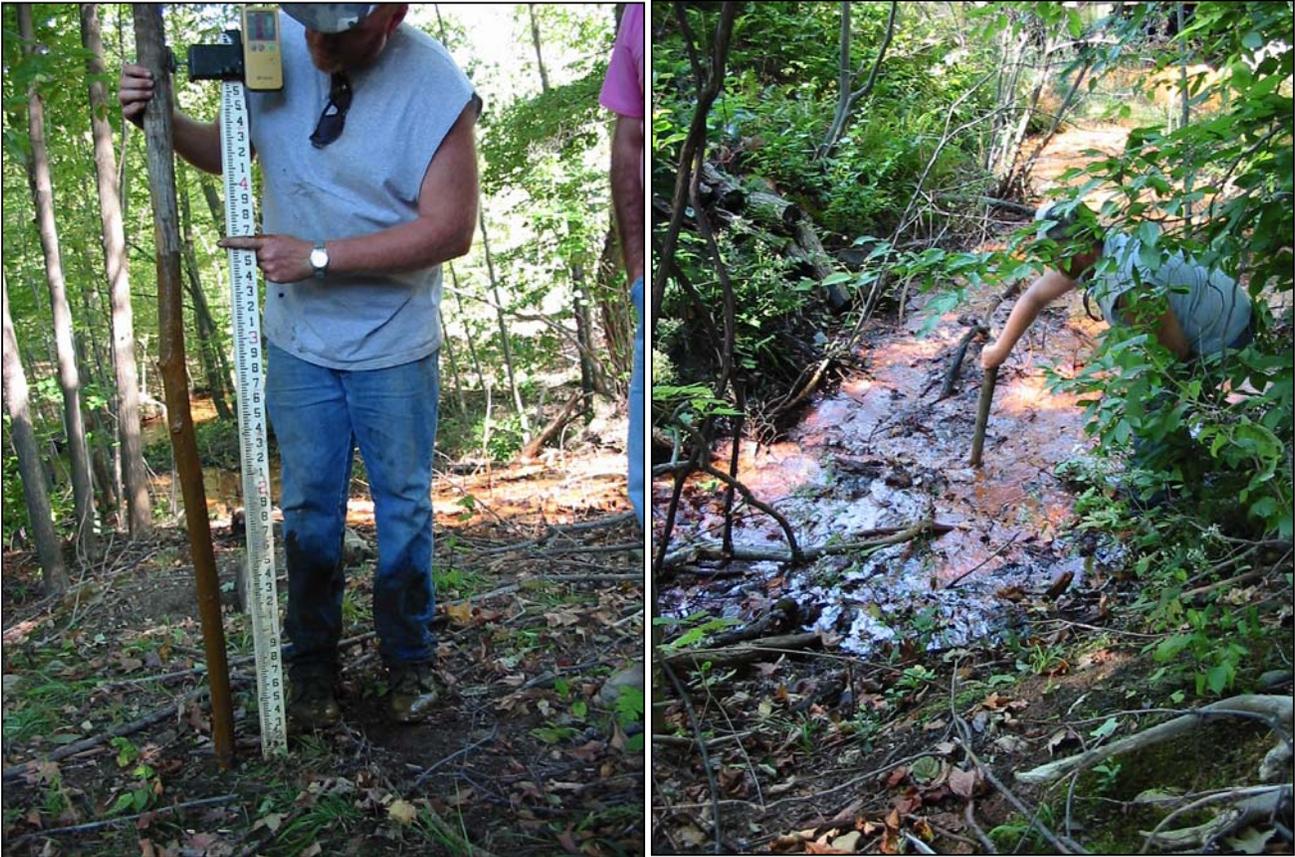
John Stoops, foreman for Quality Aggregates Inc., roughly measures the depth of iron precipitate that has accumulated from the 87-7 discharge. Notice the depth of sludge within the channel was over 42"!!!

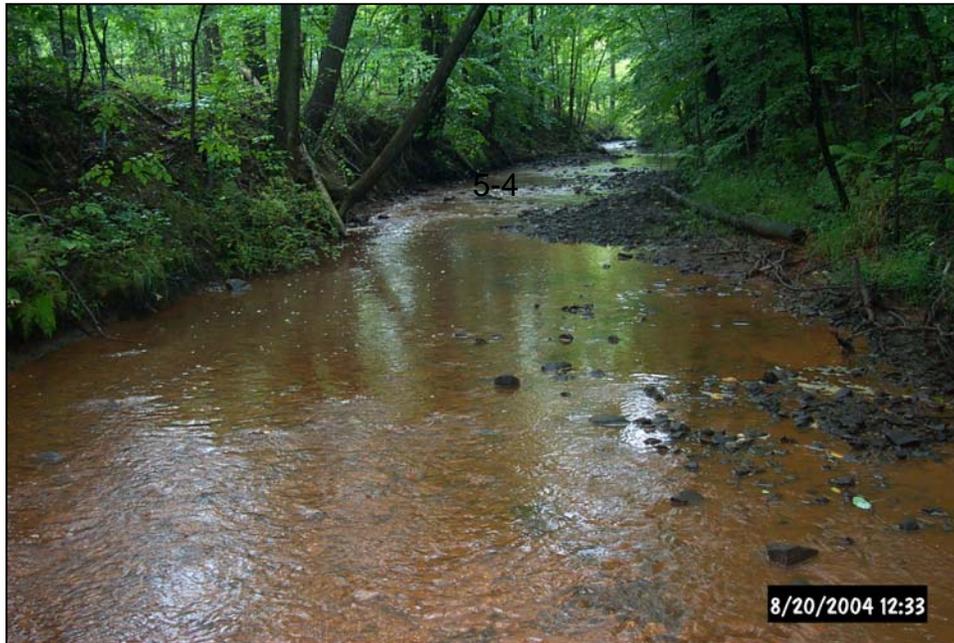
This is Fox Run shortly before construction illustrating the amount of remediation needed to restore the stream.

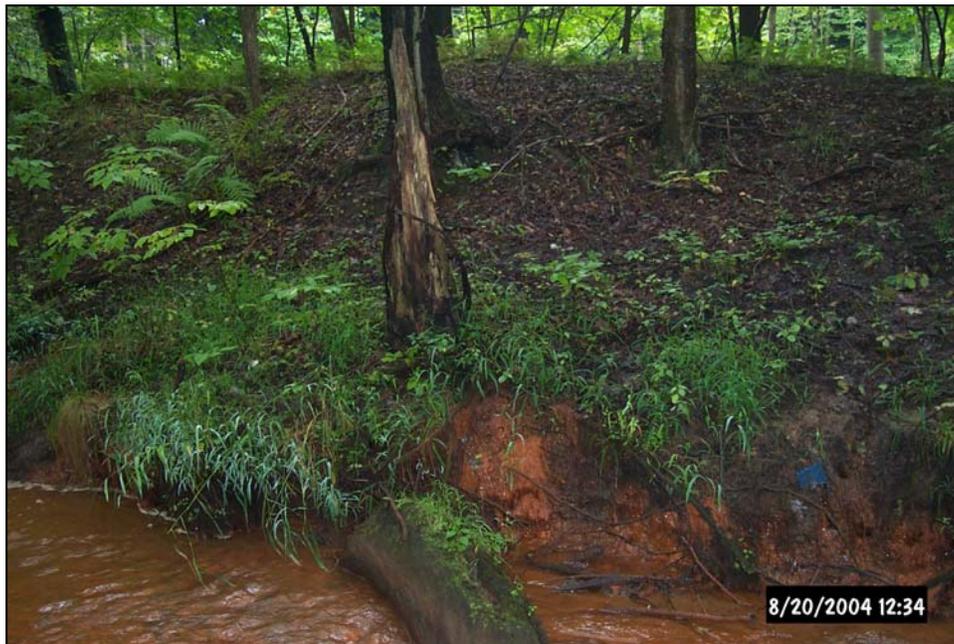
Multiple seeps, such as the one pictured above, are present along the banks of the stream. When combined, the seeps are responsible for a considerable amount of degradation to the stream.

Collection Channel: The collection channel is successfully conveying not only 87-7, but also numerous other small seeps. Each of the seeps is estimated to be from less than 1 gpm to 5 gpm. While conveying the water to the settling pond, the discharges degas with respect to carbon dioxide, are oxygenated, and orange, iron-bearing solids are observed to be precipitating within the channel.

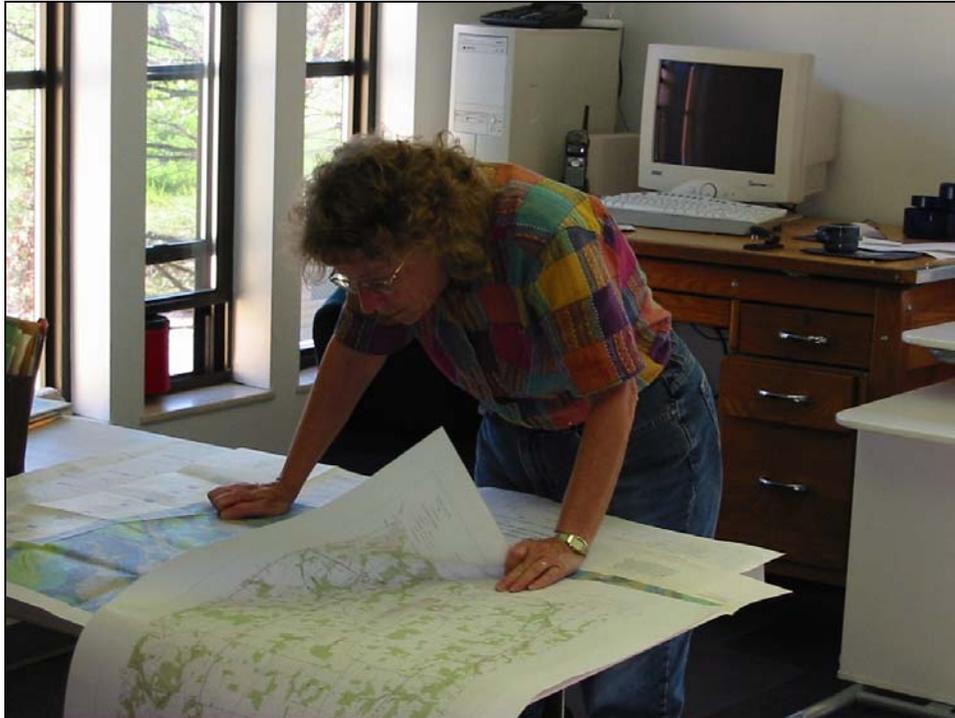
Margaret Dunn of BioMost, Inc. reviewed topographic and geologic maps of the area prior to excavating test pits to determine coal and potential mine pool elevations.

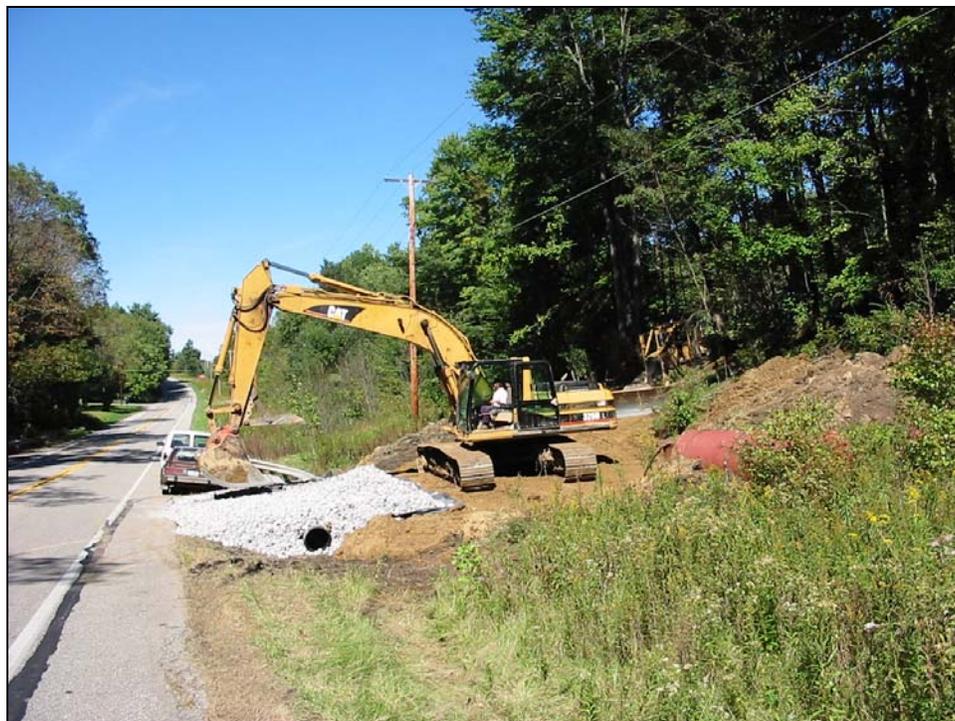
Construction on the site began with a temporary access road from State Route 62.

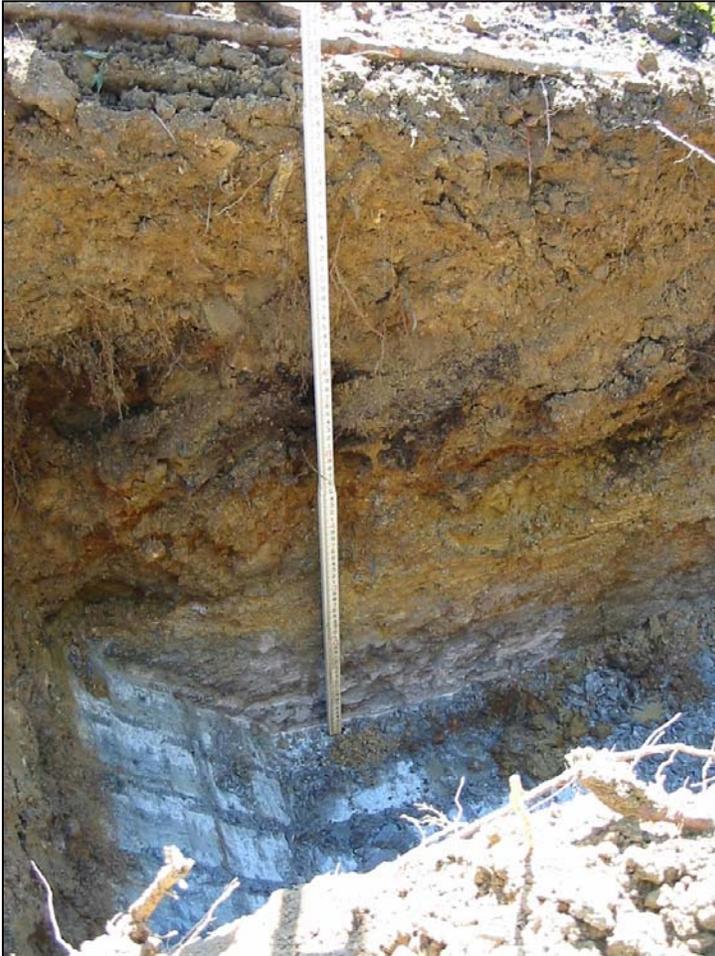
Test pits were dug to determine soil profile and depth to Brookville coalbed and the associated mine pool.

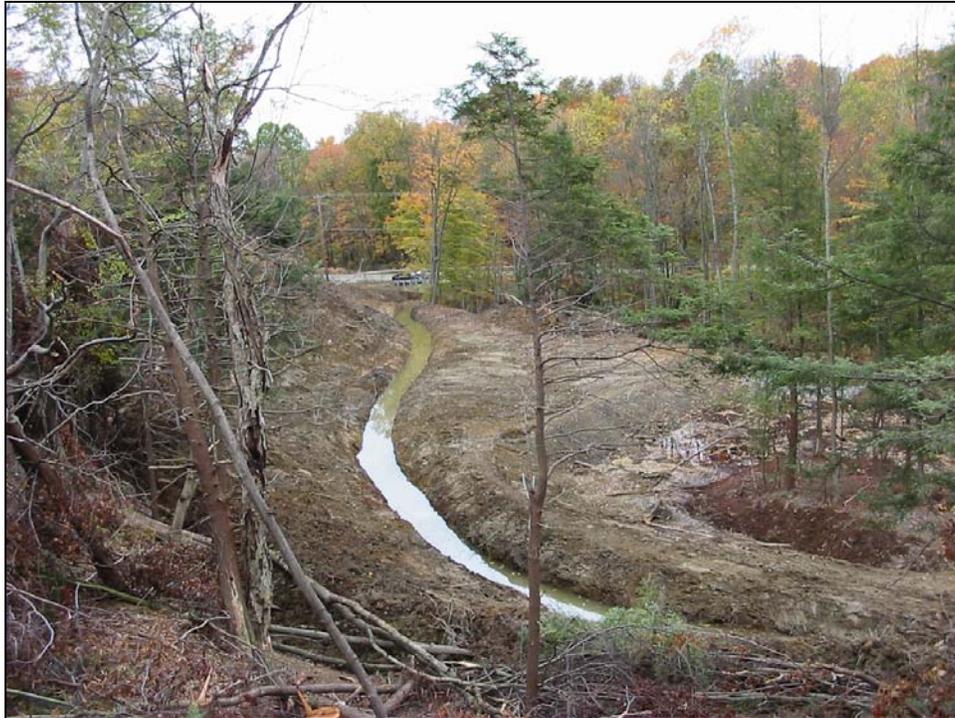
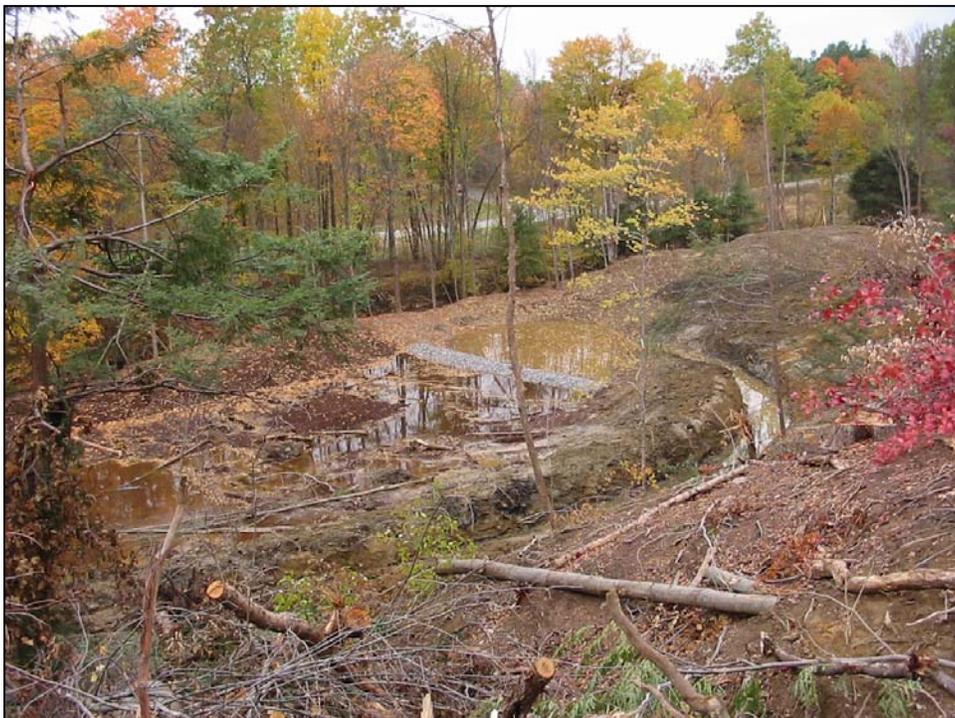
A post-construction view from the diversion ditch on the hilltop above Fox Run shows the newly installed channel that conveys the mine water (above). In the lower picture you see the end of the channel emptying into the settling pond and part of the wetland area. The site was timbered by the landowner with non-marketable treetops later placed in windrows for wildlife.

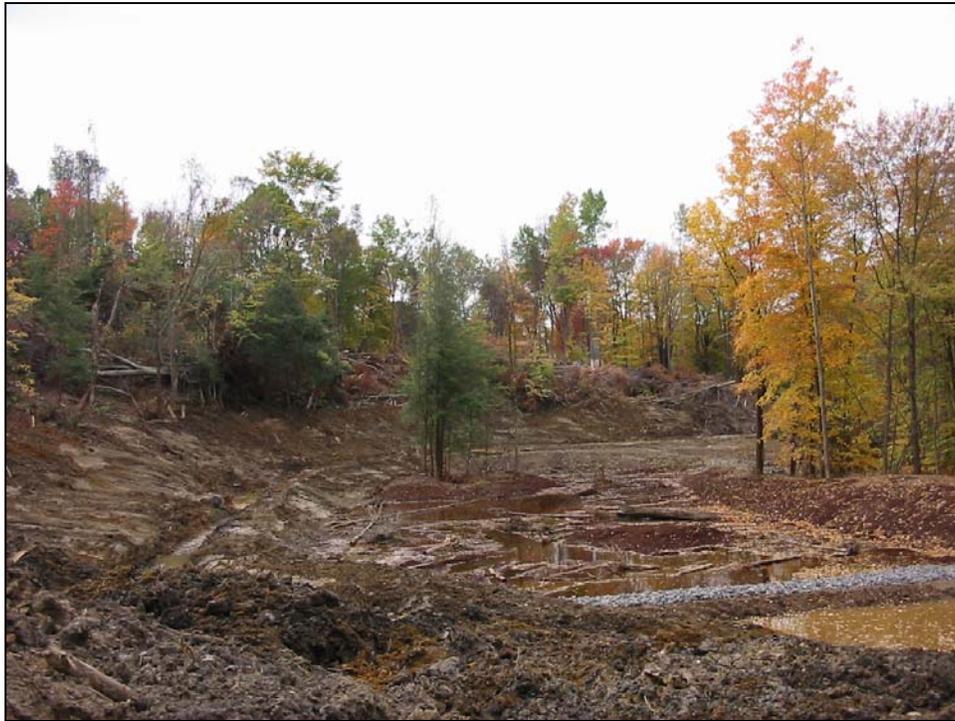
A natural hummock with native hemlock was left as part of the new wetland to naturally distribute water flow and create habitat.

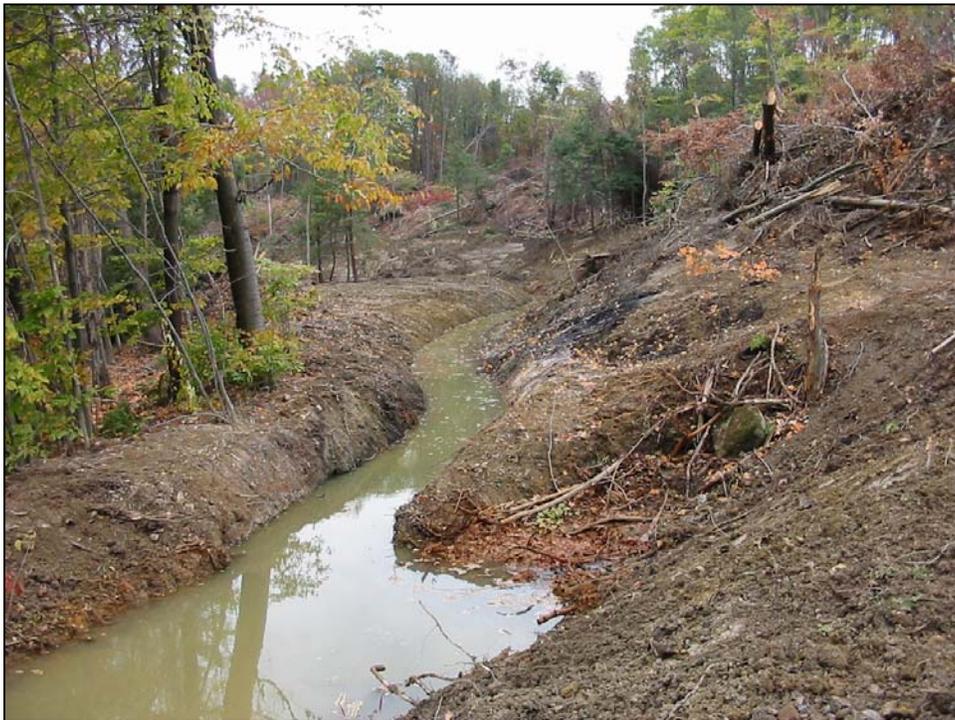
Standing at the southern end of the project near State Route 62 and looking north, the discharge is now flowing north toward the setting pond.

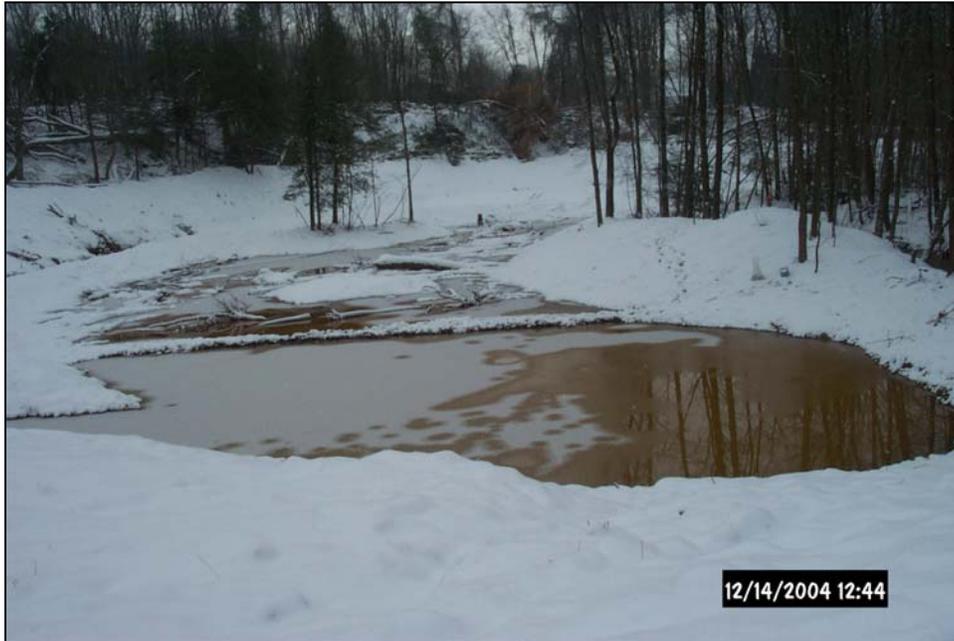
Despite being blanketed in snow, post-construction monitoring of the project was conducted by BMI and MCCD. Shawn Hedglin of MCCD sampled water quality this day.

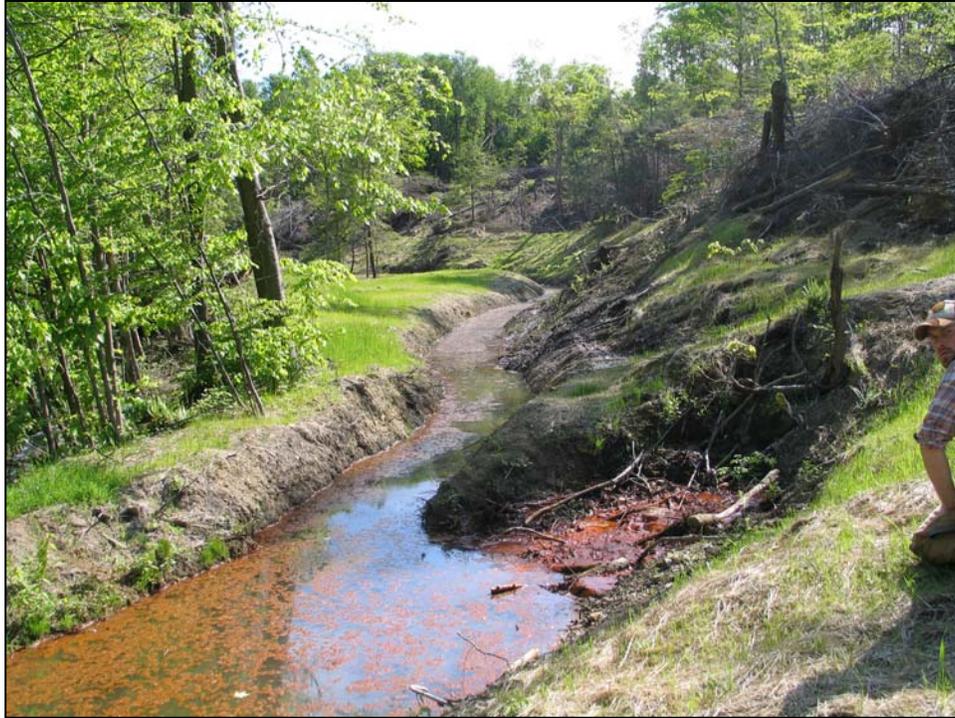
During site inspection by MCCD and BMI on 6/1/05, water quality is tested at the main discharge in order to calculate the effectiveness of the passive treatment system, shown below.
(Kyle Durrett in photo)

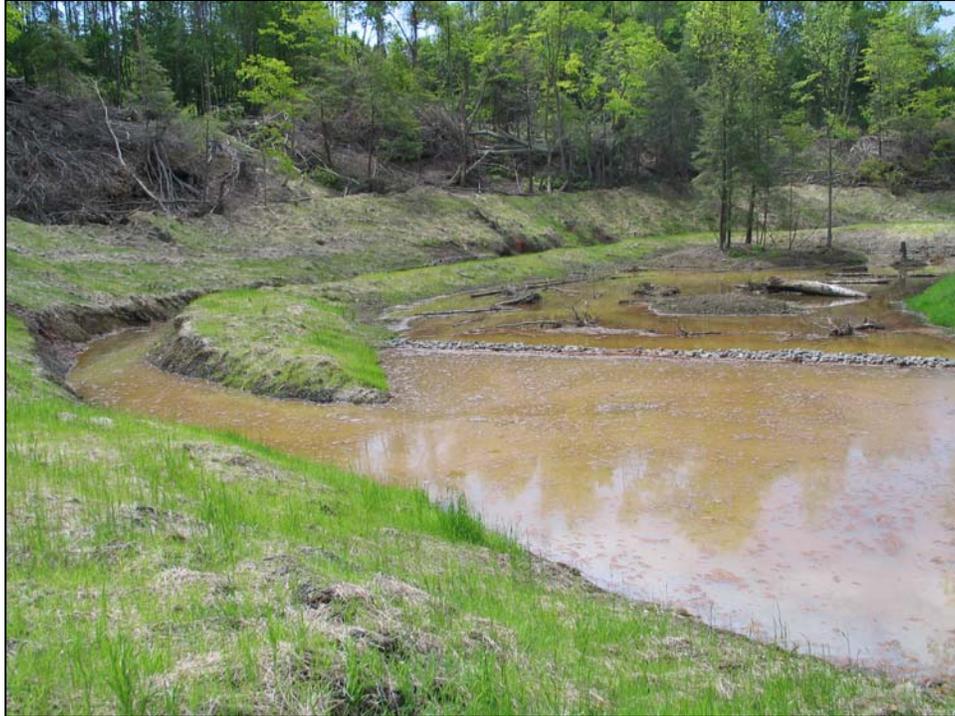
Suspended solids are retained in the settling pond where the water slows down before crossing the spillway.

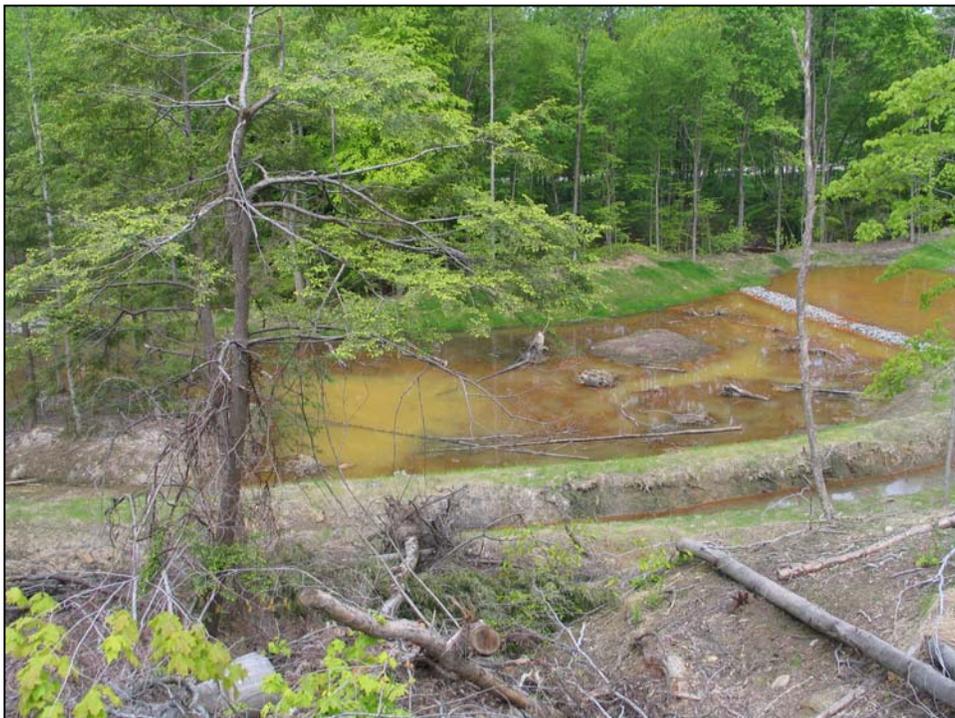
The settling pond water flows through a limestone aggregate spillway to aerate and distribute the mine drainage evenly prior to entering the wetland area.
