Fox Run Restoration Project - Phase I

**Yellow Creek Watershed
Jackson Township
Mercer County, Pennsylvania**

Re: Final Report
ME# 352997; Project # NW-20194
Fox Run Restoration Area – Phase I
Jackson Township, Mercer County, PA
870102/01 FR-trans 87

FOX RUN Restoration Area - PHASE 1: FINAL REPORT
Jackson Township, Mercer County, PA

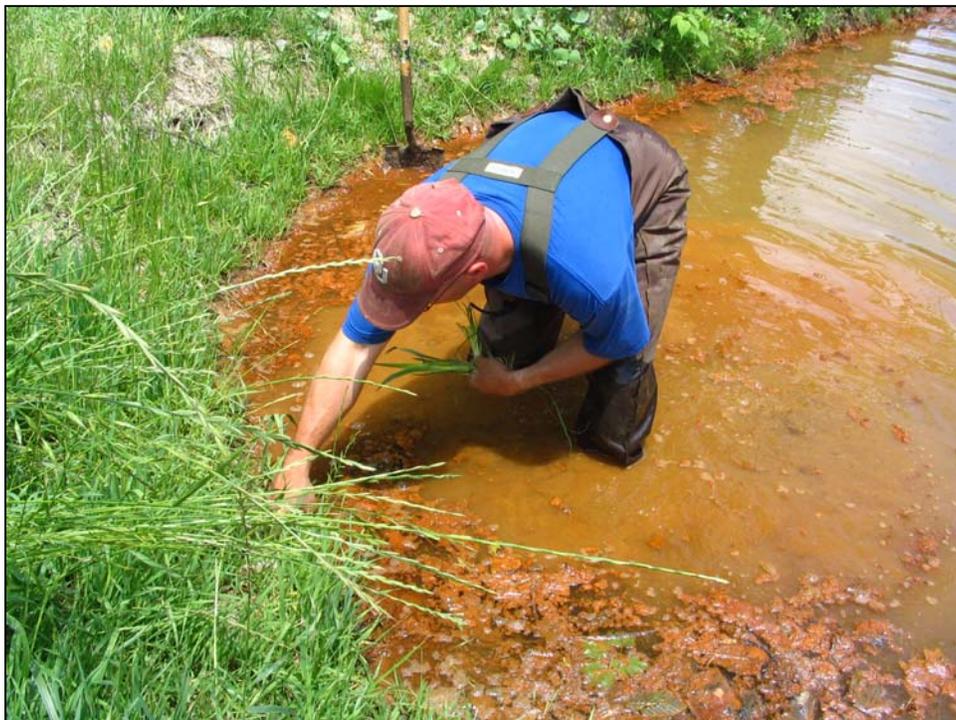
Shawn Hedglin from MCCD planting some Water Iris in the collection channel next to the main discharge.

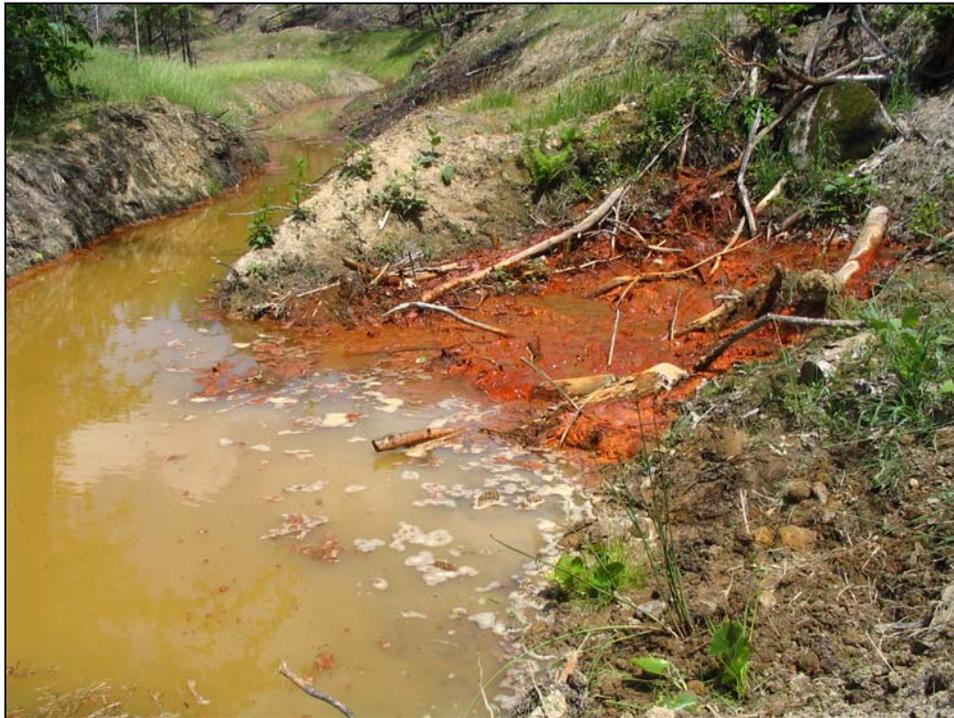
The plants visible in the foreground are newly-planted Bullrush and Spadderdock at the location of discharge 87-7.

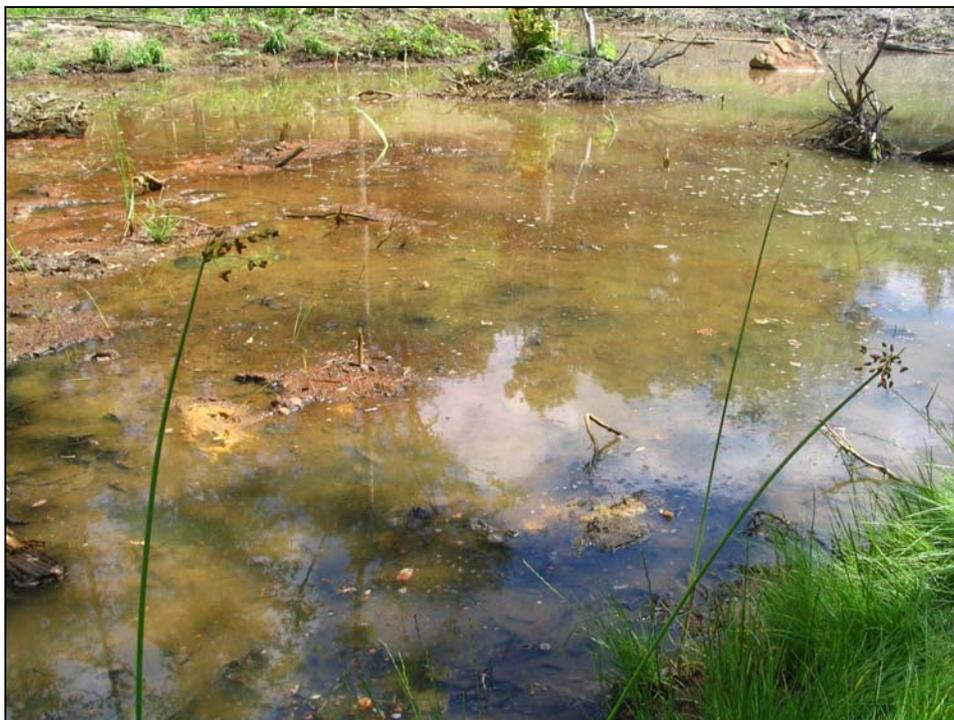
The recently-planted healthy bullrush are expected to reproduce to help establish the wetland by the end of the 2006 growing season.

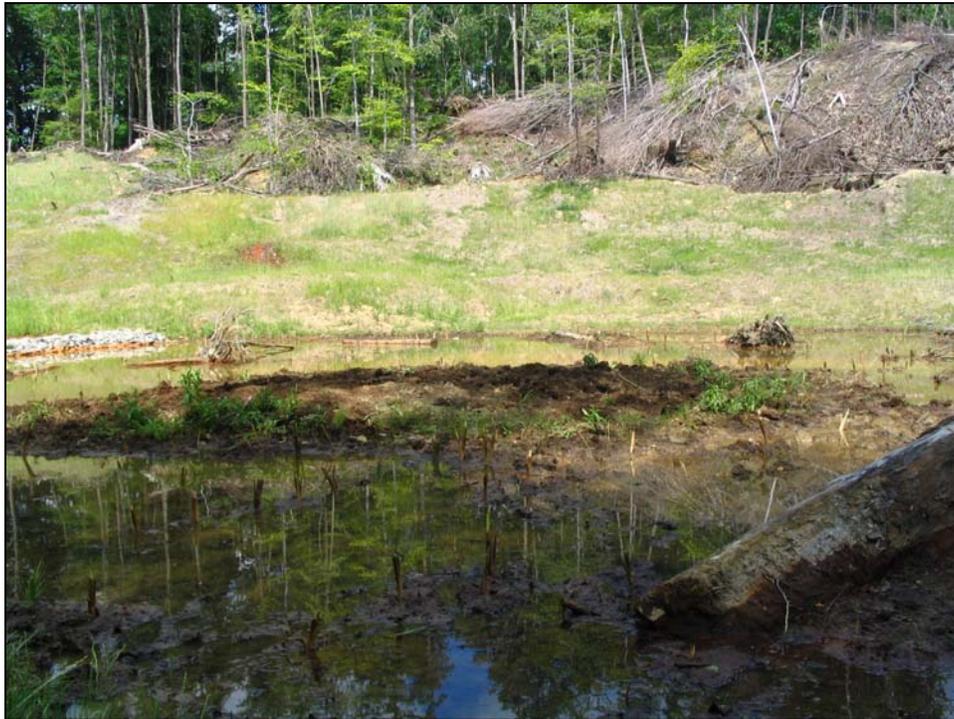
Naturally-grouped communities of species in the wetland were planted to create a more diverse “realistic” wetland by the end of the 2006 growing season. Diversity will provide stability to discourage invasive plants.

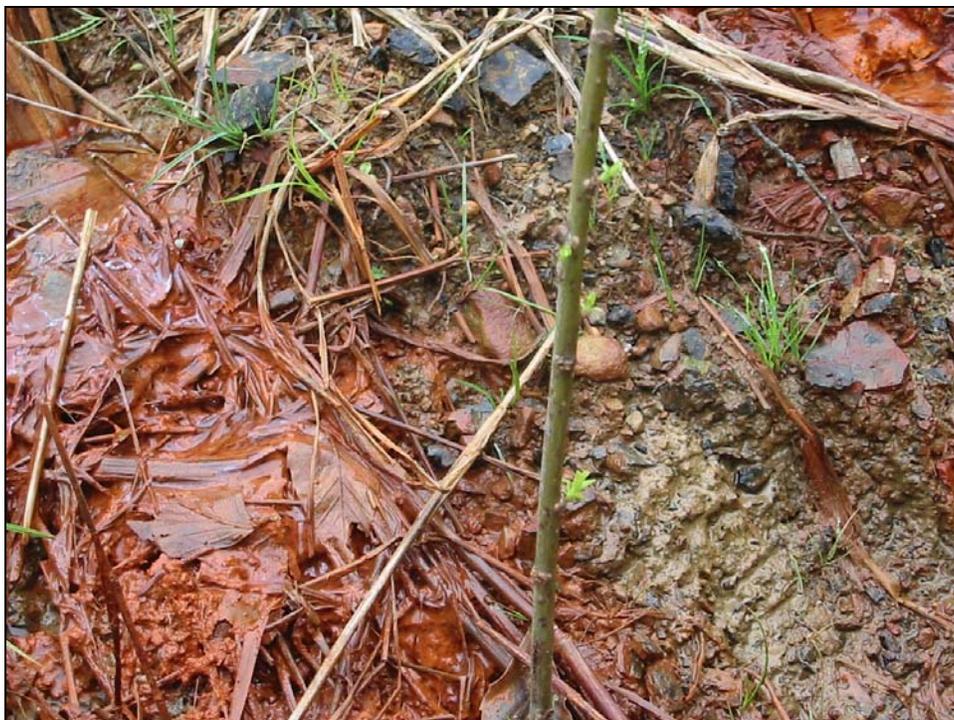
About a week after the live stakes were planted new growth could already be seen.

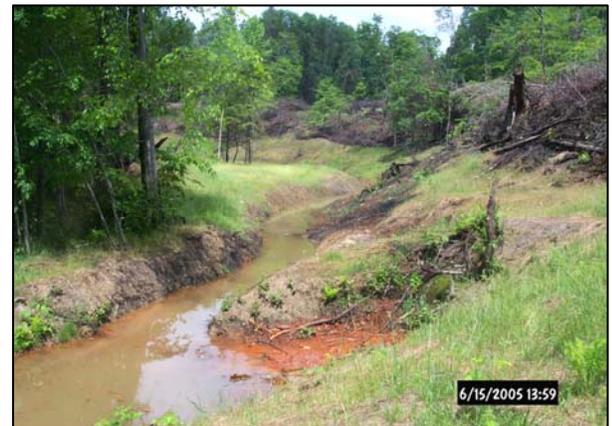
Collection Channels serve to collect, intercept, and/or combine discharges and seeps as well as to convey water. These components also collect debris such as sticks and leaves as well as sediment and iron precipitates. There is one Collection Channel (Top Right Photo) at the Fox Run Phase I passive treatment system.

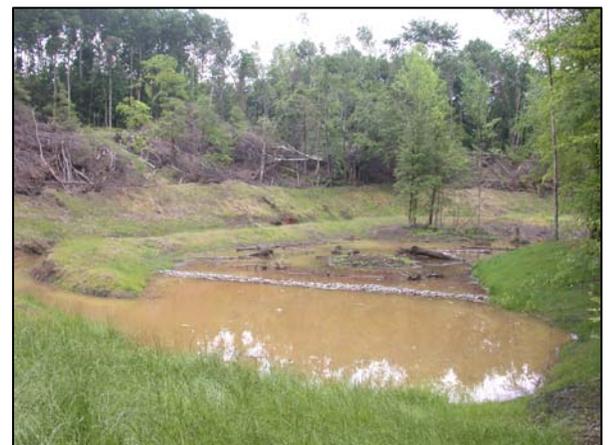
Settling Ponds and Wetlands are typically used in passive treatment systems to allow for the oxidation, precipitation, and accumulation of metal solids that occur when alkaline drainage issues from a minesite or after acidic drainage has passed through an alkalinity-generating treatment component. Although many treatment wetlands are angular-shaped shallow ponds supporting predominantly cattails, the wetlands at Fox Run Phase I have been designed, built, and planted to look and function as a natural wetland with high species diversity that provides not only treatment but also exceptional wildlife habitat. There is one Settling Pond and one aerobic wetland (Bottom Right Photo) at the Fox Run Phase I passive treatment system. (One to two years are generally needed after planting for the wetlands to become well vegetated. The Fox Run Phase I wetlands were planted in June 2005.)

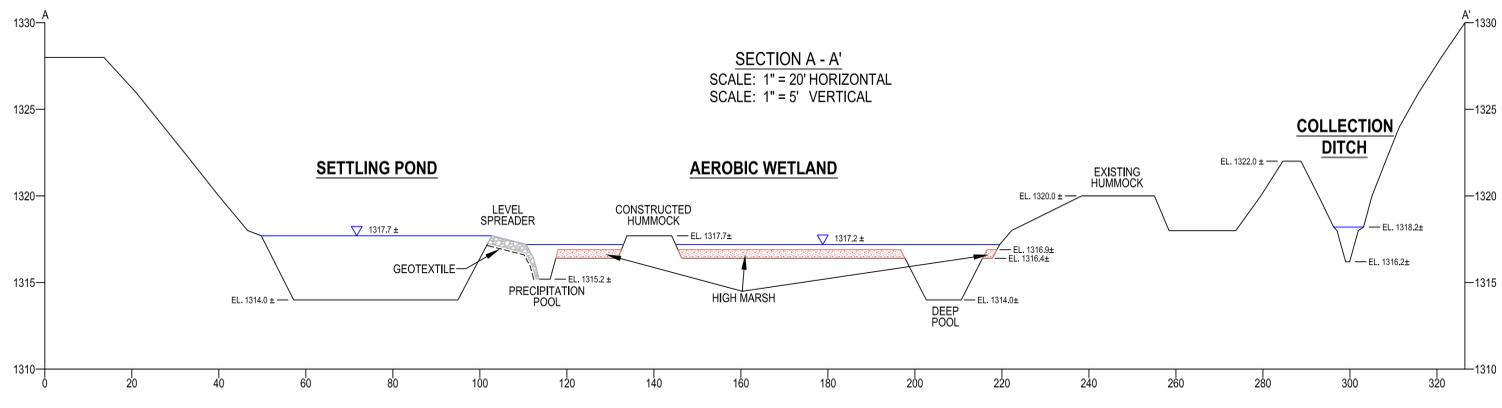
SECTION A - A'
SCALE: 1" = 20' HORIZONTAL
SCALE: 1" = 5' VERTICAL

Notes:
Base map prepared by EDM survey by Earthtech, Inc. with additional information from site inspections provided by BioMost, Inc.
Surface areas calculated at approximate water elevation.
Bottom elevation of wetlands varies due to microtopographic relief.
Property owner of area: Steve and Emma Kish
