# Goff Station Restoration Area

**Public Private Partnership Effort**  
Venango Township, Northern Butler County, PA

Re: Final Report for Project #NW90003  
Growing Greener - Environmental Stewardship and Watershed Protection Grant ME #359747  
Goff Station Restoration Area, Slippery Rock Creek Watershed, Venango Twp., Butler Co., PA  
200212/FR-trans

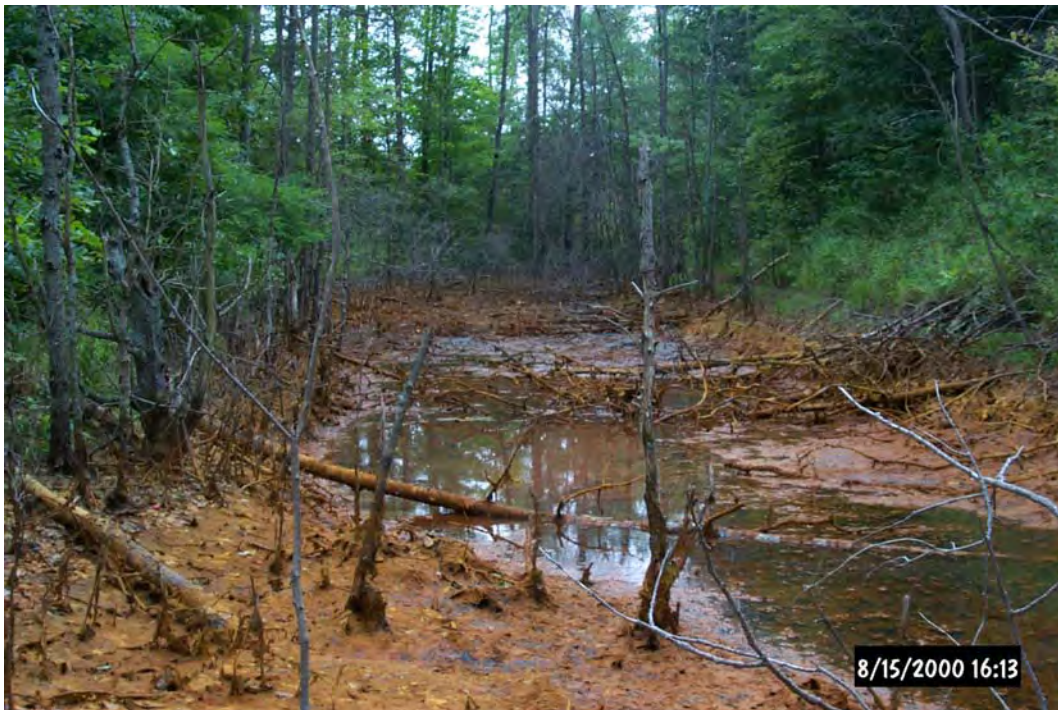
Pre-construction: ST38 discharge flows into an abandoned strip pit from an old underground mine.

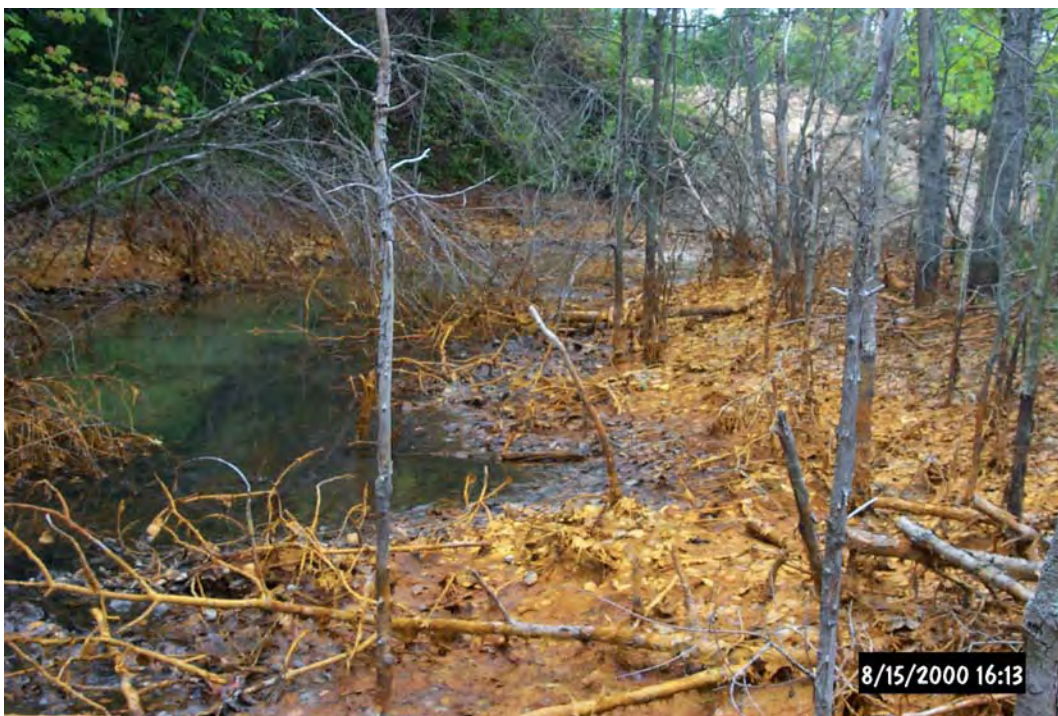
Pre-construction: the ST39 discharge flows into an abandoned strip pit from an old underground mine.

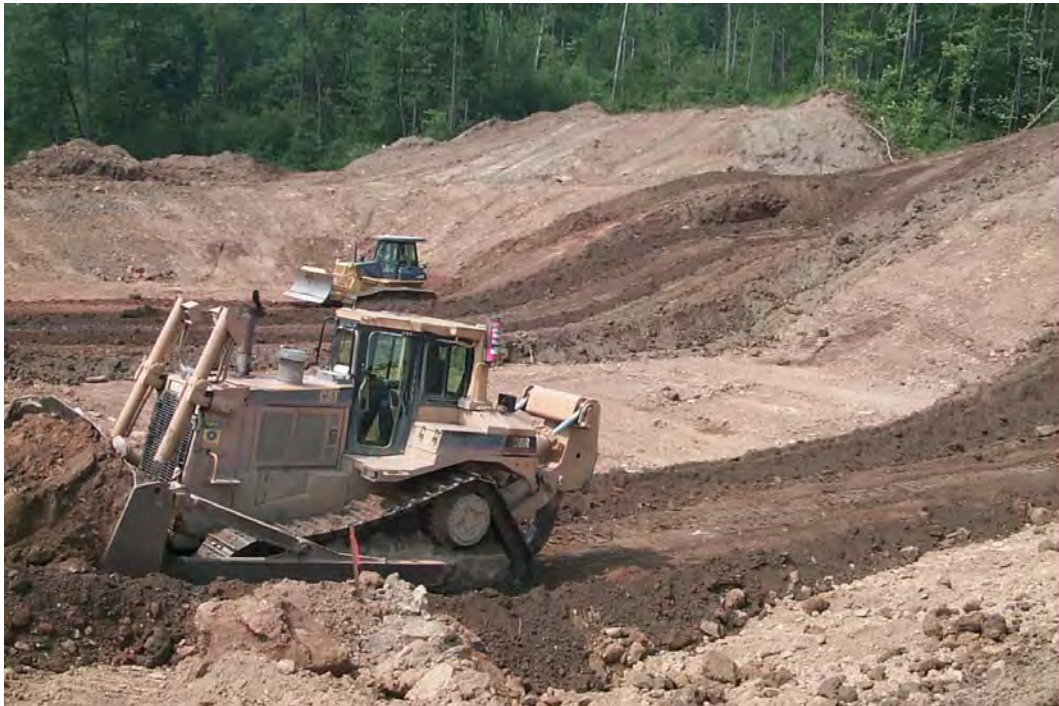
Quality Aggregates constructing ST38/39 Vertical Flow Ponds #1 & #2 which operate in parallel.

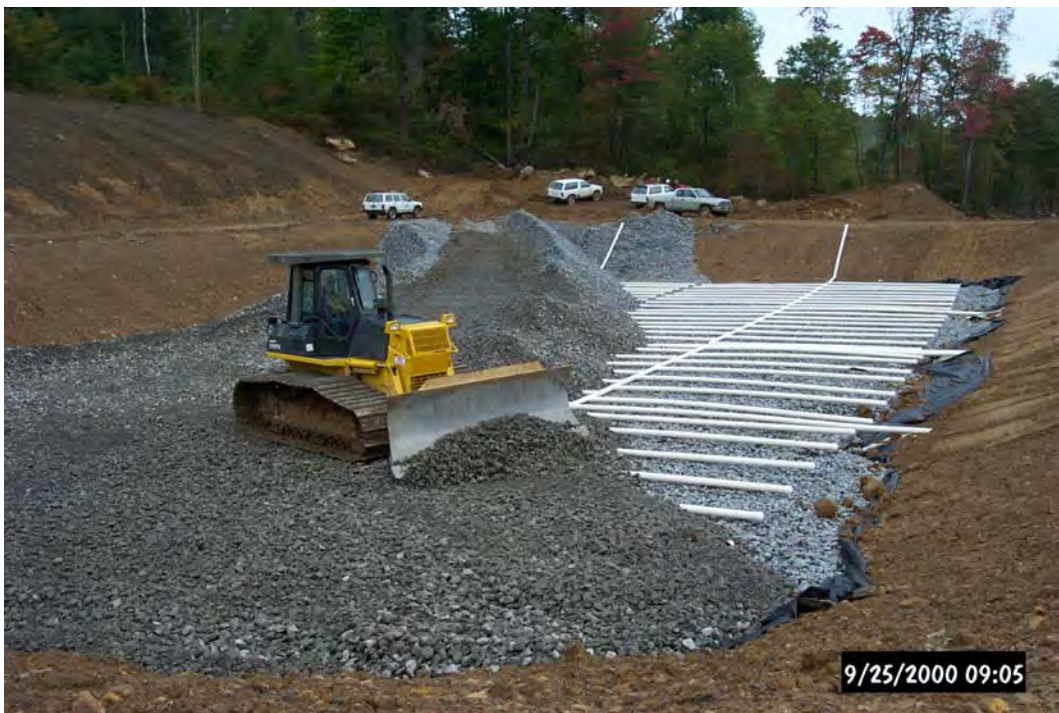
Placement of 3000 tons of AASHTO #1 limestone in Vertical Flow Pond #2 for ST38/39. Note the flushing system with additional clean outs (first known of this design in Pennsylvania).

This plumbing system allows for distribution of flow throughout the pond. As aluminum and iron solids accumulate within the Vertical Flow Ponds, a decrease in permeability is expected due to the filling of void space within the AASHTO #1 limestone layers. As the permeability decreases, the amount of head (difference between water elevation in the Vertical Flow Pond and the discharge pipe elevation) needed to push the water through the system will increase. This decrease in permeability will cause the water level in the Vertical Flow Ponds to rise.

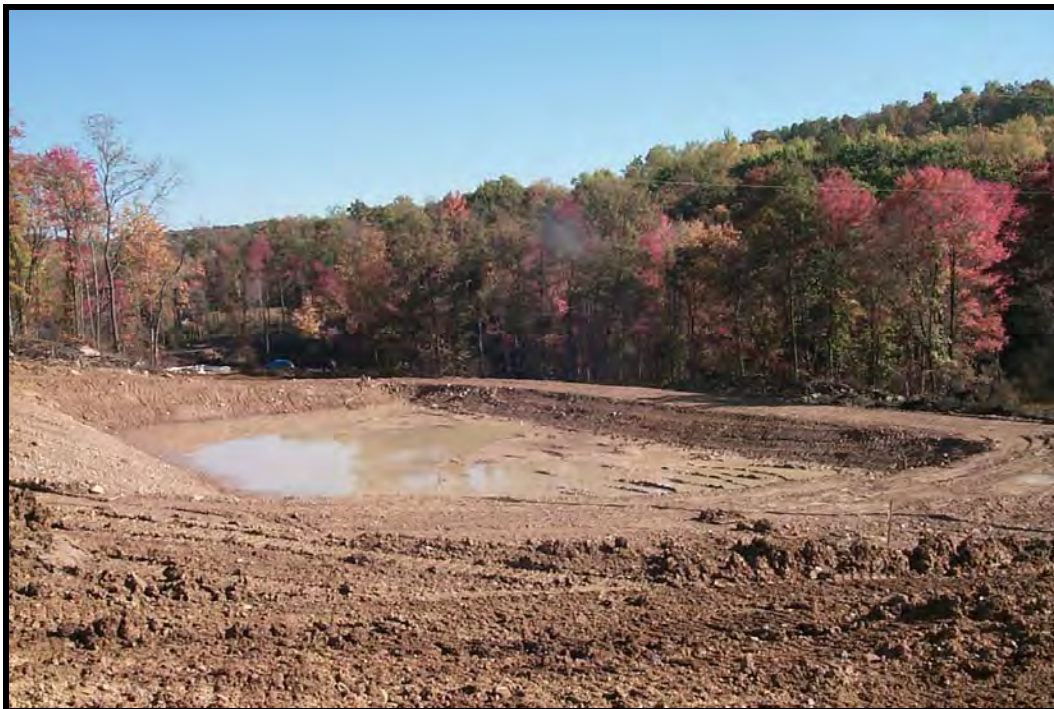
Basin excavated for the ST 38/39 treatment wetland. (10/12/00)

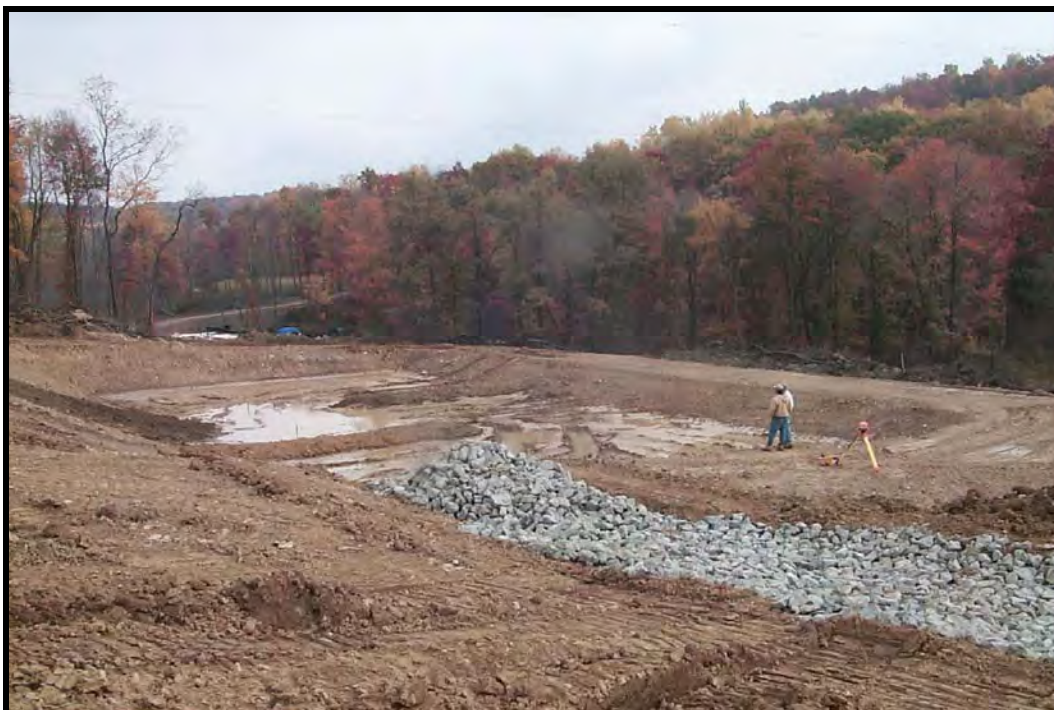
ST 38/39 wetland basin with flow diversion structures and limestone spillway inlet. Laser level was used to monitor elevations of the wetland basin during construction. (10/16/00)

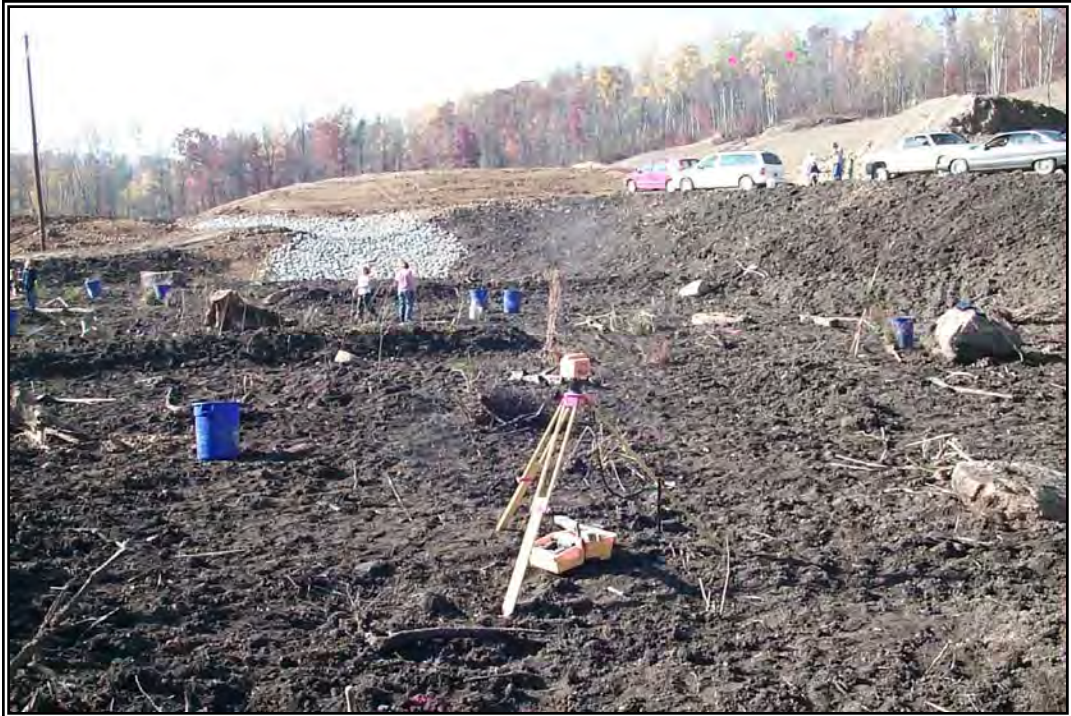
ST 38/39 wetland planting. Laser level was used to transplant vegetation to appropriate elevations. (10/21/00)

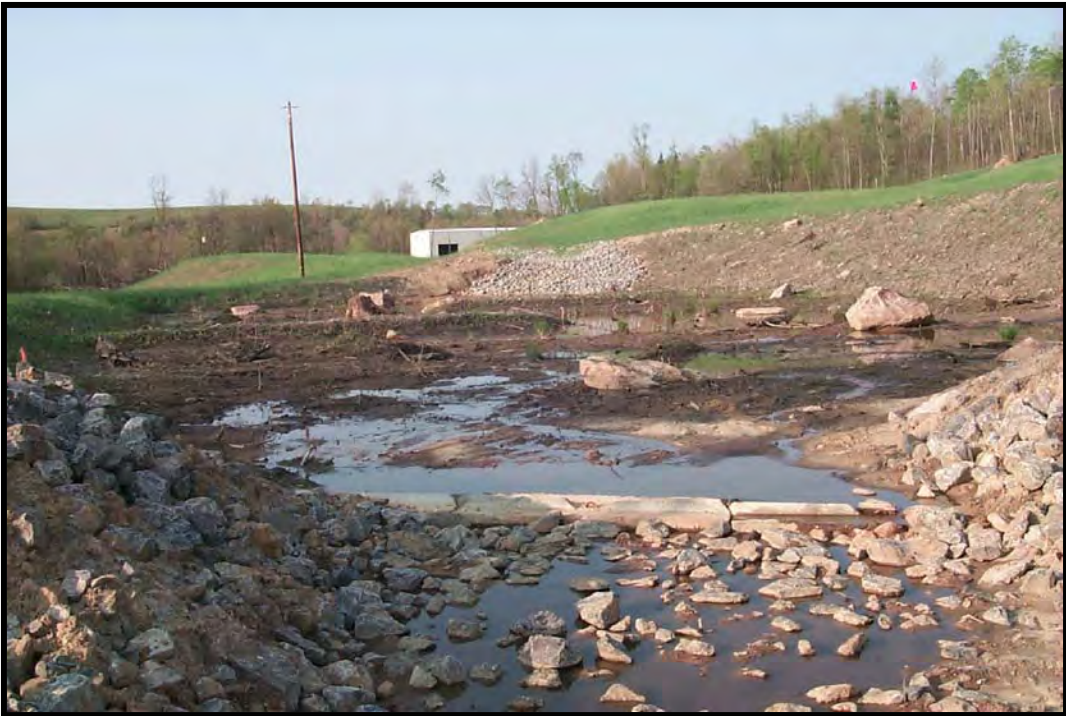
ST 38/39 wetland with following installation of new outlet structure.  
(5/7/01)

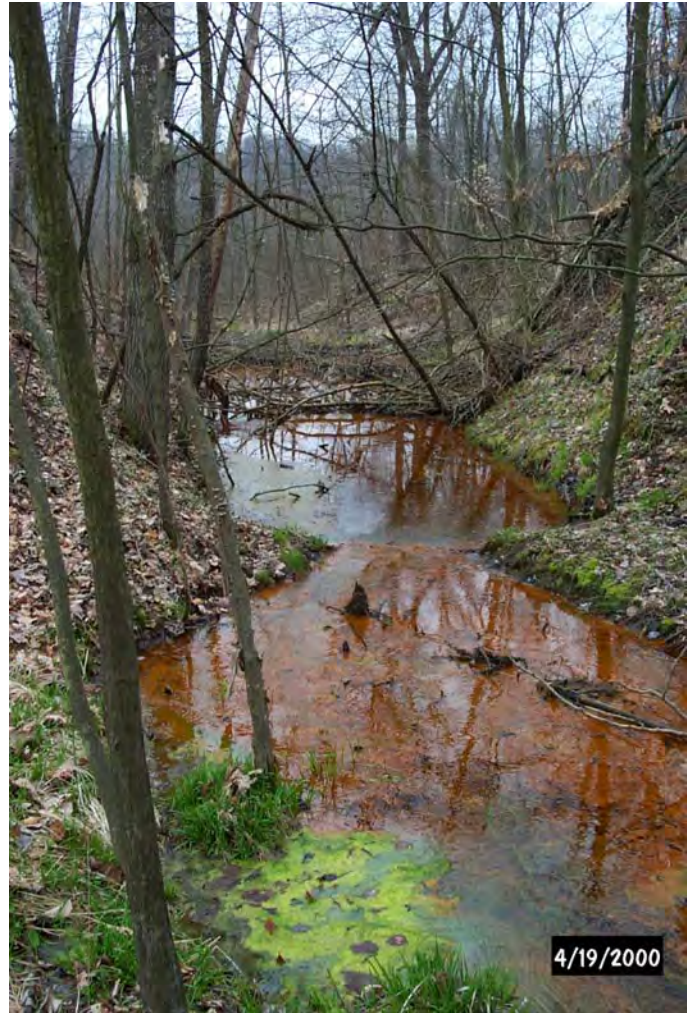
Source of abandoned mine discharge ST40 (left) flowing into and pooling in an abandoned pit (right).

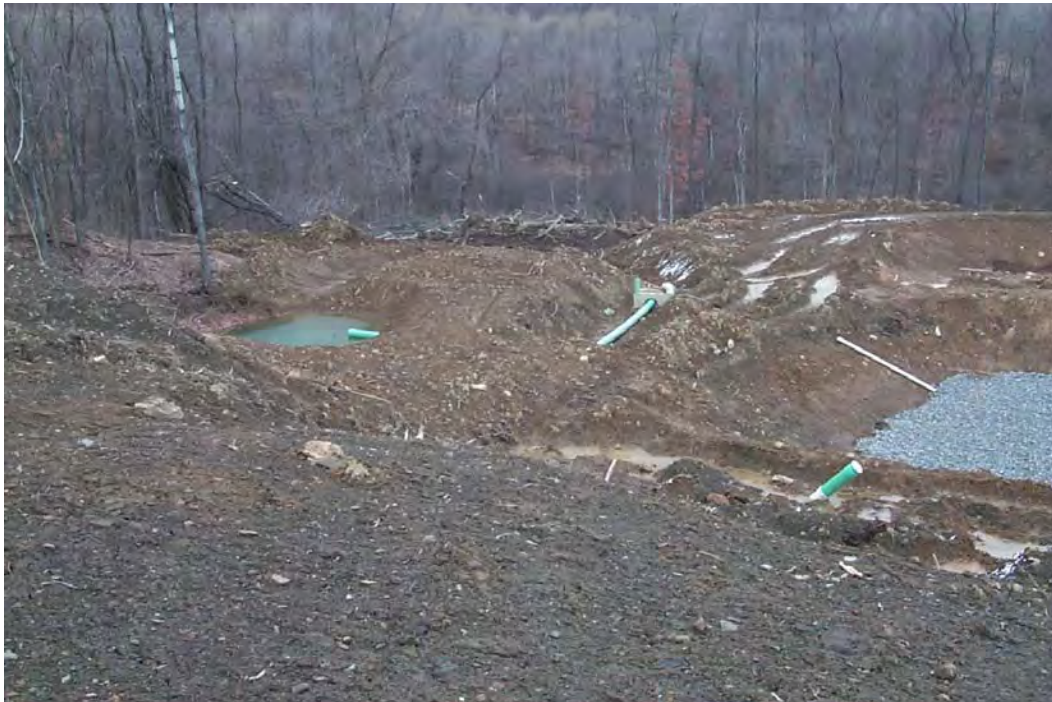
View of a portion of the ST 40/40A/42 collection system. Note ST42 pool far left, splitter box center, and clean out far right.

Collection System: The ST40 discharge is first directed through the bat hibernaculum to provide humidity and the sound of running water. The water is then pooled by a small breastwork. Using a down-turned elbow intake, the flow is conveyed by 10" SCH40 pipe to the inlet box for VFP3 & 4. During construction of the sump for ST40, additional seepage (ST40A) was discovered. After an unsuccessful attempt to seal the seep with Bentafix, the drainage was later combined with ST40. Clean-out pipes were installed at ~100-foot intervals along the collection pipe.

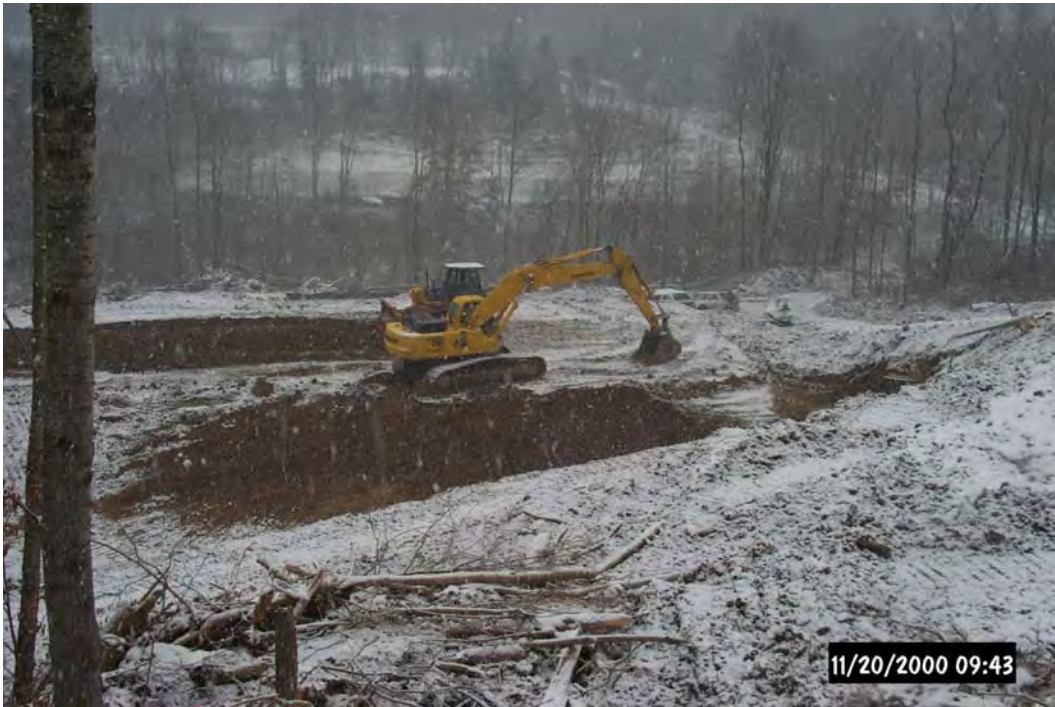
Construction of Vertical Flow Ponds #3 & #4 for ST40/40A/42 with the option of including ST41 by Quality Aggregates.

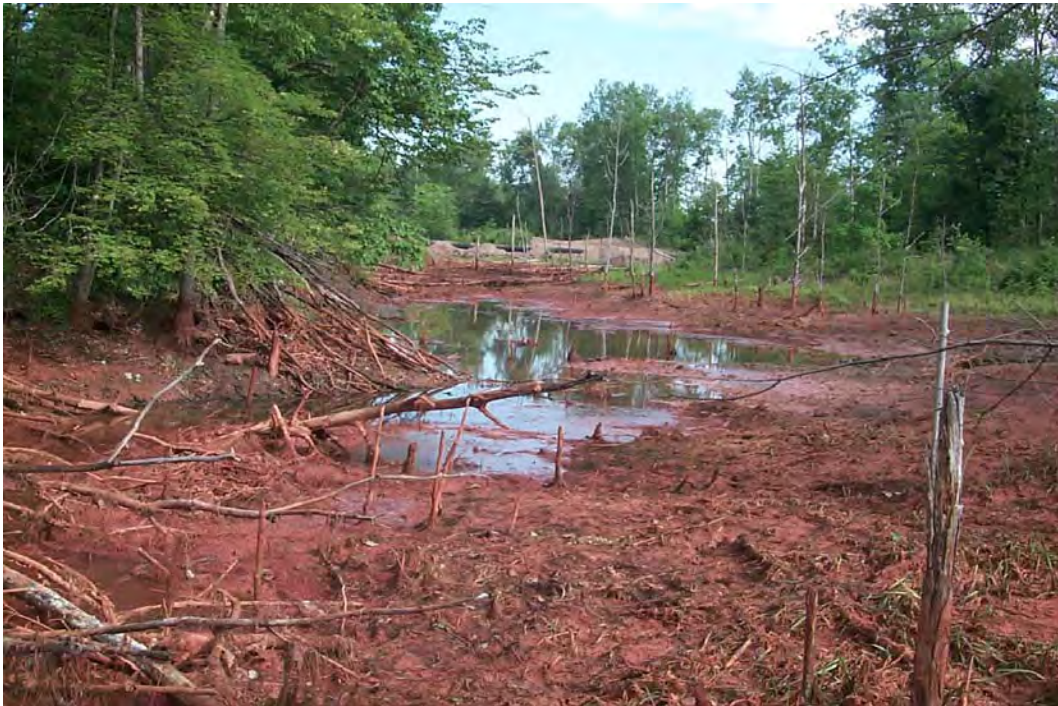
ST41 flowed into an abandoned strip pit from an old underground mine. This strip pit was then used as the basin for the ST41 treatment Upper Wetland. (7/24/00)

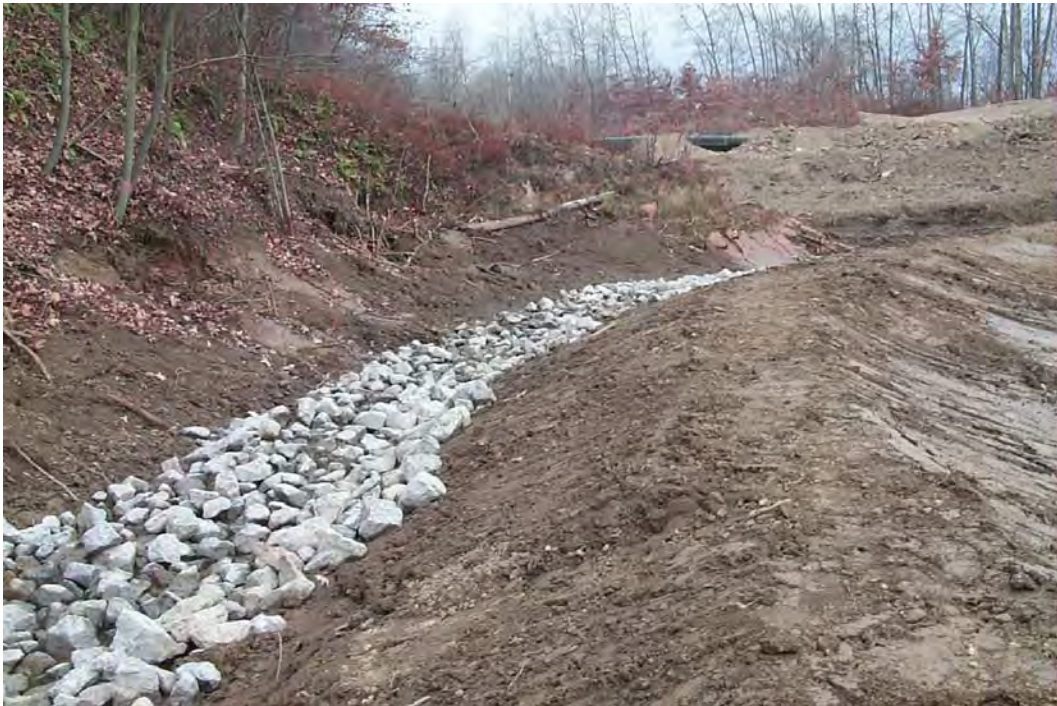
Collection ditch for seeps from abandoned underground mine workings to be treated by the ST41 Upper Wetland. (11/8/00)

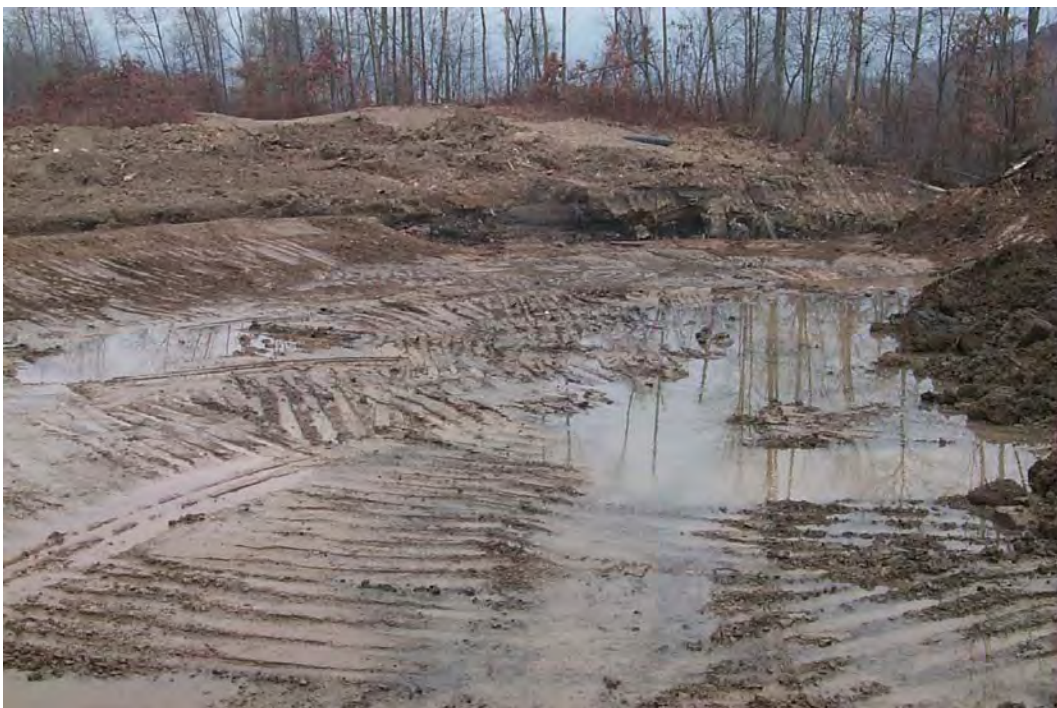
Section of ST41 Upper Wetland excavated to appropriate depth for the placement of hydric substrate. Berm of collection ditch visible to the left. (11/8/00)

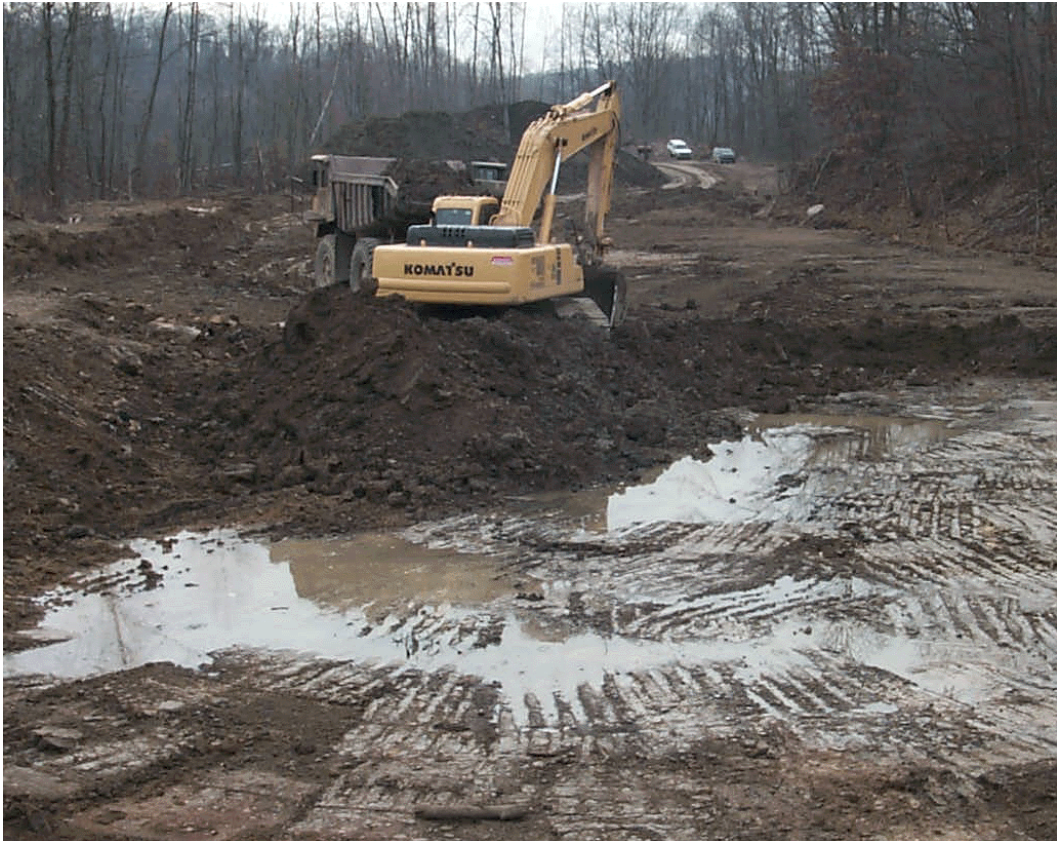
Placement of hydric substrate in ST41 Upper Wetland. (11/8/00)

Upper Wetland: The iron precipitate that was found in the area was moved and covered with clean fill from the site. The remaining substrate was then excavated to the appropriate elevation and grade, and the footprint of the treatment wetland was enlarged. Limestone pond fines were then used to line the base of the treatment wetland which were then covered with the hydric substrate material remaining from a mitigation project in another county. This was made possible by Bob Beran and Jeff Reidenbaugh of Aquascape and Quality Aggregates. This cut, which used to discharge dark orange-red, iron-laden water, became within a matter of a few months a widely acclaimed, successfully constructed, naturally-functioning wetland. The water discharging from the Upper Wetland is conveyed by a rip-rap lined, R4 limestone, channel 500 feet in length to a plunge pond to combine with the treated flows from Wetland 2.

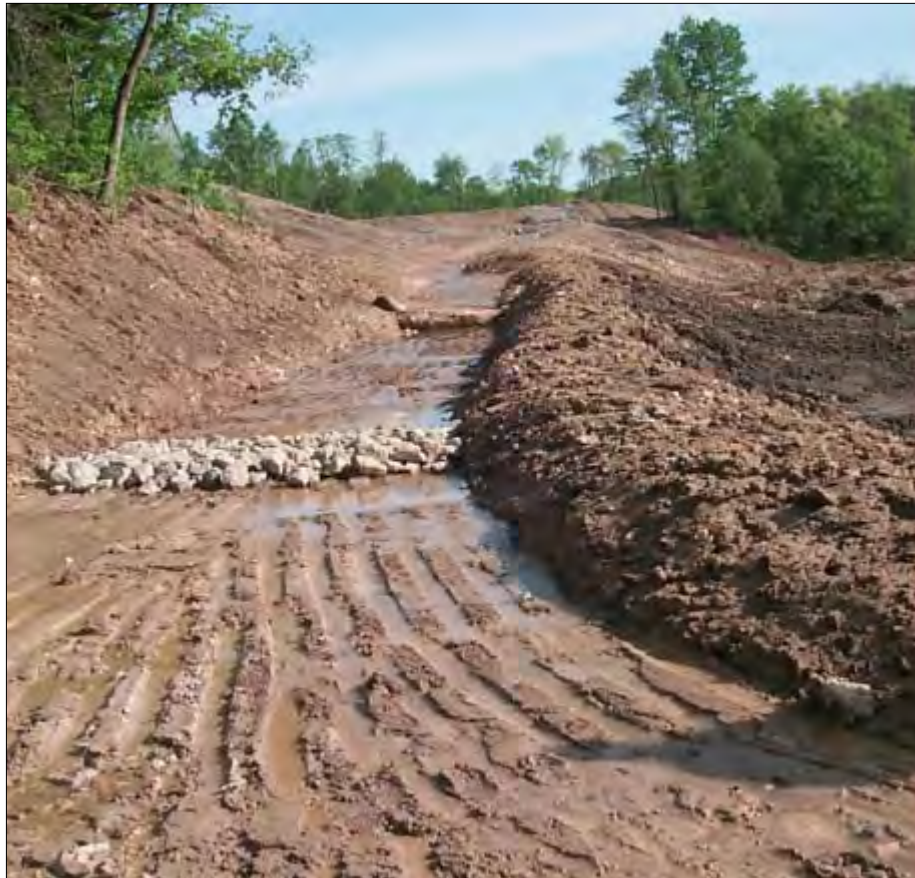
Bioswale following construction, before soil amendments and planting. (5/31/01)

During isolated incidents in which flows from Wetland 2 were diverted into the Bioswale, the hay mulch was found to be inadequate for the retention of seed and soil. As a result, plastic netting was used as an erosion control fabric. Following the replacement of soil, seed, and hay mulch, the plastic netting was stapled into the Bioswale substrate. Although the application of the netting greatly reduced the problems previously experienced when high volume flows entered the Bioswale, preferential flow pathways and evidence of erosion were still observed beneath the netting before the vegetation

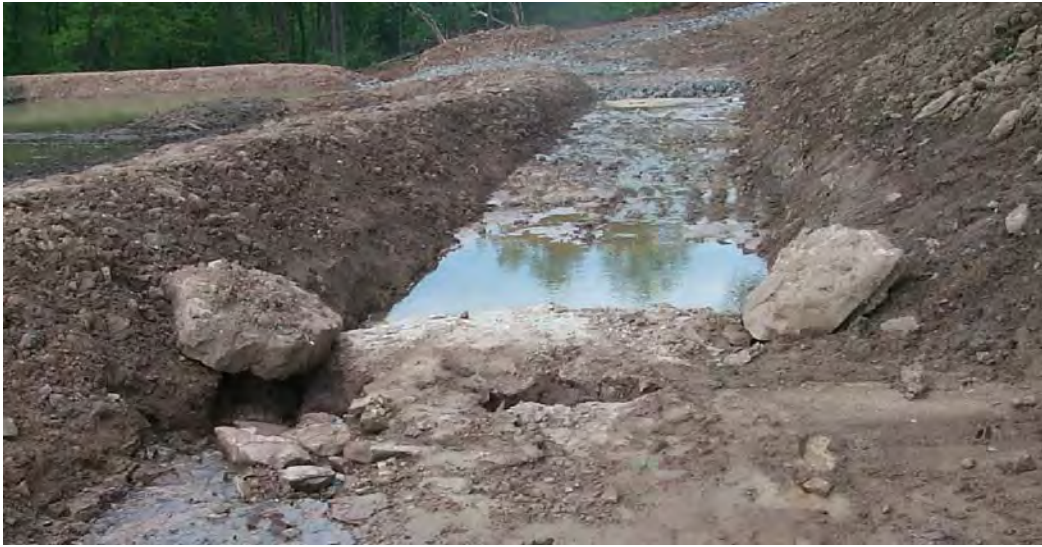
Plunge pool within the Bioswale. (5/31/01)

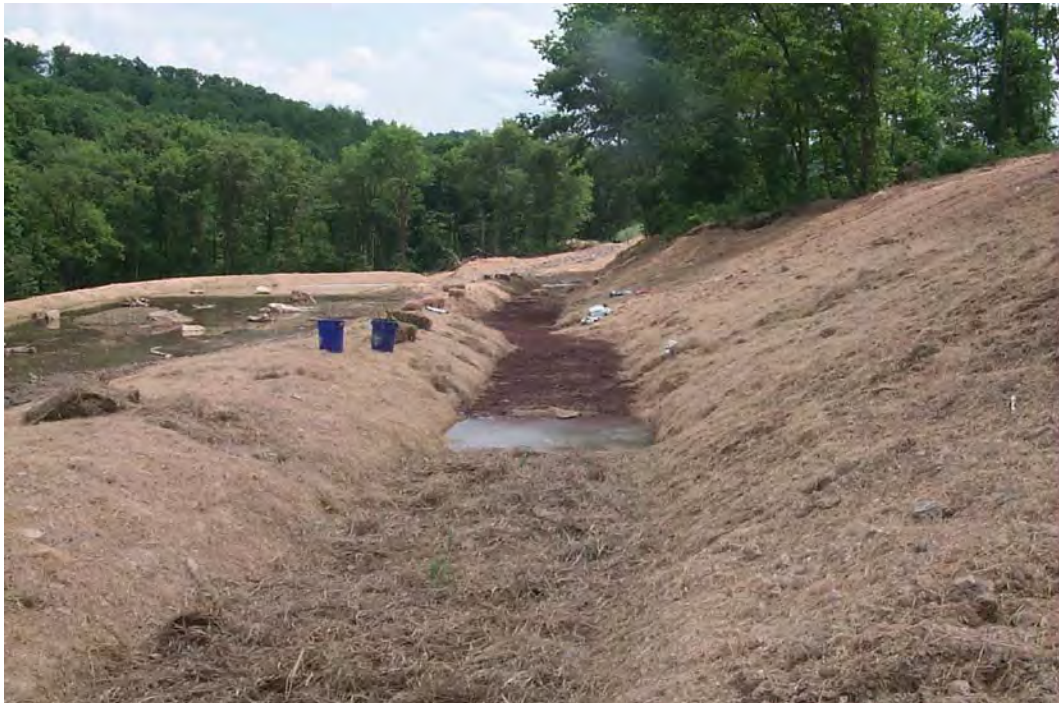
Initial soil amendments, seeding and mulching of Bioswale. (6/20/01)

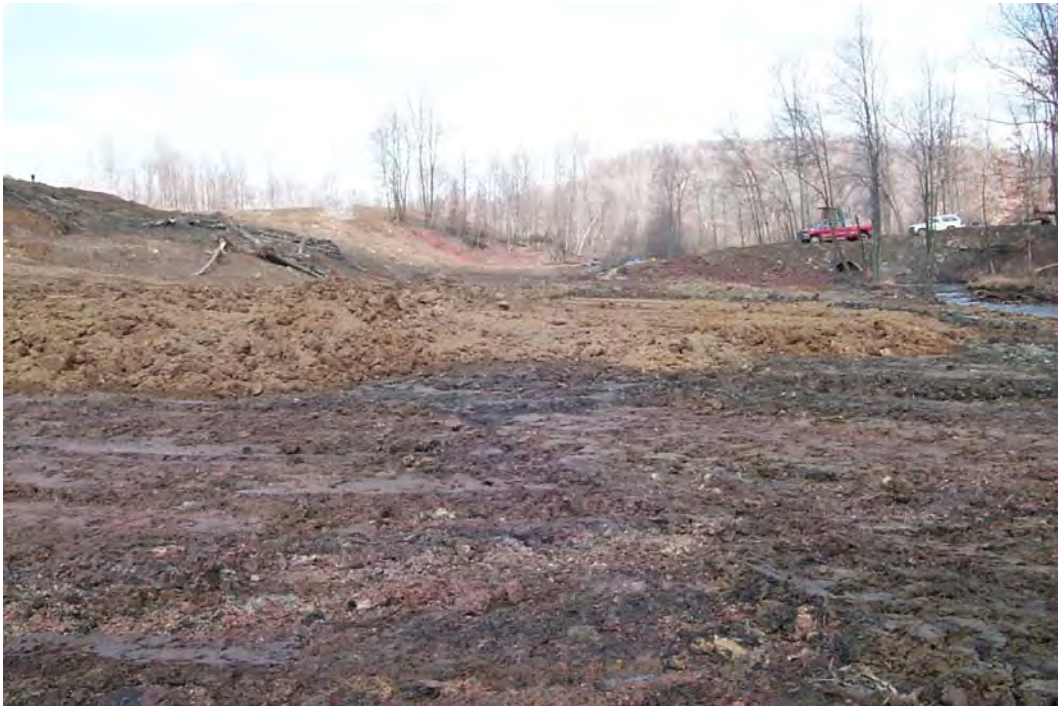
Placement of clay over remaining coal refuse to seal the floor of the final wetland. (3/23/01)

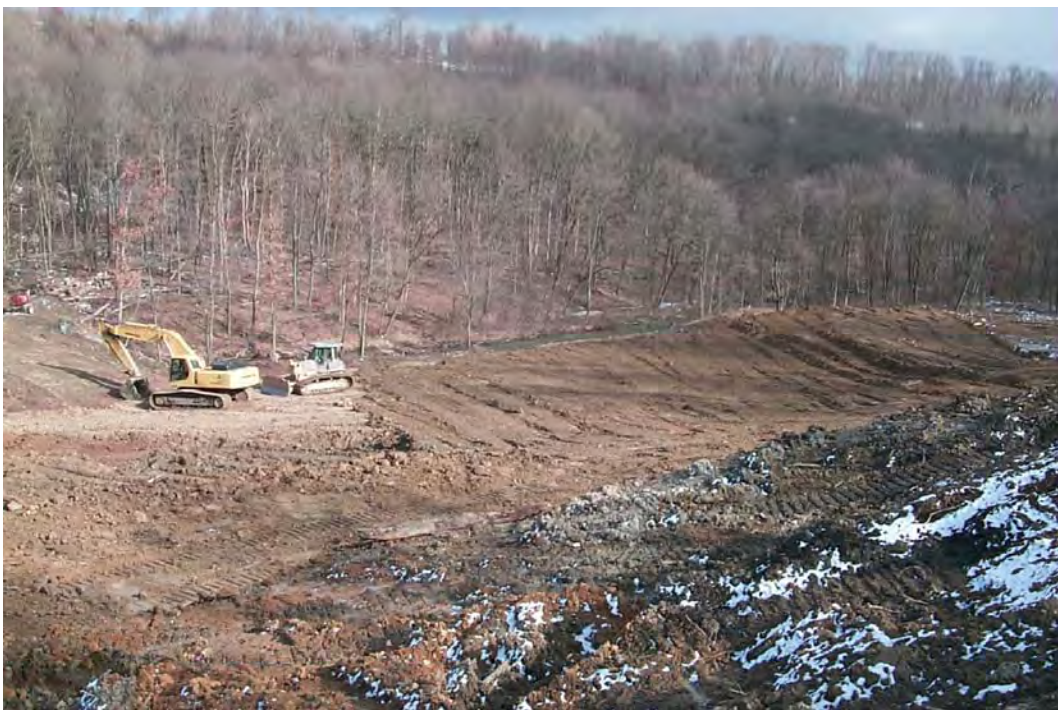
Placement of clay to seal the floor of the final polishing wetland. Murring Run can be seen in center of the photo. (3/28/00)

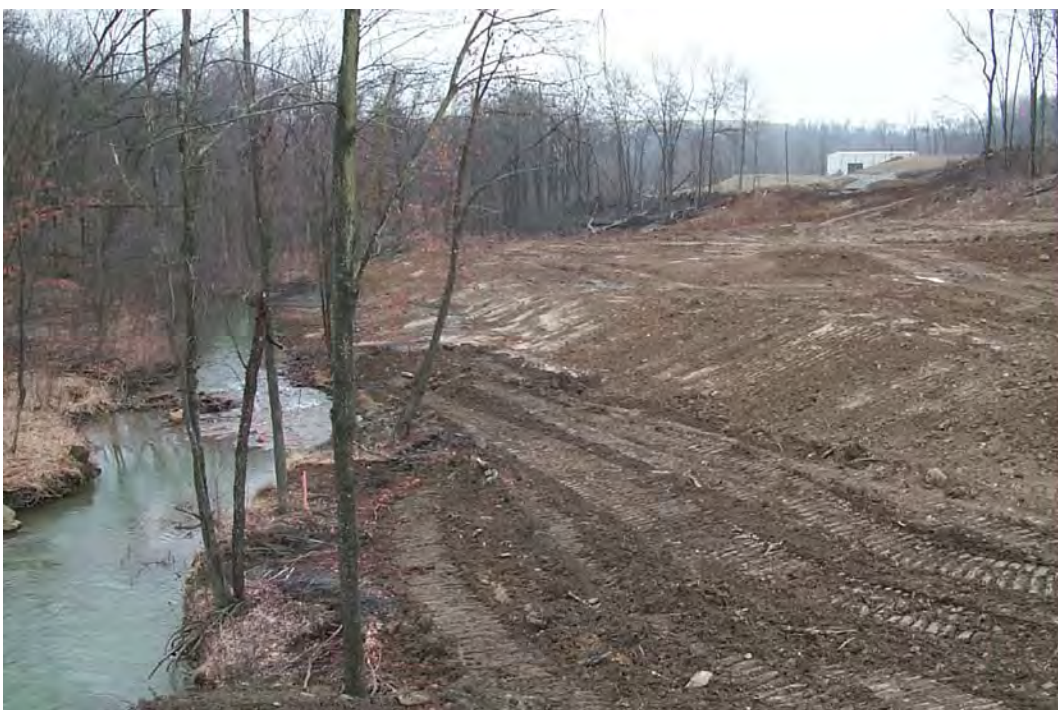
Riparian area (south of stream crossing) with addition of topsoil. (4/4/01)

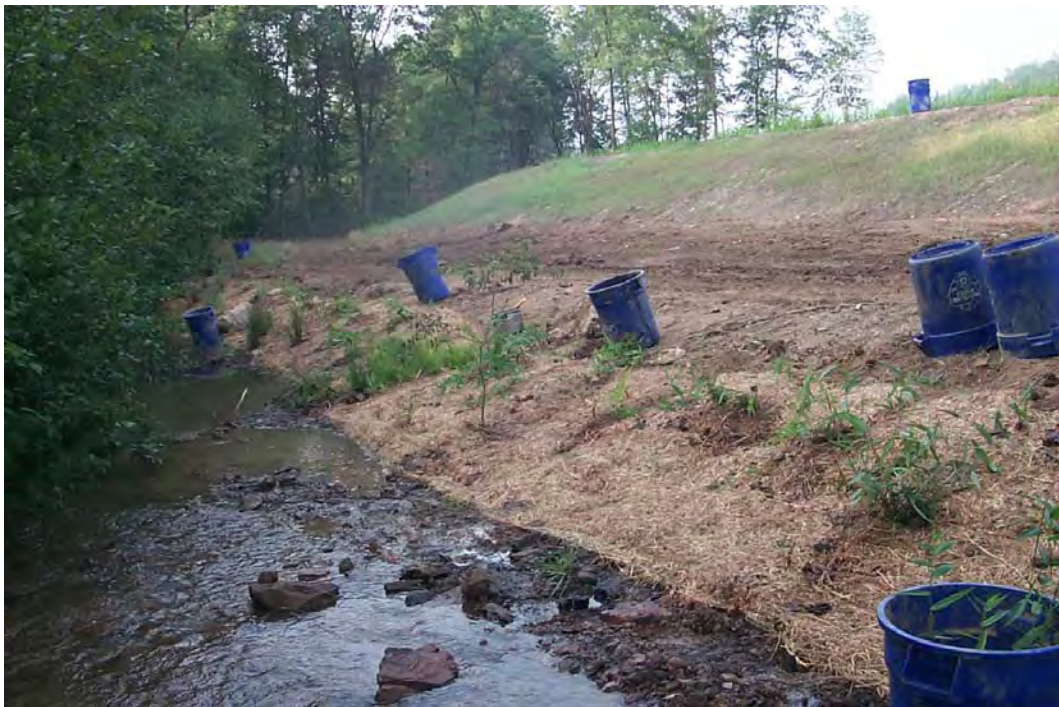
Planting of riparian area (south of stream crossing) following addition of soil, seeding, and installation of willow wattles and erosion control fabric. (8/9/01)

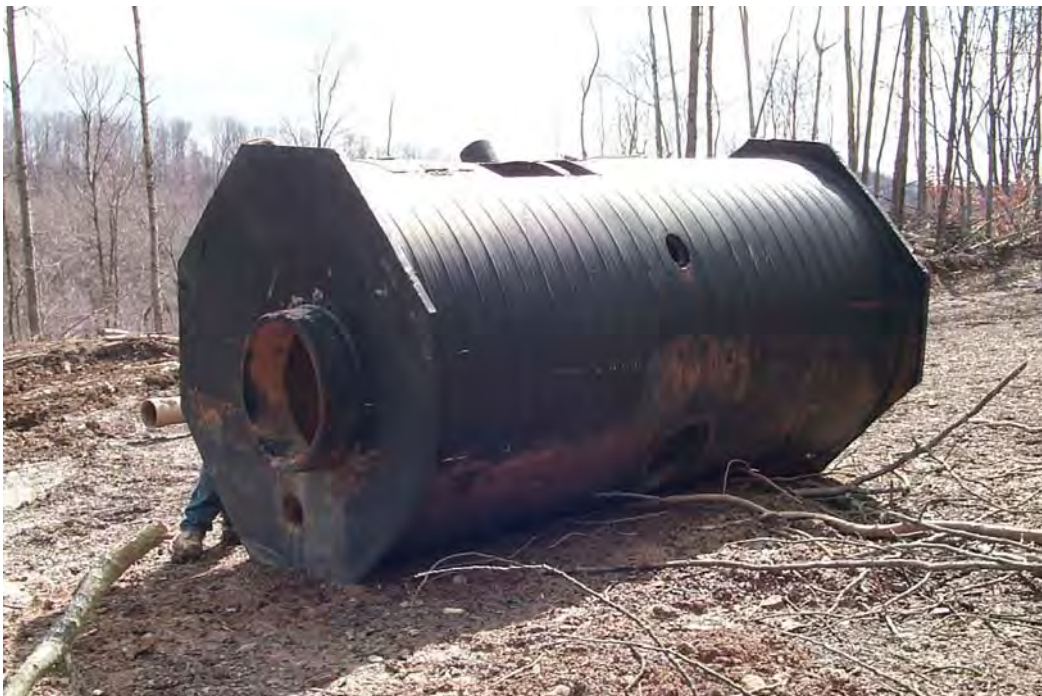
HDPE Manhole used as artificial cave for bat hibernaculum. (3/23/01)

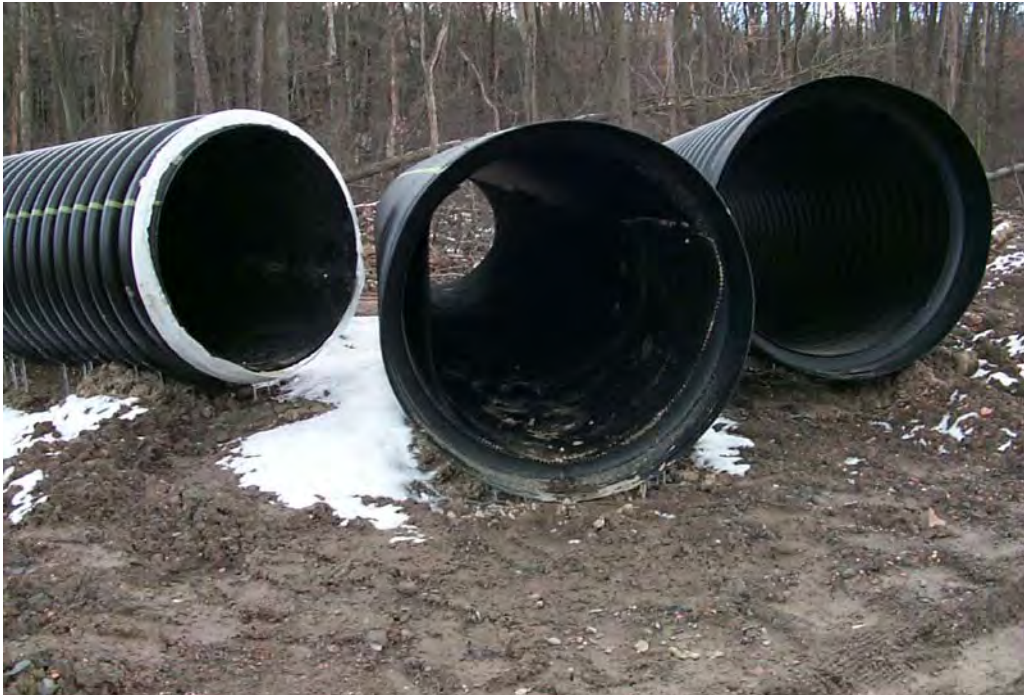
Culvert pipe was used to provide a 60-foot tunnel entry into the bat hibernaculum. (3/28/01)

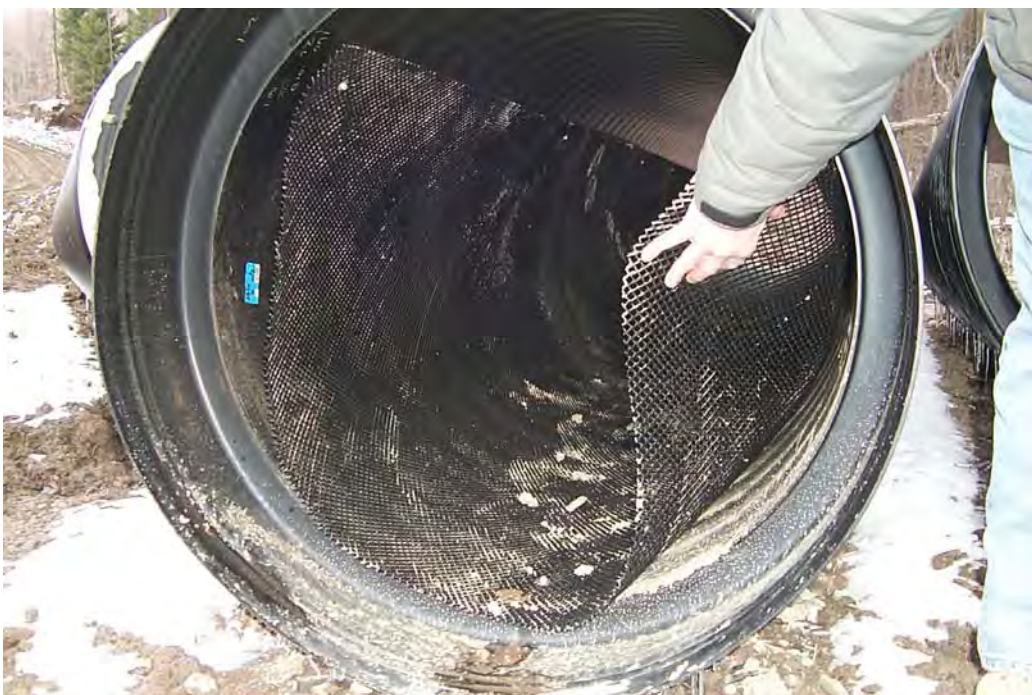
Tex-net (plastic netting) was used to line inside of the tunnel and HDPE manhole to provide foot-holds for bats. (3/28/01)

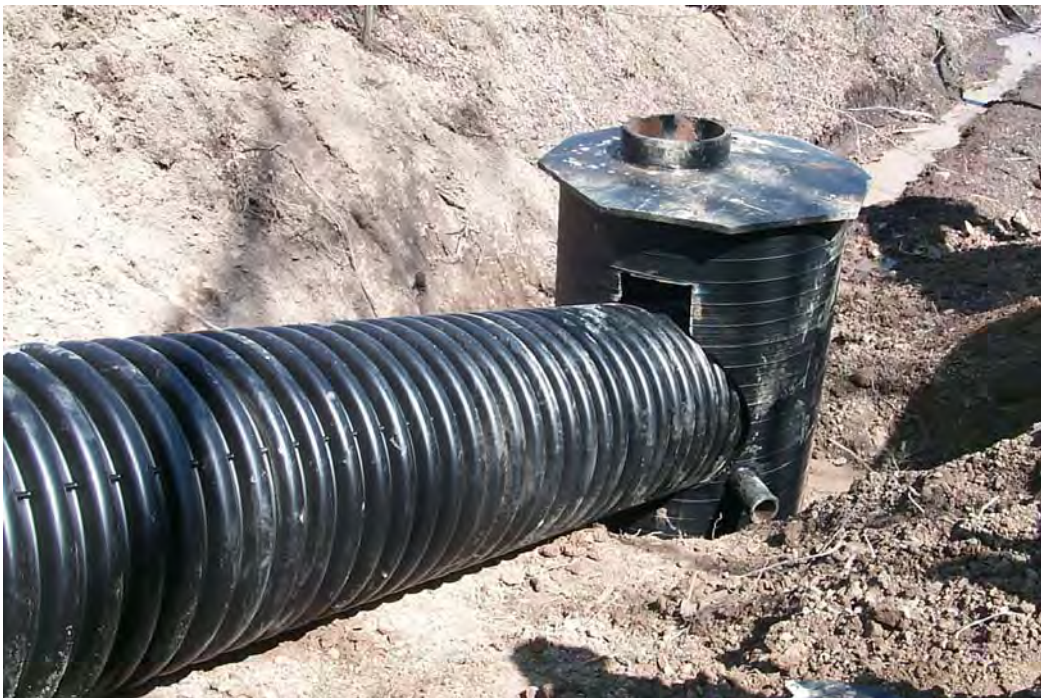
Installation of tunnel onto the bat hibernaculum. (4/4/01)
