**Neal Run**  
**Abandoned**  
**Coal Refuse**  
**Removal**

**Project**  
**Summary**

**A Public-Private Partnership Effort**  
**AWARE & Stream Restoration Inc.**

**Aultmans Run Watershed**  
**Young Township**  
**Indiana County, Pennsylvania**

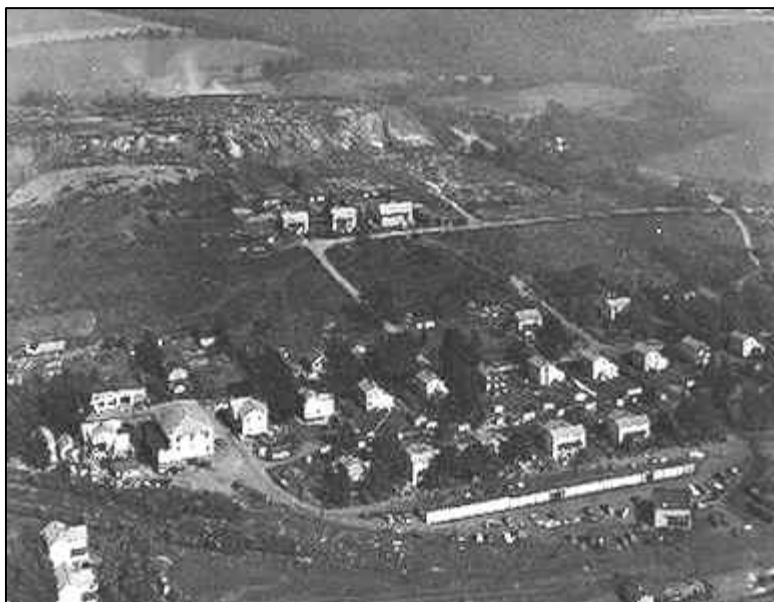
**Figure 1: Aerial view of McIntyre, PA. Burning refuse pile can be seen at the top of the photo. (ca. 1945) (Ref. Washlaski, 2010)**

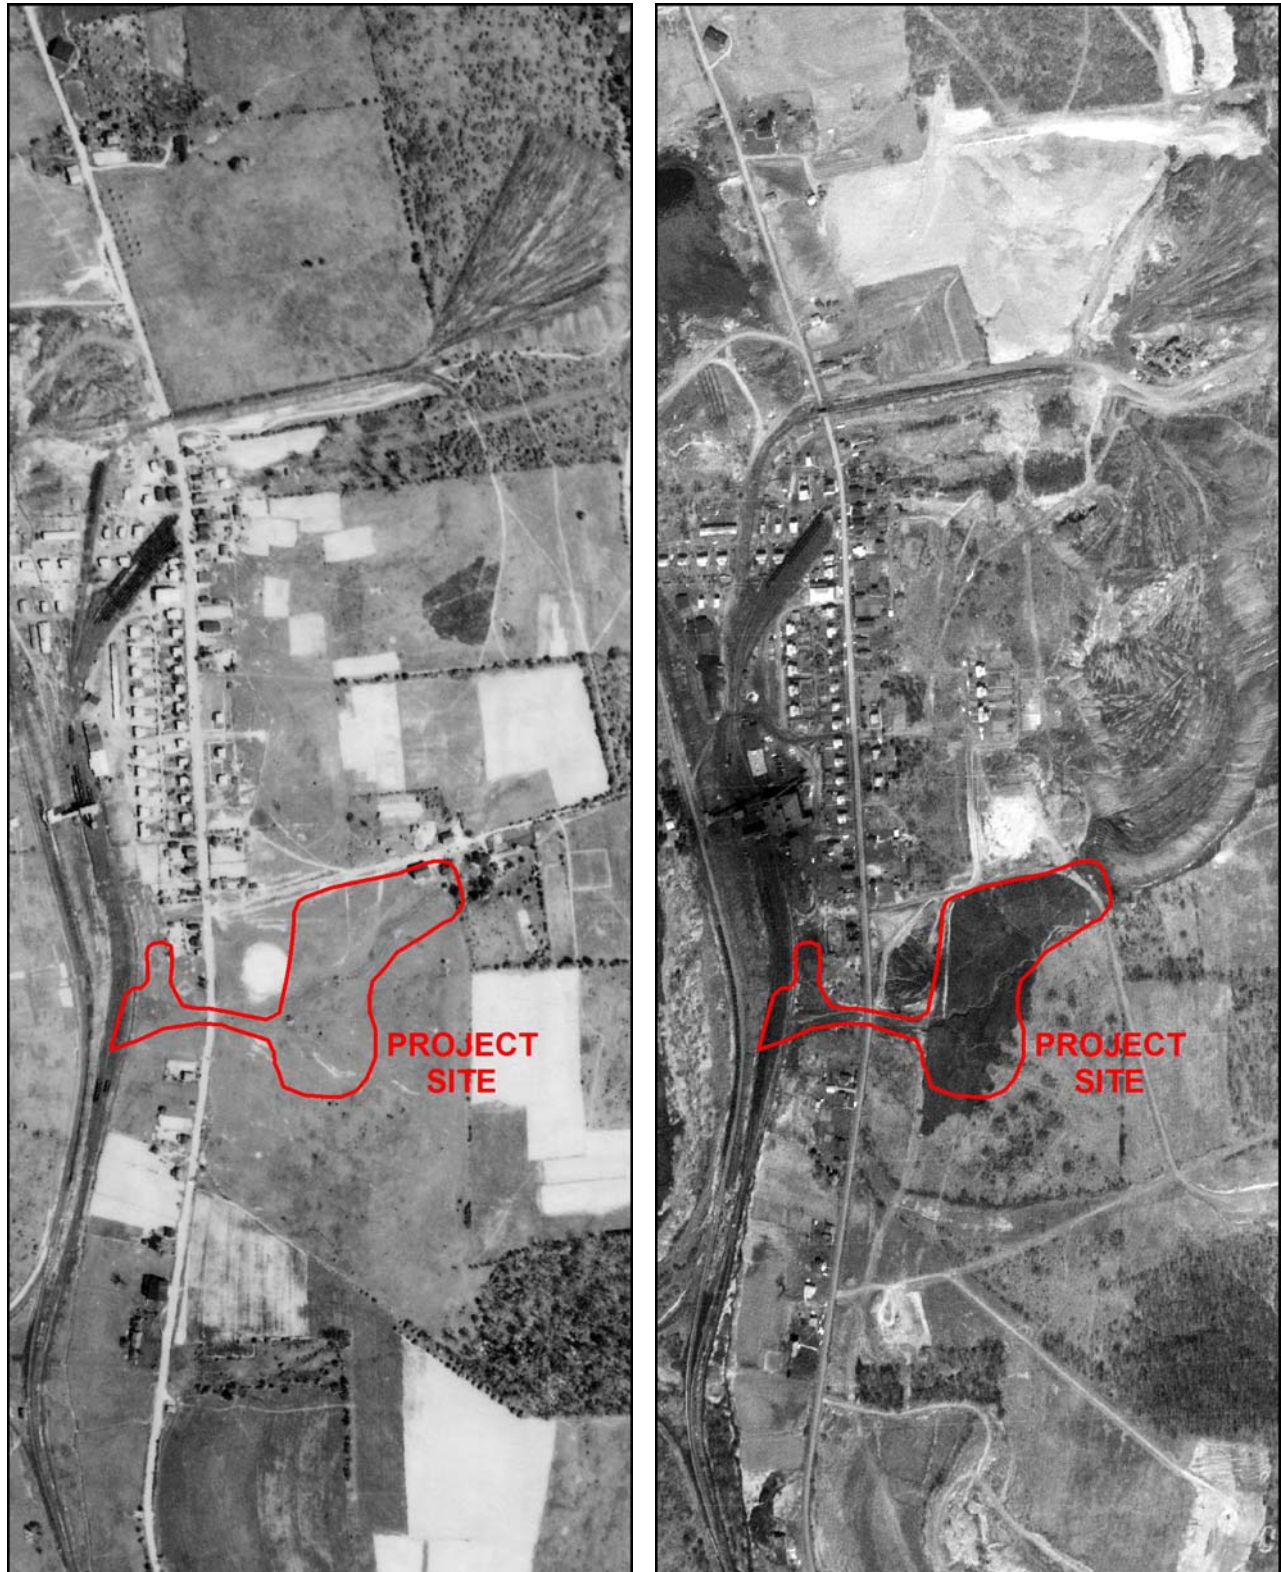
**Figure 3: Comparison of aerial photos from 1939 (left) and 1962 (right). Note the coal refuse pile has been enlarged significantly to the south in the 1962 photo.**

The following aerial photographs (Figures 3 & 4) depict changes throughout the history of the project site.

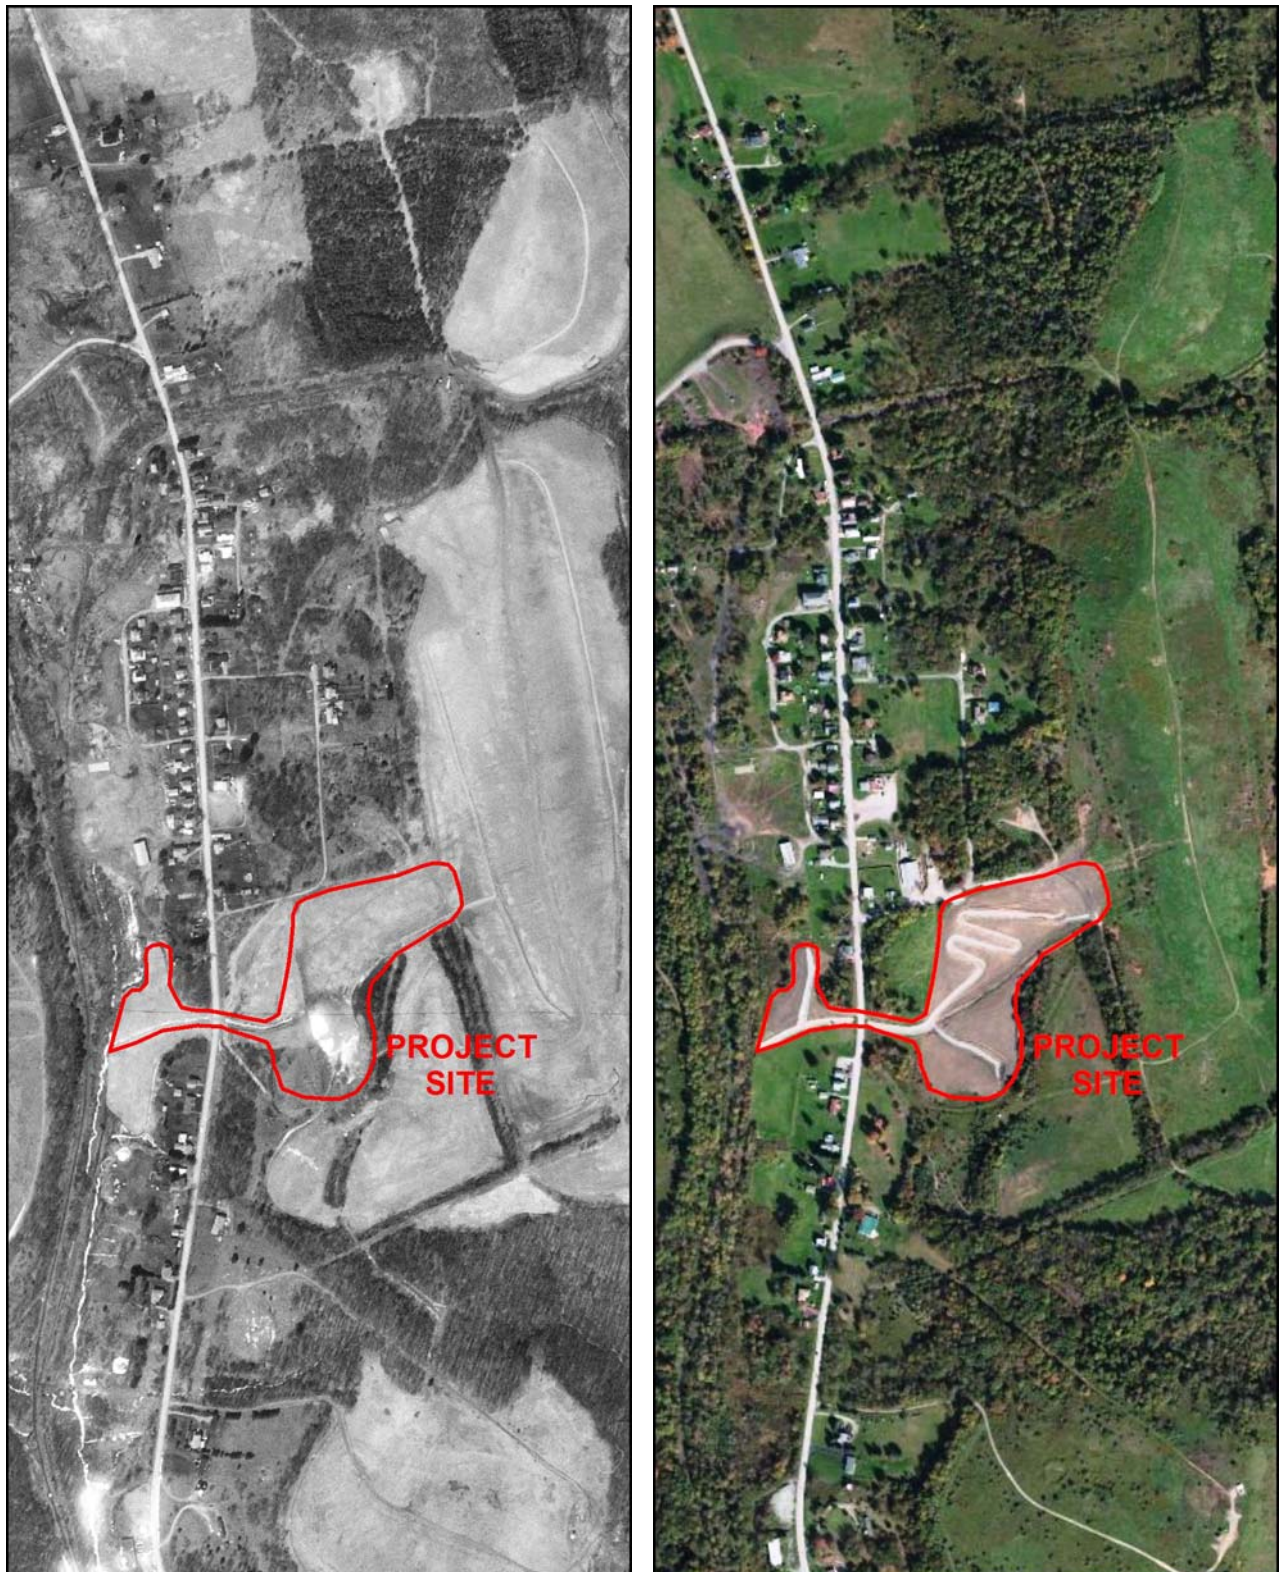
**Figure 4: Comparison of aerial photos from 1993 (left) and 2011 (right). The 1993 aerial photo shows the recently reclaimed coal refuse site. Coal refuse was spread further south for stabilization and to attempt to extinguish the fire. The 2011 aerial shows the newly constructed treatment system.**

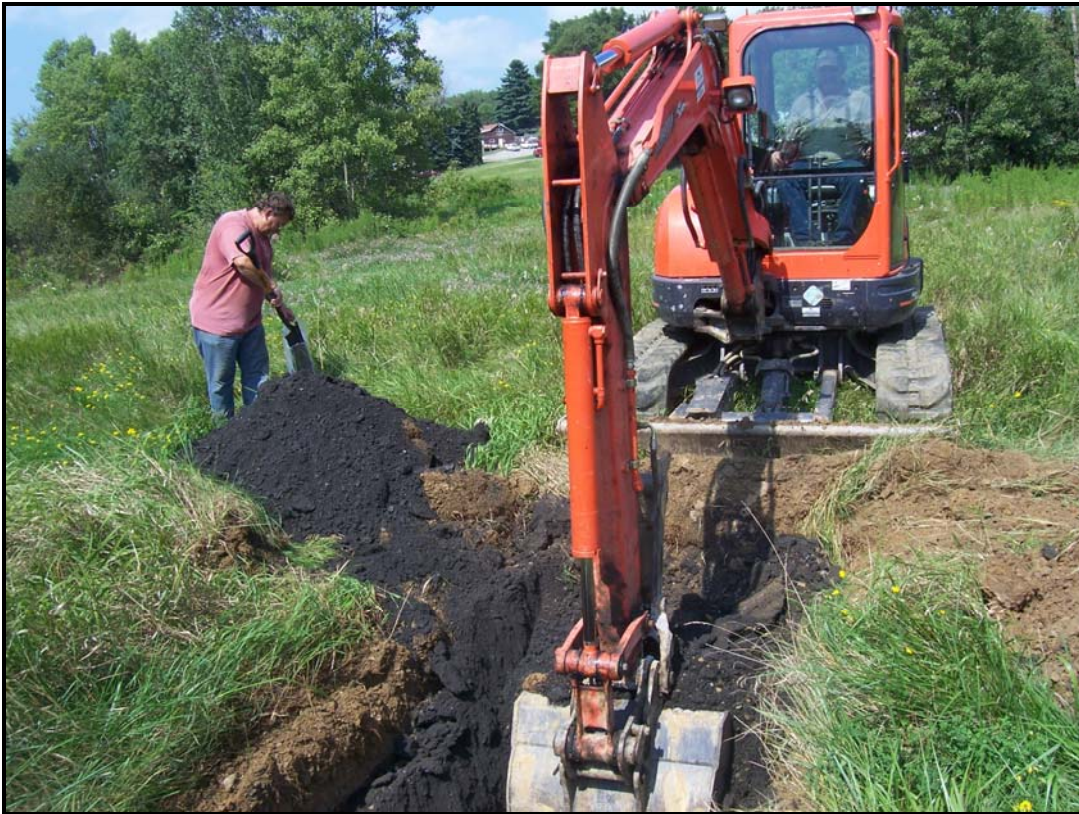
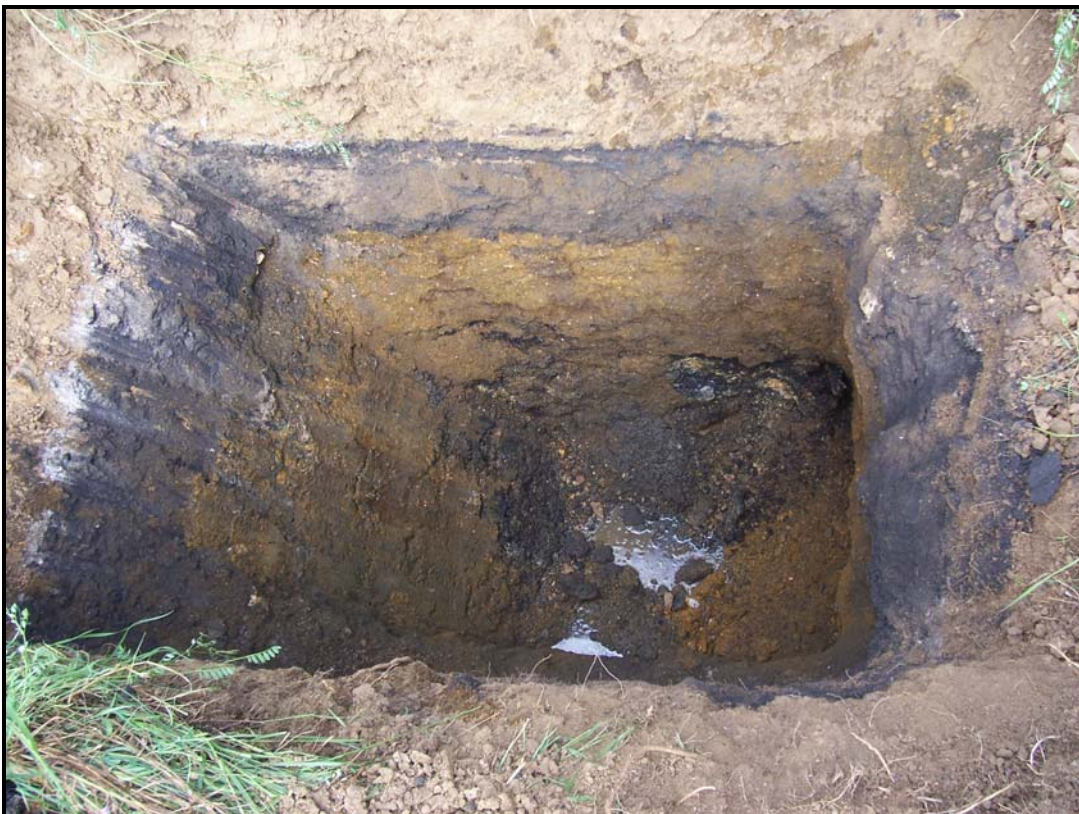
**8/12/10 - Test Pit Excavation**

At no cost to the Commonwealth, Robindale Energy Services excavated a series of test pits, some of which were logged by BioMost personnel, within the project site to determine material characteristics including the coal refuse. Furthermore, a piezometer was installed in December 2009 within the project area. Also, at no cost to the Commonwealth, as part of the partnership effort, John Foreman, PG, representing Central Blair Electric Company, provided the drilling services.

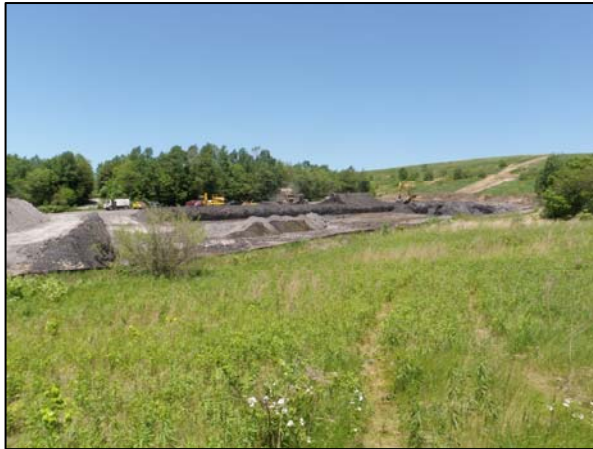
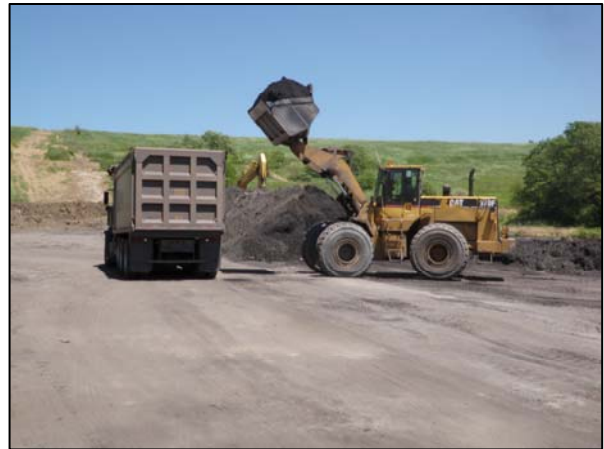
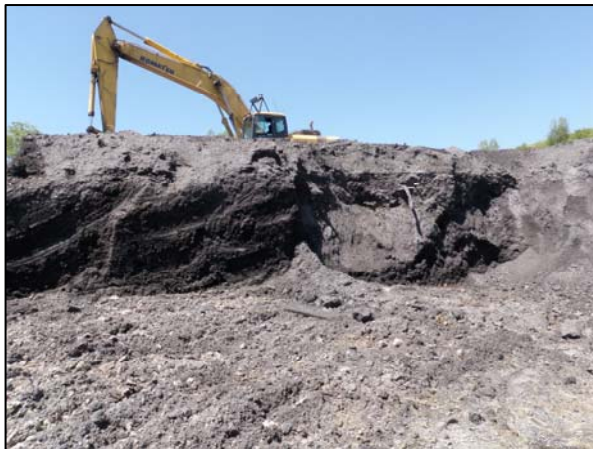
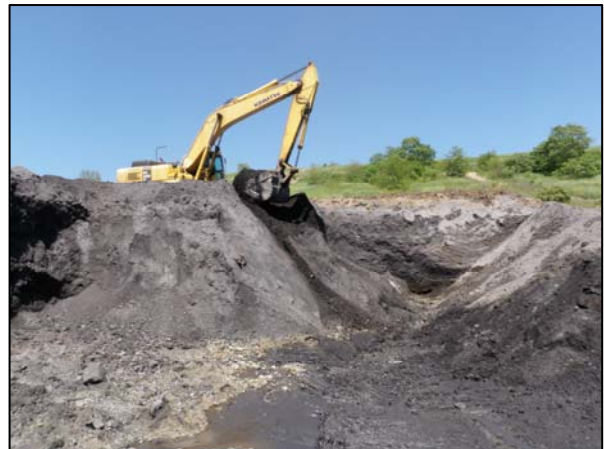
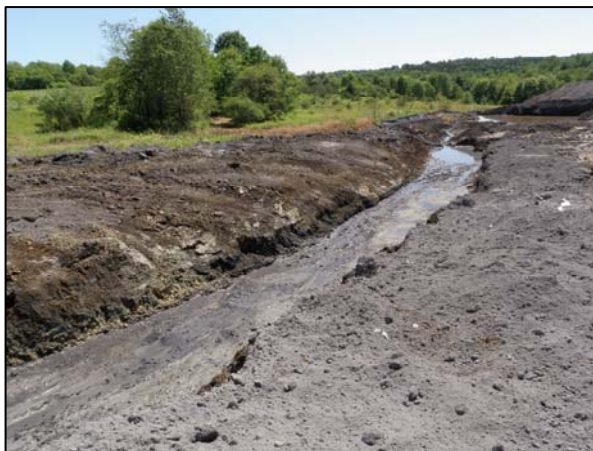
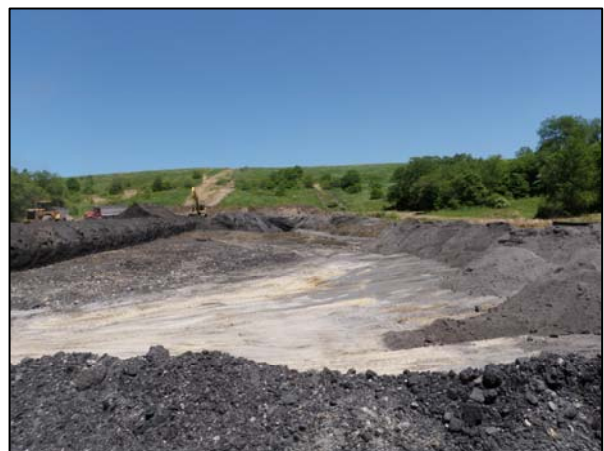
**6/2/11 – Coal Refuse Removal**

A \$200,000 Growing Greener 2 remaining grant was awarded to AWARE to implement the design plan. Construction occurred over the course of 2011 and 2012 during which 37,608 tons of refuse were removed. As non-fuel grade material was to remain onsite, over 7,753 tons of Mineral CSA, a PADEP-approved co-product, were blended with potentially acid-producing material to provide alkaline addition. (Please note that the Mineral CSA was donated by project partner Harsco Minerals.) In addition, Synagro donated, permitted, placed, and incorporated 487 tons of biosolids onto the re-graded site, which provided an excellent growth medium for revegetation with a seed mixture that included warm and cool season grasses and flowers.

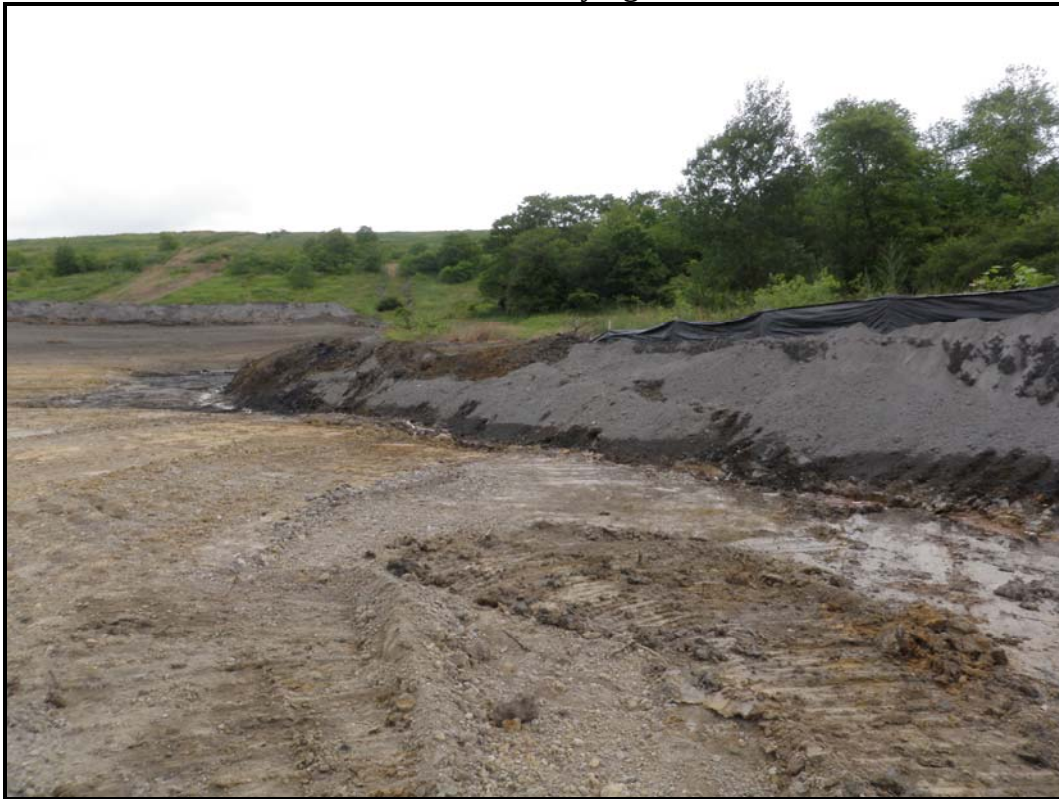
**6/14/11 – Mineral CSA Overlying NFG Coal Refuse**

A total of three OPCs were constructed to help improve the remaining discharges located on site. The longest, OPC1, carries the seep emanating from the toe of the large, reclaimed refuse pile located upgradient of the site through an existing culvert and into Neal Run. OPC2 was constructed to address any lingering discharges and lower the water table within the remaining NFG refuse located to the south of an existing ditch. Some refuse was fuel grade; however, the majority of the refuse within this area of the site had been mixed with soil material and, therefore, unusable for power generation. OPC3 is west of McIntyre Road (SR-3031) and was constructed to intercept and to convey AMD seepage, which is located behind a residence, to OPC1. Primarily NFG refuse was present west of SR-3031; however, the site was re-graded and Mineral CSA was utilized for alkaline addition.

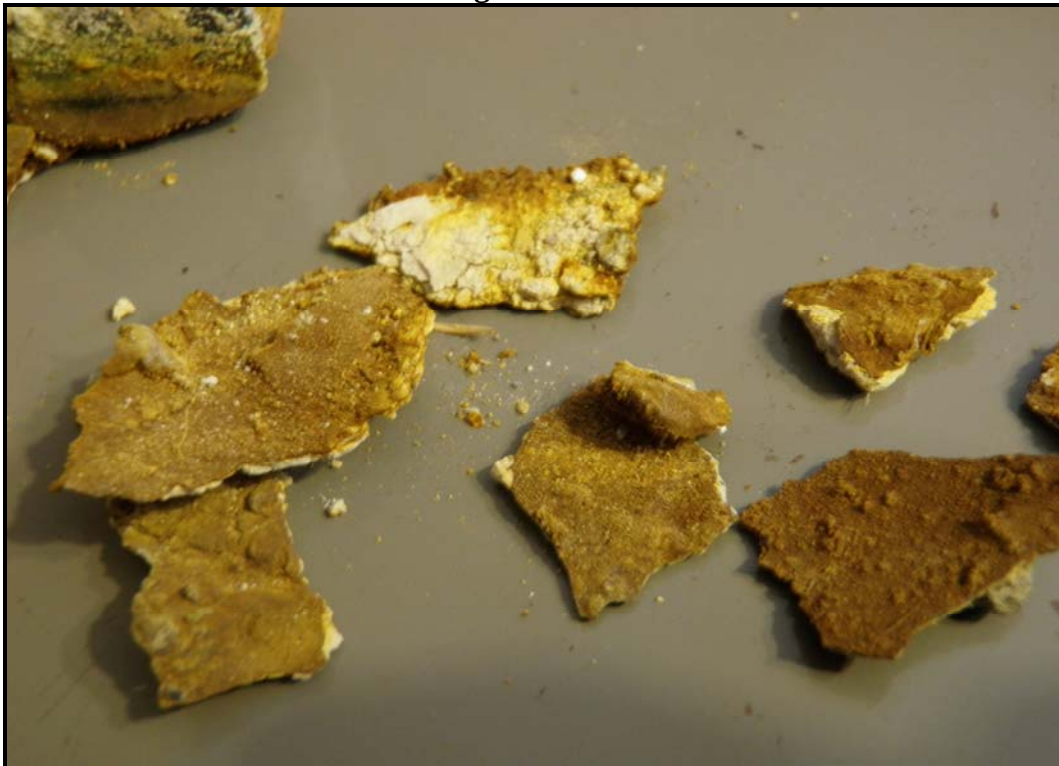
**7/7/11 – Iron-Bearing Material that Formed at the Site  
During Construction**

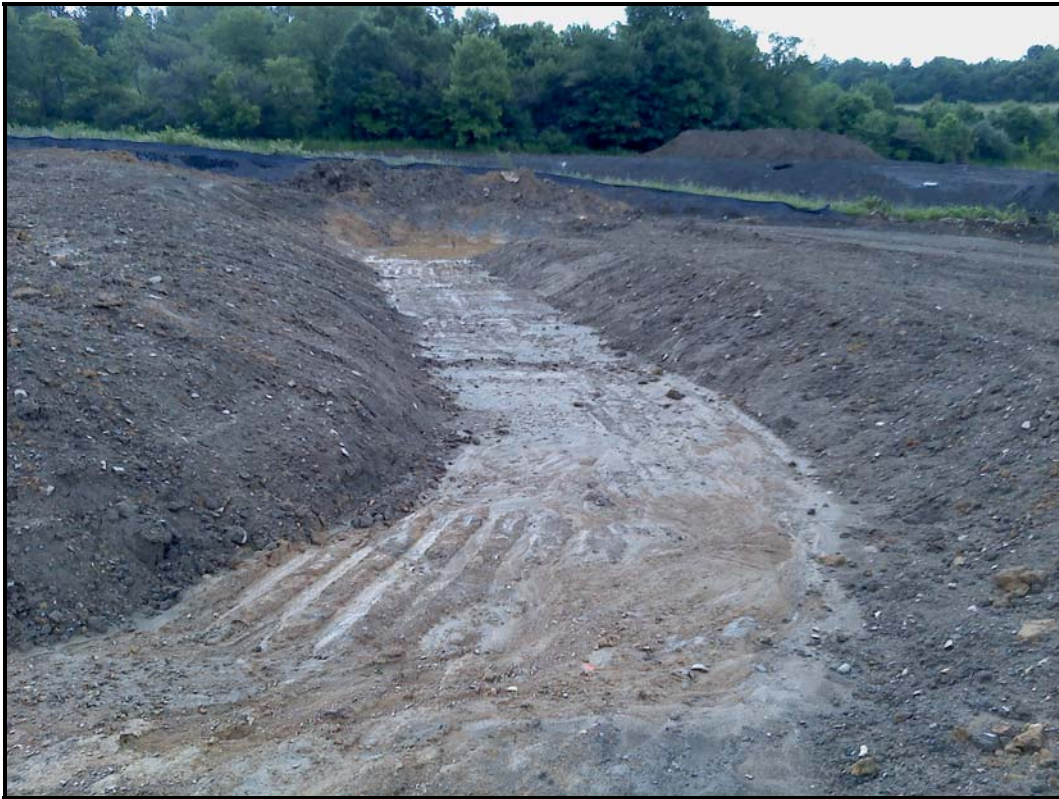
**7/19/11 – OPC Excavation**

The OPCs were constructed in original ground to help avoid potential leaks. Once graded, the OPCs were lined with a permeable geotextile and with limestone riprap (R4

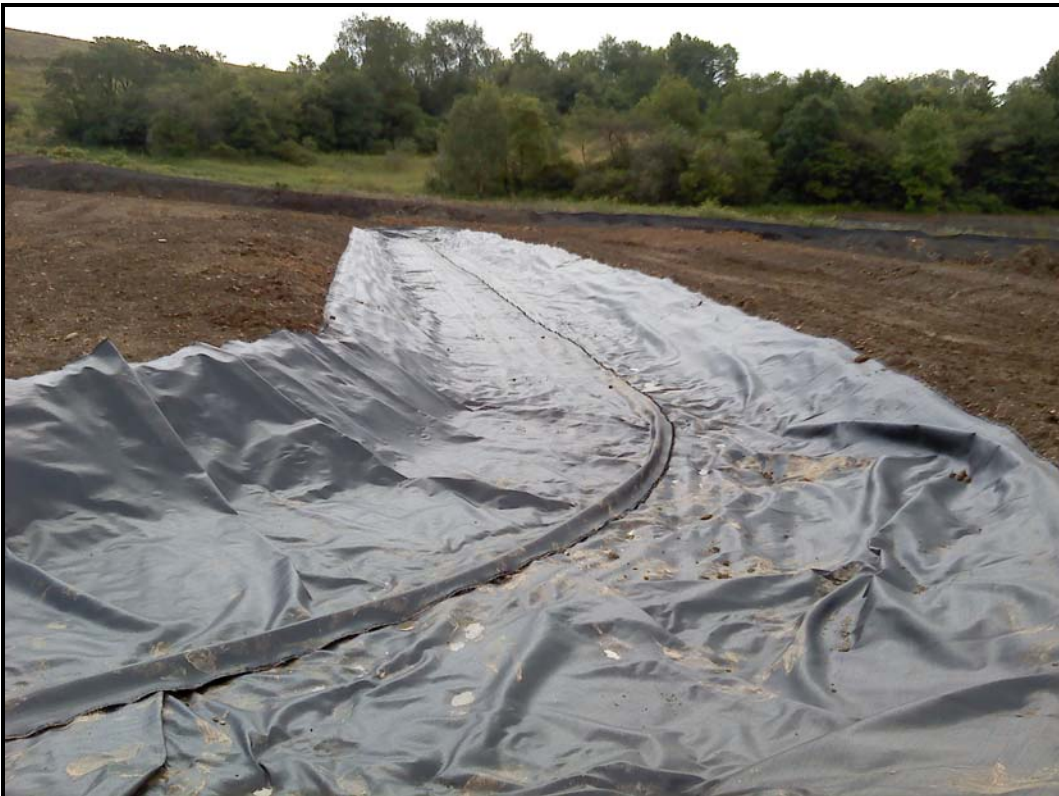
**7/19/11 – OPC Installation of Geotextile Liner**

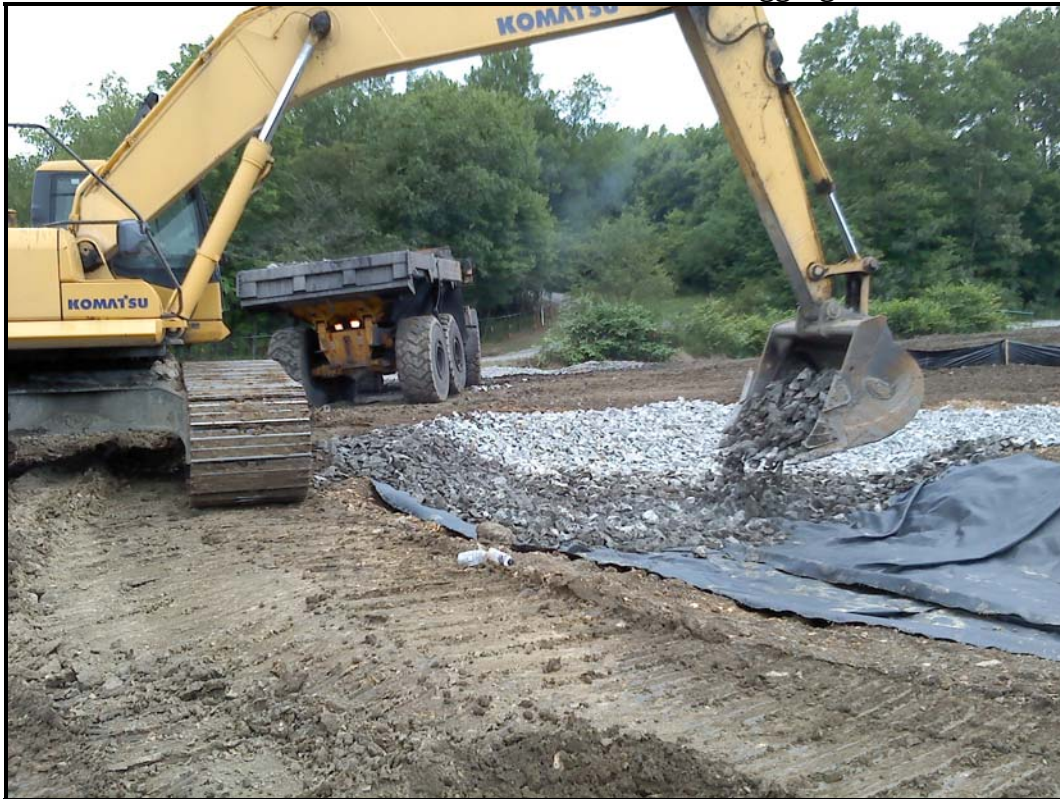
**7/19/11 – OPC Placement of Limestone Aggregate**

& R5) from the Torrance Quarry of Hanson Aggregates (average calcium carbonate of 62%). Most of the construction work was completed by July 2011.

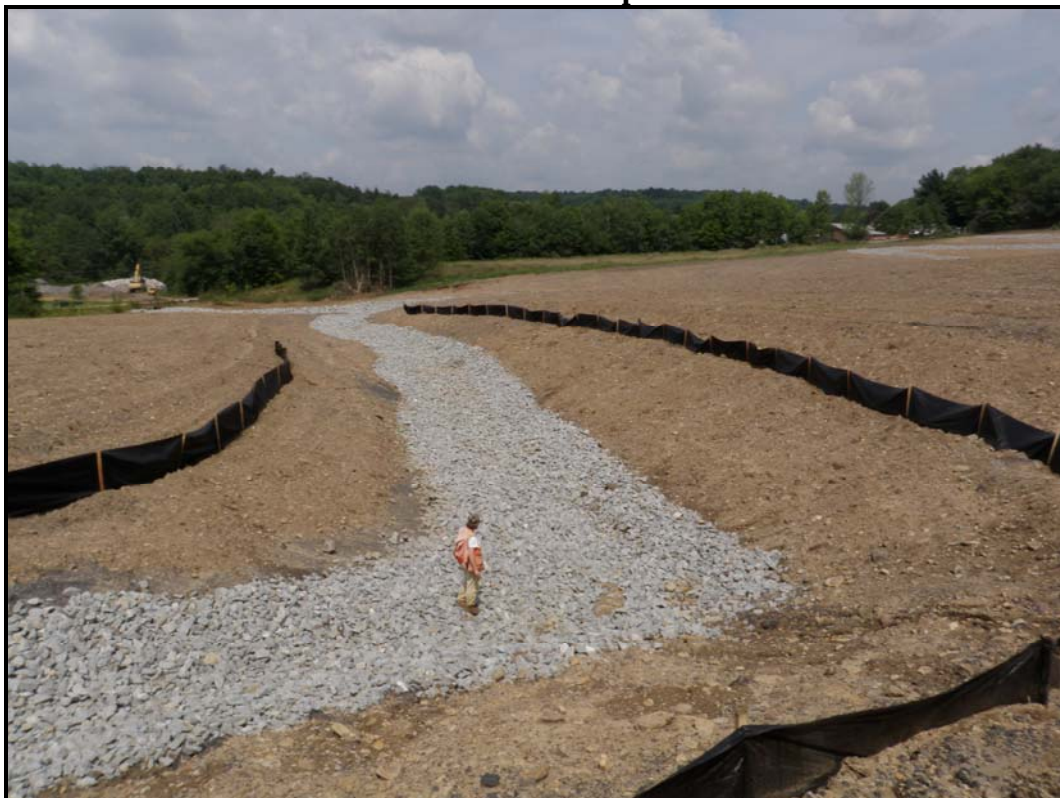
**8/2/11 – OPC Completed**

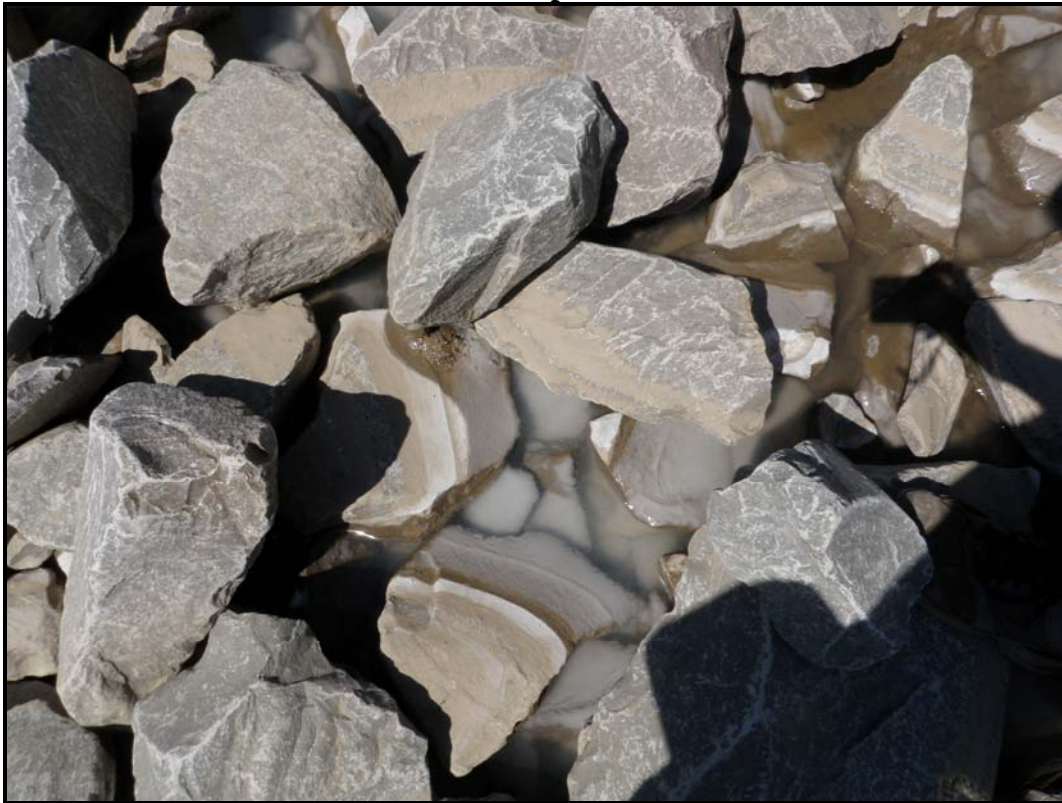
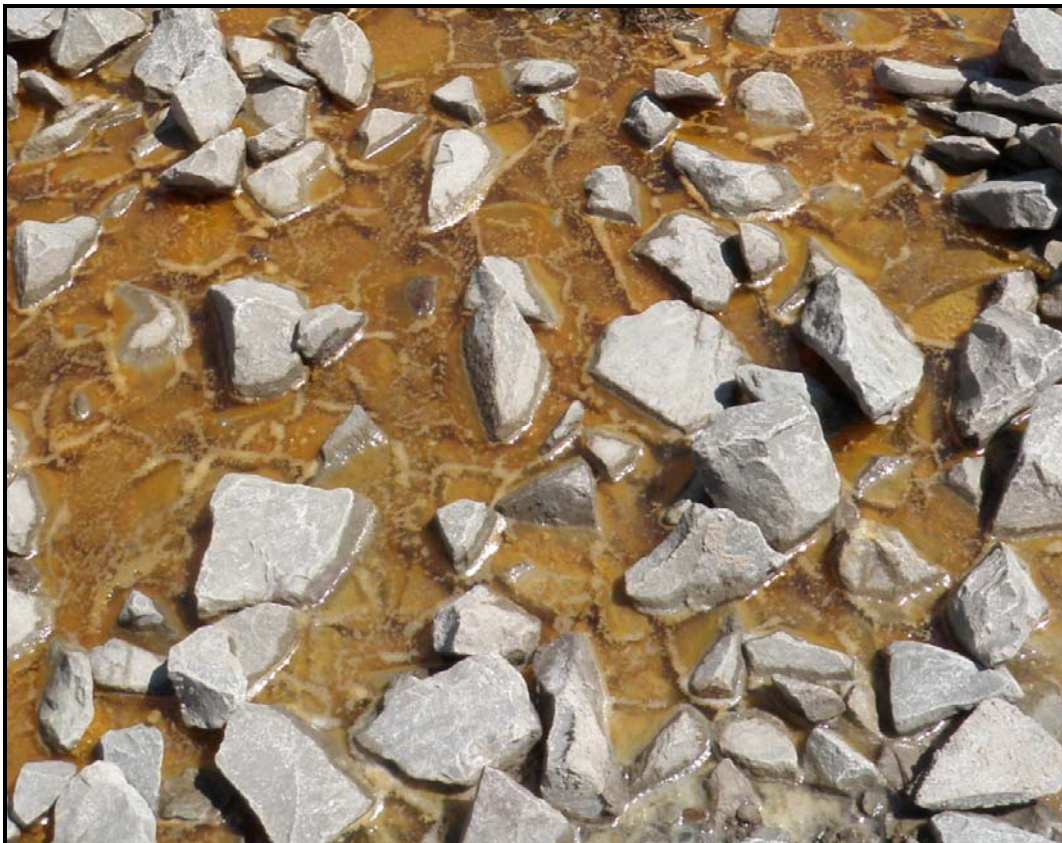
**8/12/11- OPC Precipitate Formation**

The observed decrease in ferrous concentrations is considered to be in response not only to dilution from D3 and D6 but also to the oxidation of ferrous to ferric within OPC1 at low pH.

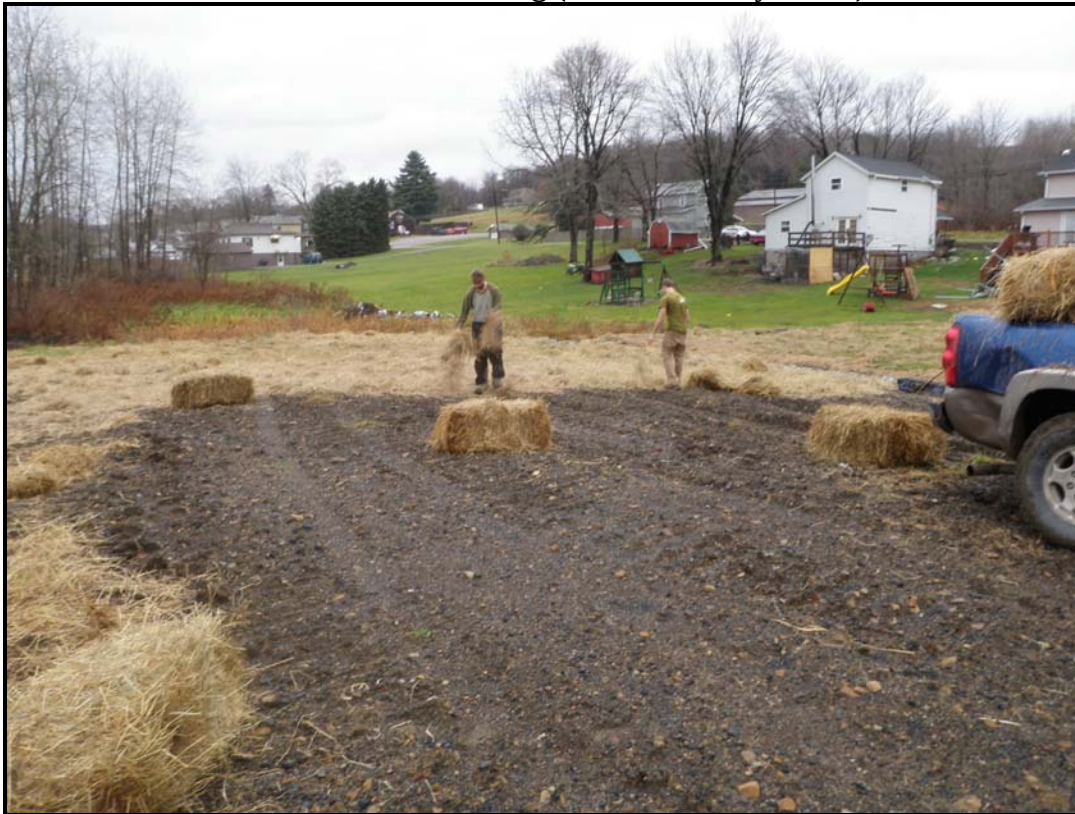
**1/15/11 – Initial Seeding (west of McIntyre Rd.)**

A temporary cover was seeded after construction in anticipation of adding biosolids to the soils in 2012. Synagro, the largest sewage recycling company in the USA, applied for, and received, a permit to land apply biosolids at the site. Synagro donated not only the resources to acquire the necessary permits but also the biosolids and the application effort as part of the partnership effort. The biosolids were produced by treating the residual sewage sludge from the Johnstown Redevelopment Authority with calcium oxide (quicklime). The calcium oxide increases the pH and temperature to inactivate pathogens and control odors (pH of 12 for over 24 hours before the biosolids are transported to the project site). The biosolids were then spread over the reclamation site and incorporated by disking with a tractor. A total of 487 tons of biosolids were spread at the site, approximately 80 tons per acre. The site was seeded and mulched shortly after the application of the biosolids. The seed mixture used at the site included a combination of warm and cool season grasses and flowers along with a temporary cover crop, *Secale cereale*. (Refer to Table 3.)

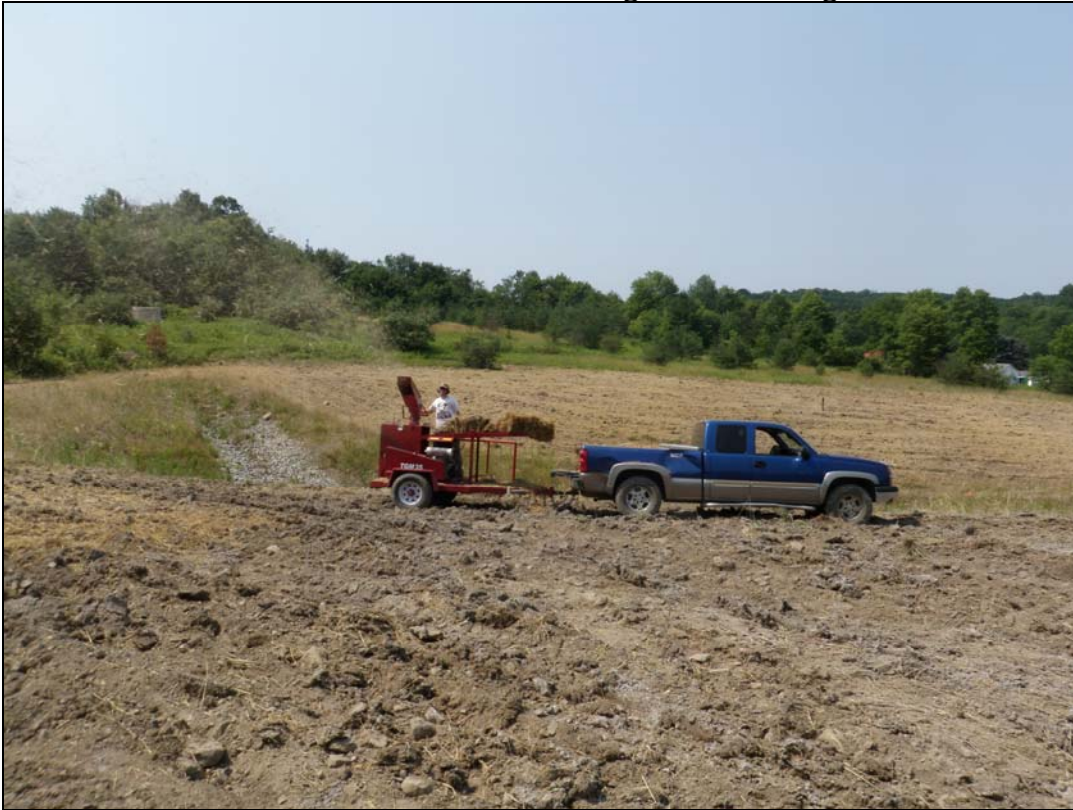
**6/28/12 – Permanent Seeding and Mulching**

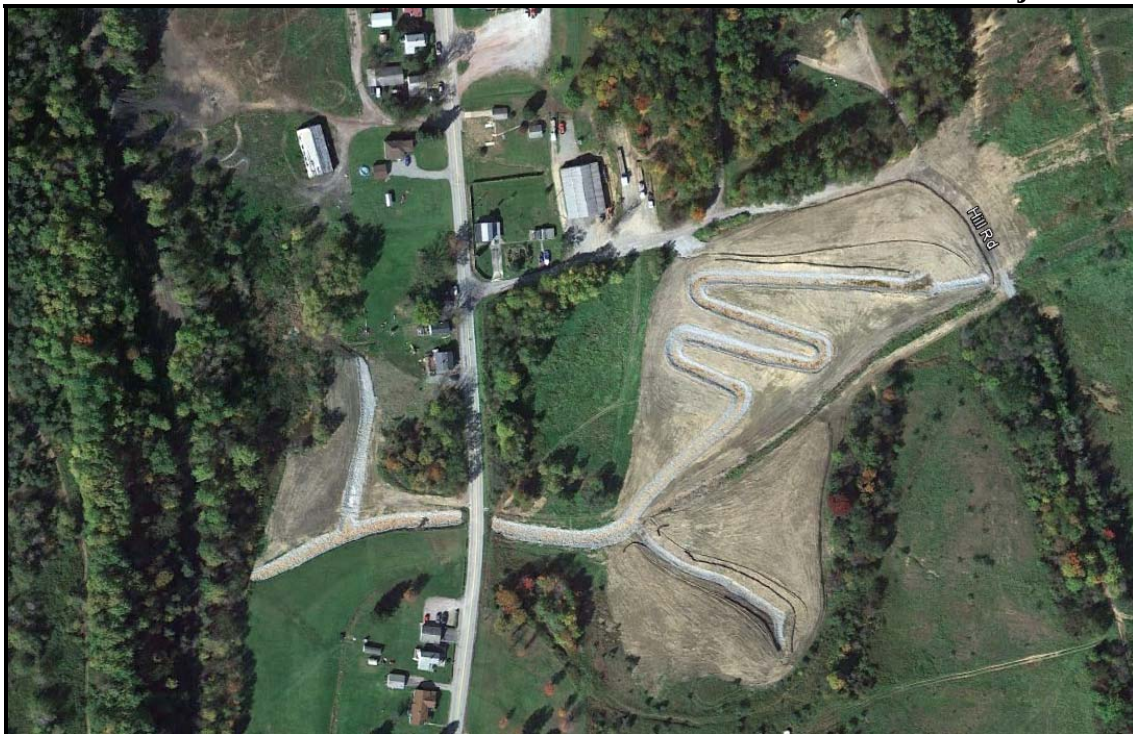
**2011 Aerial Photo of Neal Run Abandoned Coal Refuse Removal Project**
