**McCaslin Road Passive Treatment System**  
**SRI O&M TAG Project #17 Request #3**  
**OSM PTS ID: PA-150**

Requesting Organization: Montour Run Watershed Association (in-kind partner)

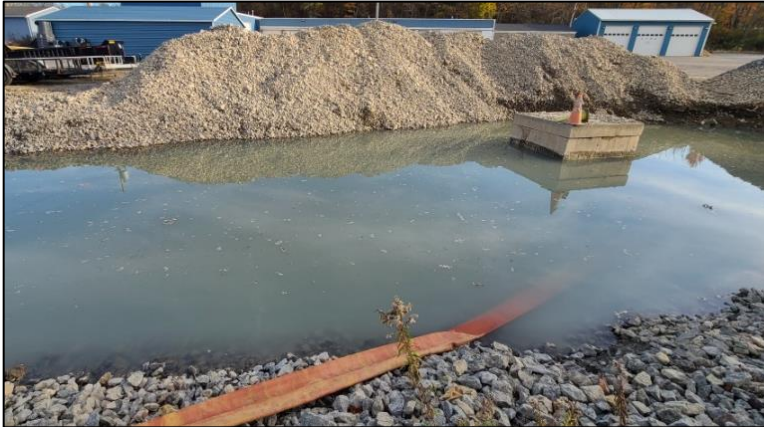
**Top Left:** Limestone and pipes were removed and sludge pumped to the settling pond (11/10/21).  
**Top Right:** Underdrain piping cleaned and removed for later placement back into the pond (11/10/21).  
**Bottom Left:** Reinstalling underdrain after washing stone and improving the intake manifold (11/12/21).  
**Bottom Right:** Stone graded similarly to original design contours with 5 tri-axle loads of limestone added to the pond (11/16/21).

Work Completed: In November 2021, BioMost mobilized equipment to the site. A decision was made to take the opportunity to do preventive maintenance while addressing the limestone elevation. Prior to starting the maintenance, a site inspection was performed and found that water was backed up and leaking out of some of the cleanouts of the AMD collection and conveyance pipe. The existing limestone was washed and pulled out of the AFVFP. Sludge was flushed/pumped to the settling pond/wetland. The influent pipe to the AFVFP was found to be plugged with debris and sludge which was removed. An HDPE perforated inlet pipe was added to the raw water pipe which previously dead-ended into the limestone. Underdrain pipes were removed, cleaned, and replaced. Five loads of new limestone were purchased and placed in the bottom of the AFVFP, washed limestone placed on top, and the stone leveled. Following this maintenance water was no longer backed up in the cleanouts. The system appeared to be working again.
