Slippery Rock Watershed: **AMD Treatment, Education, and Recreation Project** **Final Report**

Butler County, Pennsylvania

Barkley Road Passive
Treatment System

December 2022

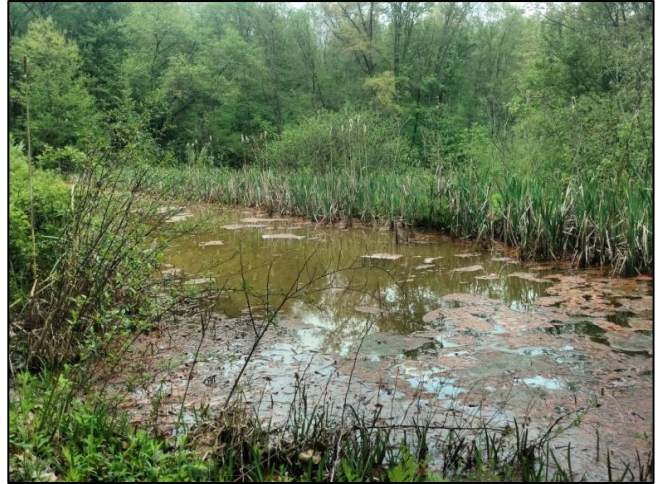
Overflow at CP
Caused by Sludge Accumulation

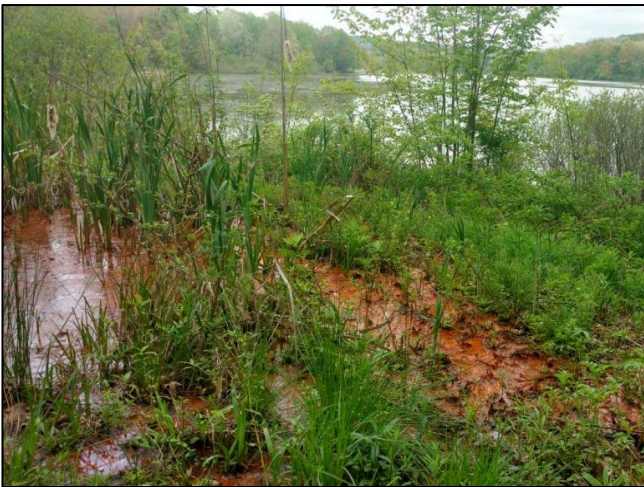
Wetland (WL) Filled with Sludge and Vegetation

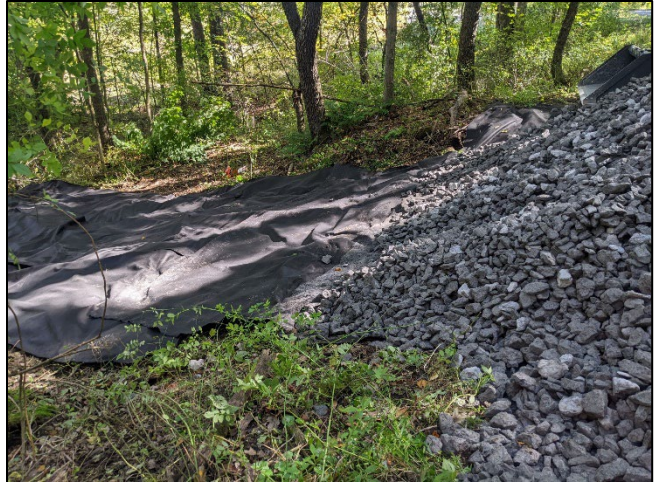
Placement of Geotextile for Site Entrance and Placement of AASHTO #1 aggregate

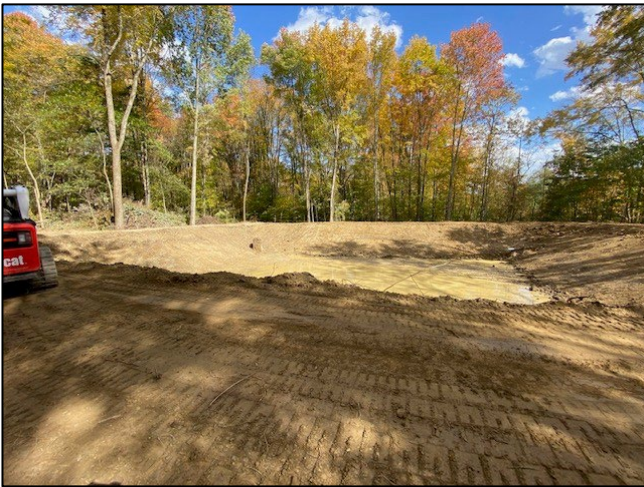
Sludge Pond Construction

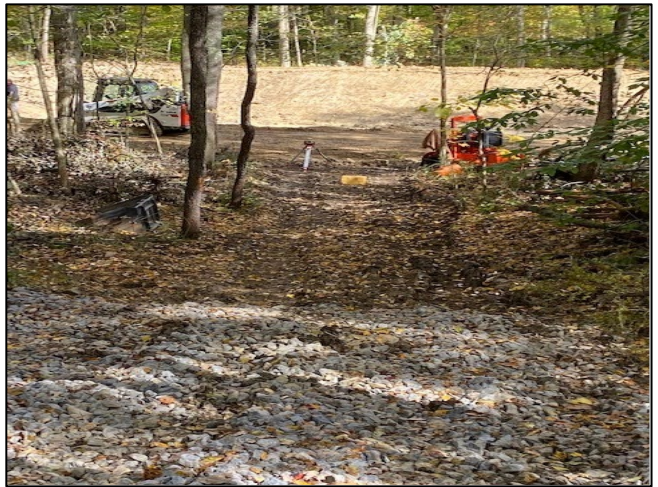
Site Entrance to Sludge Pond Entryway

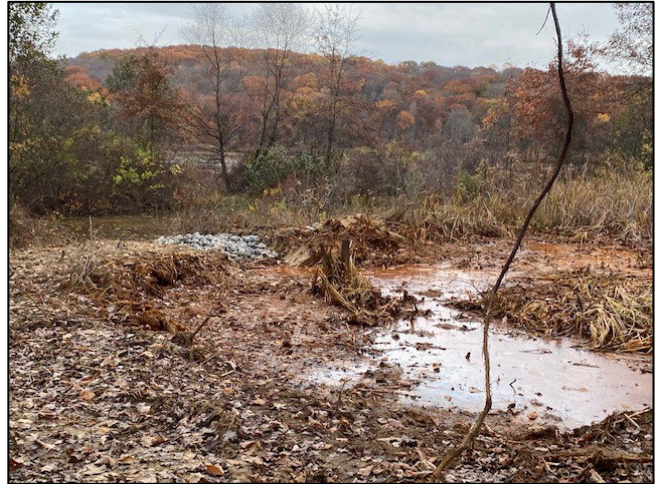
Sludge and Vegetation Removal from Wetland

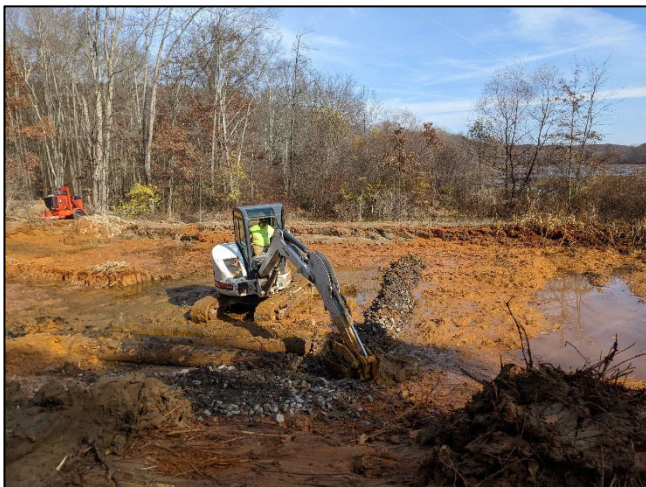
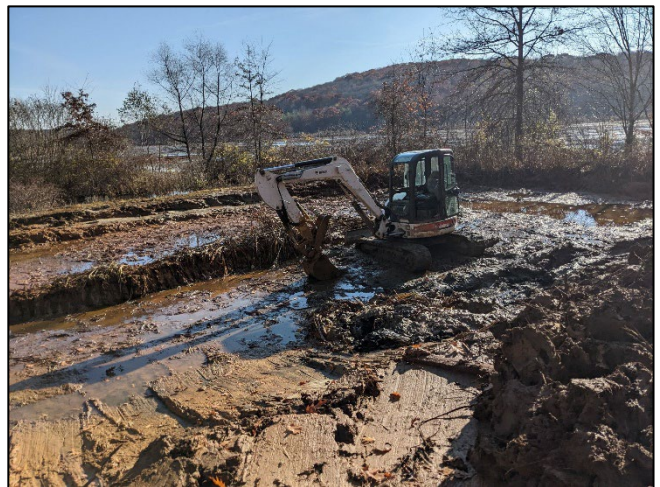
Sludge Removal From Wetland

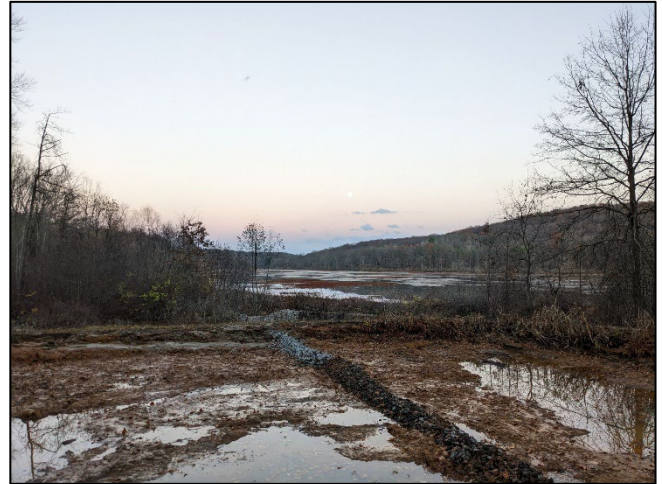
Overview of Level Spreader
Across the Width of Wetland

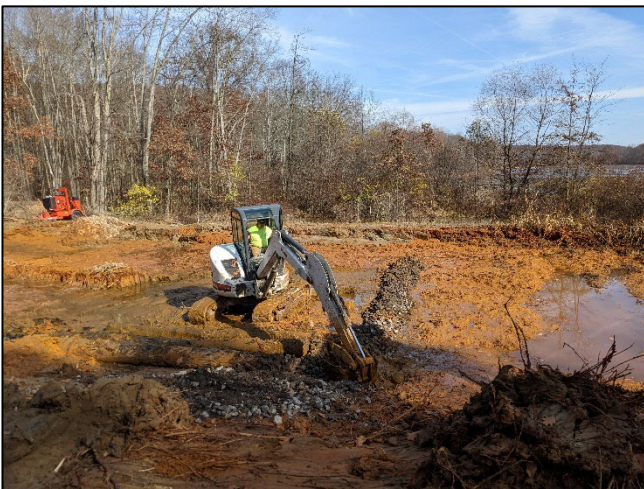
Placement of Level Spreader in Wetland

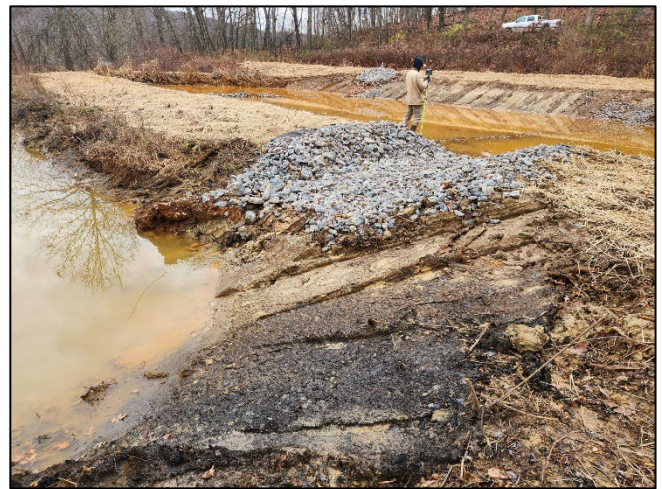
Settling Pond and Wetland Cleaned and Stabilized

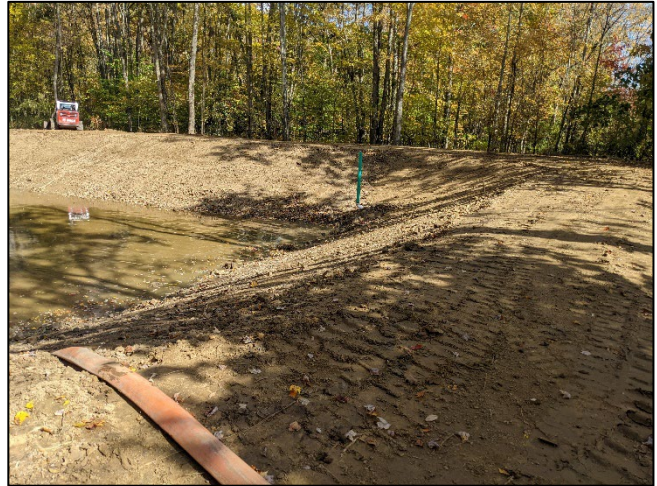
Sludge Line Filling Sludge Pond and Dewatering Riser

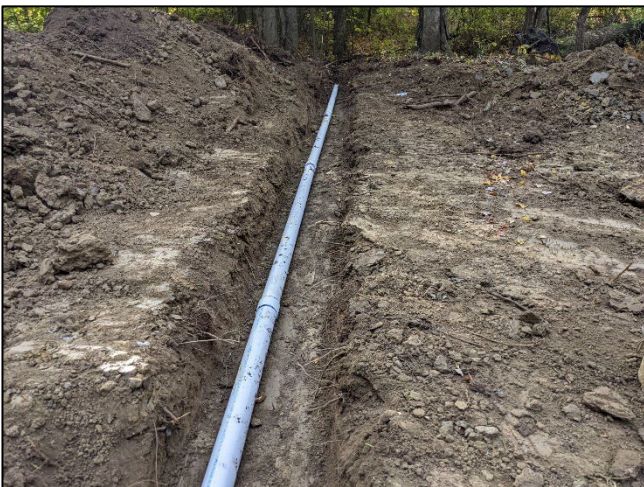
Dewatering SCH40 PVC Outlet Pipe

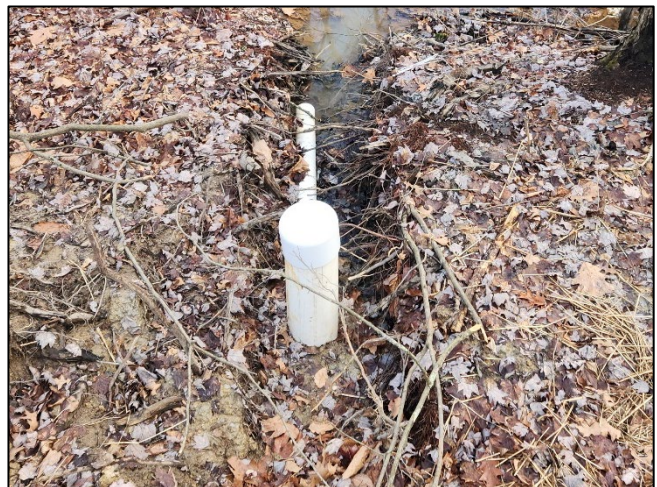
Dewatering Valve in Riser with Cap

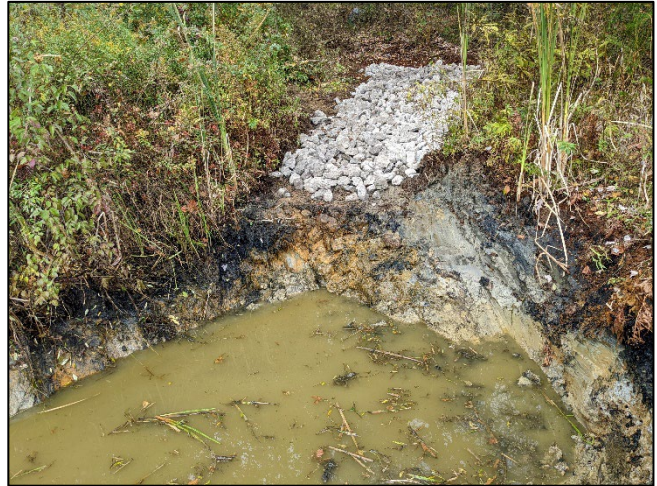
Construction of Spillway for Wet Zone to Collection Pond

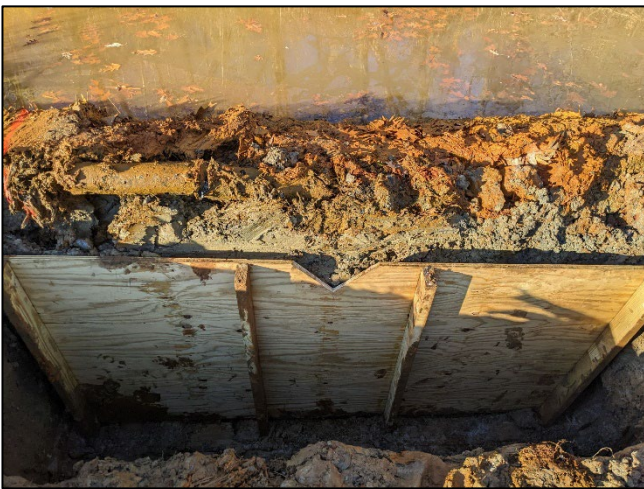
Construction of 6" 90° V-Notch Weir

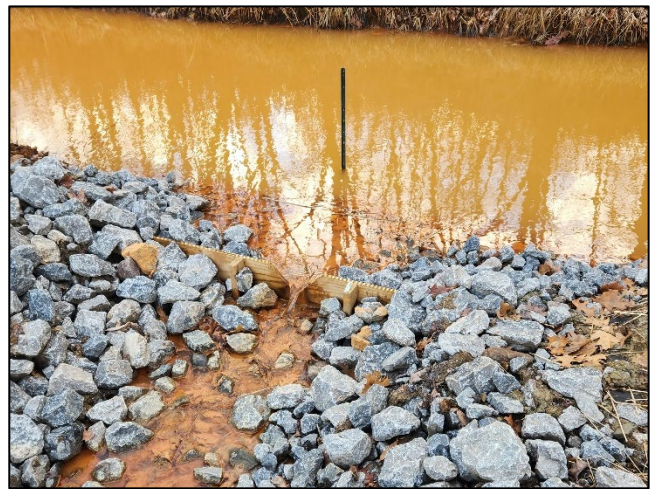
As-Built 6" 90° V-Notch Weir in Spillway

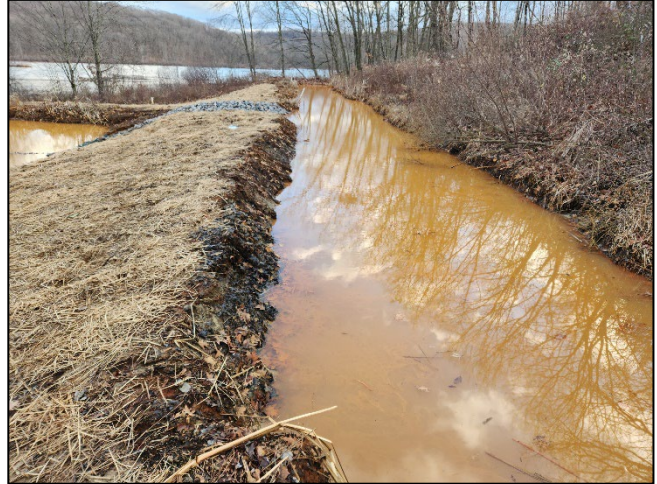
Seeding and Mulching of Collection Pond Berm

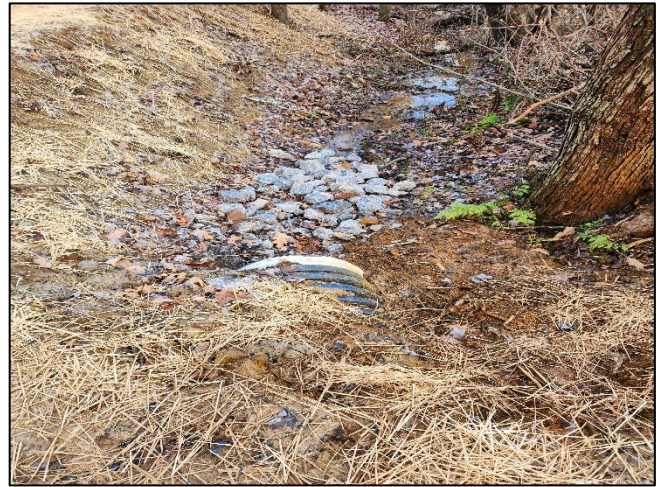
Rock Lined Outlet of 24" N12 Culvert Pipe

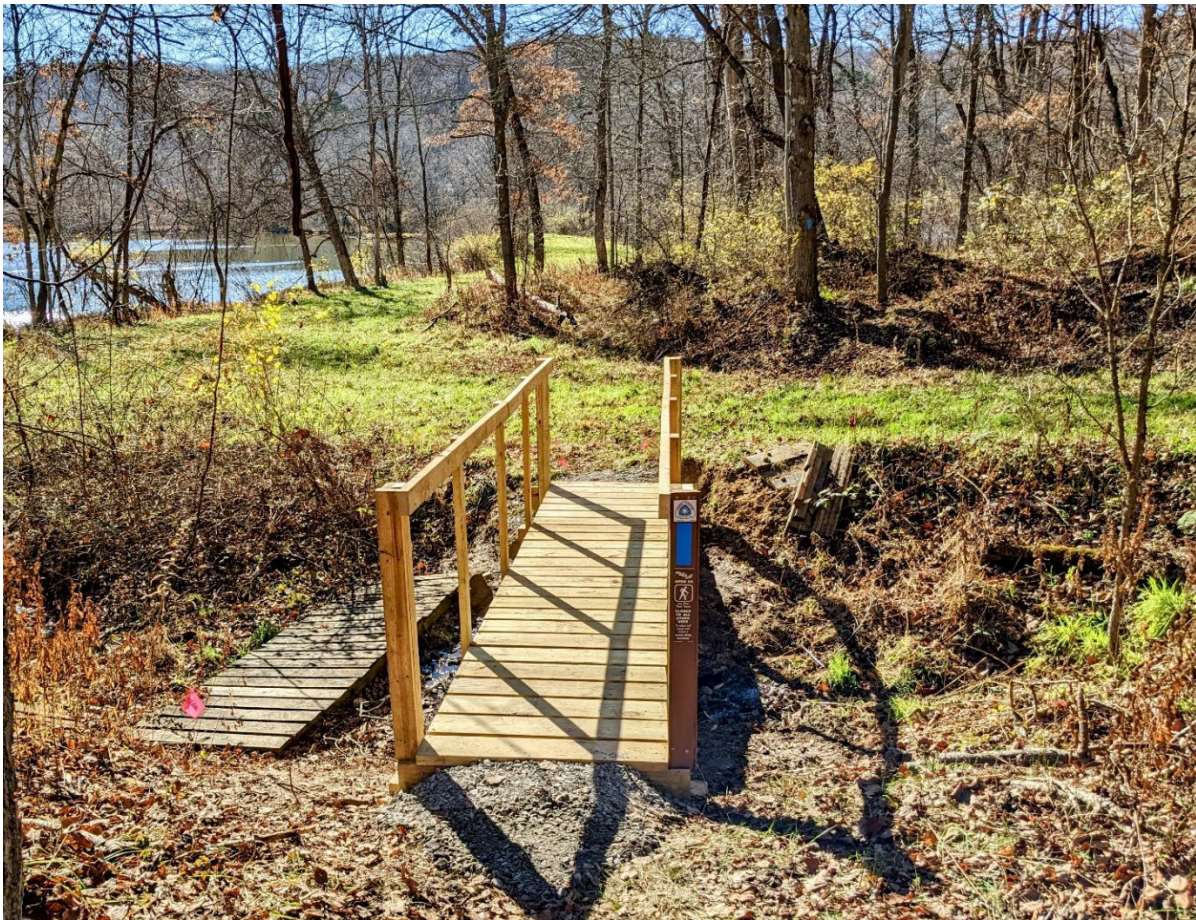
Original (14ft) and replacement (19ft) unnamed bridge 0.8 mi west of Higgins Road

As part of this project, four large named bridges (Beaver Dam, Memorial, Pry, and KL24) and four smaller unnamed bridges were replaced. The new bridges were designed to be longer than the original ones to overcome past and future bank erosion issues. For example, the new Beaver Dam bridge was built to be 40 feet long compared to the previous bridge, which was 35 feet long. In addition, about 500 feet of new boardwalk were built along the trail, and approximately 4,500 feet of other trail improvements were completed, such as placing limestone in wet and muddy areas. Beaver dams newly flooded one section of the trail, so efforts included building up the low areas and installing mini bridges to allow water to flow across the trail.

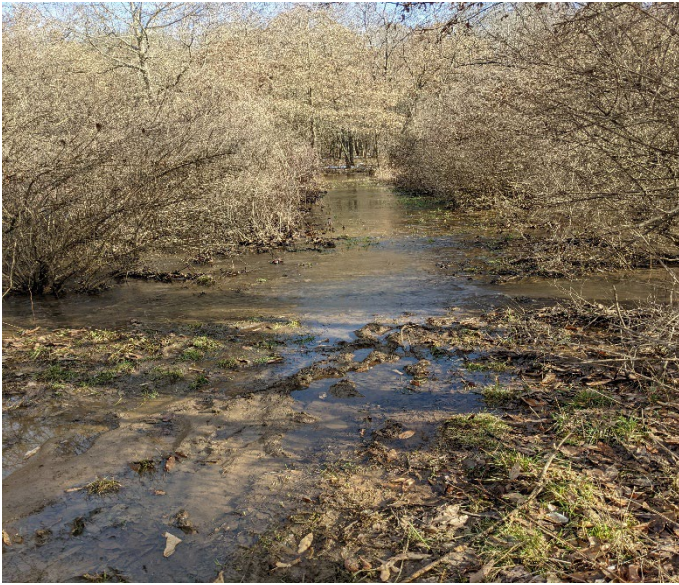
Recently flooded section of trail South of Pry Road.

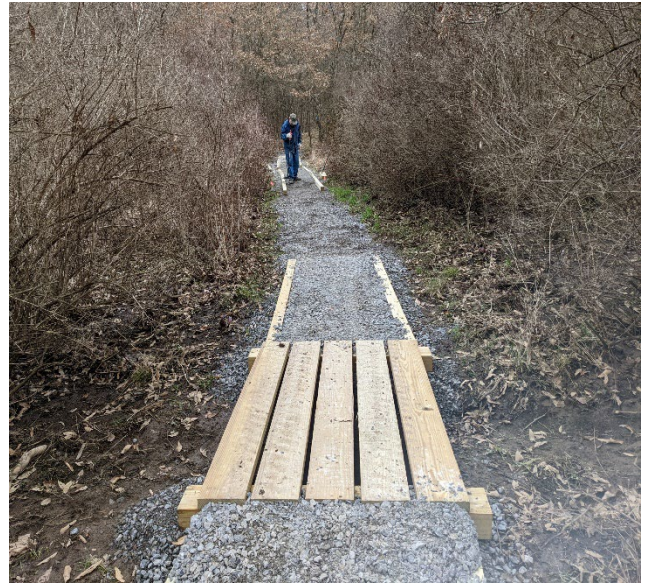
Improved built-up sections with small bridges to allow future flooding to flow across the trail.

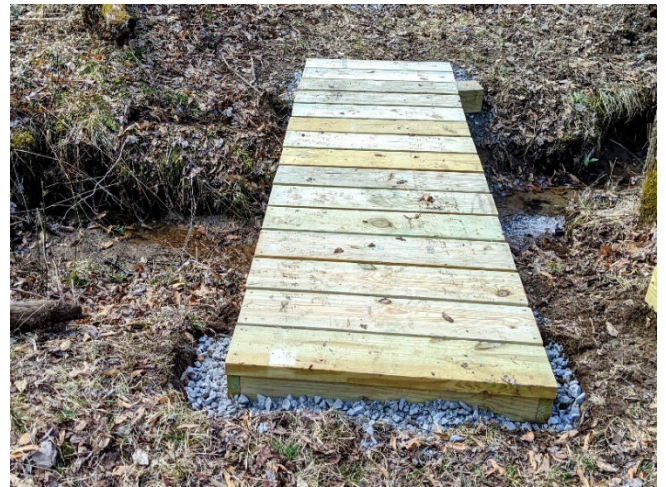
New replacement of small bridge South of Pry Road.

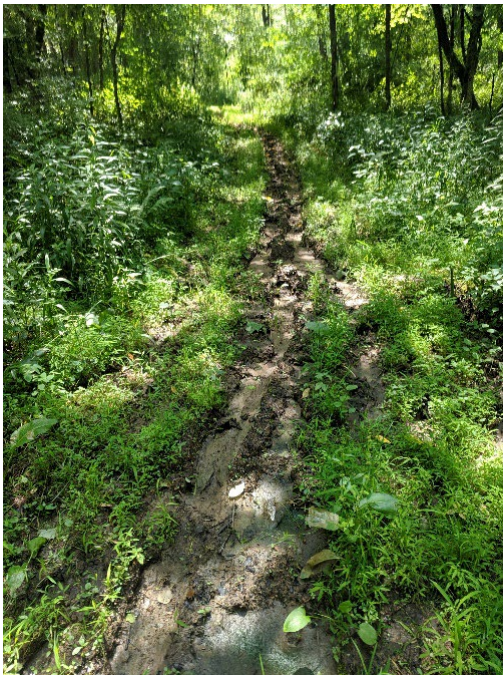
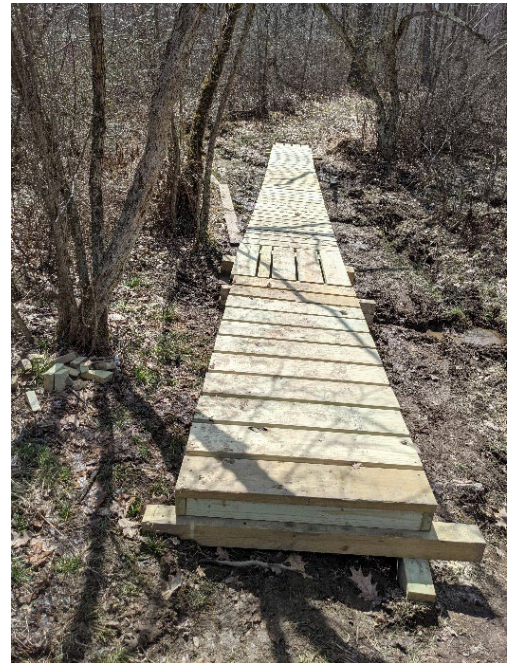
Before and After building boardwalk 0.4 miles south of Pry Road.
