Rock Tunnel Passive Treatment System
SRI O&M TAG Project #55 Request #2
OSM PTS ID: PA-175

Requesting Organization: Somerset County Conservation District (SCCD)

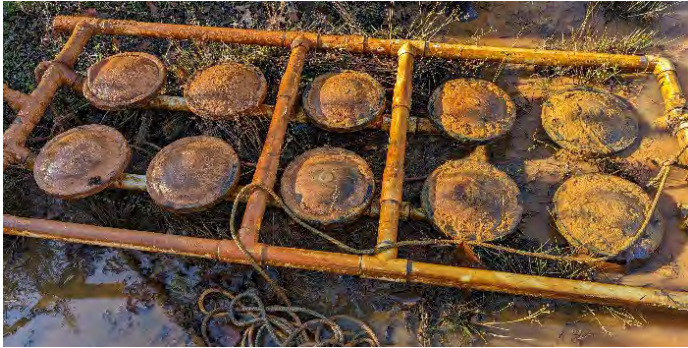
Top Left: Air sled retrieved from pond was found to be plugged and some disc diffusers broken (11/16/23).
Top Right: Bubble disc diffusers were cleaned and replaced as needed (11/16/23).
Bottom: Air sleds were redeployed (left) and concrete blocks were placed in spillway to achieve better flow distribution (11/16/23).

On 11/10/23 BioMost mobilized to site to perform further maintenance. All three air sleds were removed and cleaned as needed to remove iron accumulation. Some of the bubble diffusers needed maintenance so a second trip was scheduled for repairs.
