Spaghetti Hole Passive Treatment System SRI O&M TAG Project #58 Request #1 OSM PTS ID: PA-64

<u>Requesting Organization:</u> Altoona Water Authority <u>Requesting Organization Representative:</u> Amy Sipes <u>Municipality/County:</u> Altoona, Blair County <u>Dates of work performed:</u> 5/10/2019 to 7/11/2019

Photo Log

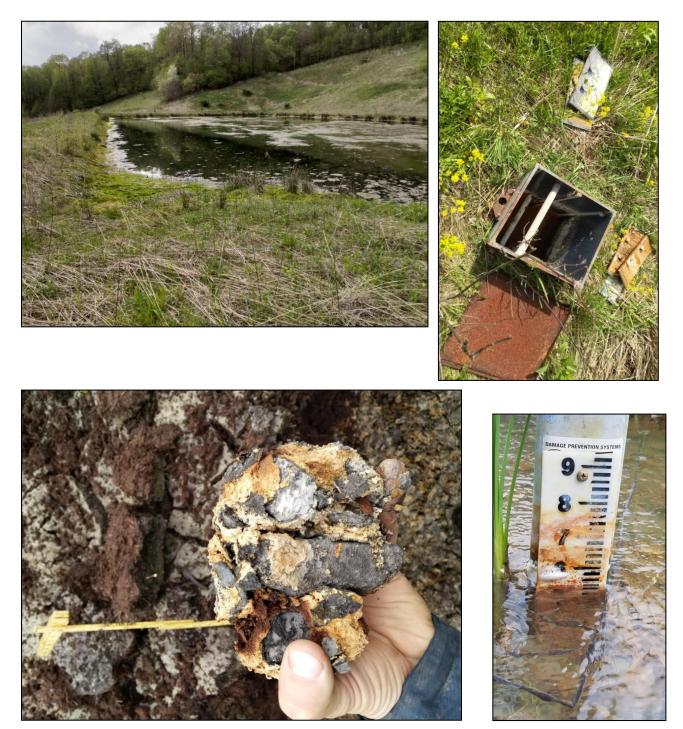
Top Left: Water level of the SAP dropped after lowering the stop logs.
Top Right: Stop logs removed from SAP outlet to lower the water level in the SAP pond.
Bottom Left: Much of the limestone was observed to still have void space, with only a few places appearing to be impermeable due to Fe and Al precipitates.
Bottom Right: The staff gauge was improperly set for the new weir elevation at the SAP outlet.

<u>Work Completed:</u> SAP stop logs were removed from the Agri Drain box to determine if adjusting head pressure would allow an increased amount of flow to pass through the SAP. After two days, there was no longer an overflow at the treatment system bypass. To further assess the media, test pits were dug in four locations throughout the pond. Most of the organic media appeared to be in good condition. Much of the limestone was clean enough to have void space, with only a few places close to appearing impermeable due to iron and aluminum precipitates. The tests pits were filled and some of the stop logs were re-installed to allow water to fill the pond.

<u>Current Recommendations</u>: Confirm the elevation of the staff gauge at the SAP outlet is adjusted to the proper elevation relative to the new weir height for flow measurements. Continue to monitor the SAP water level to determine the proper amount of stop logs required to maintain water levels on top of the media but not bypassing the SAP overflow pipe. Based on available data, even when the current system is net alkaline, aluminum solids are usually present at the system effluent.

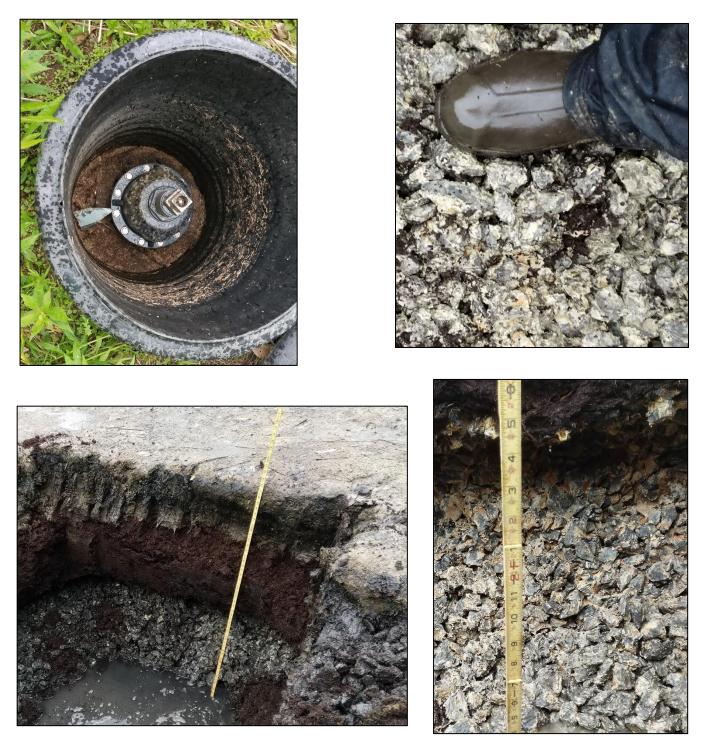
Top Left: 10" PVC valve requires valve tool to open (standard 2" handle).
Top Right: Top of limestone layer with compost removed shows aluminum precipitates.
Bottom Left: Test pits revealed a 1" = 8" layer of precipitates overlaying 1.0' - 1.5' layer of compost with relatively clean limestone for a 20-year-old system.
Bottom Right: Close up of limestone layer with aluminum precipitates below compost layer.

The existing SAP pond has a compost layer approximately one foot to two feet thick with overlying sediment. The purpose of a compost layer in a SAP of this vintage is to cause ferric iron (Fe^{+3}) to be reduced to the ferrous form (Fe⁺²) to keep iron from precipitating within the underlying limestone layer. Since 2016, the average total iron concentration in the raw (influent) water has been less than 1 mg/L which does not justify the presence of organic material. The test pits excavated in 2019 show a notable accumulation of aluminum solids in the limestone, which is not unexpected as the presence of organic material does not prevent the precipitation of aluminum solids. It is recommended that the compost be removed and placed as a soil amendment in the area around the treatment system and that the first 1-2 feet of limestone be washed to remove as much of the aluminum solids as feasible. The underdrain piping is PVC and, if exposed, would likely be broken and need significant repairs. Several temporary wash basins could be constructed within the SAP to facilitate cleaning of the limestone that appears to be AASHTO #3 size aggregate. Care should be taken during the washing process to capture the precipitate in the wash basins and transfer the material into the dewatering basin as possible and avoid concentrating the material in the lower portion of the limestone and around the underdrain pipes. The cleaned limestone would be placed back into the SAP and leveled. The limestone cleaning is expected to remove the majority of metal precipitates but some metal solids would remain. Geochemical modeling using PHREEQ-n-AMDTreat beta v6.0 indicate the presence of metal solids enhances metal removal through sorption. Any underdrain pipes that may be damaged during limestone cleaning should be repaired using flexible rubber couplers and pipe of similar size and type. Over time it is expected that the solids formed by the proposed automatic flushing limestone-only vertical flow pond upstream of the SAP pond will clog the limestone in the SAP and that the SAP will function primarily as a settling pond. The size of the existing SAP pond is conducive for this purpose it will provide over four times the settling capacity as the existing sedimentation pond. The existing SAP pond emergency spillway would then function as a primary spillway.

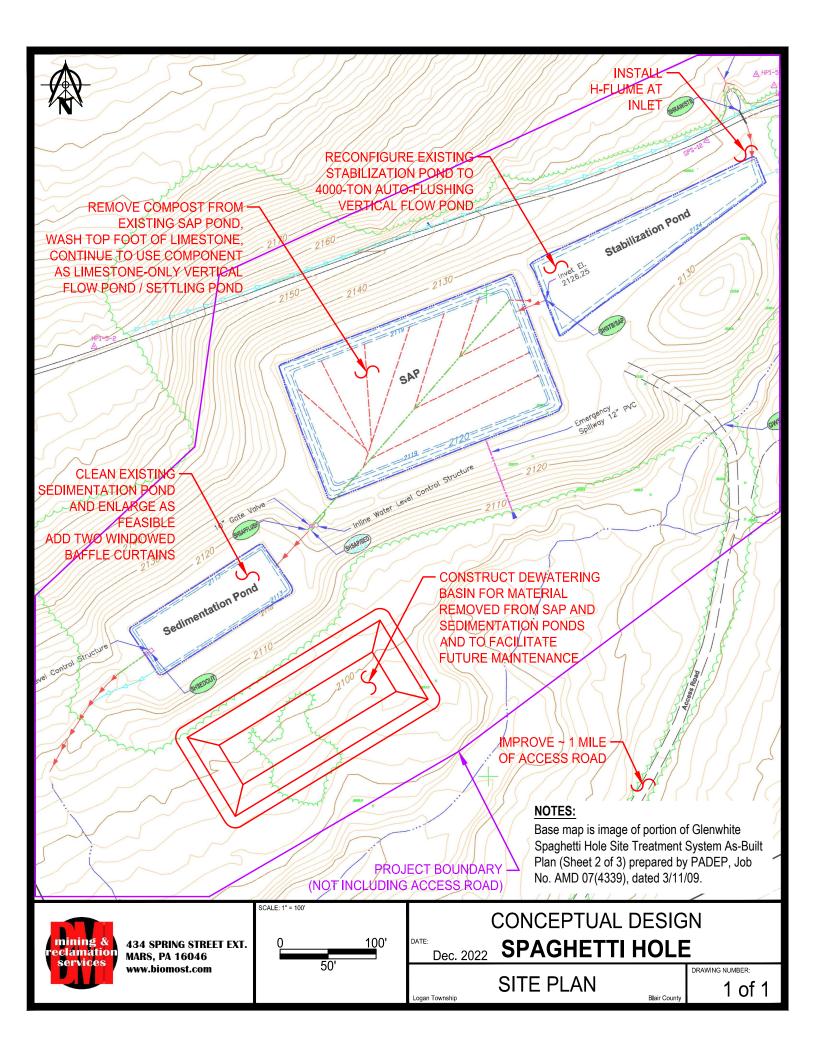
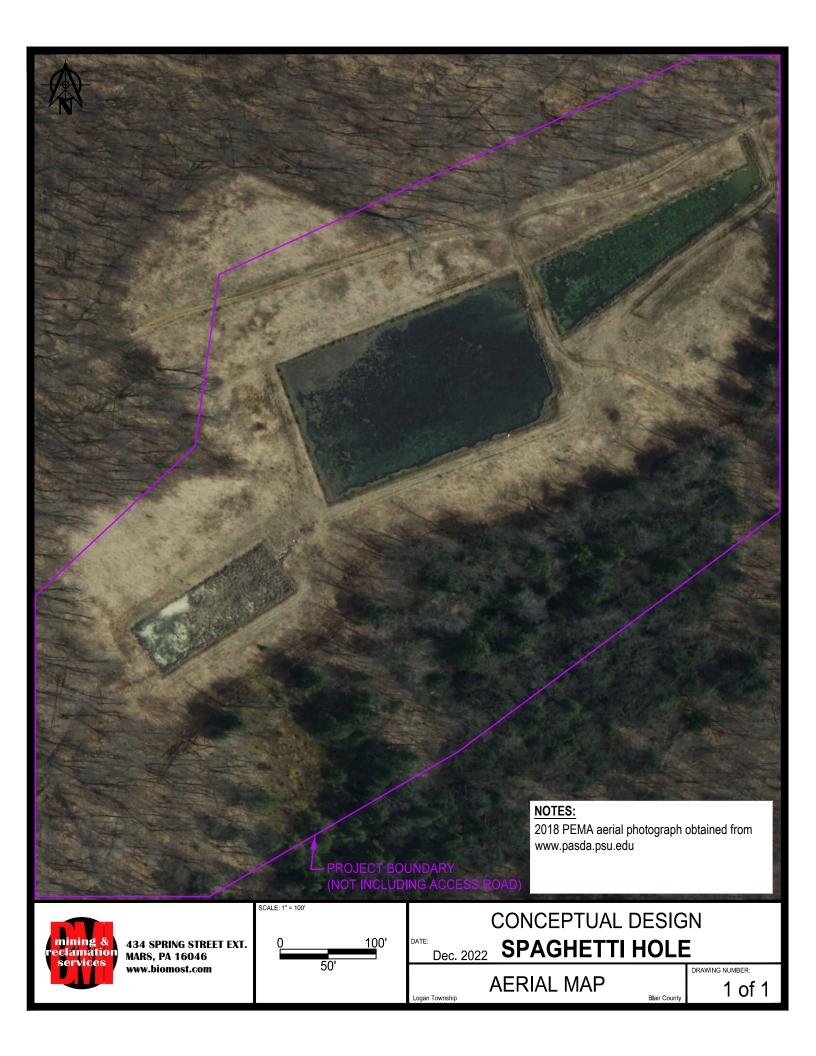
<u>Future Considerations:</u> When the stop logs in the Agri Drain box are configured to direct flow through the SAP treatment media, the overall water chemistry is typically alkaline with low iron and aluminum concentrations. The system effluent chemistry (Point SHSEDOUT) indicates that the system can neutralize all the acidity (e.g., the effluent typically has a circumneutral pH and negative acidity) but has difficulty settling sufficient aluminum solids to consistently result in concentrations below 1 mg/L. This system was constructed in 2002 and for a system of this age, typically alkaline effluent is a noteworthy success. However, the test pits did document that plugging of the limestone layer with aluminum (whitish) solids is occurring to a degree. In order to provide the most cost-effective enhancement of the existing system, a proposed conceptual design has been developed to rehabilitate the system using the existing components in their current configuration with improvements that will continue to neutralize acidity and precipitate aluminum while providing enhanced solids removal. The improvements discussed below are noted on the Conceptual Design prepared as part of this report.

The sedimentation pond is relatively small and is essentially filled with sediment and vegetation. To provide additional settling capacity, it is recommended that the pond be cleaned to restore at least the original water volume and if no liner is present and soil conditions indicate that leakage would not be anticipated, the bottom should be excavated to provide additional solids storage volume. In order to help increase settling effectiveness, two floating widowed baffle curtains should be installed. Material removed from the sedimentation pond will be placed in the proposed dewatering basin.

Attachments: Conceptual Design Site Plan, Site Overview Photo, AMDTreat Cost Calculations.
