**Minersville Passive Treatment System**  
**SRI O&M TAG Project #68 Request #1**  
**OSM PTS ID: PA-172**

Dates of Work Performed: 10/01/2020 to 10/05/2020

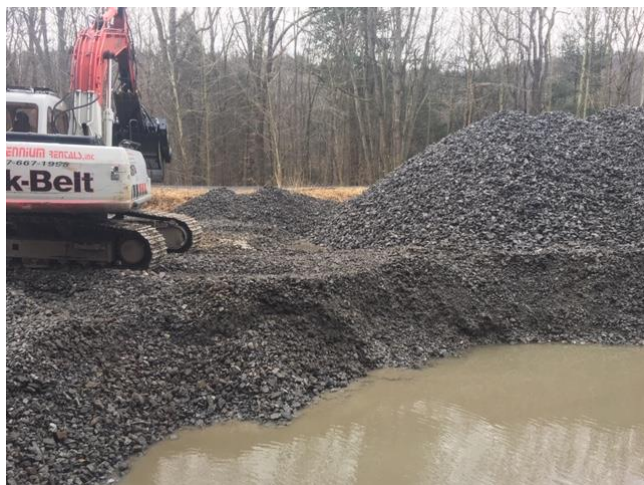
**Top Left:** Washing and removing limestone from the Minersville limestone bed.  
**Top Right:** After limestone and internal baffles had been removed.  
**Bottom:** Cleaned limestone was placed back in the bed and infiltration trenches
