Blacks Creek Maintenance Pond

Project Summary

Blacks Creek Pond Construction

EPA Section 319 Project #1819

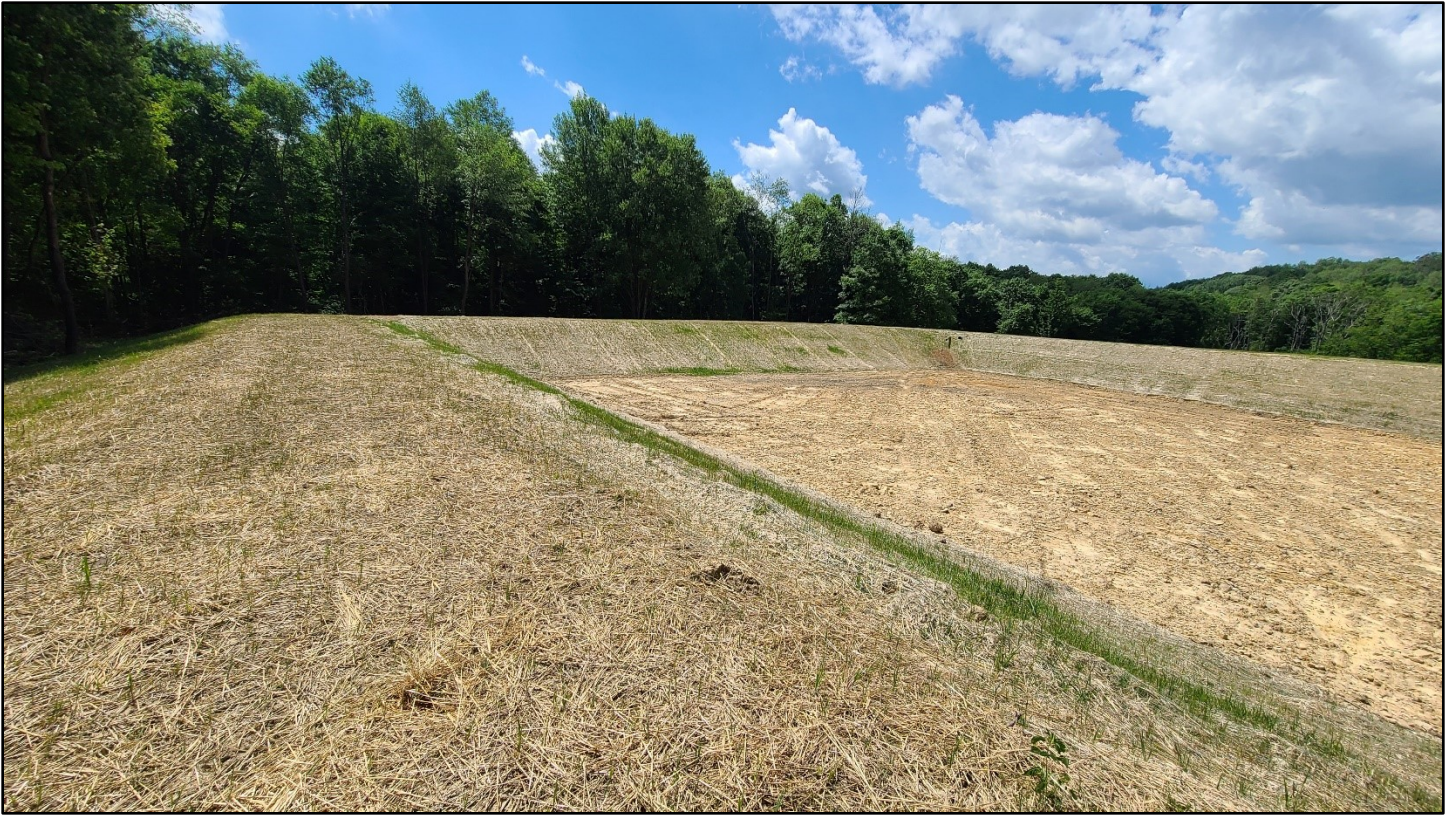
Top: View of new maintenance pond facing East.

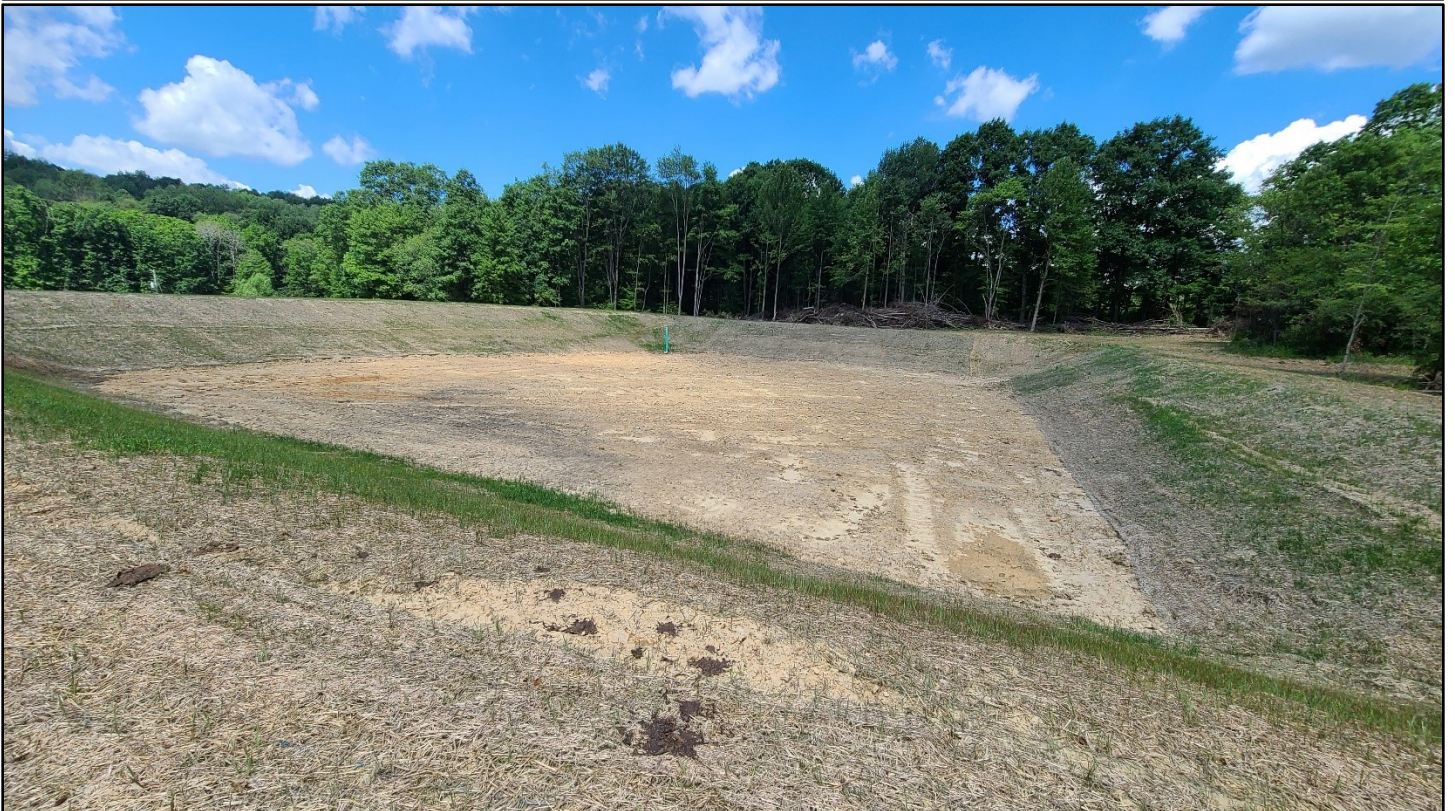
Bottom: View of new maintenance pond facing West.

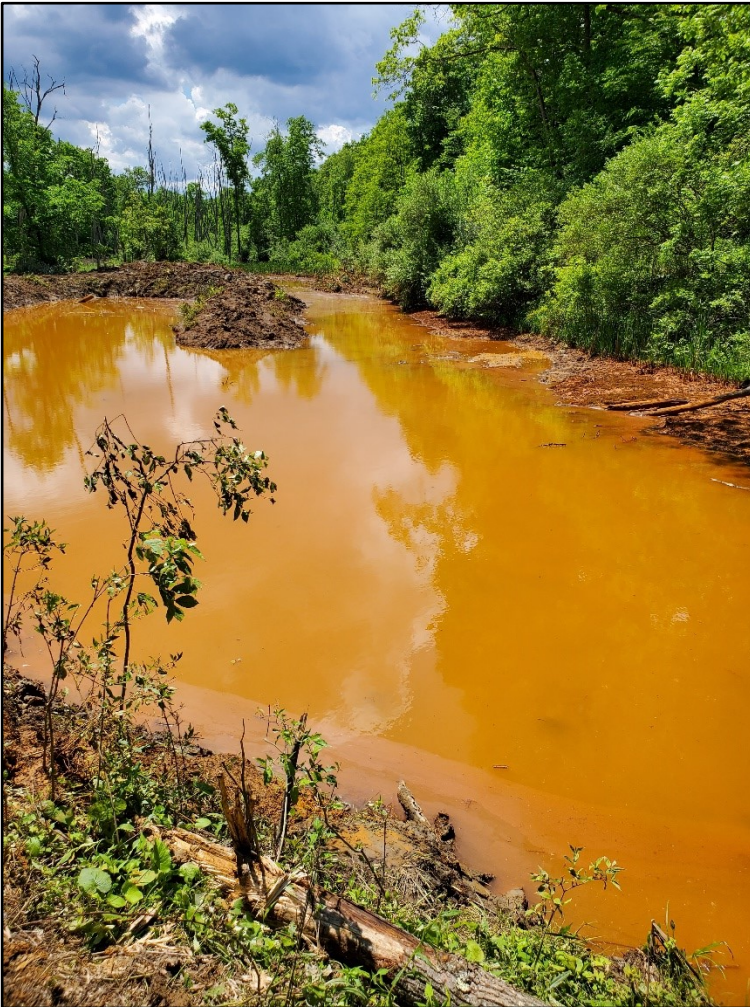
Left: Cleaned area of BC19/19B view facing south.

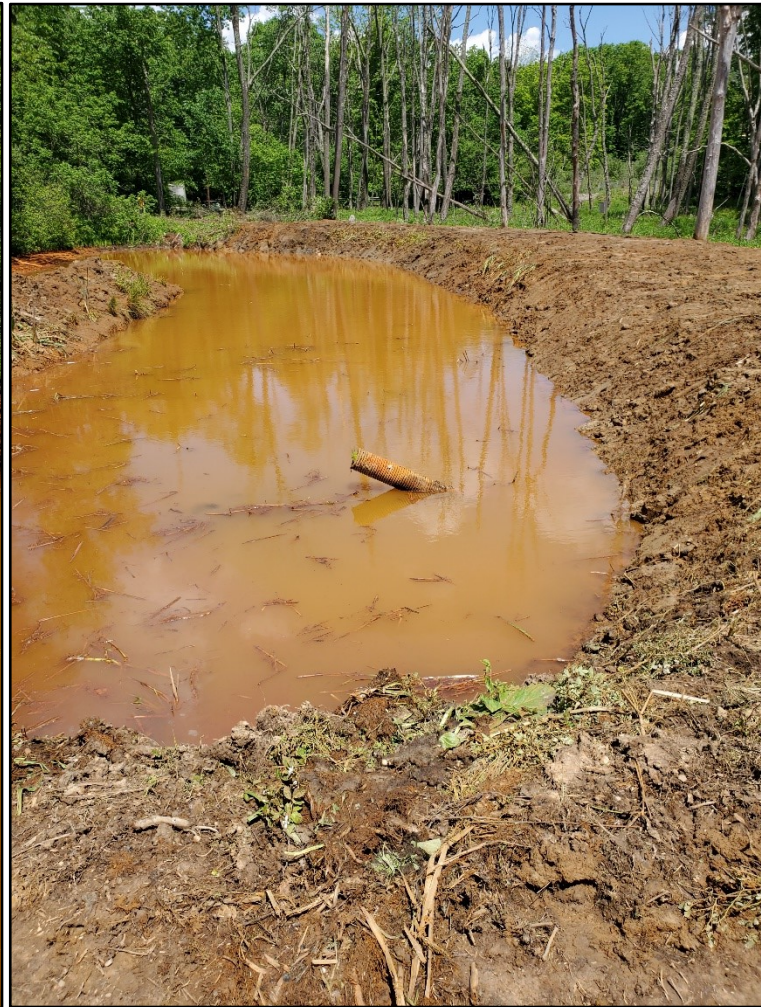
Bottom: Cleaned area BC19/19B facing North.
