Bilger Run BR3.9 Discharge Passive Treatment System Final Report June 2008

Bilger Run Construction Photos

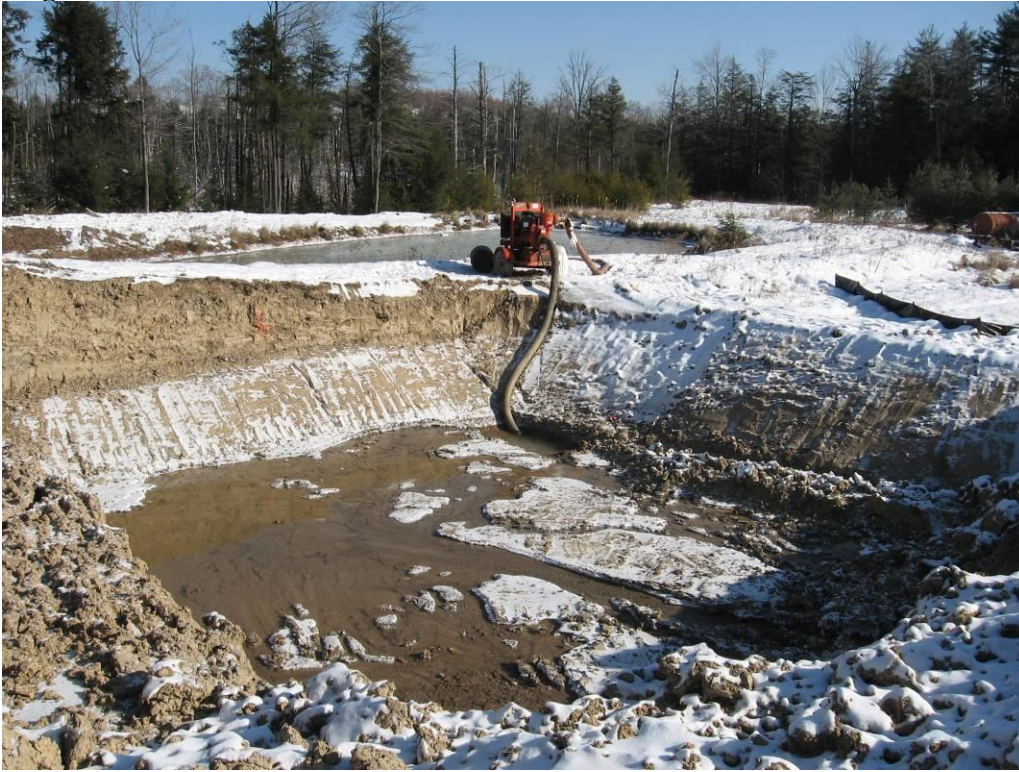
ALD excavation and dewatering pump, January 21, 2008

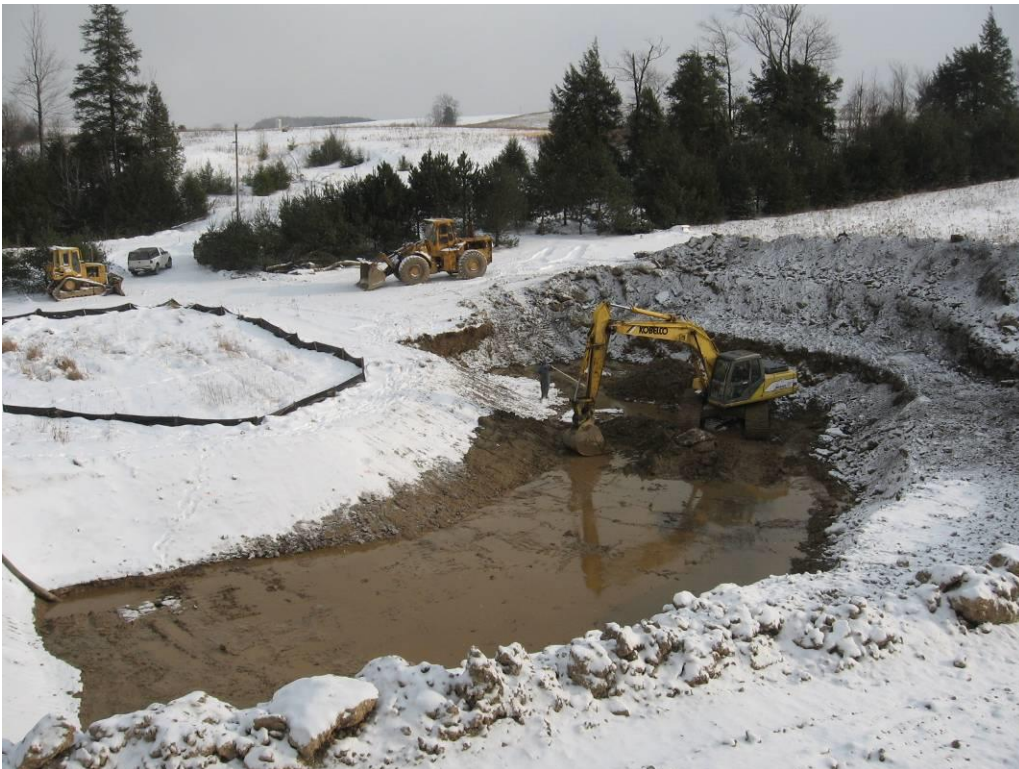
ALD excavation, January 24, 2008

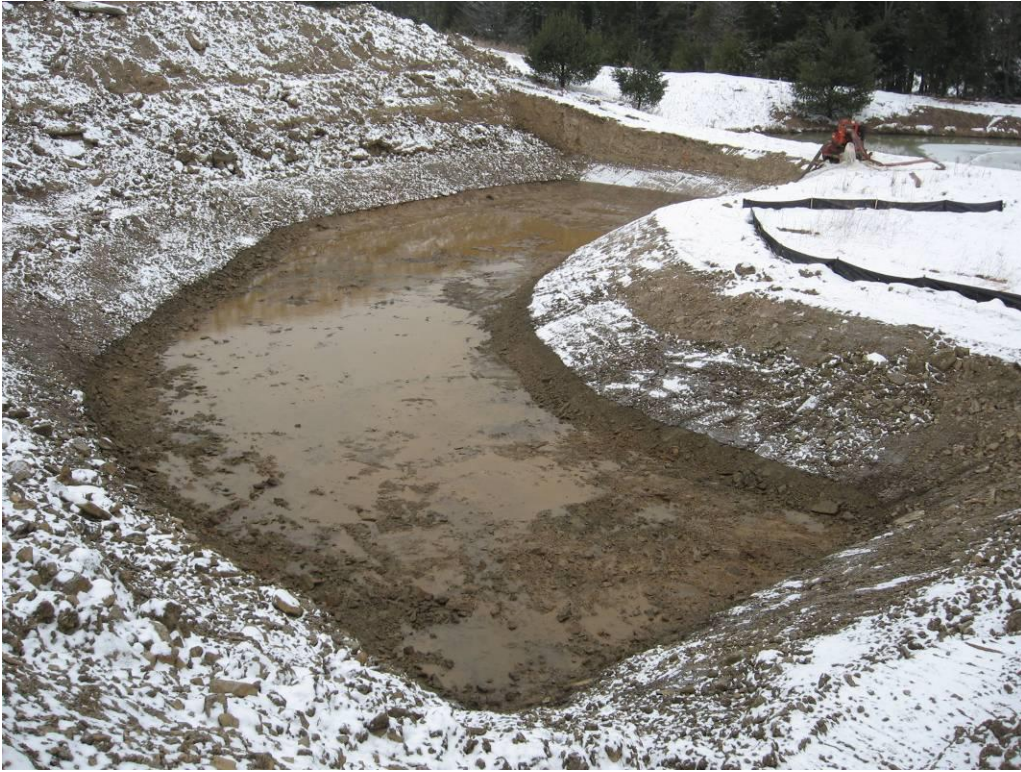
ALD excavation, January 28, 2008

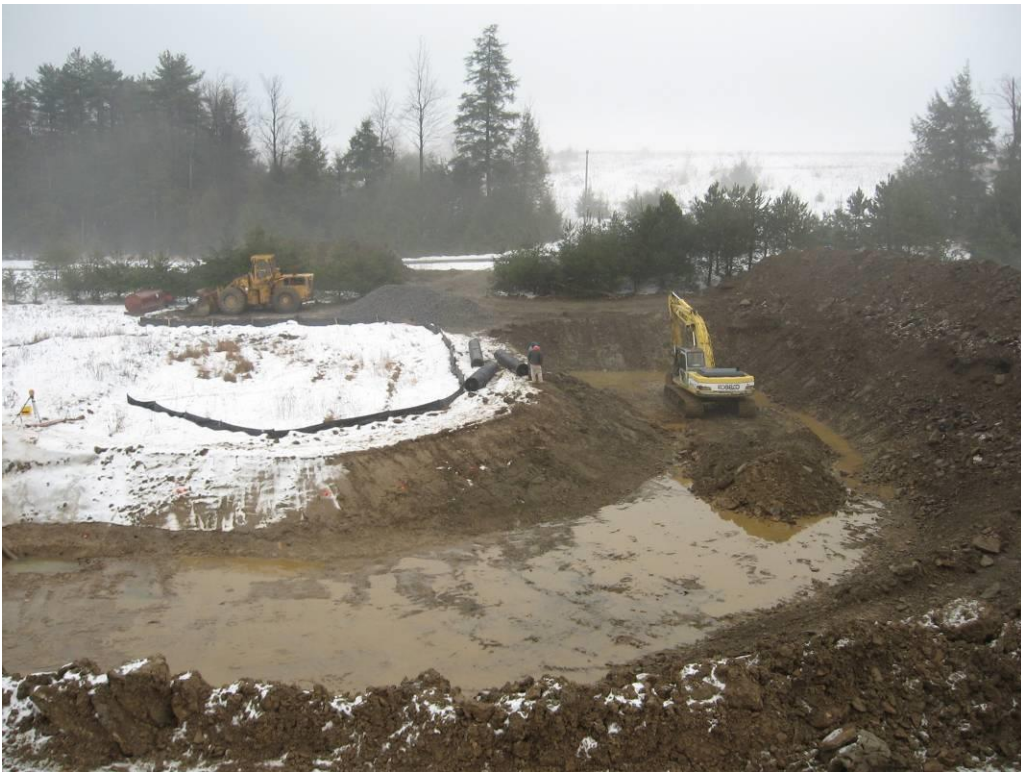
ALD excavation, January 29, 2008

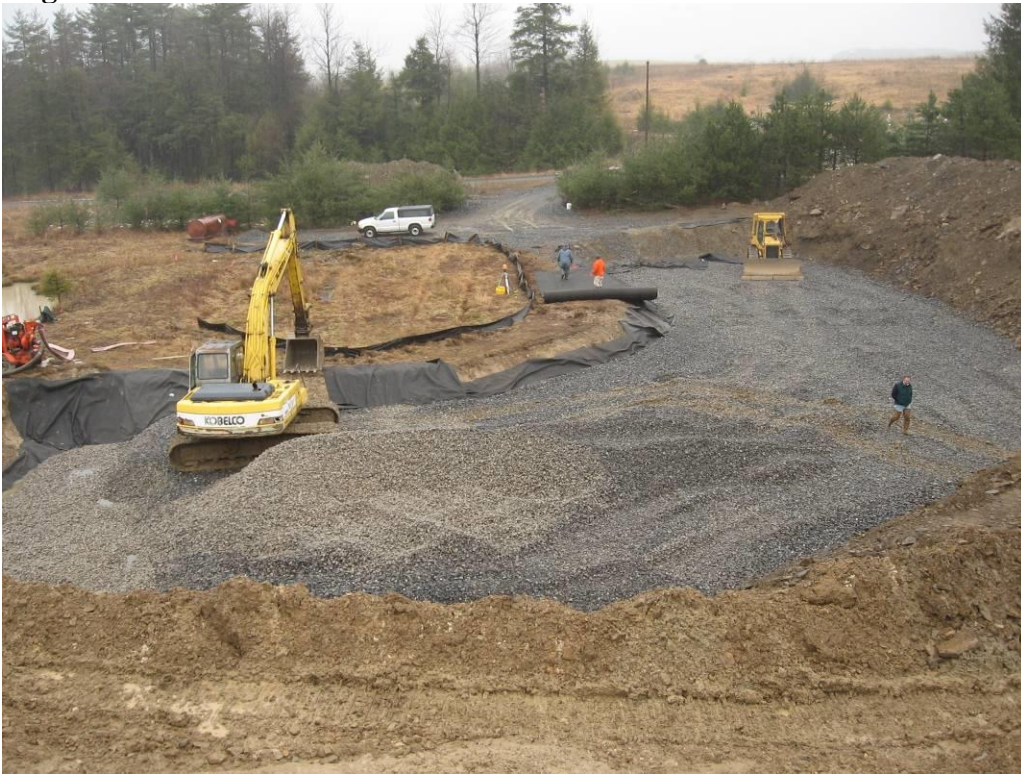
ALD limestone placement, February 6, 2008

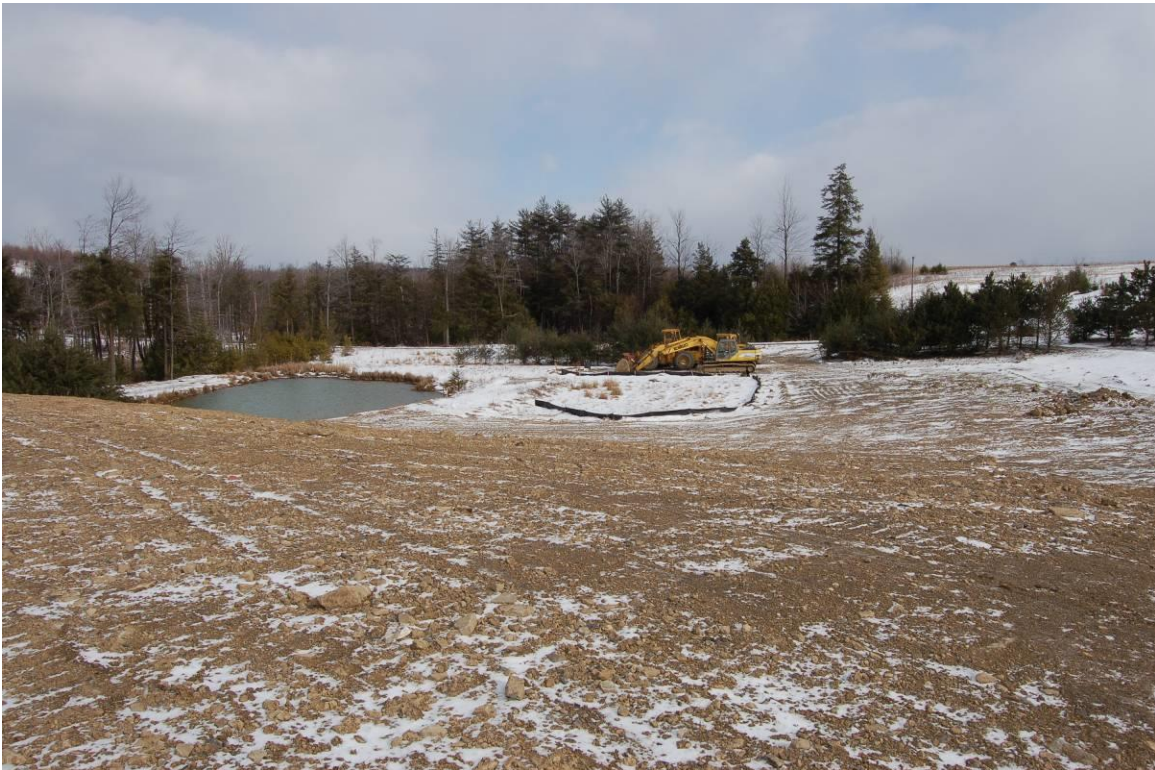
ALD finished grade, February 19, 2008

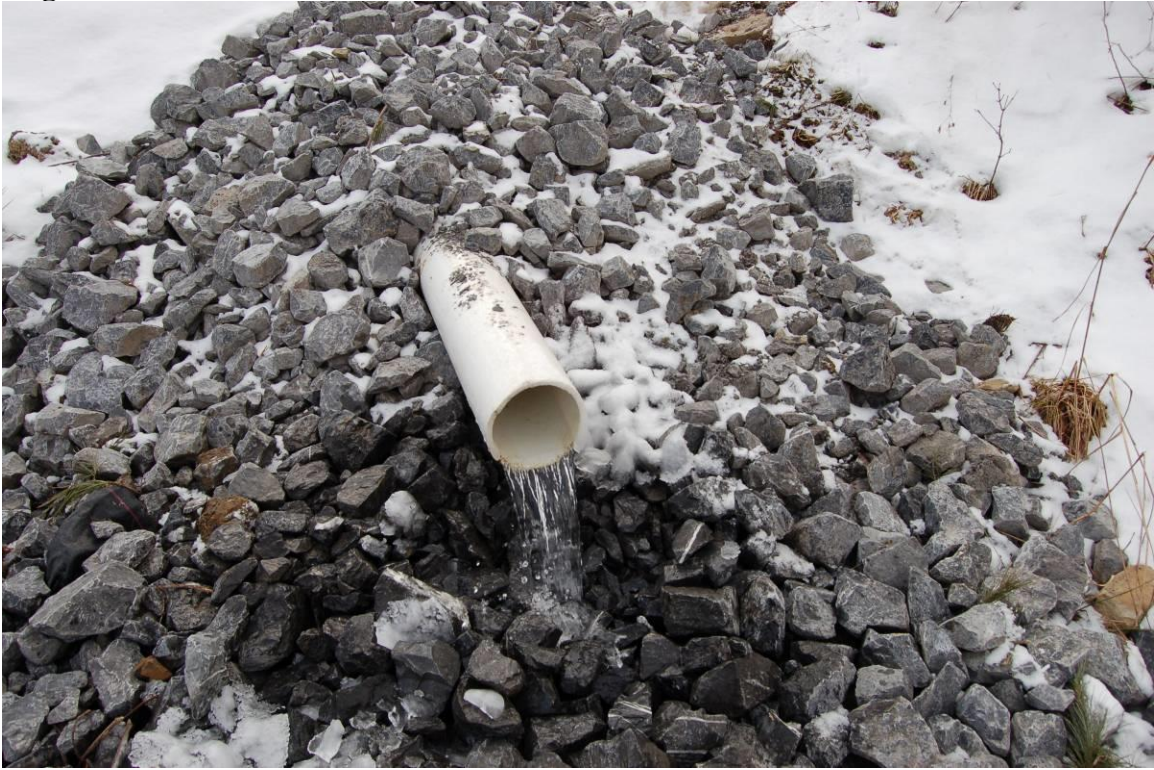
ALD outfall, February 19, 2008

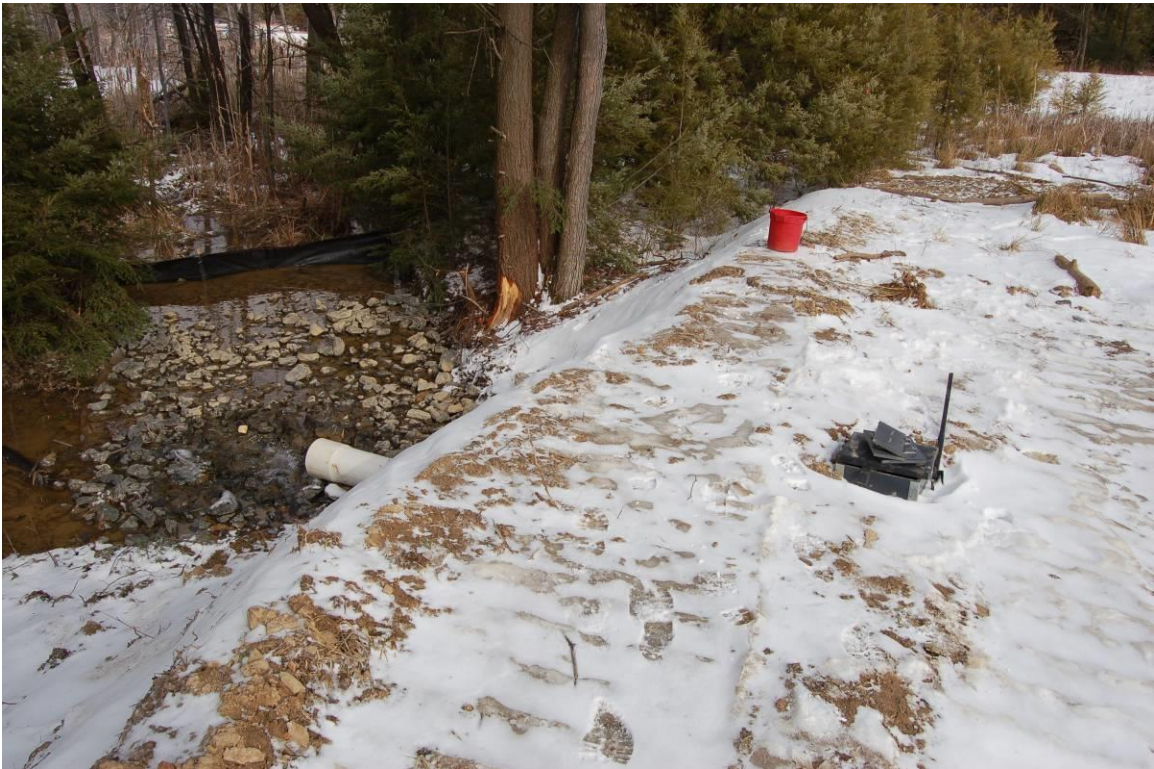
System final outfall, February 19, 2008
