Allegheeny County
Conservation District

Montour Run

Watershed Assessment and Implementation Plan

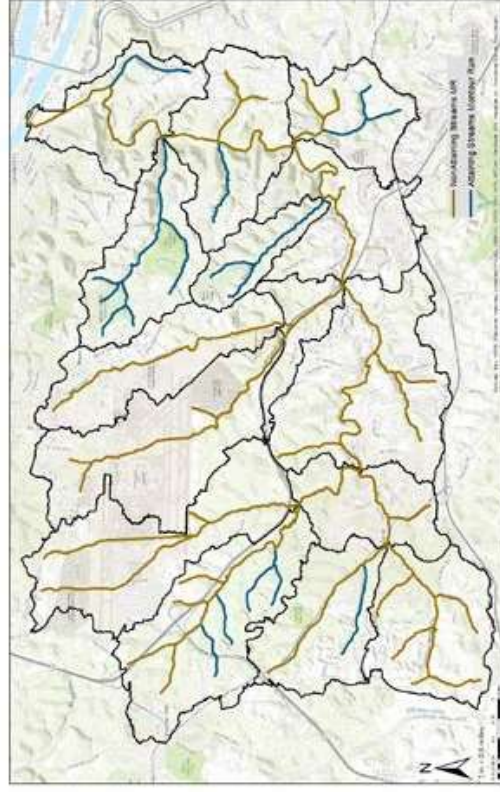
Figure 1.3.1-Attaining and non-attaining streams in the Montour Run Watershed.

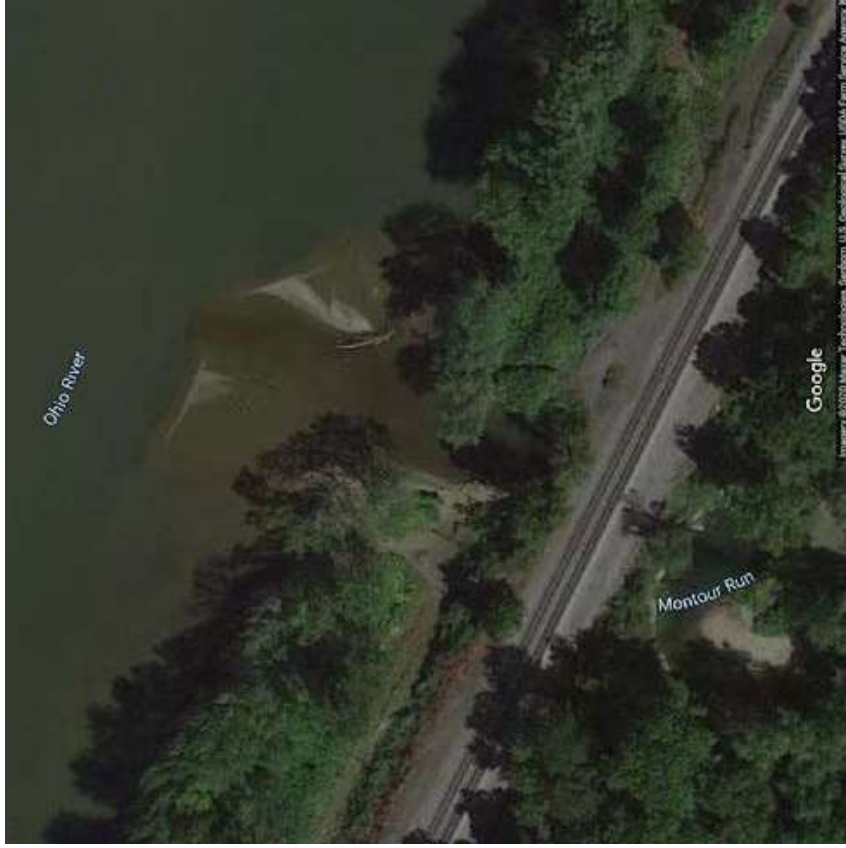
Figure 2.1.2-Sediment-laden water drains from Montour Run (center, bottom of image) into the Ohio River. Blue arrows indicate two regions of visible sediment accumulation. Image downloaded from Google Maps-Imagery 2020

barren land. Excess stormwater runoff erodes stream banks and transports sediments and any other nutrients to the stream. Frequently, erosion and siltation increases the Total Suspended Solids (TSS) found in stream water. TSS are defined as solids in water that can be trapped by a filter. The solids consist of diverse materials including clay particles, metals, suspended organic particles, silt, and decaying plant and animal matter. Suspended sediment can cloud water, increase water temperatures, and lead to other problems such as low dissolved oxygen that ultimately affect habitat quality. Sediment deposition can coat stream substrate, decreasing overall habitat quality and availability. Evidence of this sedimentation problem can be observed on aerial photograph images and internet mapping applications such as Google/Bing maps as sediment-laden water and the accumulation of sediment and a "sandbar" where Montour Run empties into the Ohio River (Figure 2.1.2).

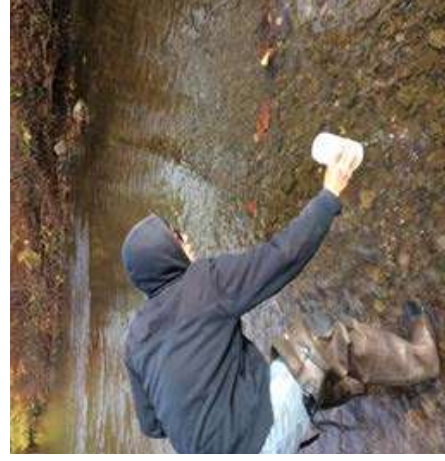
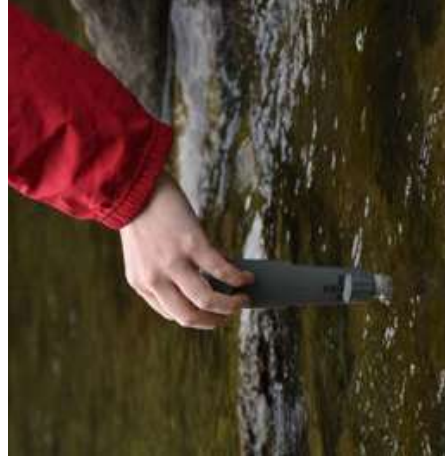
Water Quality Sampling

Iron, aluminum and manganese are metals commonly associated with AMD in the area. The average concentrations of aluminum and iron are 0.20 and 0.26 ppm, respectively. Both of these metals show higher concentrations in the headwaters, specifically in the

spring 2018 with decreasing concentrations as one progresses downstream. The average aluminum and iron concentrations at MR08-North Fork were 1.8 and 1.8 ppm, respectively. At MR07-South Fork the average aluminum and iron concentrations were 0.43 and 0.25, respectively. This corresponds to AMD discharges identified by the 2003 AMD Cleanup Plan. The concentrations at MR05 are also high for these parameters where there are known AMD discharge points (Figure 2.2.6, Figure 2.2.7). The current aquatic life standard for iron is less than 1.0 ppm. This is being exceeded at MR08 and MR05. The aquatic life standard for dissolved aluminum is 0.00063 to 3.2 ppm for chronic exposure (over 4 days) and 0.0001 to 4.8 ppm for acute exposure (less than 1 hour). Aluminum can be particularly toxic to macroinvertebrate and fish populations as it can inhibit an aquatic organism's ability to regulate salt concentrations and clog gills, potentially resulting in death or affecting growth and reproduction. A similar trend can be seen in manganese concentrations, but at much lower amounts. Concentrations of manganese were measured in ppb. The currently aquatic life standard for manganese is 50 ppb which is exceeded at several locations in the Spring 2018 (Figure 2.2.8). All measured metal concentrations matched patterns observed in the sulfate and iron analysis, i.e. higher concentrations in 2018 versus 2017, likely due to the overflow of mine pools caused by extreme precipitation events. If higher precipitation rates continue to occur, as predicted by many climate change models, this would negatively impact both water chemistry and aquatic life in Montour Run.

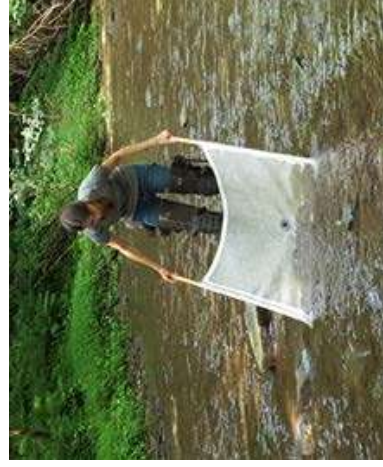
Macroinvertebrate sampling with a kick net

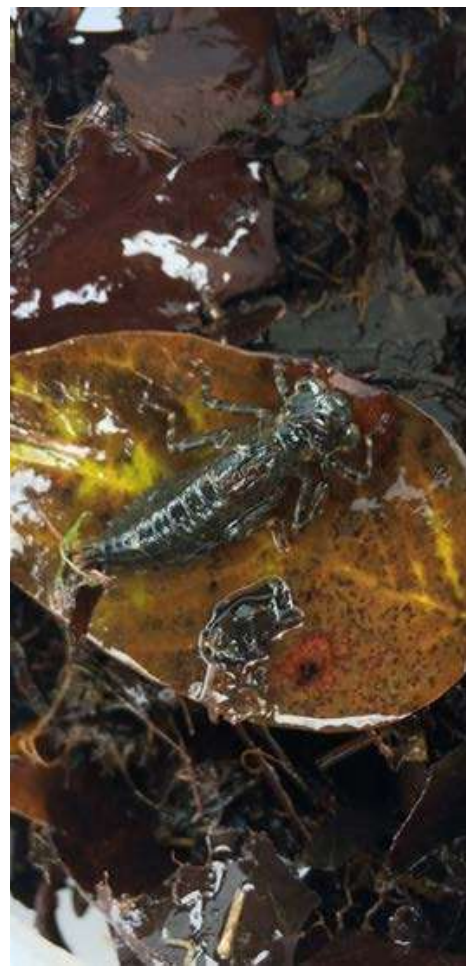
Dragonfly nymph found in Montour Run during November 2018 sampling
