Oven Run B Passive Treatment System Redesign and Construction

Shade Township, Somerset County, Pennsylvania

Final Report

September 2022

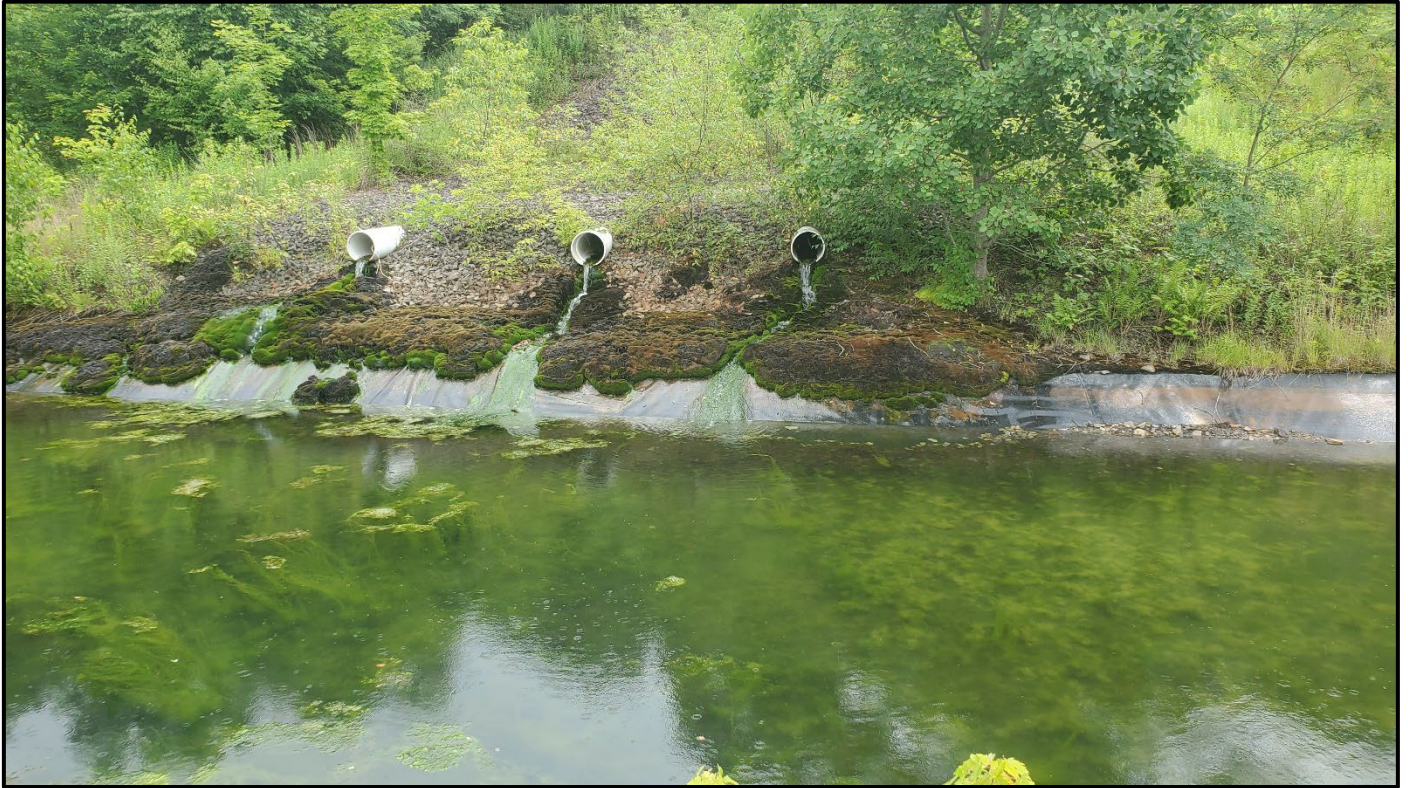
Top: Three of five 18-inch SCH40 PVC pipes flowing into the Moat from underground coal mine. (6/28/20)

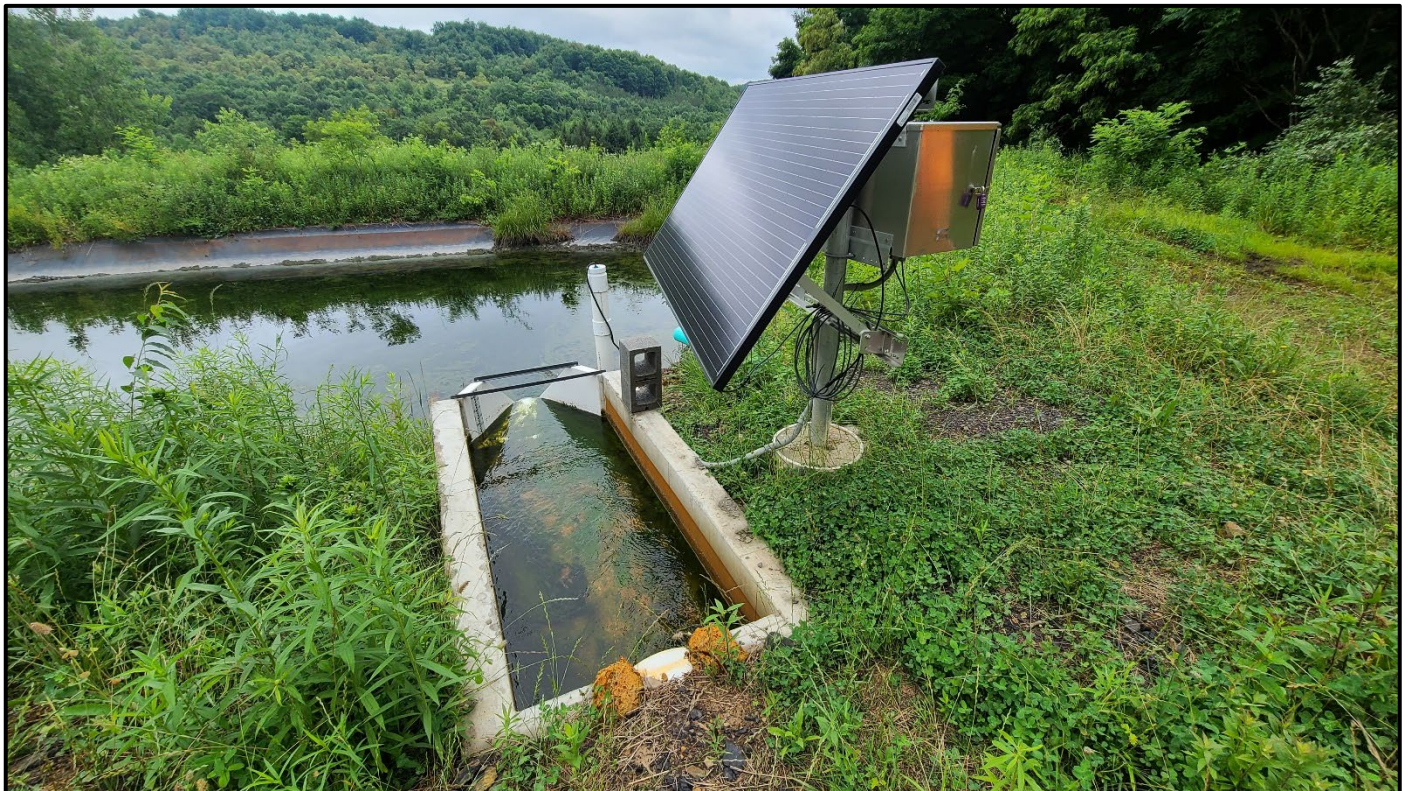
Bottom: H-Flume flowing into holding pond with solar panel and control panel to record flow. “ORBI” monitoring point. (7/7/22)

The current project included an innovative approach to redesign and rehabilitate the treatment system. One of the assumed problems of the original system was the immense size of the SAPS ponds which each contained about 10,000 tons of limestone and were suspected to be short-circuiting. To alleviate this issue, the majority of SAPS1 was divided into three separate Auto-Flushing Limestone Only Vertical Flow Ponds (AFVFPs) that utilize solar-powered Agri Drain Smart Drainage structures (Smart Drains). The Smart Drains are programmed to have daily fill/flush cycles that not only reduce short-circuiting but help to alleviate armoring and plugging of the limestone. Over half of the total acidity is associated with the 2.8 pH and 25 mg/L of aluminum, about 79 mg/L and 139 mg/L of acidity, respectively. Most, if not all of the aforementioned acidity is expected to be neutralized by this initial treatment step. The original collection pond was expanded into a portion of what was SAPS1 and converted to a holding pond that provides the ability to quickly dose the AMD into the three AFVFPs on an alternating set schedule which increases retention time and improves limestone dissolution. The remaining segment of SAPS1 was left in place as a dewatering basin to facilitate future maintenance and is designed to receive sediment and other materials from the various treatment components. In addition, a Moat (forebay) was constructed to help collect and convey the AMD into the holding pond. A flume and data logger were installed to measure flow.

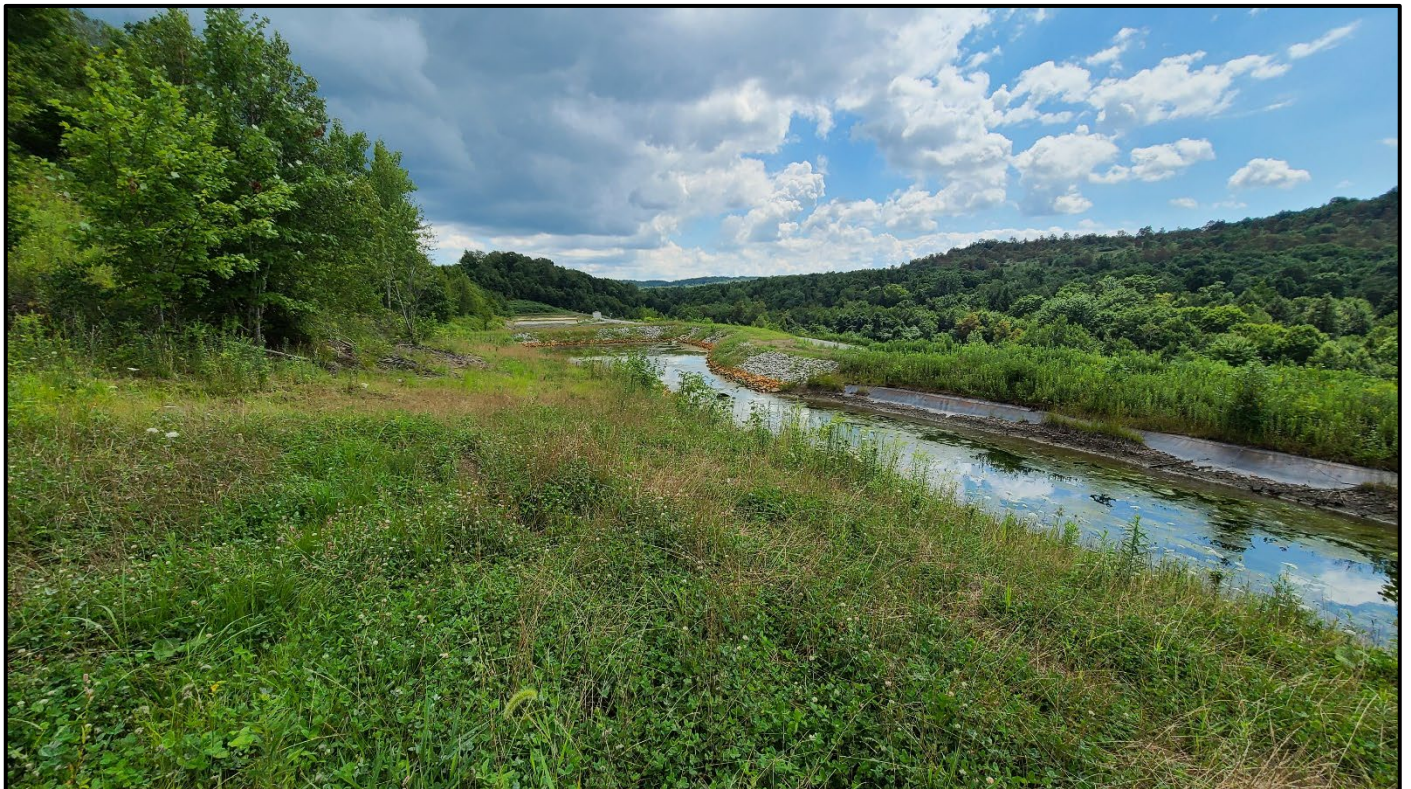
Bottom: Overview of the extended holding pond section. (9/21/22)

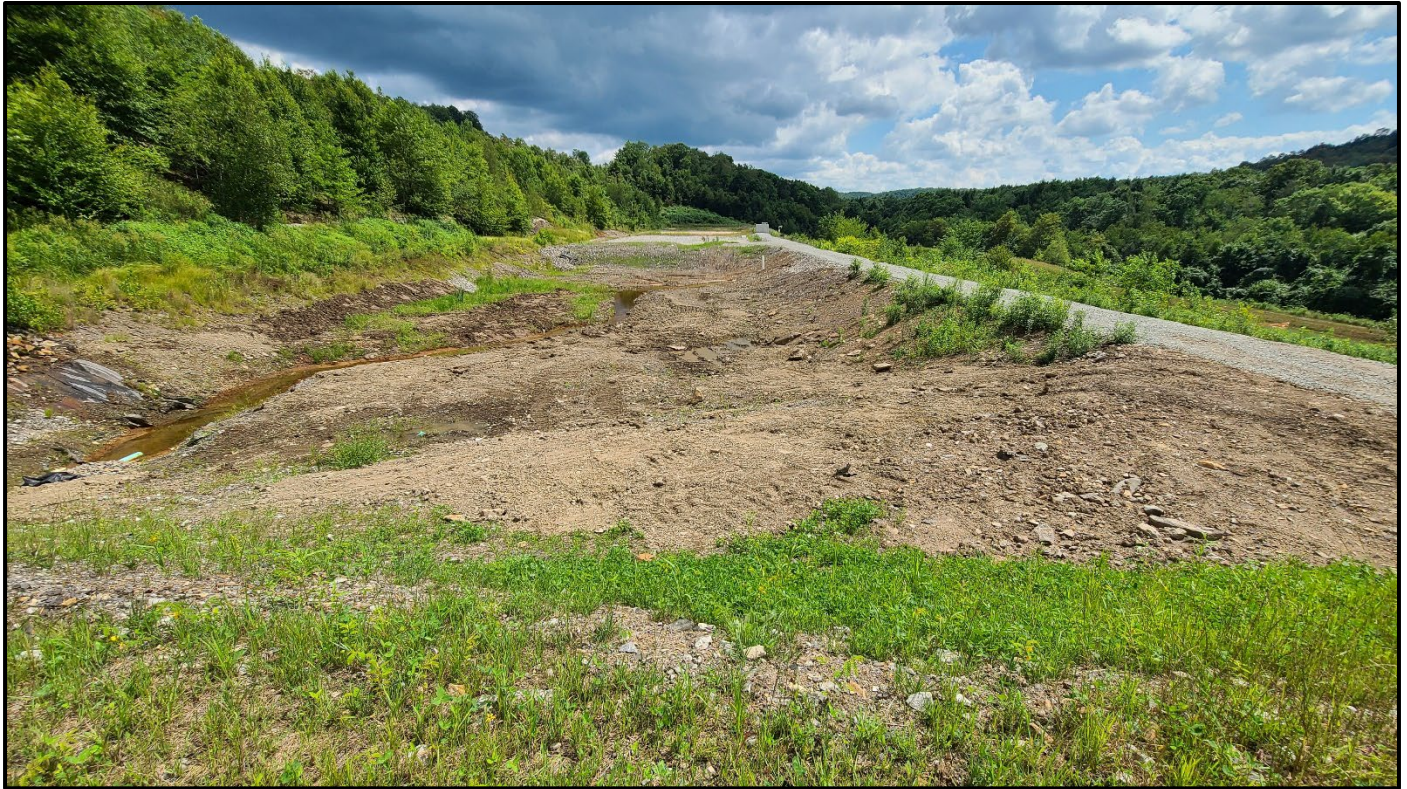
Top: Overview of the dewatering basin. (9/21/22)

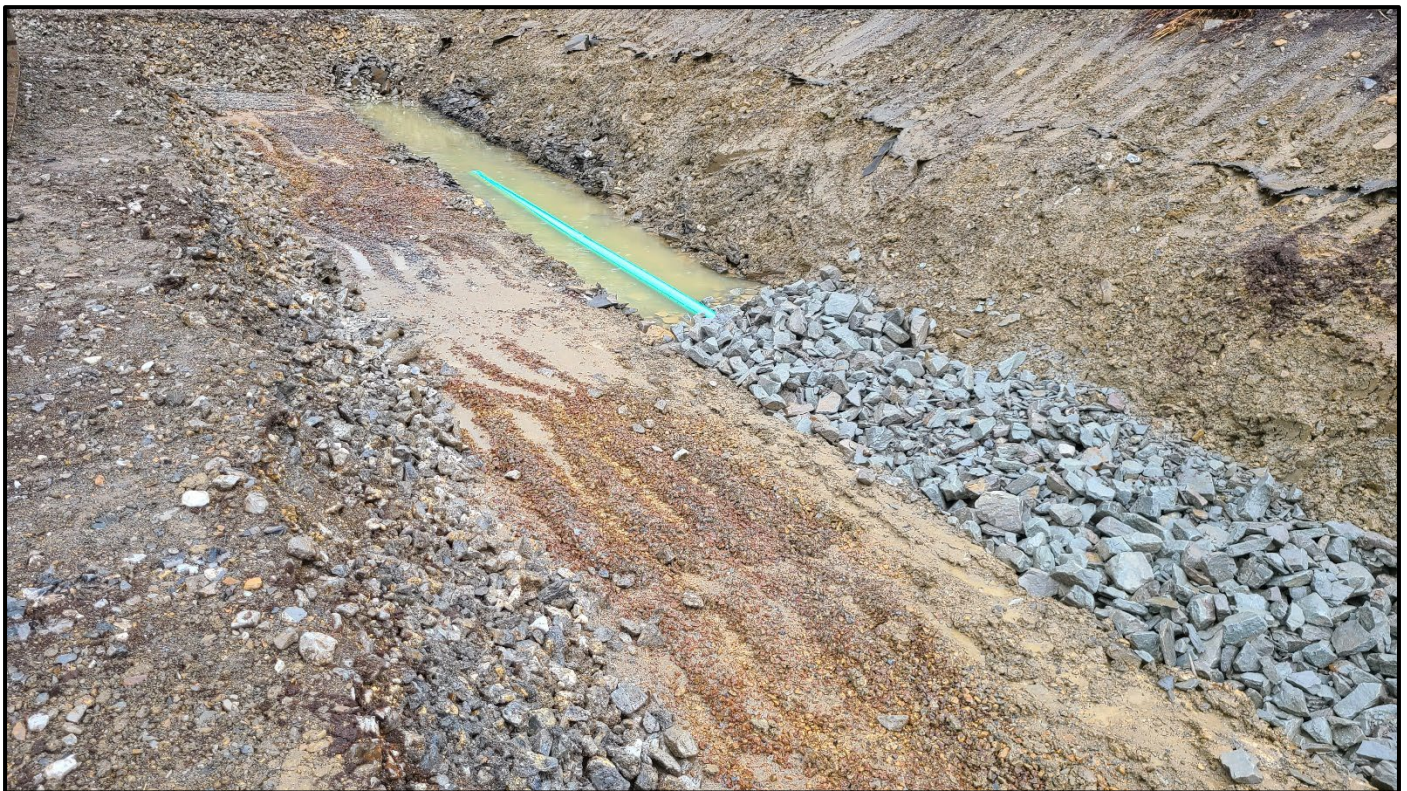
Bottom: Rock drain under construction showing 6-inch SDR35 PVC pipe and aggregate. (4/29/21)

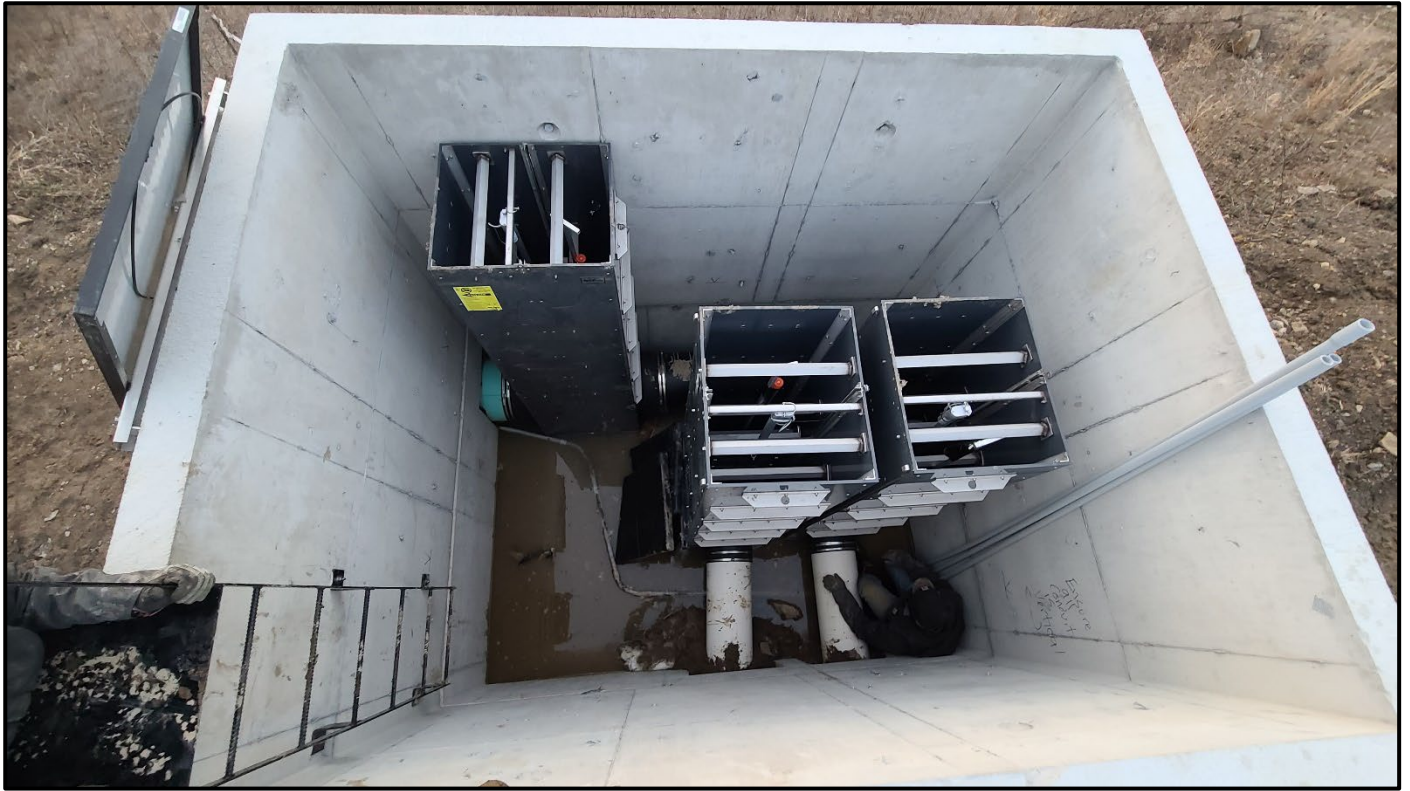
Top: Three-Way Flow Splitter with Agri Drain Smart Drainage System structures connected to 12-inch SCH40 pipe that flow into AFVFPs. (2/16/22)

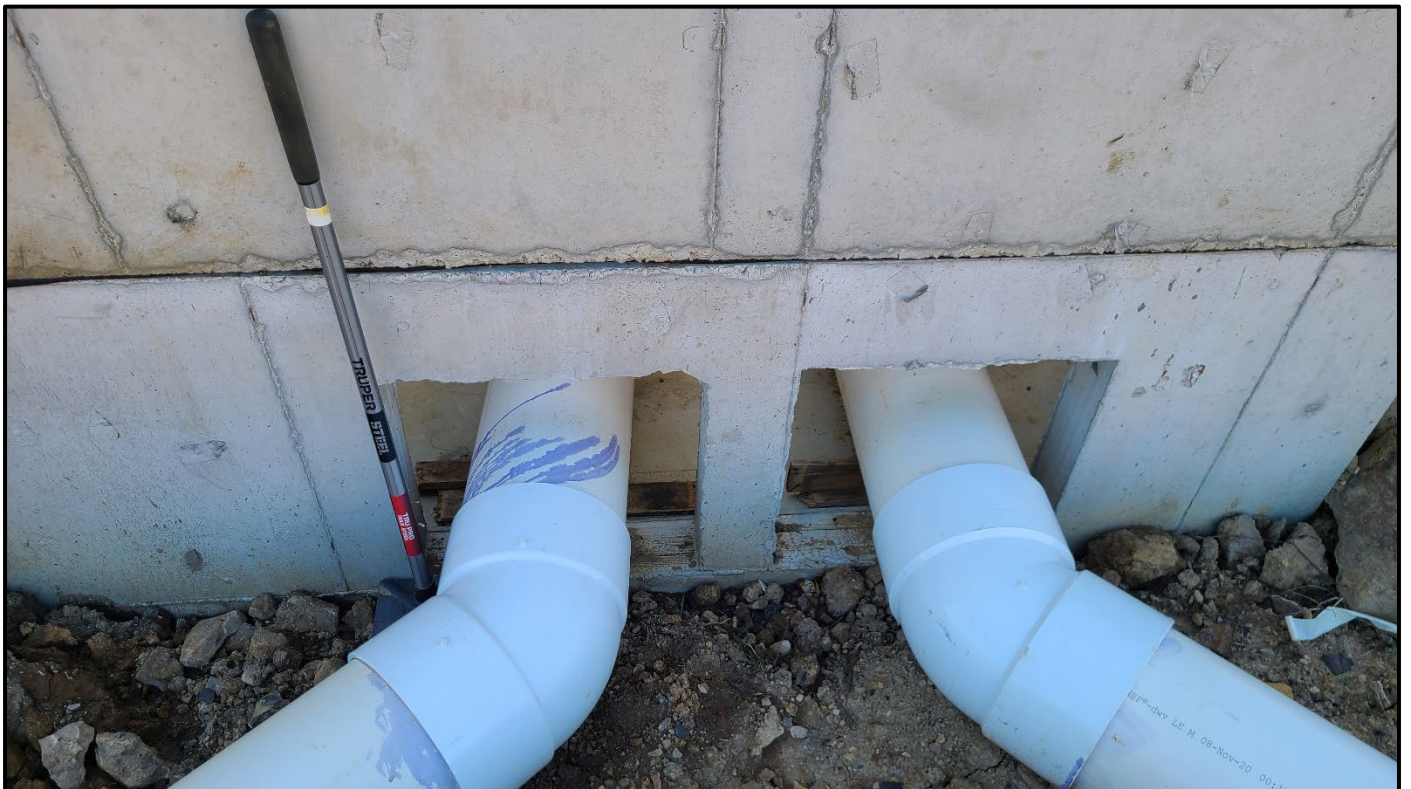
Bottom: 12-inch SCH40 PVC pipes from Three-Way Splitter to AFVFP 1 and AFVFP2. (10/20/21)

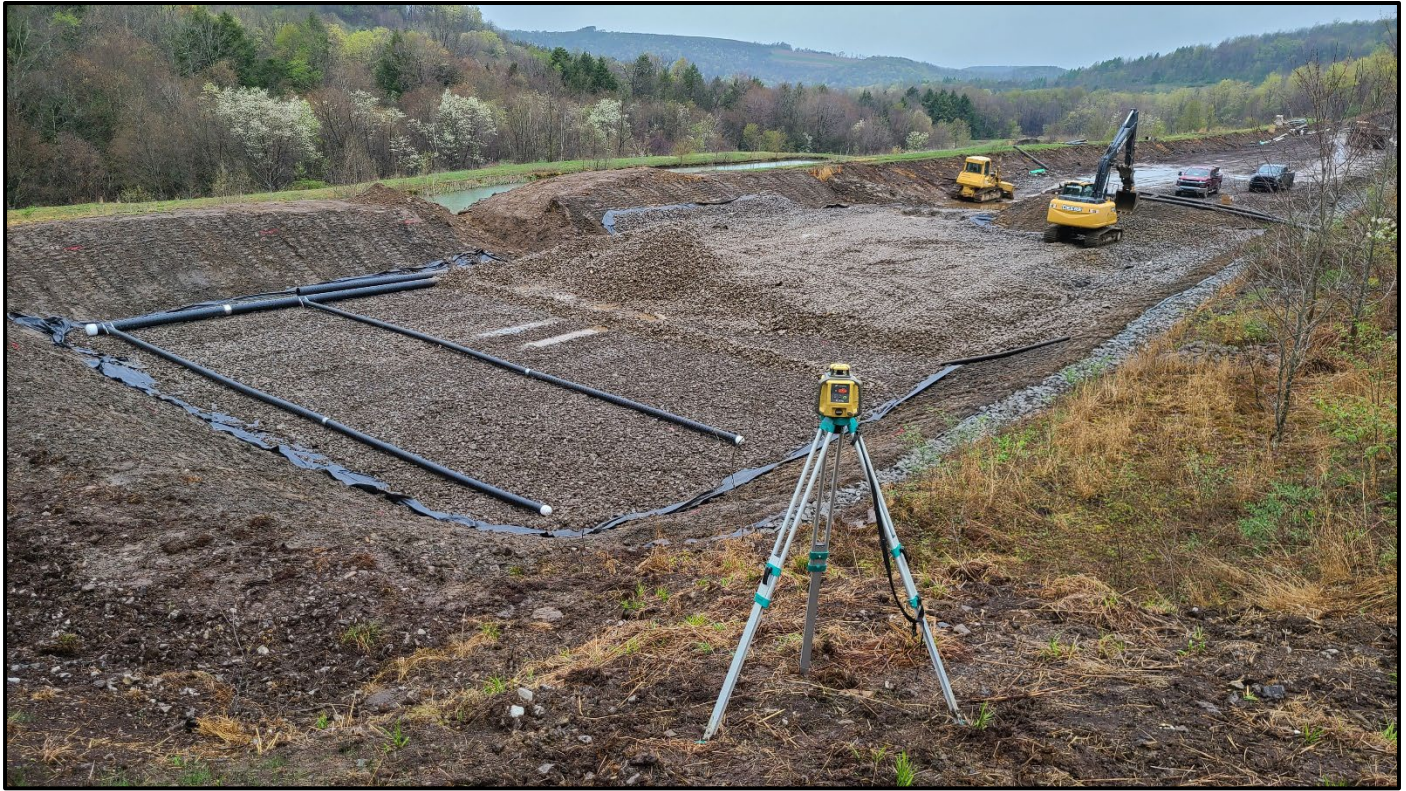
Top: Construction of AFVFP3 showing bedding stone, underdrain pipe and limestone. (4/29/21)

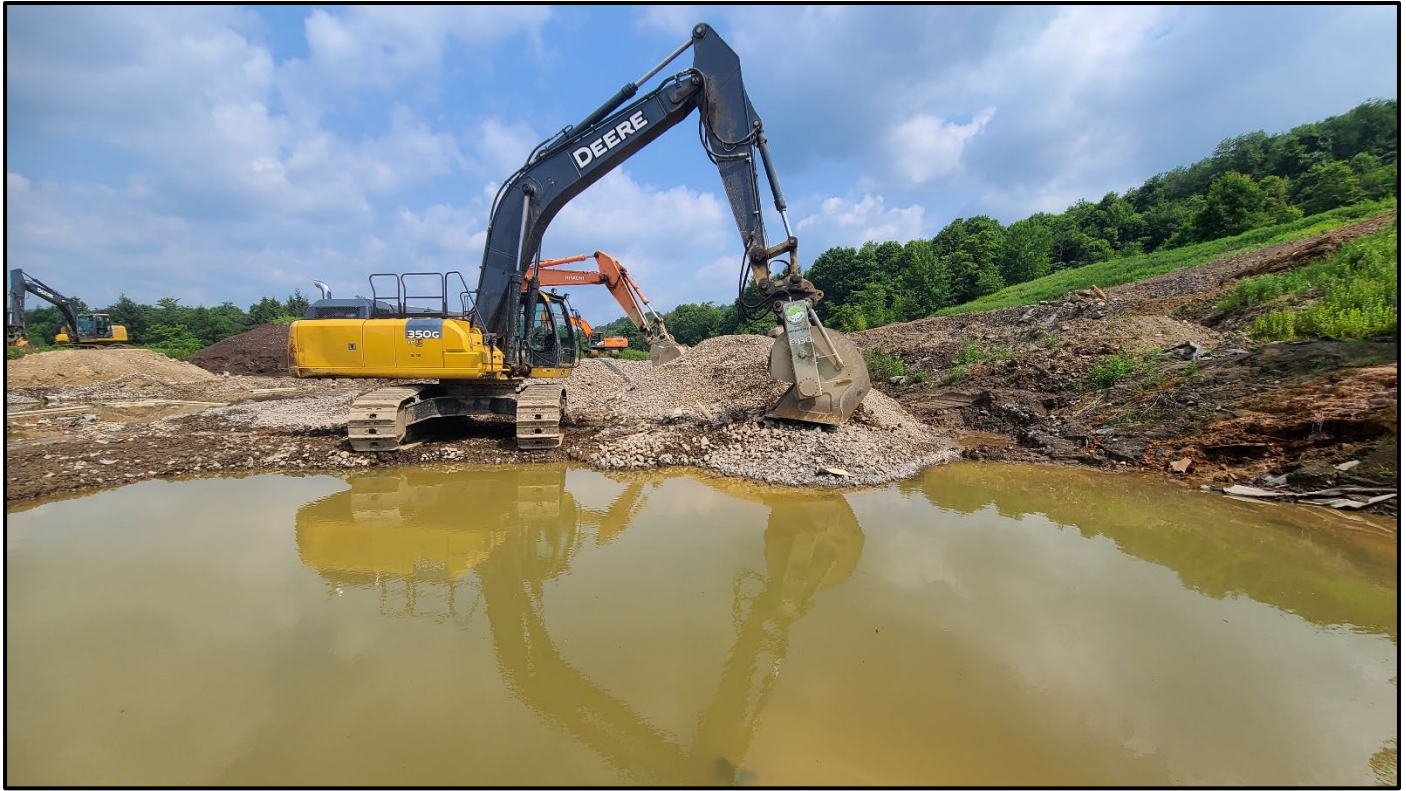
Top: Cleaning limestone to be reused. (9/21/21)

The old compost was removed from both original SAPS, placed on site, and revegetated. The limestone removed from the SAPS was washed for reuse, with an estimated two-thirds recovery. Initial plans were to crush the SAPS2 limestone for use in the JVFP treatment media, however this proved cost prohibitive

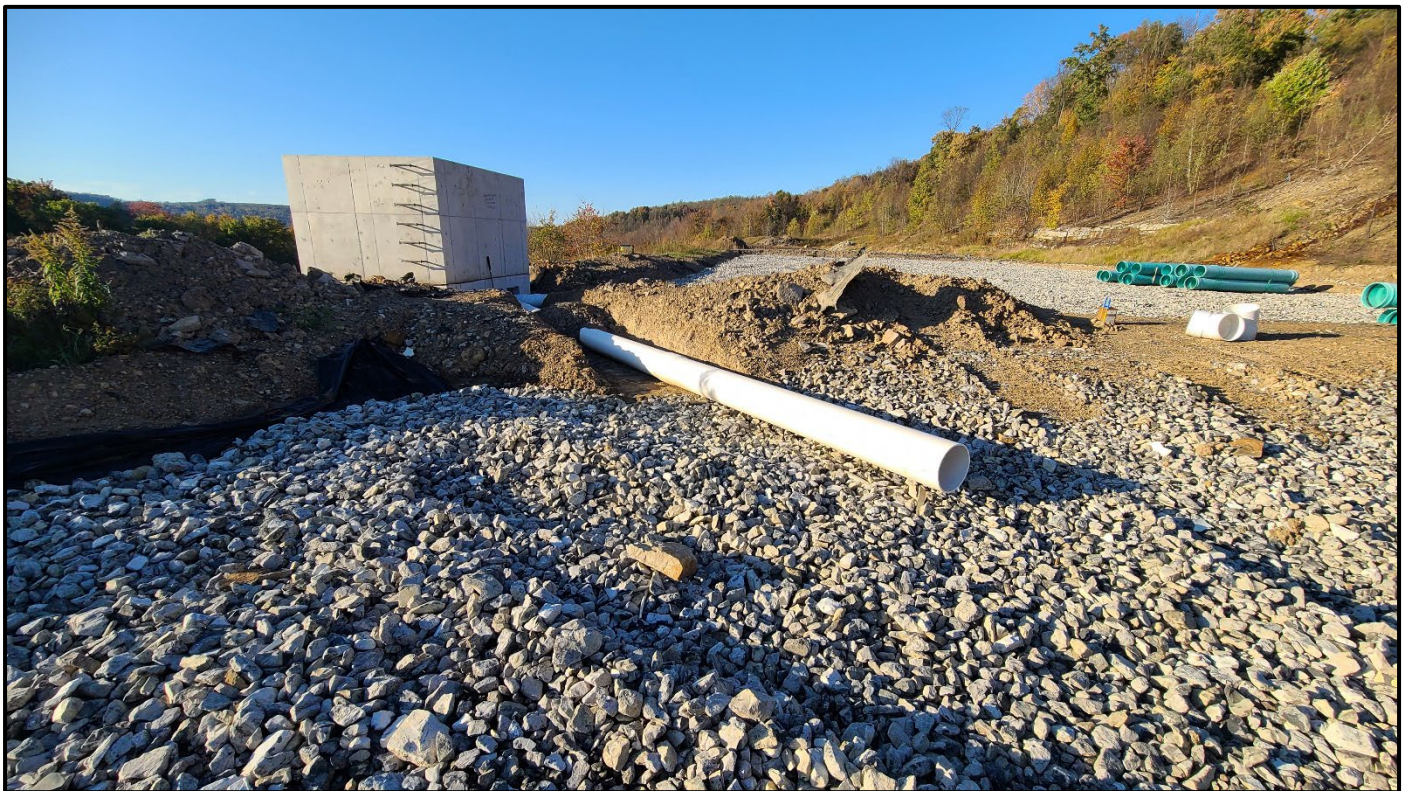
Bottom: Inlet pipe to AFVFP2 in place. (10/20/21)

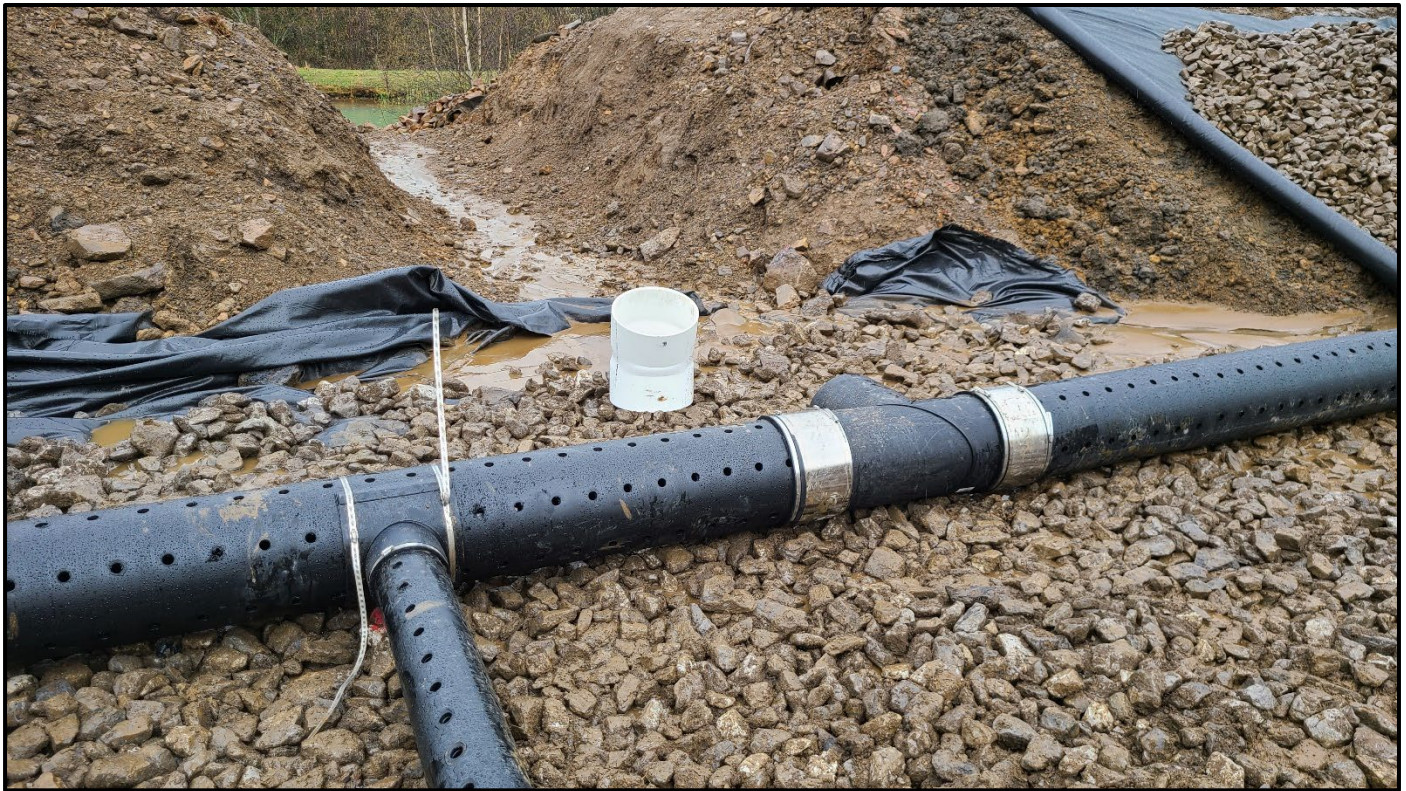
Top: 12-inch DR-26 HDPE header pipe with 12-inch HDPE tee connected with 12-inch non-shear flexible couplers with 6-inch DR-17 perforated lateral. (4/29/21)

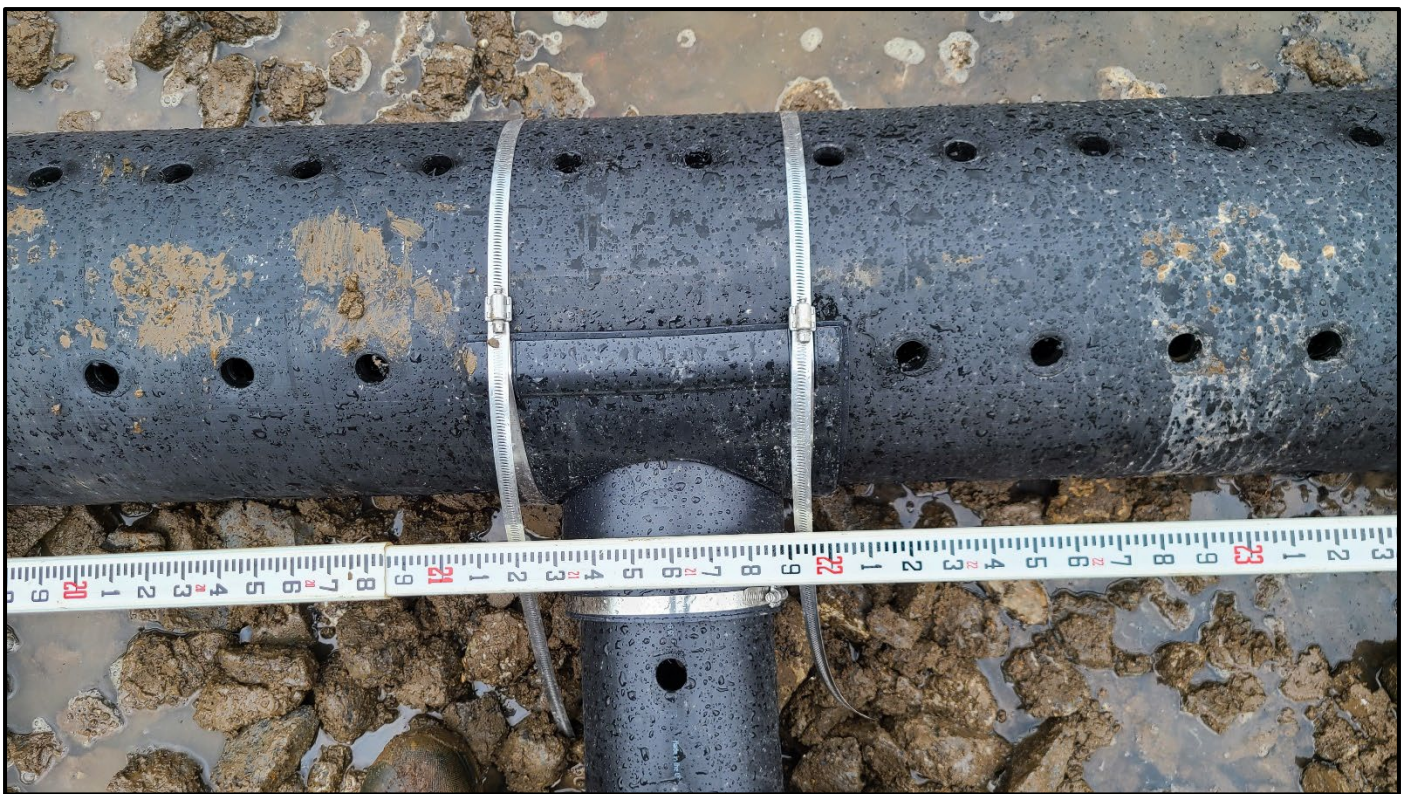
Bottom: Perforated lateral pipe with 12-inch x 6-inch flexible saddle tee connection. (4/29/21)

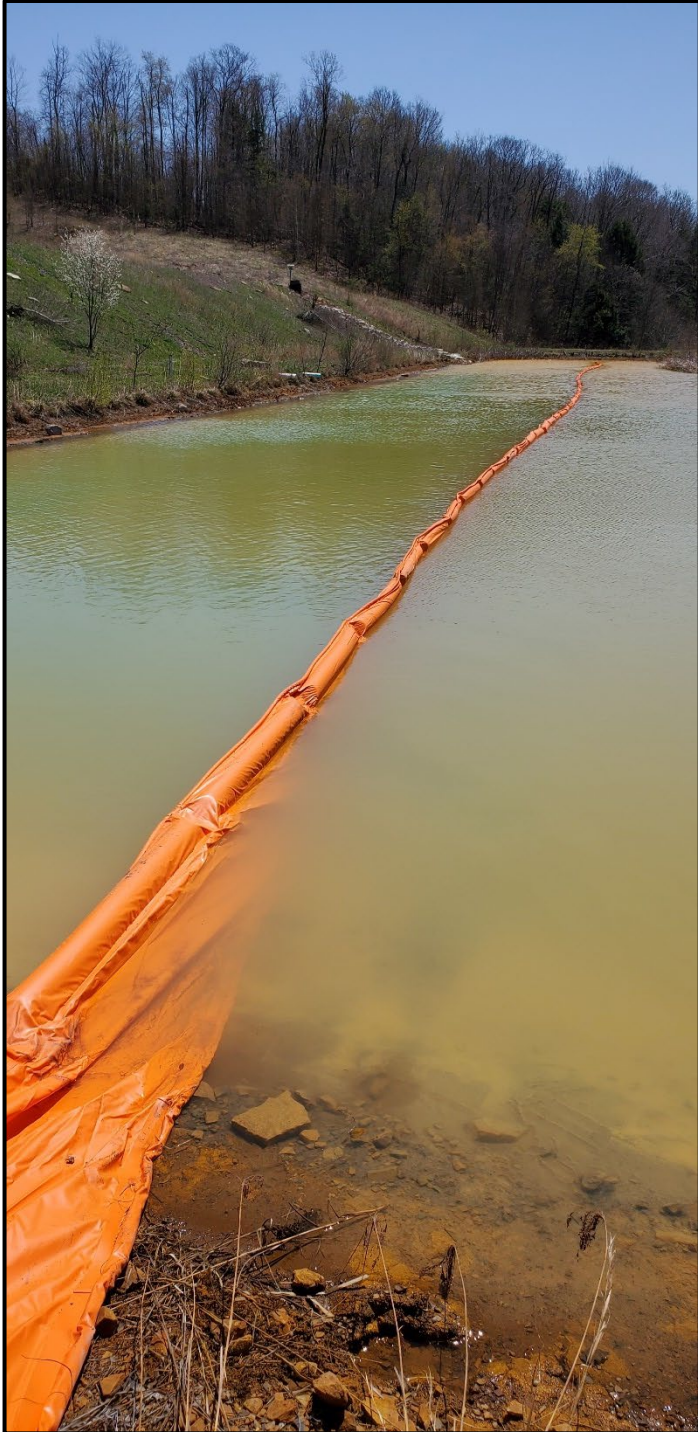
Top: Settling Pond 1 with direction baffle curtain. (9/21/22)

Settling ponds 1 (SP1) and 3 (SP3) have remained mostly unchanged except for the addition of baffle curtains and outlet piping.

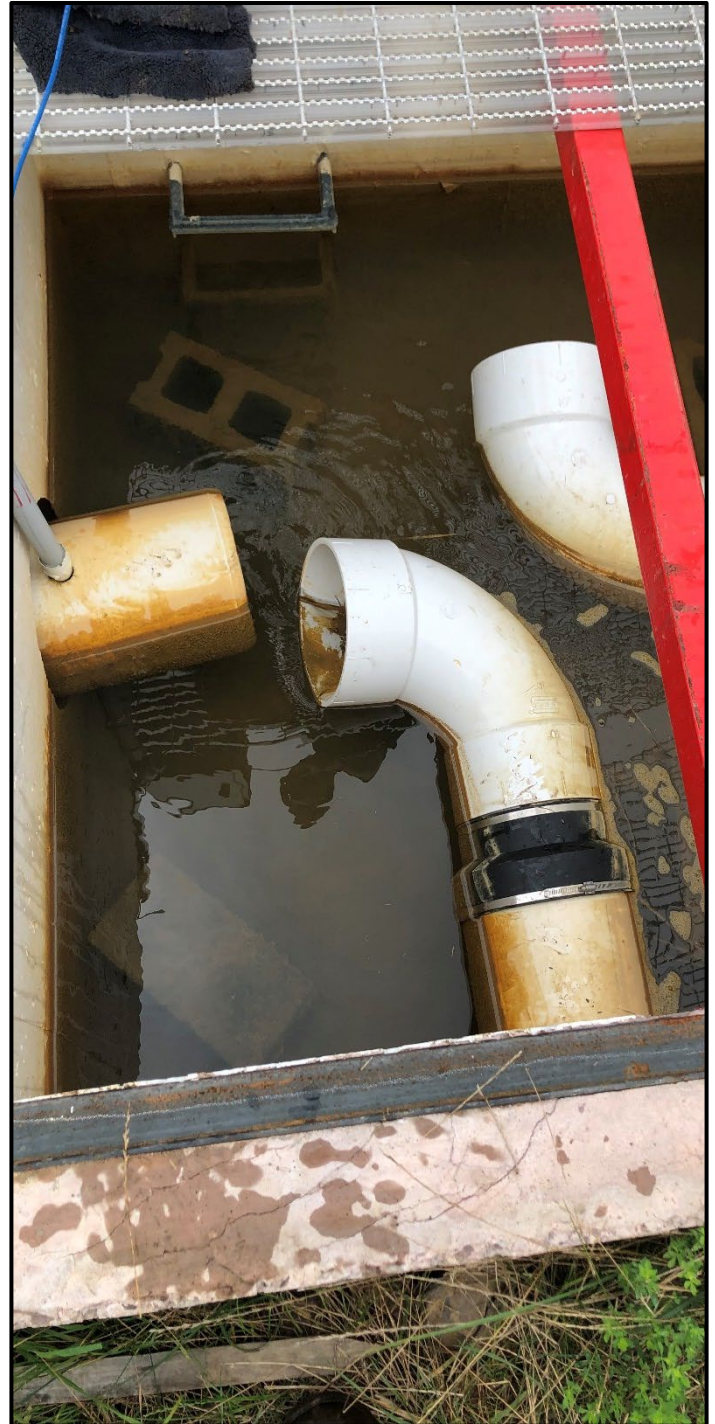
Bottom: Two-Way Splitter with top aluminum grating removed to access 10-inch SCH40 PVC 90° elbows connected to 12-inch SCH40 PVC pipes used to adjust flow to JVFPs. (10/06/22)

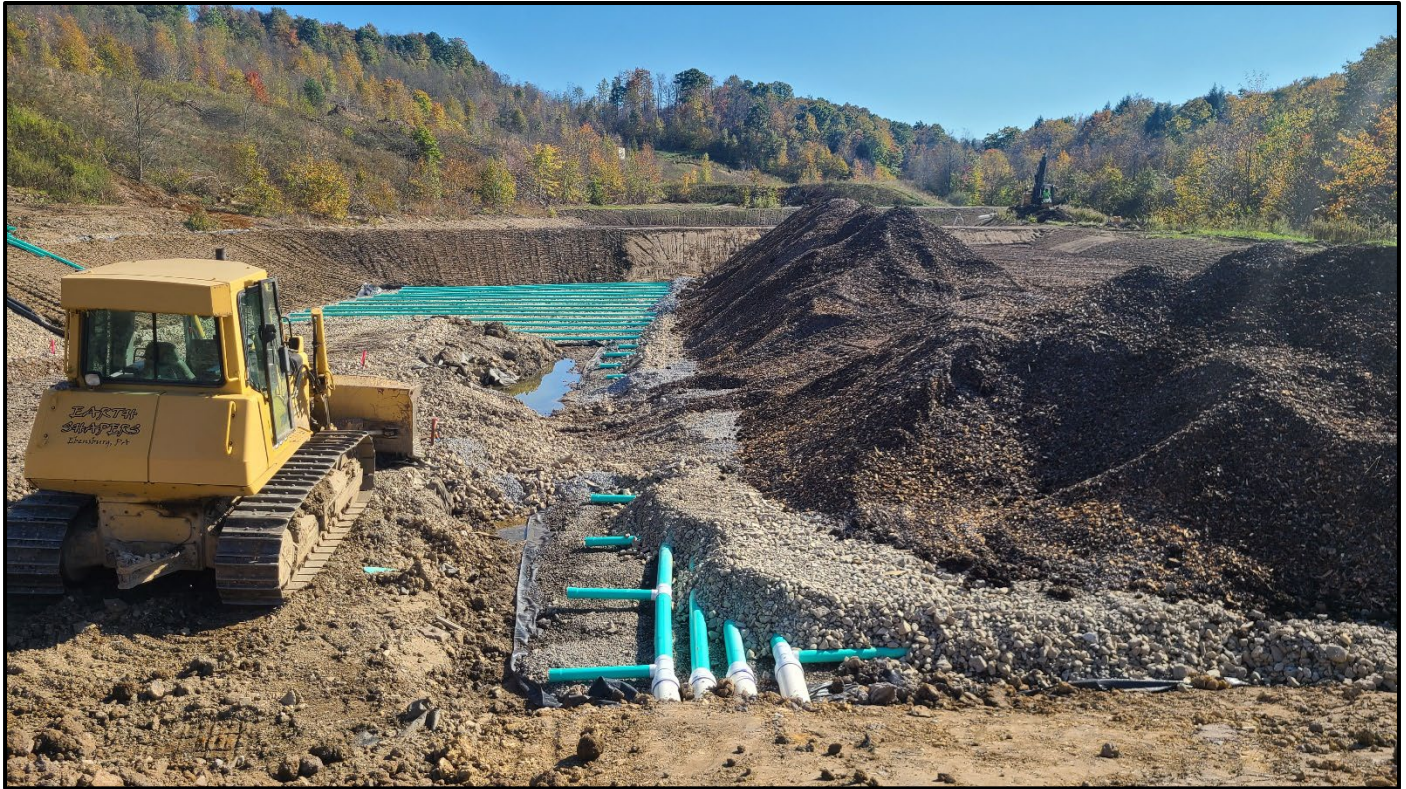
Top: Jennings-type Vertical Flow Pond underdrain with solid 6-inch SDR35 PVC header pipes and perforated 4-inch SDR35 PVC lateral pipes. To the right is the mix of 2,800 tons of limestone, 700 CY of spent mushroom, and 1,400 CY of wood chips. (10/20/21)

Similar to SAPS1, the majority of SAPS2 was split into two Jennings-type mixed media Vertical Flow Ponds (JVFPs). The initial treatment provided by the AFVFPs is projected to reduce long-term maintenance needs of the JVFPs. The remaining portion of SAPS2 was converted into a new settling pond (SP2) to provide additional settling of solids following the AFVFPs.

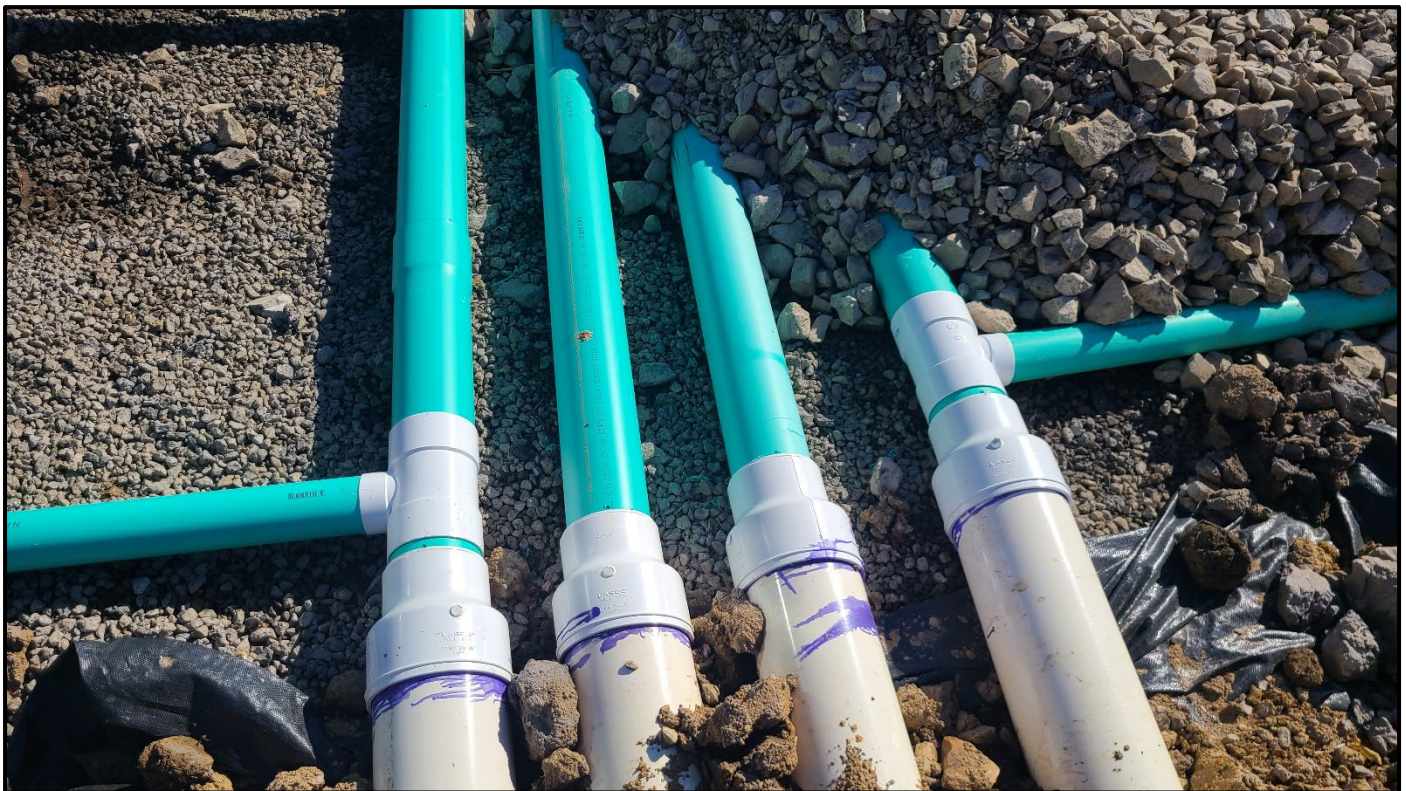
Bottom: Transition of 6-inch SDR35 PVC pipe to 8-inch SCH40 pipe to pass through embankment. (10/20/21)

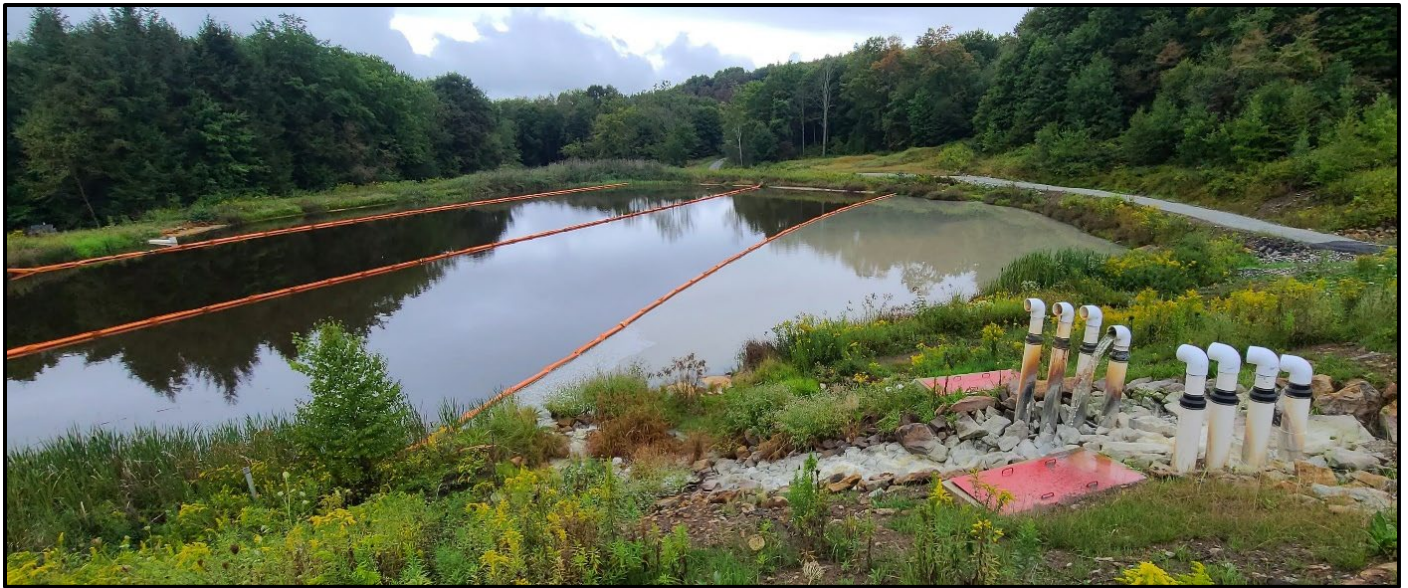
Top: JFVP1 and JVFP2 riser pipes discharging to SP3 with baffle curtains. (9/8/22)

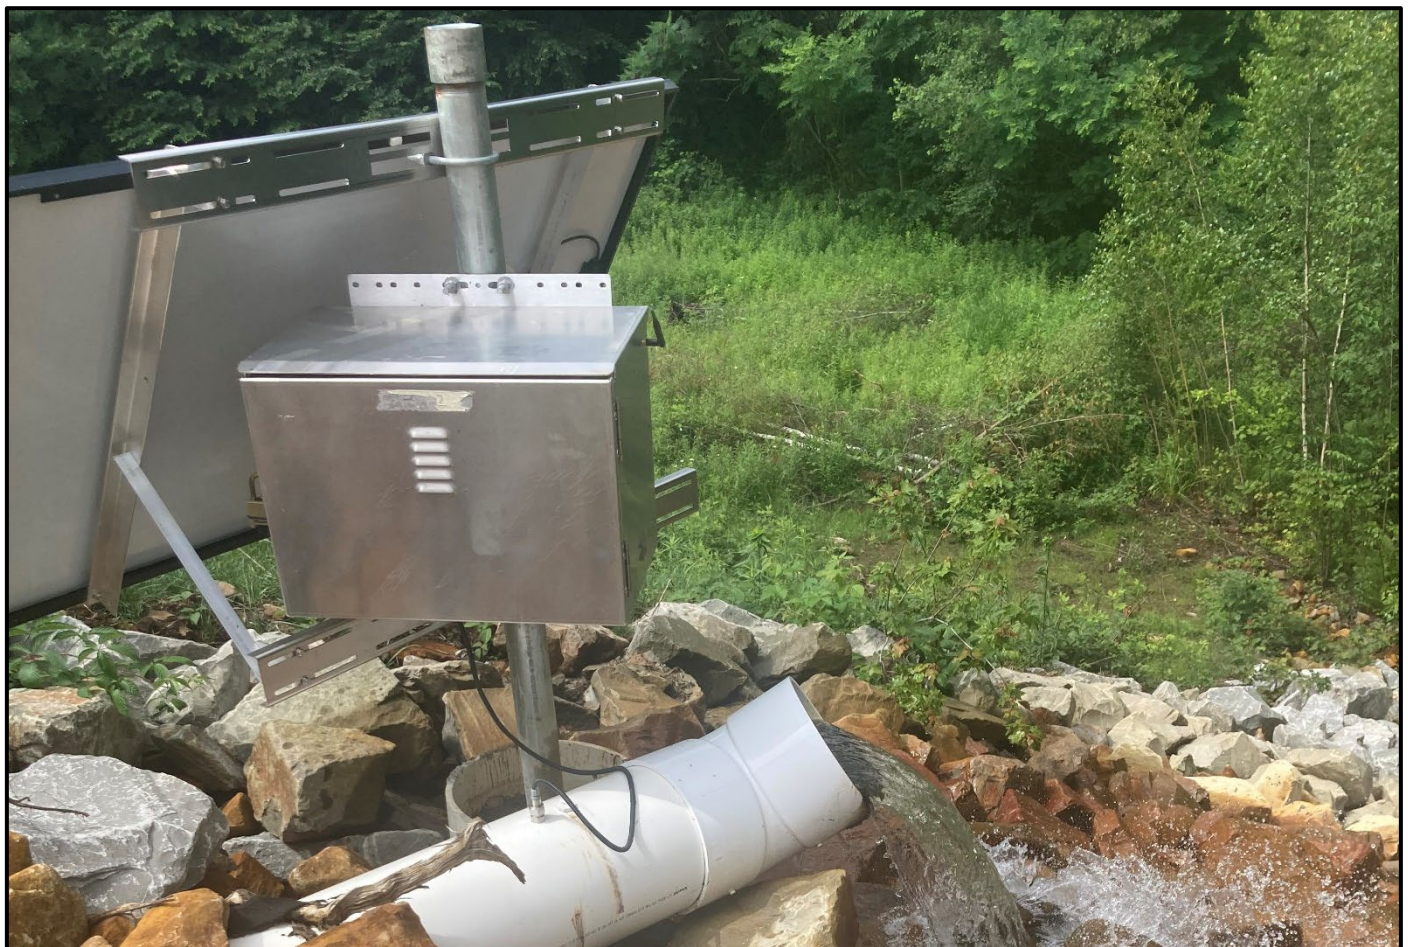
Bottom: Outlet of system at SP3 with solar powered pH meter portion of telemetry system. (9/21/22)

The system effluent measured at the outlet of SP3 (ORBO) had a pH of 7.01 and acidity of -168 mg/L indicating the water was net-alkaline. The entire acid load was neutralized with an additional 279 lb/day of alkalinity (as negative acid load) being discharged to Oven Run. The total acid change (acid neutralized plus excess alkalinity produced) was 697 lb/day. The total effluent iron, aluminum, and manganese loads were reduced to 2.5, 0.0, and 5.2 lb/day, respectively.
