Oven Run Site B Passive Treatment Systems
SRI O&M TAG Project #56 Request #1
OSM PTS ID: PA-57

Oven Run B System Evaluation

**AMD RECLAMATION PROJECT
PASSIVE TREATMENT SYSTEM
RE-DESIGN / REHABILITATION
OVEN RUN B**

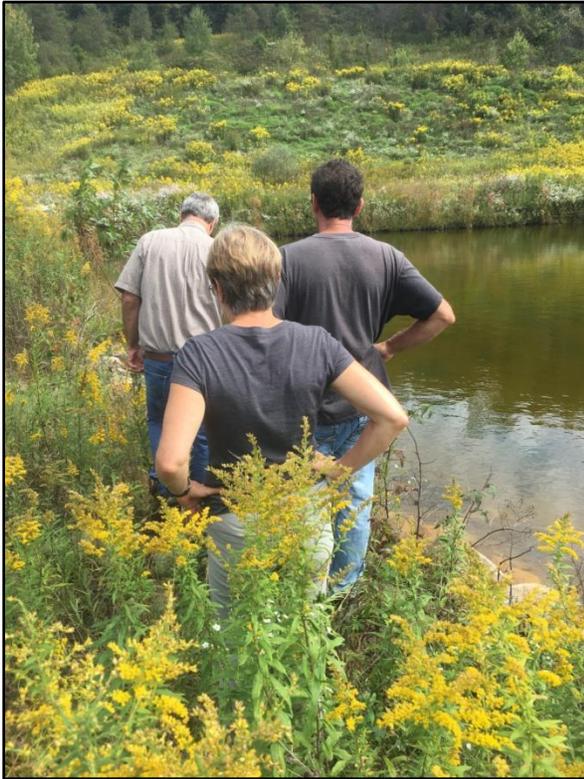
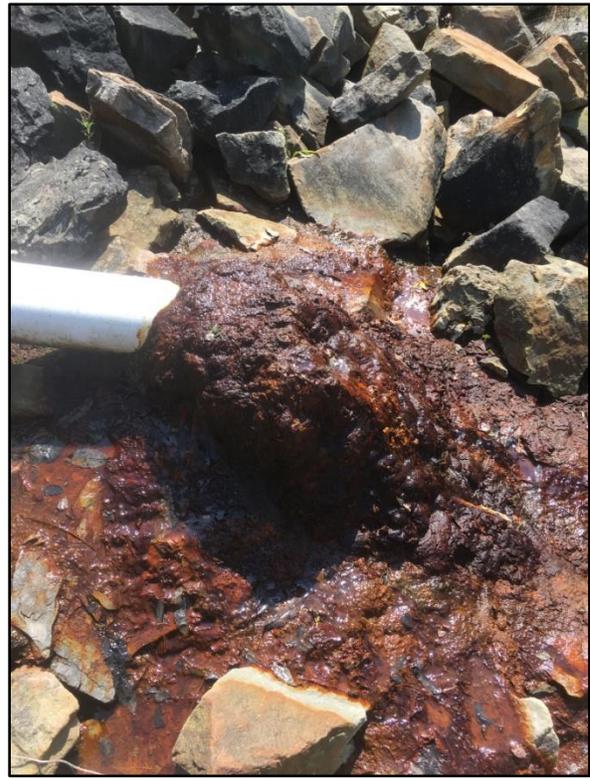
Top Left: Field meeting to discuss system maintenance needs and options.
Top Right: Iron precipitates clogging a pipe in the system.
Bottom Left: Final outlet spillway riprap had been washed away.
Bottom Right: Raw water inlet pipes and the forebay were functioning as designed.

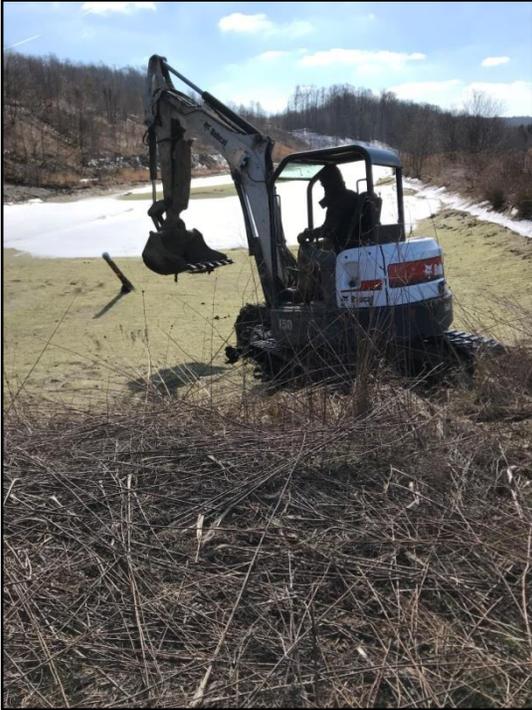
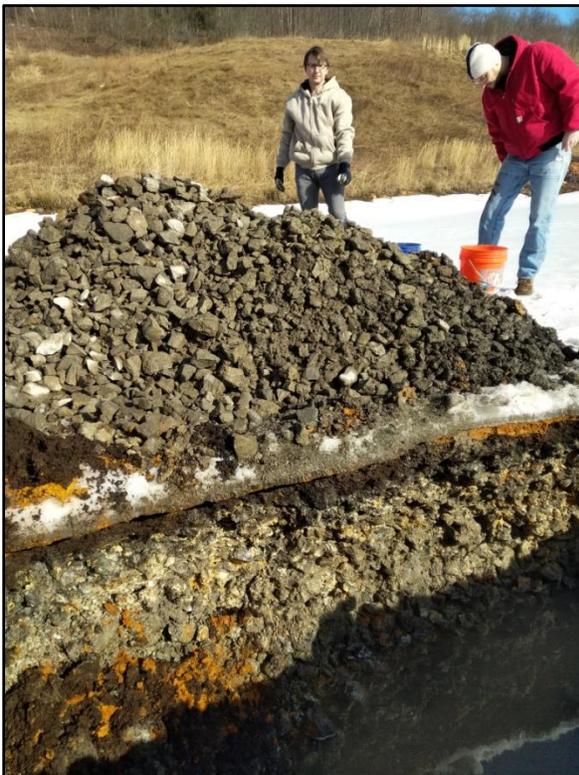
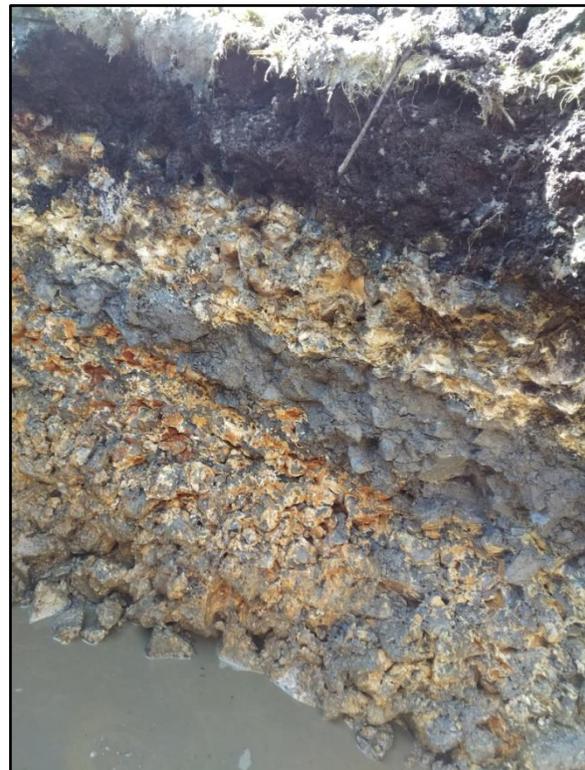
Top Left: Test pits were dug in SAP1 to evaluate the treatment media.
Top Right: Large amounts of Fe and Al precipitates were present in the SAP1 media.
Bottom Left: SFU collected limestone from SAP1 & SAP2 which was used in bucket tests.
Bottom Right: Treatment media in SAP2 appeared to contain a lot of metal precipitates.

Test pits (See attached photos) were excavated on 2/28/2019 using a small excavator. Five test pits were dug in SAP1 spread out across the length of the pond. Four test pits were dug in SAP2 with two towards the inlet end and two towards the outlet end of the pond. The test pits indicated some variability in thickness of compost layer, stone layer, and composition of stone. In general, SAP1 contained an algal mat over most of the pond often with a 1-3” layer of iron on top of 6-10” of compost and 2.5 to 4 feet of limestone. The test pit with the least amount of treatment media was located near the eastern berm close to the hillside and therefore may be due to the internal slope of the pond. Some of the test pits seemed to contain a mixture of AASHTO #1 and #57 limestone. It is uncertain why #57 limestone would have been placed unless possibly for bedding of pipes within the media. There also appeared to be some variability within the limestone as to where and how much iron and aluminum precipitates were observed; however, significant accumulation of metals within the treatment media were observed in all test pits. Test pits dug further away from the inlet had a thicker cleaner layer of limestone before precipitates were encountered which may indicate short-circuiting. The SAP2 test pits were similar, but with perhaps slightly less depth of treatment media and perhaps a slightly thicker layer of iron on top of

the compost. During some of the test pits, a “lens” of what appeared to be a mixture of clay and limestone without the presence of iron and aluminum was observed. It is unknown if the clay was forming from the weathering of the limestone, washed in, or was placed there because the material had not been properly screened/washed. This material is likely not very permeable and could be contributing to the problem along with media and potentially piping/perforations plugged with precipitates.

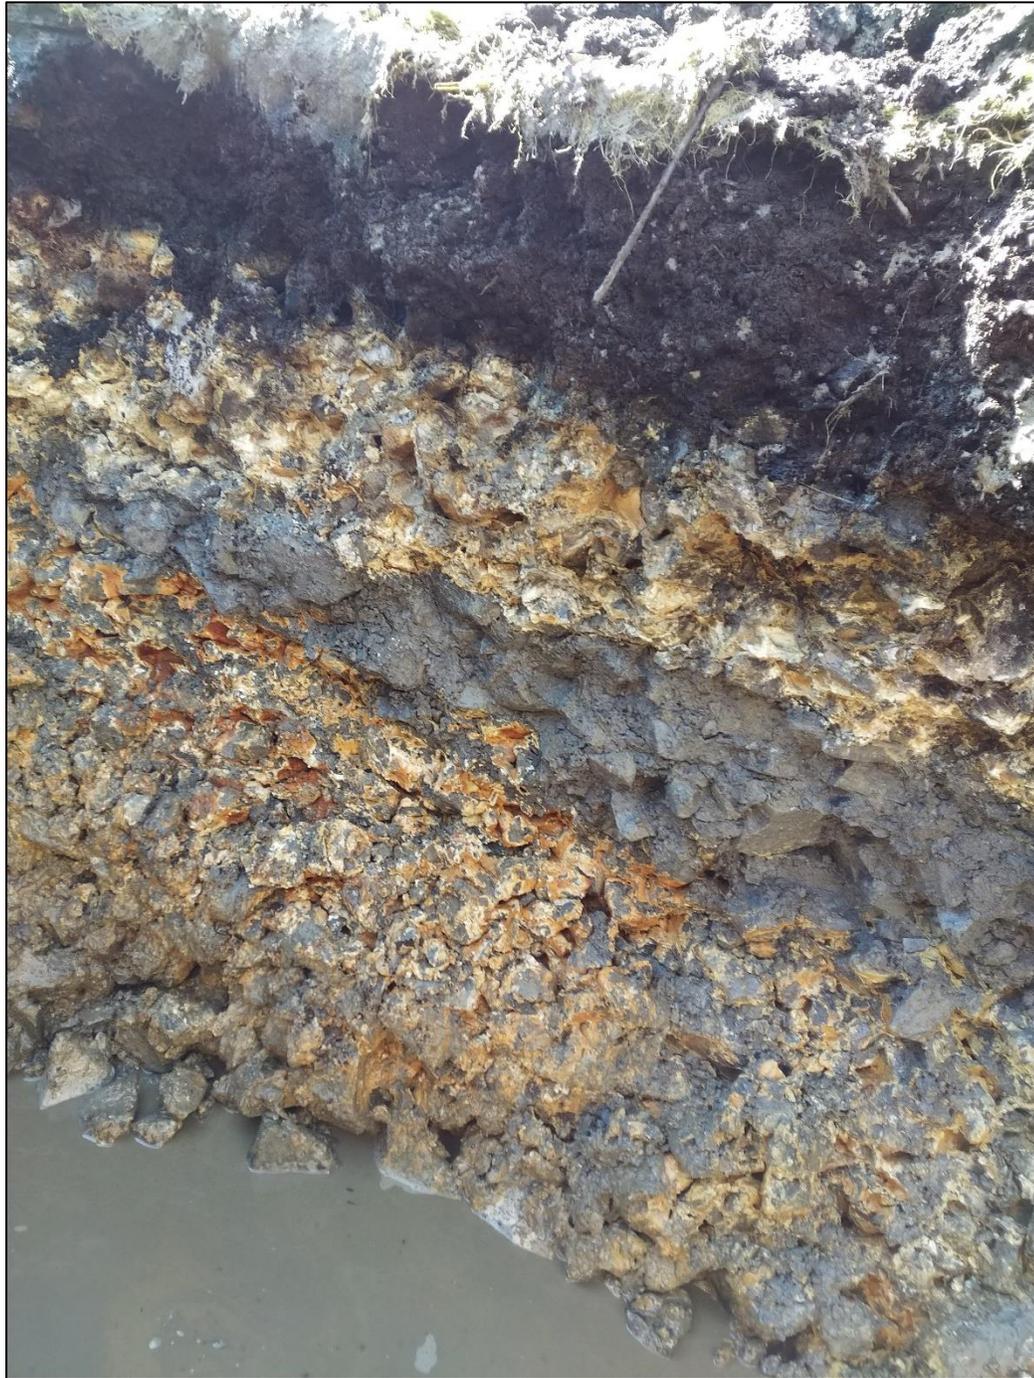
Oven Run B Test Pit Photos

Test pit within Oven Run B SAP1. An algal mat covered the entire pond. Below the algae was often a layer of iron on top of the compost. The limestone was often coated in iron and aluminum precipitates, but there were also “lenses” of clean or mixtures of clay and limestone that did not appear to have contact with AMD.

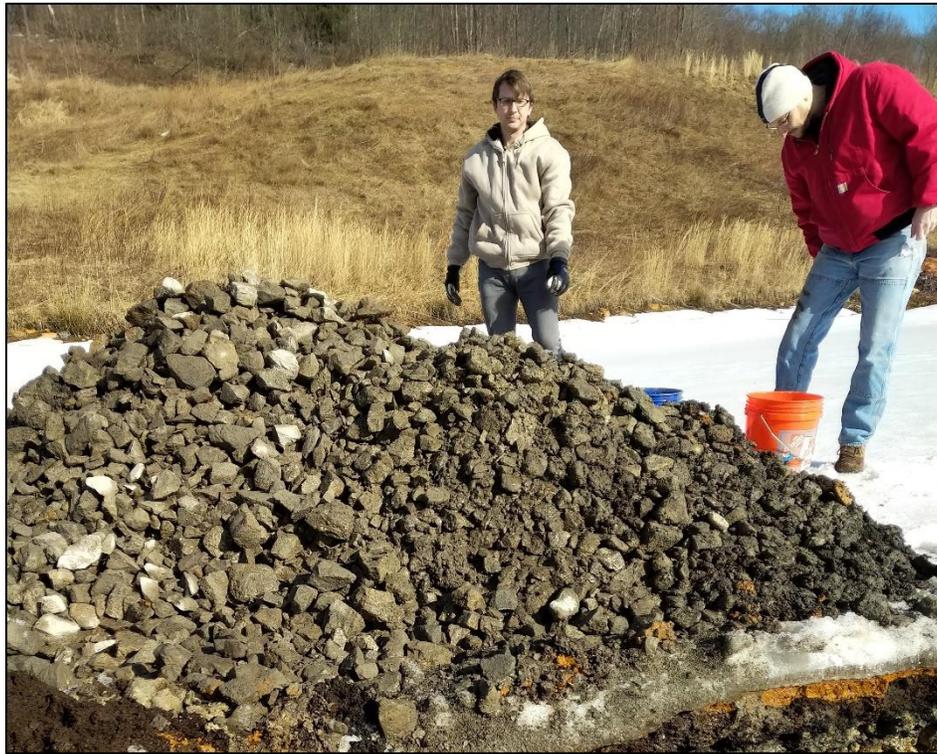
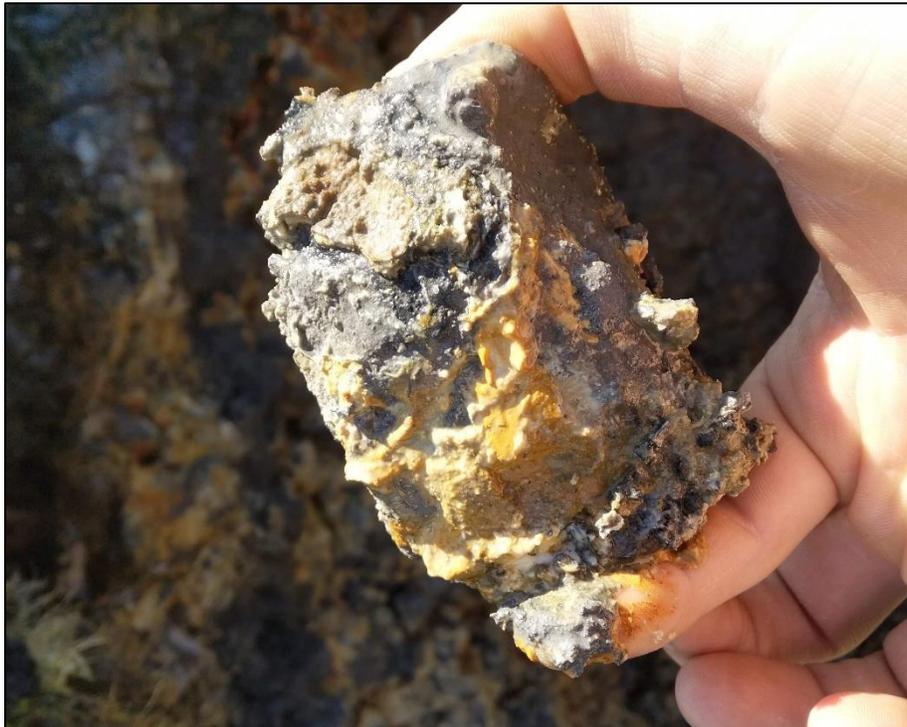
In some areas within the SAPs, the stone looked fairly clean and fresh (Above) while other stone was heavily coated with iron and aluminum precipitates (Below).

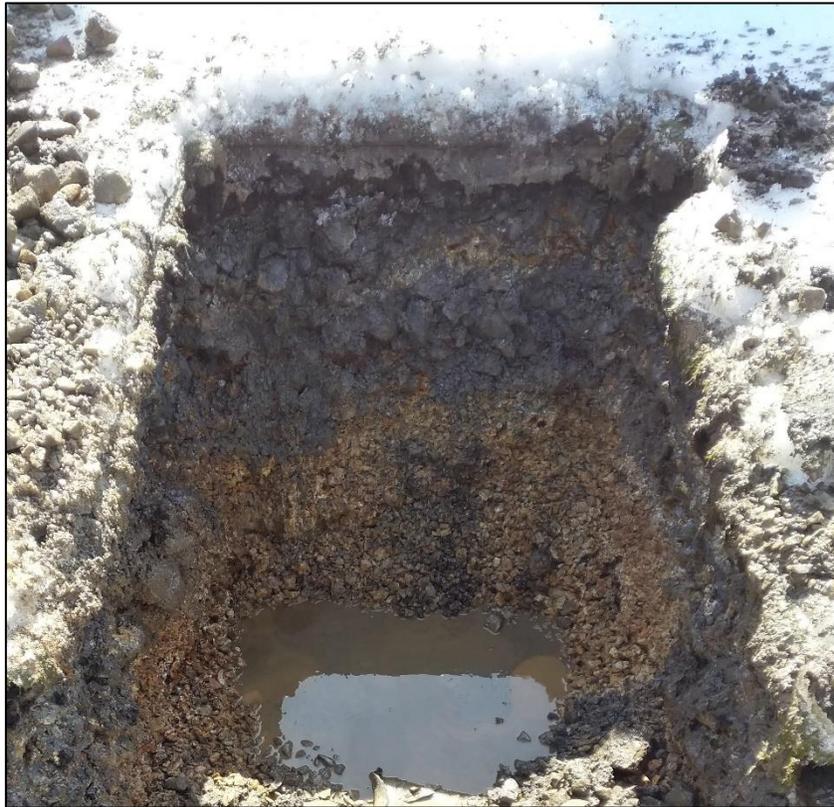
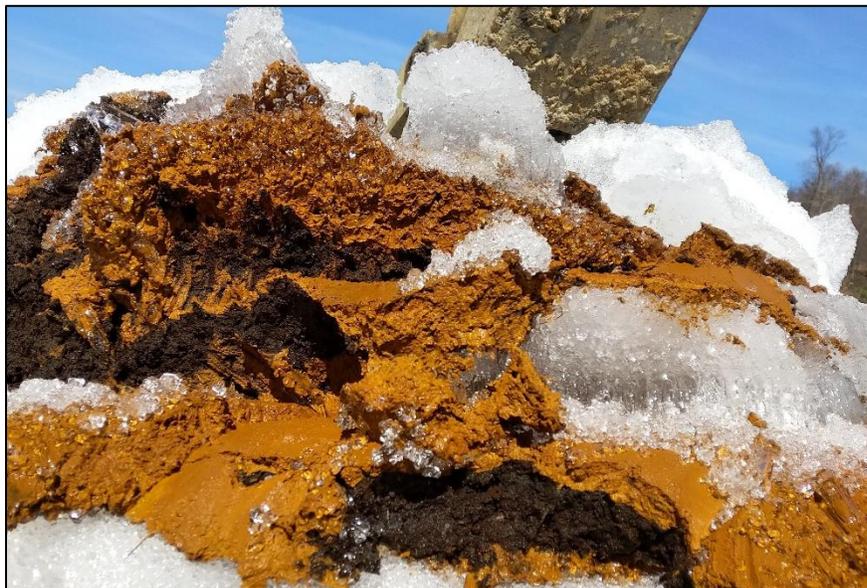
Test pits within SAP2B (Above) were relatively similar. A layer of ice covered the pond, so it was uncertain if it was covered with algae. In general, SAP2B had a thicker layer of iron (Below) on top of the compost
