CURRENT PERFORMANCE OF A PASSIVE WETLANDS TREATING
ACID MINE DRAINAGE FROM UNDERGROUND MINE SEALS AT
MORaine STATE PARK, BUTLER COUNTY, PENNSYLVANIA

A THESIS

A Thesis in partial fulfillment of the requirements for a Master of Science Degree
in Earth Sciences, California University of Pennsylvania; California, Pennsylvania

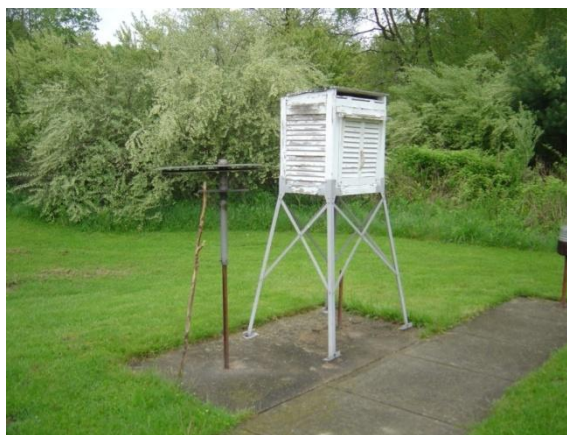
Figure 7 – Weather Station at Moraine State Park Office

flow rate from the treatment pond system. Precipitation in the region is measured at several recording stations. Three regional stations, between 7 and 12 miles from the park, have been recording data since the late 1940s, which is prior to the beginning of initial AMD flow monitoring for the original mine reclamation projects completed in the 1960s and 1970s. A meteorology weather station is located at the Moraine State Park South Shore Office (Figure 5). Park Rangers record the daily total precipitation, maximum and minimum temperature, plus wind speed and direction. The park staff measure lake water temperature a few times each month. The climatological data are maintained at the Moraine State Park South Shore Office. This station was utilized for January 2007 through September 2008 precipitation and temperature measurements for this study. The weather station is located approximately 4.5 miles from both the passive wetlands treatment system and the untreated AMD discharge, and 2.3 miles from the control stream (Mount Chestnut, Portersville, and Prospect USGS Topographic Quadrangle Maps). Precipitation data from 2007 through September 2008 recorded at the park office are included in Appendix 1, Table 1.

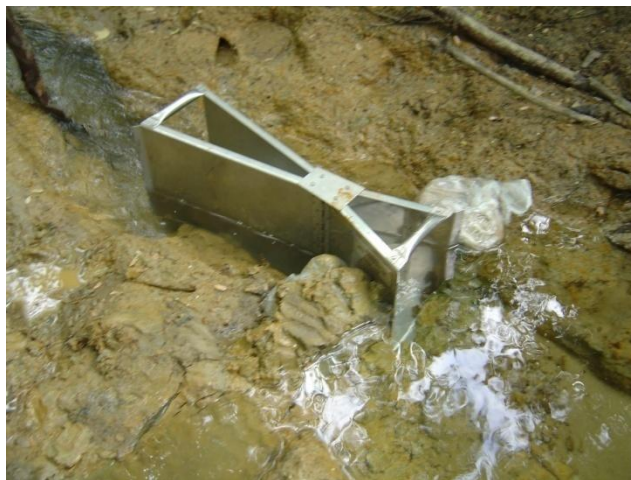
Figure 8 – 1 inch Portable Baski® Flume

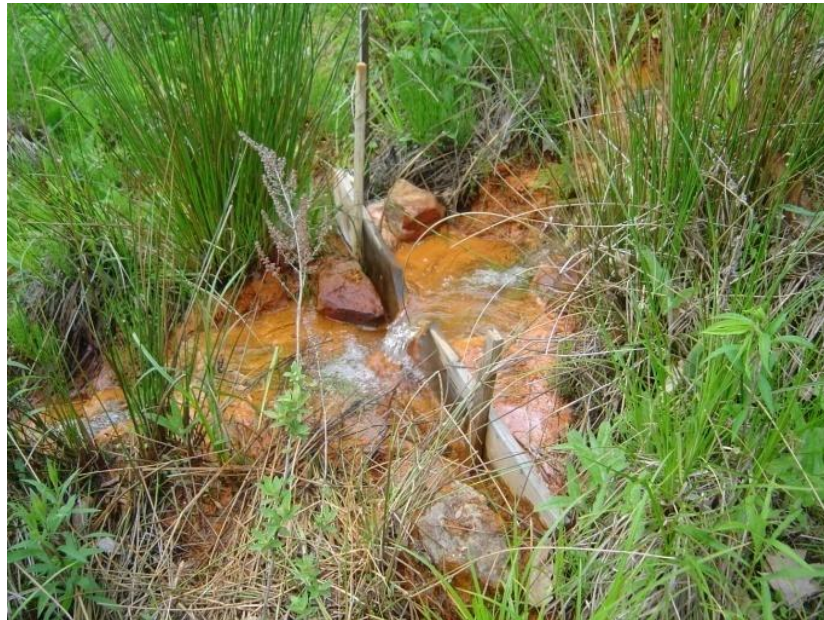
Figure 9 - 90° Triangular (V-notch) Weir at Pond 1 Outlet (MSP-1)

These weirs were constructed from ¾ inch lumber. The weir for Pond 3 was installed against pre-existing 2 inch by 10 inch pressure treated lumber that had been installed during the original pond construction as a flow regulating device.

Another flow regulating board was later uncovered when vegetation was removed from the Pond 1 outlet area. At the time of initial site reconnaissance, these original design boards were not visible as vegetation had overgrown the outlet areas of both Pond 1 and Pond 3.

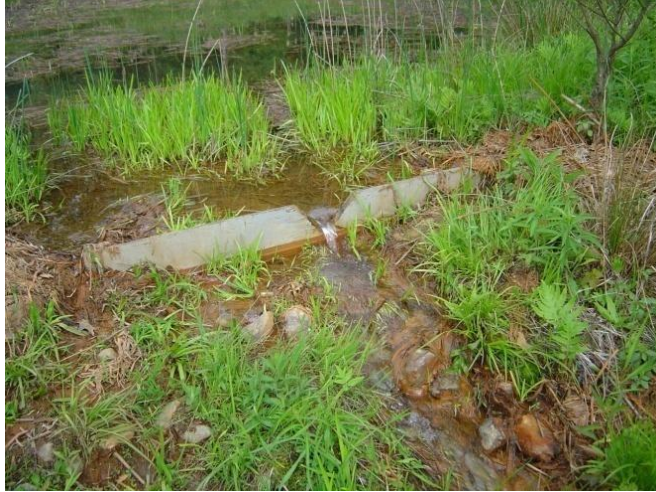
Figure 10 – Pond 3 Outlet (MSP-3)

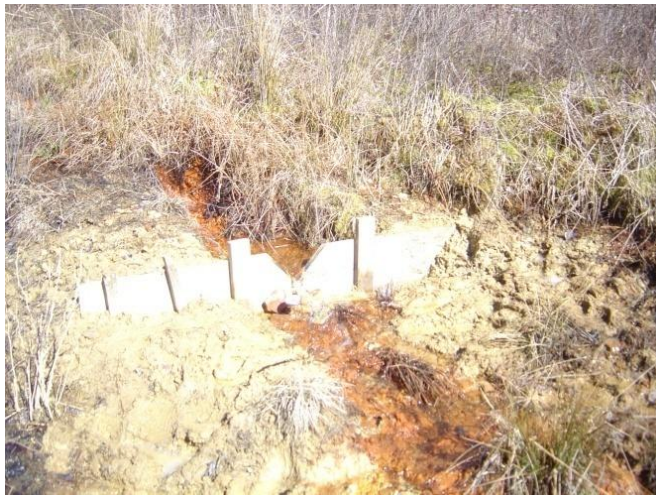
Figure 11 – Untreated Mine Drainage Discharge (MDJ-1)

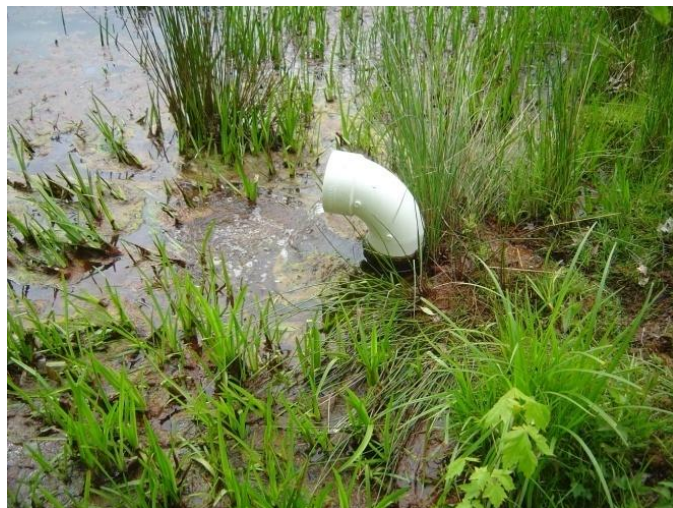
Figure 12 – Pond 2 Outlet (MSP-2)

The outflow pipe for Pond 2 was measured and a 90° “street bend” of appropriate size was purchased to attach to the outlet pipe (Figure 12). Flow was directed into a graduated bucket and the standard bucket and stop watch method used to measure the flow rate from Pond 2 (Trimmer, 1994). This 90° pipe was attached each time a flow measurement was made and then removed.

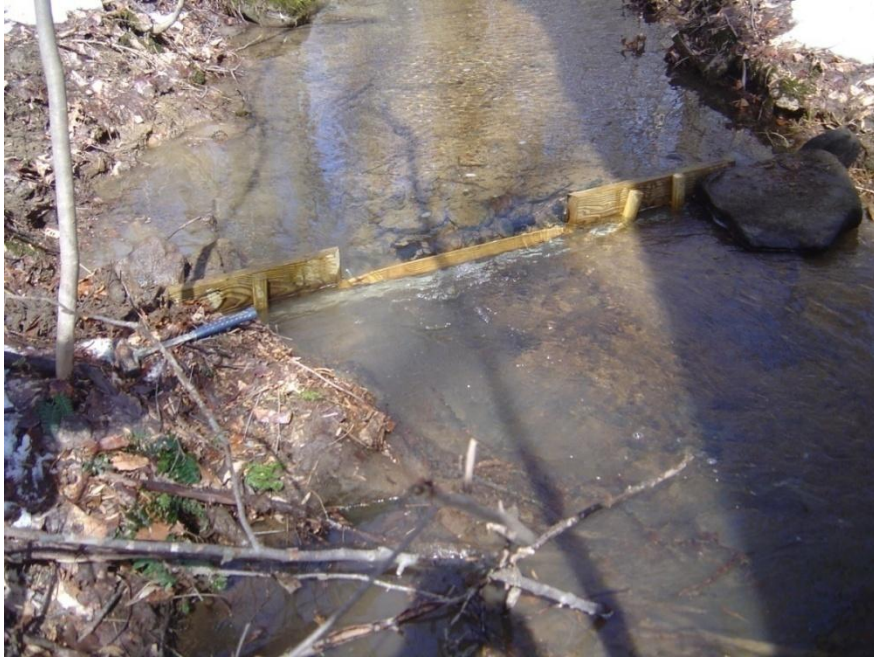
Figure 13 – Davis Hollow Control Stream Upstream (DHM-1)

determine appropriate locations to install three-foot rectangular weirs, one upstream and one downstream (Figure 13 and 14).

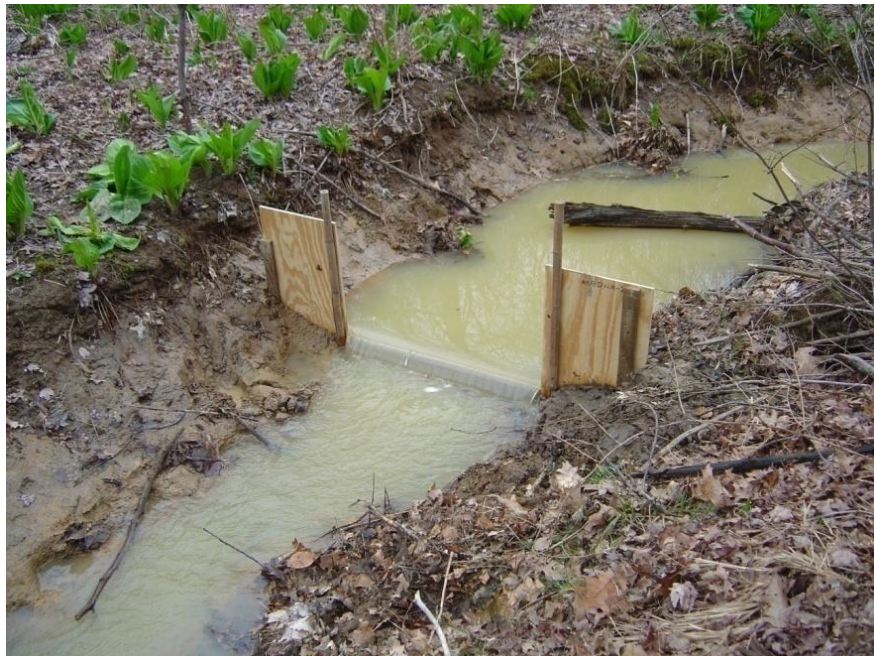
Figure 14 – Davis Hollow Control Stream Downstream (DHM-2)

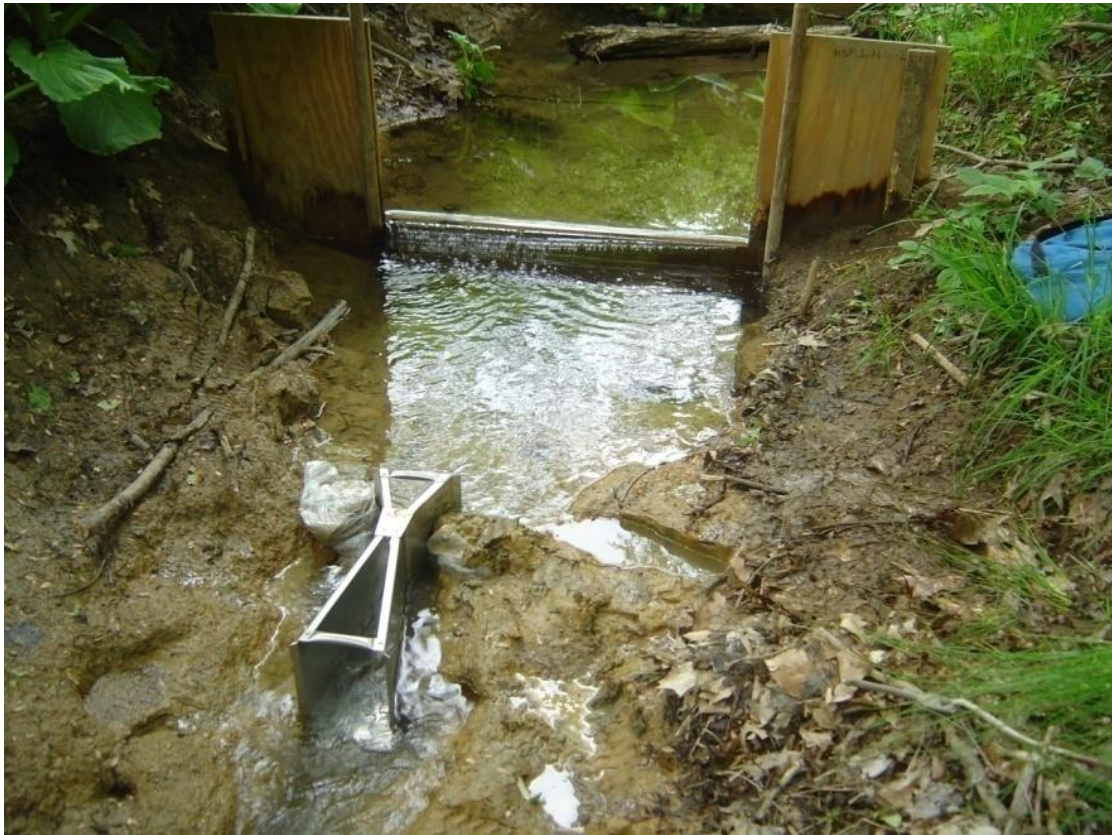
Figure 15 – Baski® Flume Measurement near DHM-2

It was believed that if the flow rates diminished significantly at the control stream monitoring locations, and measurements could not be made at the 3 foot wide weirs, then either the 8 inch or the 1 inch portable Baski® flume (Figure 12) could be used to collect flow measurements.

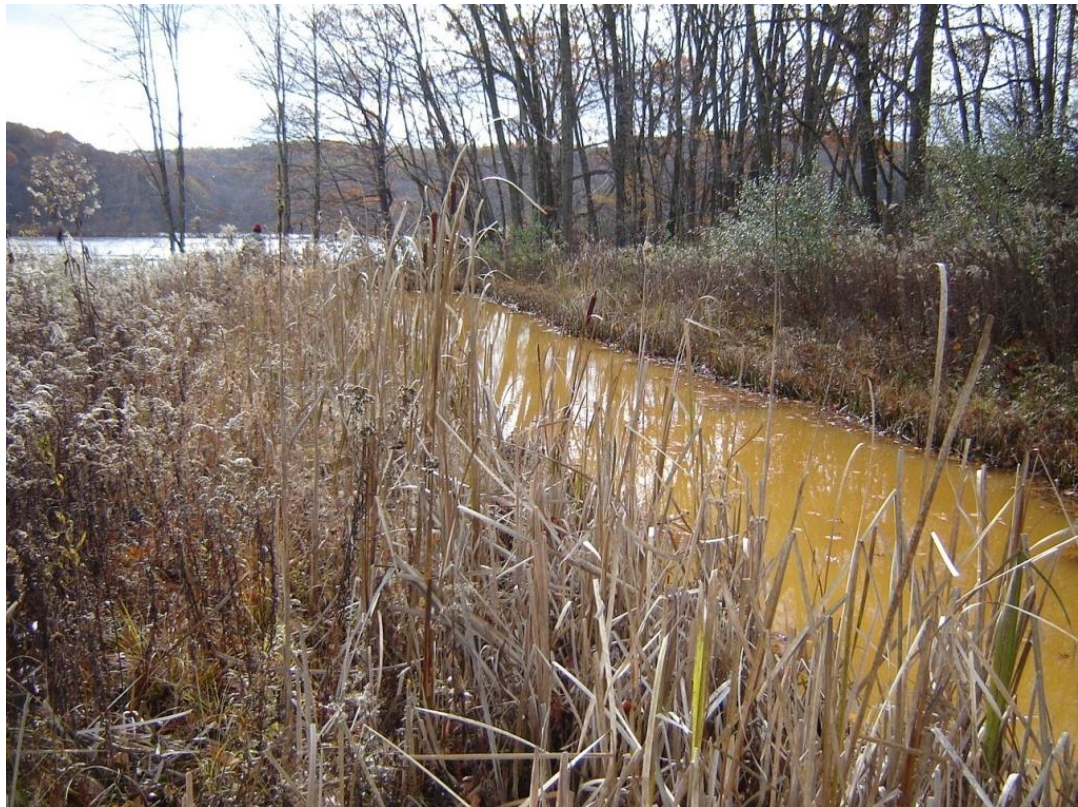
Figure 19 – Pond 1

Pond 1 measures approximately 185 feet by 14 feet (Figure 19) and is the primary settling pond in the system. Pond 2 measures approximately 100 feet by 45 feet and a monoculture of cattails (*Typha latifolia*) has become well established in this shallow pond (Figure 20). A photo of the original pond construction, located at an information display adjacent to the wetlands, indicates the placement of compost and straw bales in Pond 2 to increase the flow distance and therefore the detention time of water. Pond 3 measures approximately 100 feet by 40 feet and has emergent vegetation during the summer months (Figure 21). The adjacent untreated AMD discharge (MDJ-1) is located proximal to Burton Road (Figure 16) where it emerges from a sphagnum moss covered area, approximately 174 feet from where the flow enters Lake Arthur. This discharge location is located proximal to where the Kildoo Mine is shown on Figure 6. The control stream (Davis Hollow) is located proximal to the

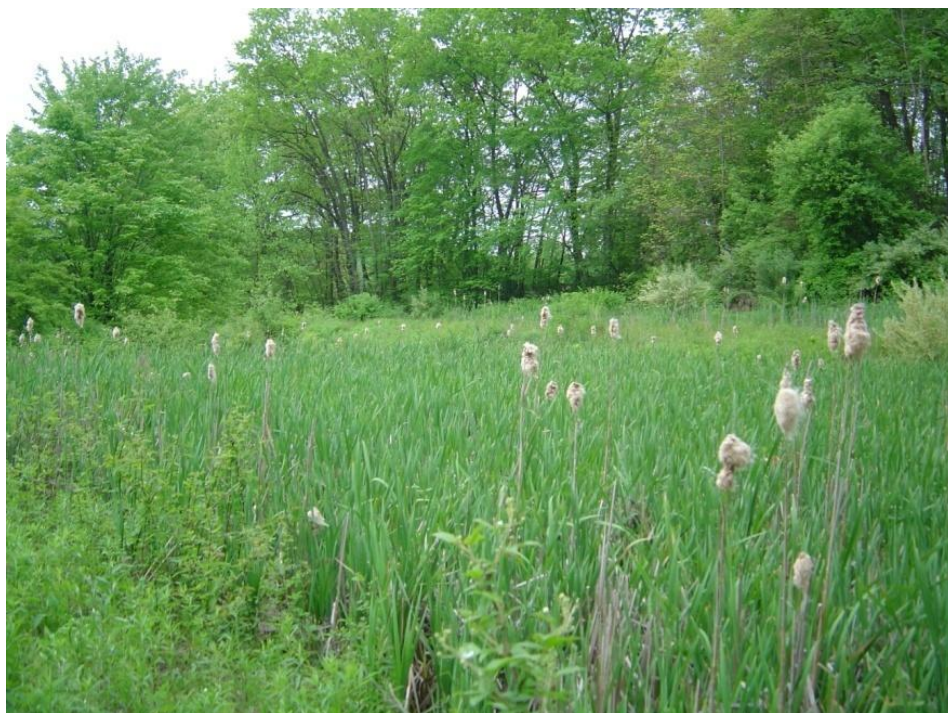
Figure 20 – Pond 2 Cattails

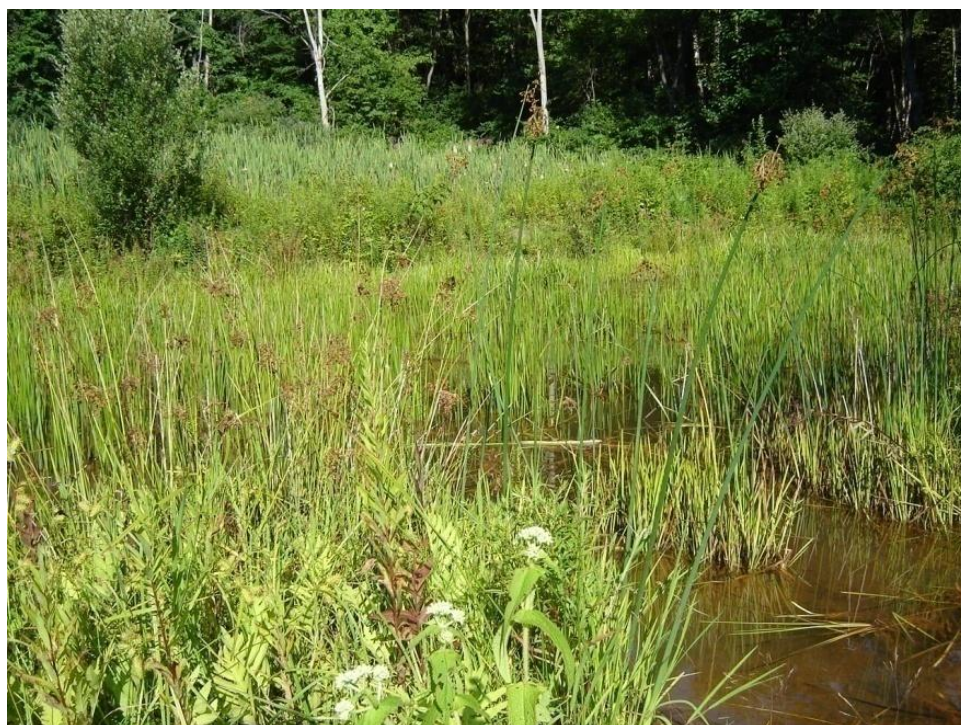
Figure 21 – Pond 3 with Emergent Vegetation

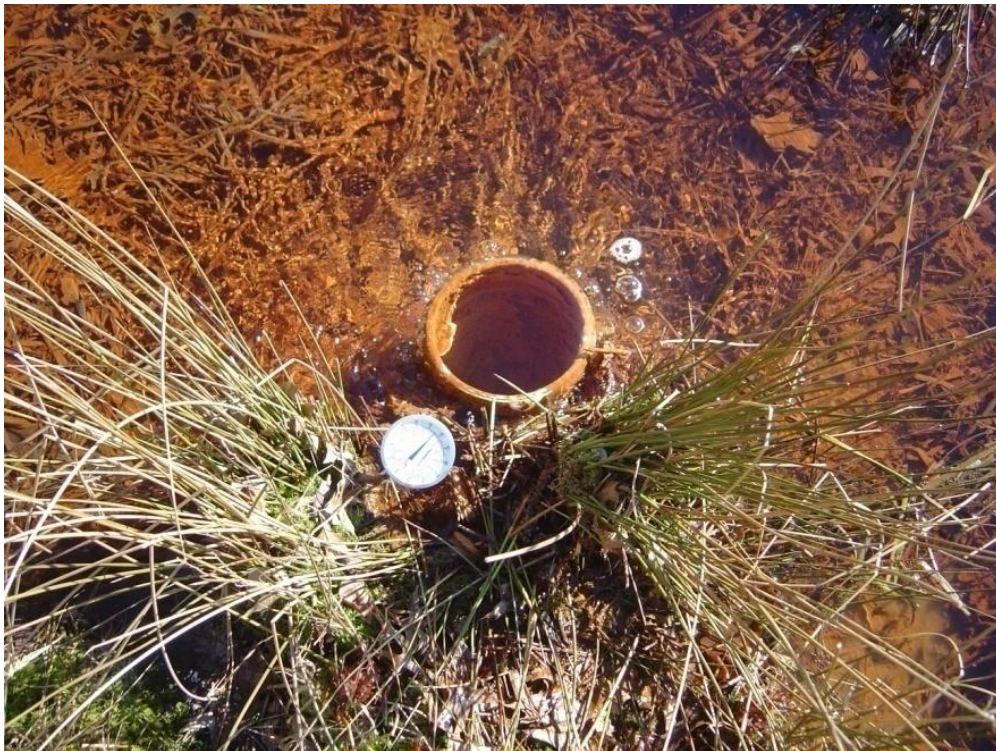
Figure 22 – Thermometer at MSP-2 for scale (note iron oxide staining)

Temperature was measured with a FISHERbrand® thermometer (Figure 19) and readings were made to the closest degree. Readings of pH were measured using a pHTestr 1, hand held pH meter, manufactured by Oakton® Instruments. This device was calibrated according to the manufacturers' recommendation. Flow depths were measured with a Lufkin Rugged Red End (No. 1066), six-foot collapsible rule. Tables of field data are included in Appendix 2 (Tables 3 through 8).

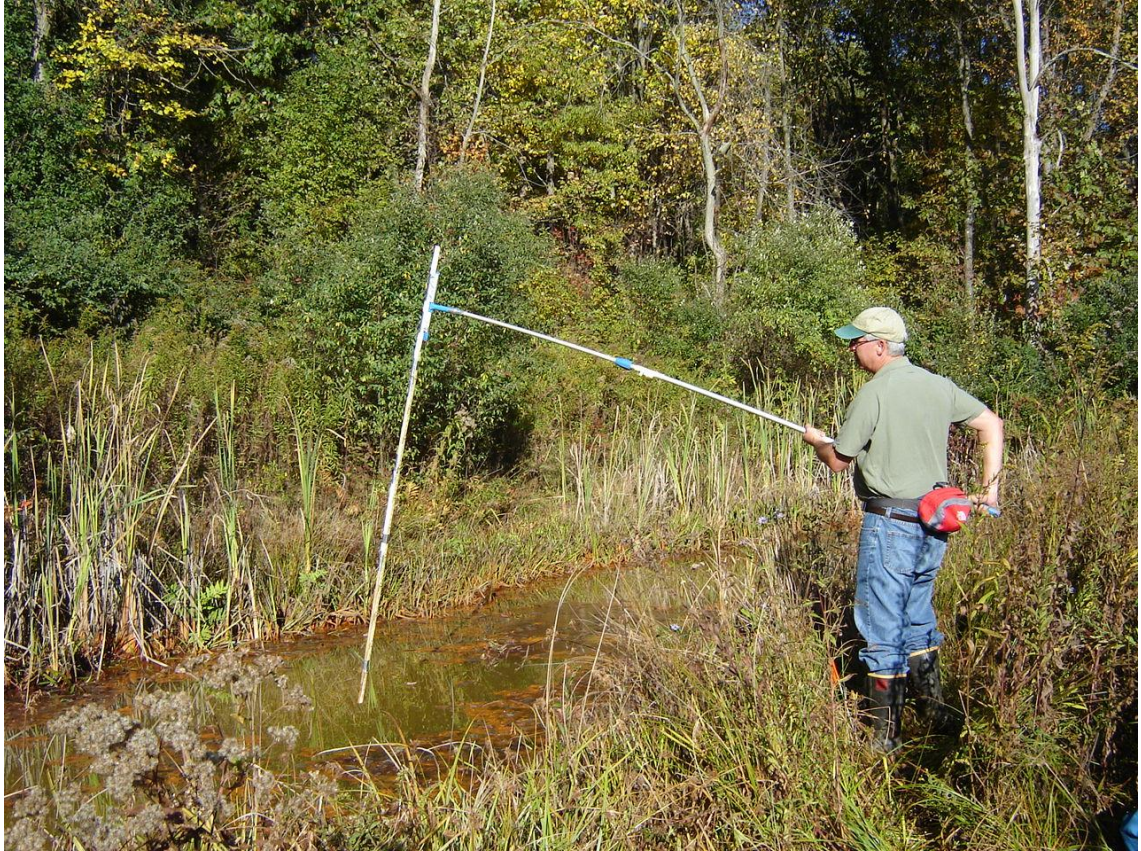
Figure 23 – Precipitate Thickness Measurement Device

Precipitate thickness was measured in Pond 1 to assist with the assessment of life expectancy or volume remaining for precipitate retention. This assessment is needed for recommendation of when and if the pond needs to be cleaned out and refurbished. A total of seven (7) iron hydroxide precipitate thickness measurements were made on October 4, 2008. Precipitate depth in Pond 1 was measured by extending a six foot graduated ruler attached to a $\frac{3}{4}$ inch wooden dowel rod, taped perpendicular to the end of an extendable aluminum pole (Figure 23).

The depth of the water was measured when the dowel rod first encountered the top of the precipitate. The wooden dowel rod/ruler assembly was then pressed into the precipitate to resistance with hand pressure and the measurement was recorded. Next, the aluminum extension pole was struck with a standard round-pointed shovel five times to drive the dowel to refusal at the bottom of the pond, and then a measurement was recorded. This procedure was repeated at seven locations along the length of Pond 1 (Figure 18). The thickness of precipitate was calculated and a cross section of the pond was constructed (Figure 21). A table of precipitate thickness measurements is included in Appendix 2 (Table 10). Since the original design depth of the pond is unknown, the depth of the pond was estimated as five feet deep. Therefore, only an approximation of the amount

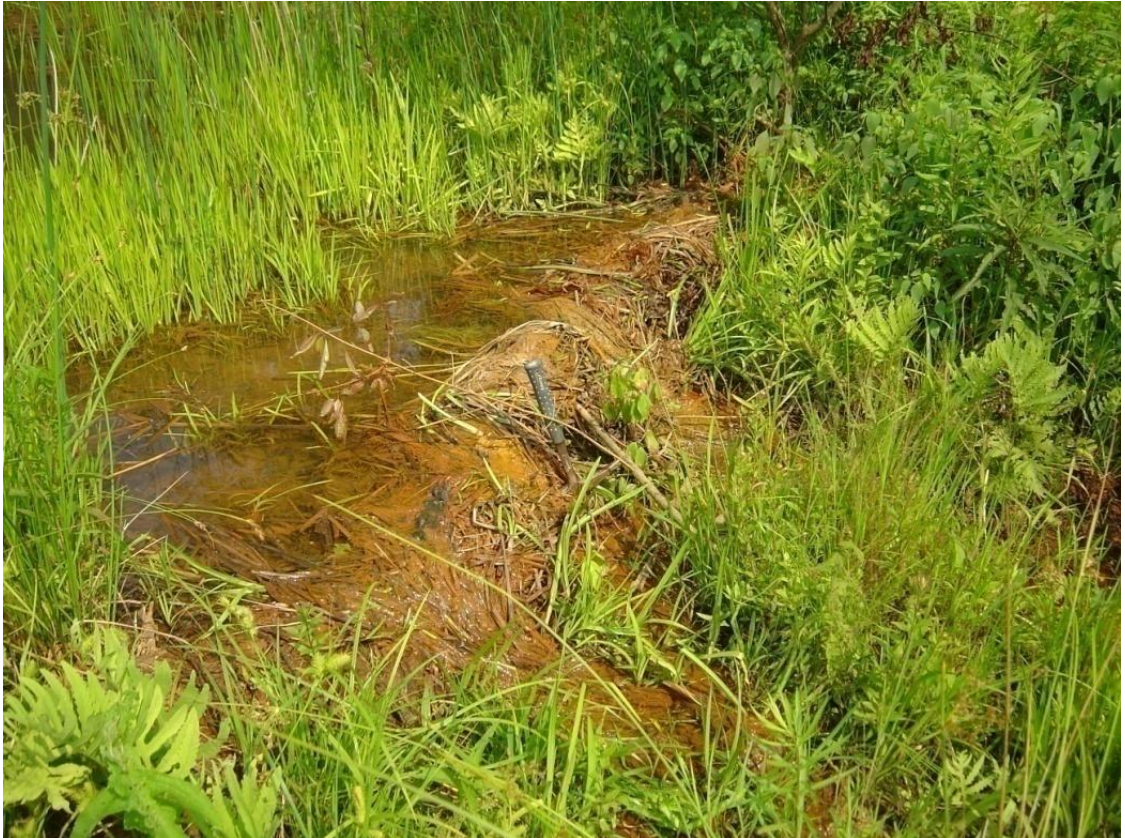
Figure 46 – Muskrat blockage of Pond 3 outlet (MSP-3 weir covered; rock hammer for scale)

Hedin et al (1994) and Watzlaf et al (2004) describe the most common maintenance concerns for passive wetlands treatment ponds is embankment and outlet stability. In addition, they describe pests (muskrats, beavers, and other burrowing creatures) causing instability of embankments, blocking outlet structures and uprooting emergent vegetation causing water level fluctuations. Muskrat(s) have been active in Pond 3 and at monitoring point MSP-3 during the time of this investigation (Figure 46). Vegetative material was piled against the flow monitoring weir, blocking the flow, and raising the pond water level. This

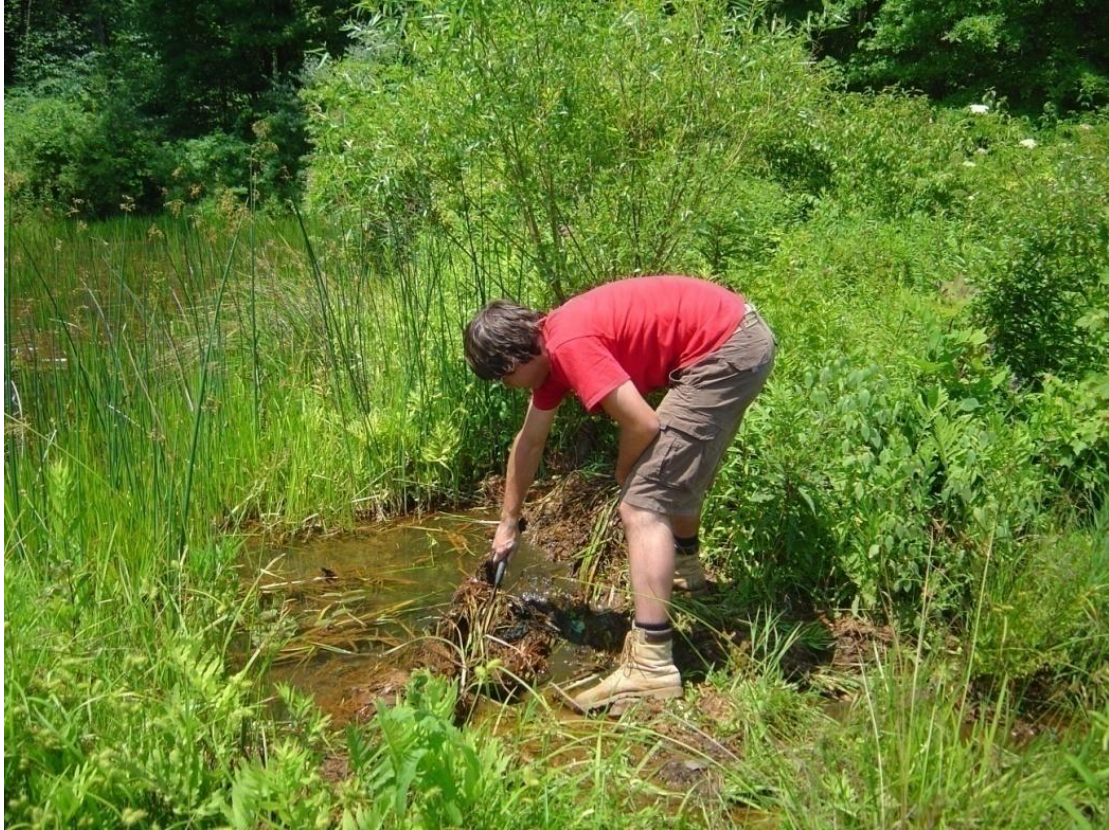
Figure 47 – (Field assistant, Paul Winter, shown removing blockage from outflow pond.)

vegetation was removed several times (Figure 47). This affected the Pond 3 water level and therefore the flow rate measurements for MSP-3. Elevated flow readings were measured but were not included on the graphs of flow data.

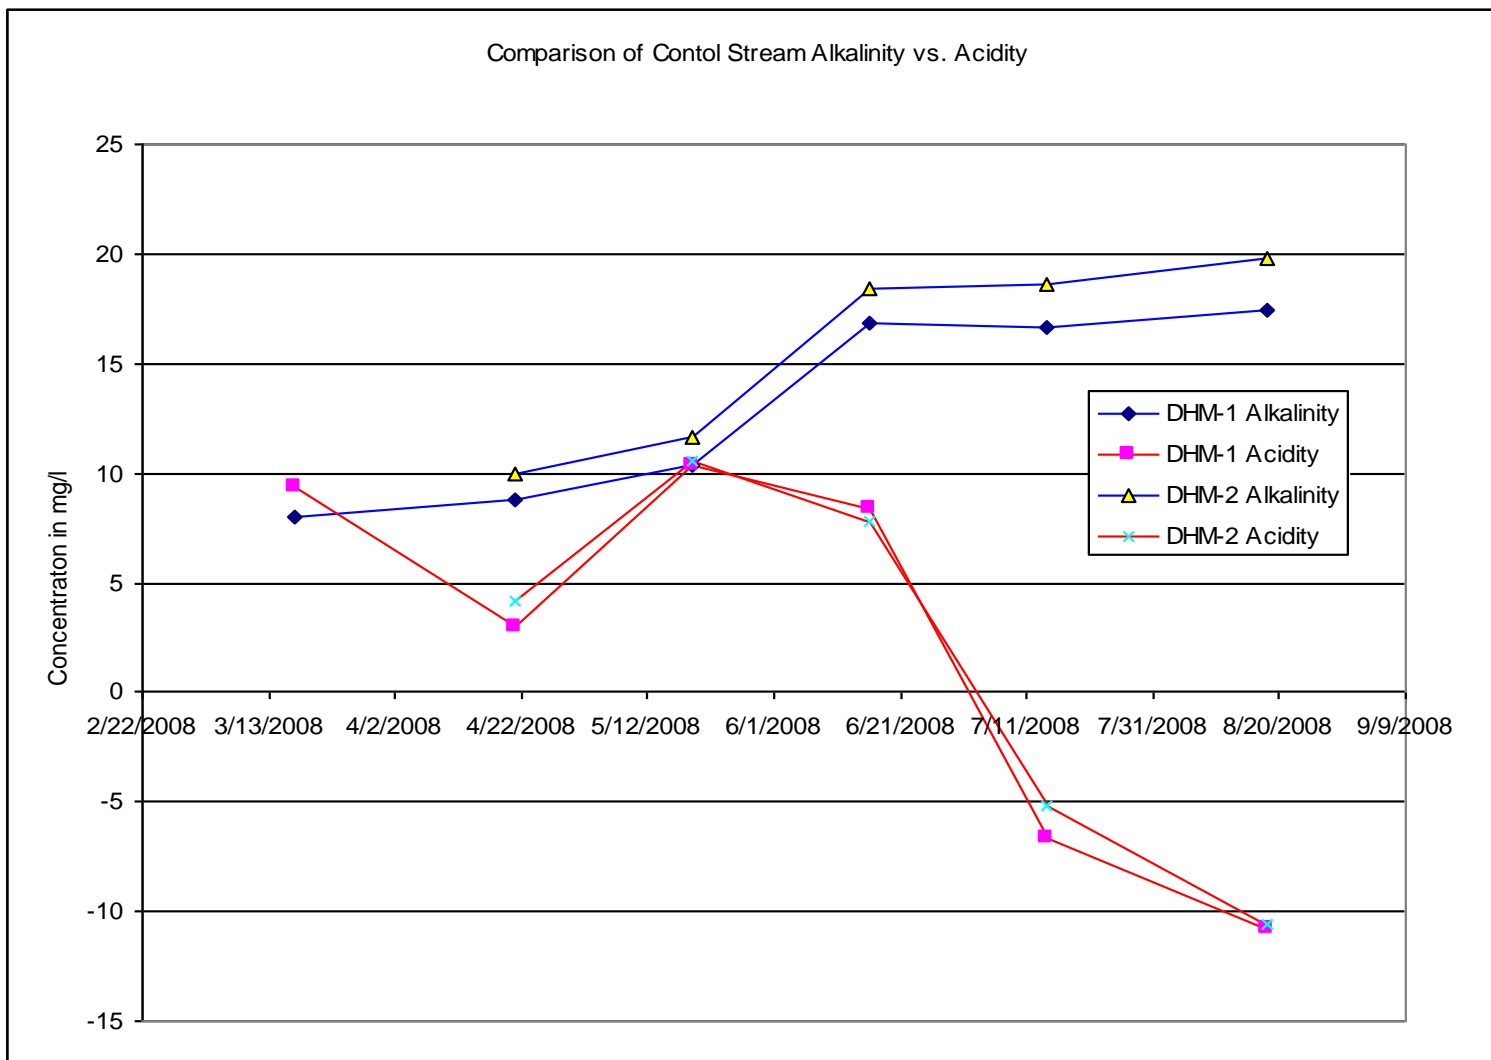
Figure 34 – Graph of Control Stream Alkalinity vs. Acidity
