# **Reeds Run AMD Remediation Construction Project Summary 2011**

# **Reeds Run AMD Remediation Construction**

## **Project Summary – 2011**

**REEDS RUN AMD REMEDIATION CONSTRUCTION**  
Aultmans Run Watershed, Armstrong Township, Indiana County, PA

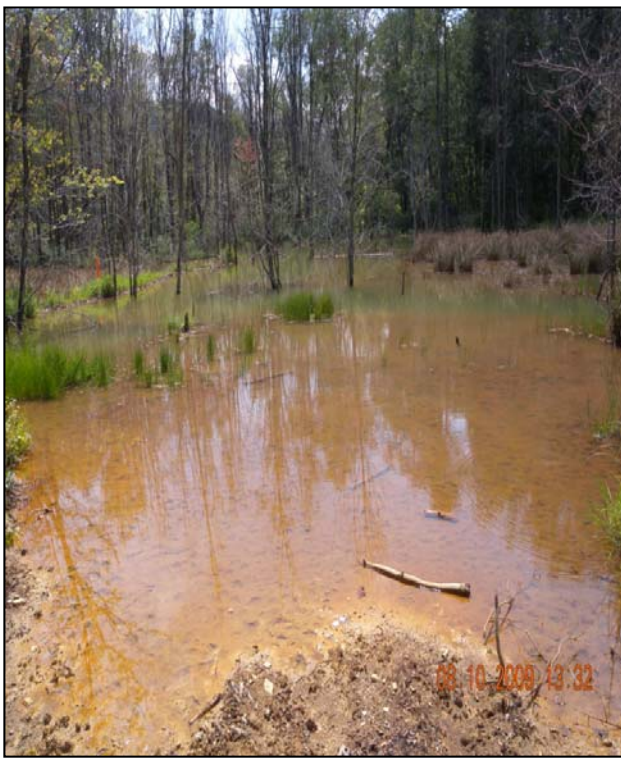
Beaver dam caused flooding in portion of project area; iron-laden sediment & lack of vegetation

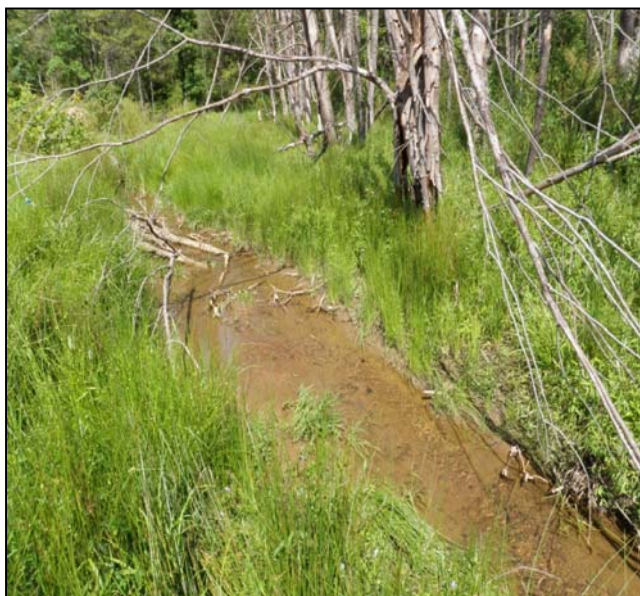
8/12/11 no iron precipitates in stream channel; water quality good (See analyses for 8/2/11.)

Even though future monitoring is required to determine improvements in the quality of Reeds Run long-term, comparing selected sample dates pre-construction with the sampling conducted post-construction dramatically illustrates the immediate improvement in Reeds Run below the AMD seep zone. Compare the acidity readings pre-construction with the negative acidity readings post-construction. In other words, Reeds Run is no longer net acidic but net alkaline. Also note the decrease in total iron content by about 80 to 90%.

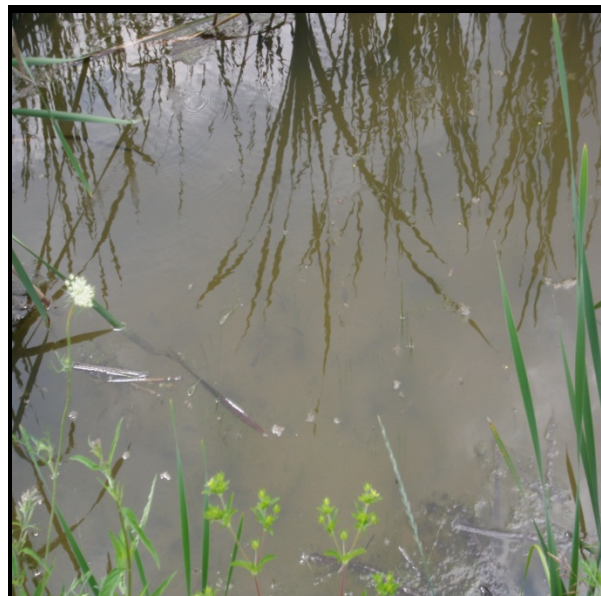
Hard to see, but there are fish in the stream!!!  
7/12/11

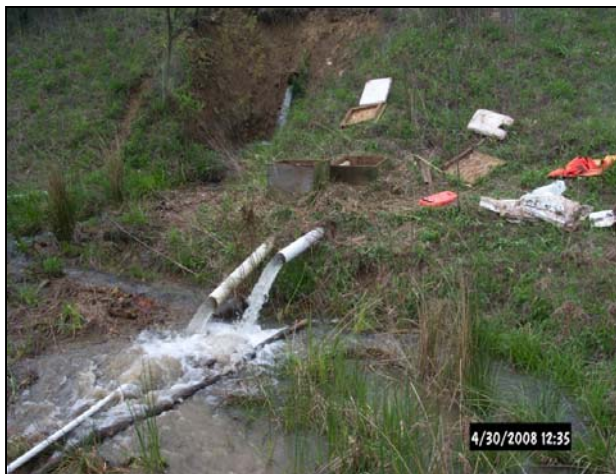
Cleaning pipes to drain existing Sediment Pond "A"

The site preparation effort included cleaning the outlet pipes to existing Sediment Pond “A” to allow draining. In addition, to aid in determining if shallow subsurface flow through the coal refuse was the main contributor of iron, manganese, and acidity to the AMD seep zone within Reeds Run and to aid in determining the coal refuse characteristics, two piezometers were installed on 12/16/09. As part of the partnership effort, John Foreman, PG, representing Central Blair Electric Company, developed the drilling program. The drilling was completed at no additional cost.

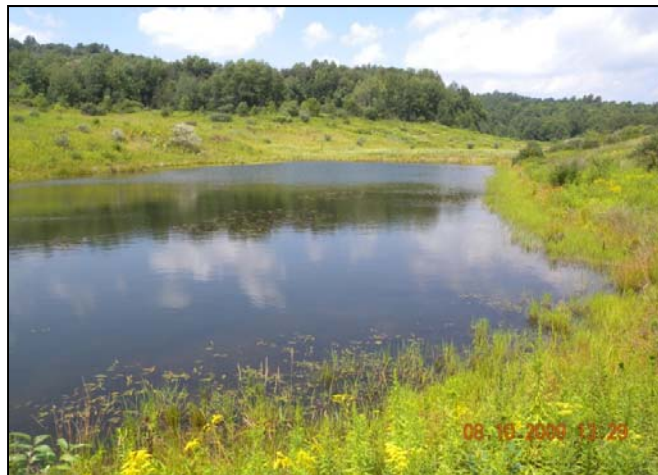
Existing Sediment Pond "A"

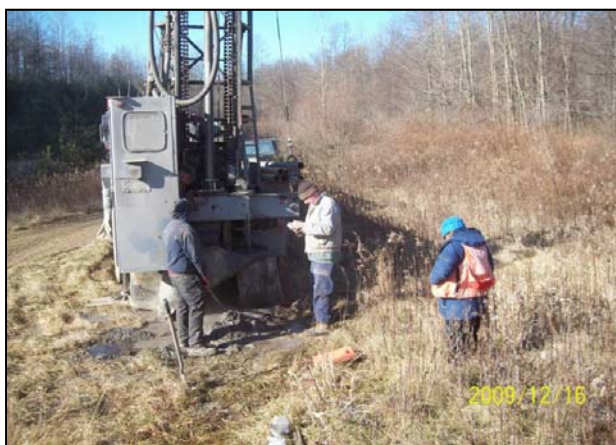
Piezometers installed 12/16/09 - Forsyth Drilling (DuBois, PA); John Foreman, PG; Margaret Dunn, PG

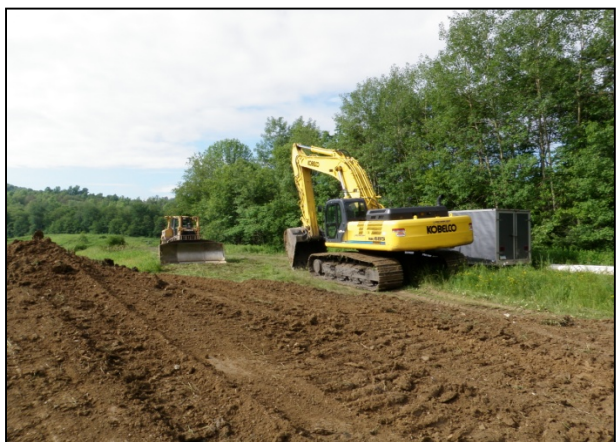
6/14/10 stripping and stockpiling soil for later use as (1) substrate (soil mixed with compost) for the created wetland, (2) a pad for the placement of NFG refuse mixed with Mineral CSA, and (3) soil cover for land reclamation

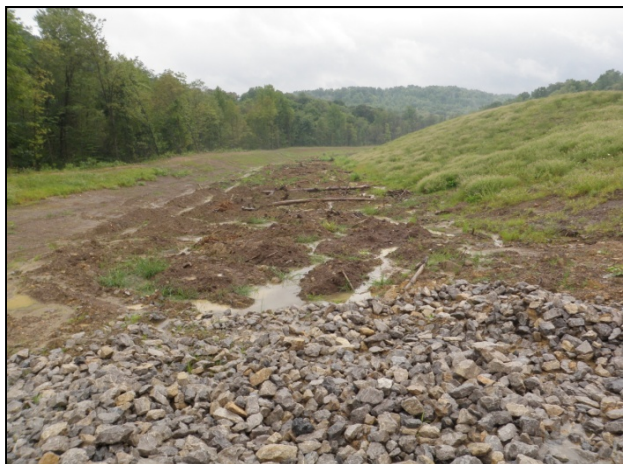
8/25/11 created wetland (center) looking downstream from inlet; vegetated Primary NFG Refuse pile (right)

After refuse removal, construction of the wetlands and open water habitat was completed by Quality Aggregates (Pittsburgh, PA) and Saddle Creek Farms Bedding (Canfield, OH) in June 2011. A 0.75-acre wetland was created along with a 0.60-acre open water habitat, which are bordered by the Primary Non-Fuel Grade Refuse Pile on the west and the stream buffer area on the east. These features were constructed within the vicinity of the original stream channel for Reeds Run which had been buried beneath the coal refuse. Water of good quality which formerly entered the existing Sediment Pond "A" was conveyed by a riprap-lined spillway to the constructed wetland inlet. A By-Pass Ditch with influent pipe (capped when not in use) was installed to divert the good quality water to Reeds Run in order to allow maintenance, if needed, of the created wetland and/or open water habitat. Within the constructed wetland, woody debris was added to provide habitat. The wetlands were created with varying water depths and soil (mixture of compost and onsite soil material) thickness to provide the opportunity for biological diversity. The open water habitat was also constructed to provide a variable depth of water from ~1 to 3<sup>+</sup> feet. A riprap-lined spillway conveys the open water habitat effluent to a channel (effluent end of permanent diversion ditch) which confluent with Reeds Run.

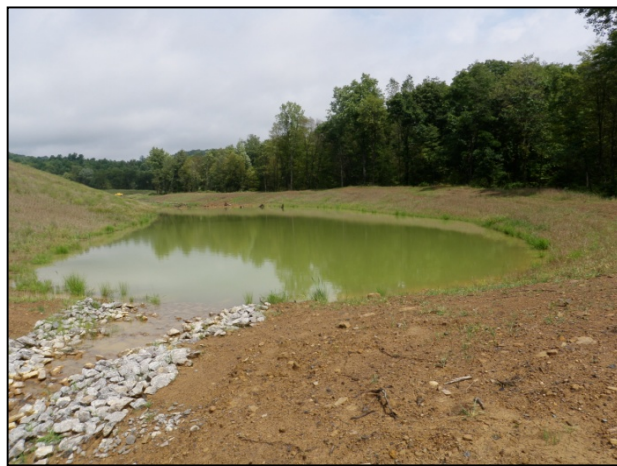
8/25/11 open water habitat looking upstream from outlet; vegetated Primary NFG Refuse pile (left)

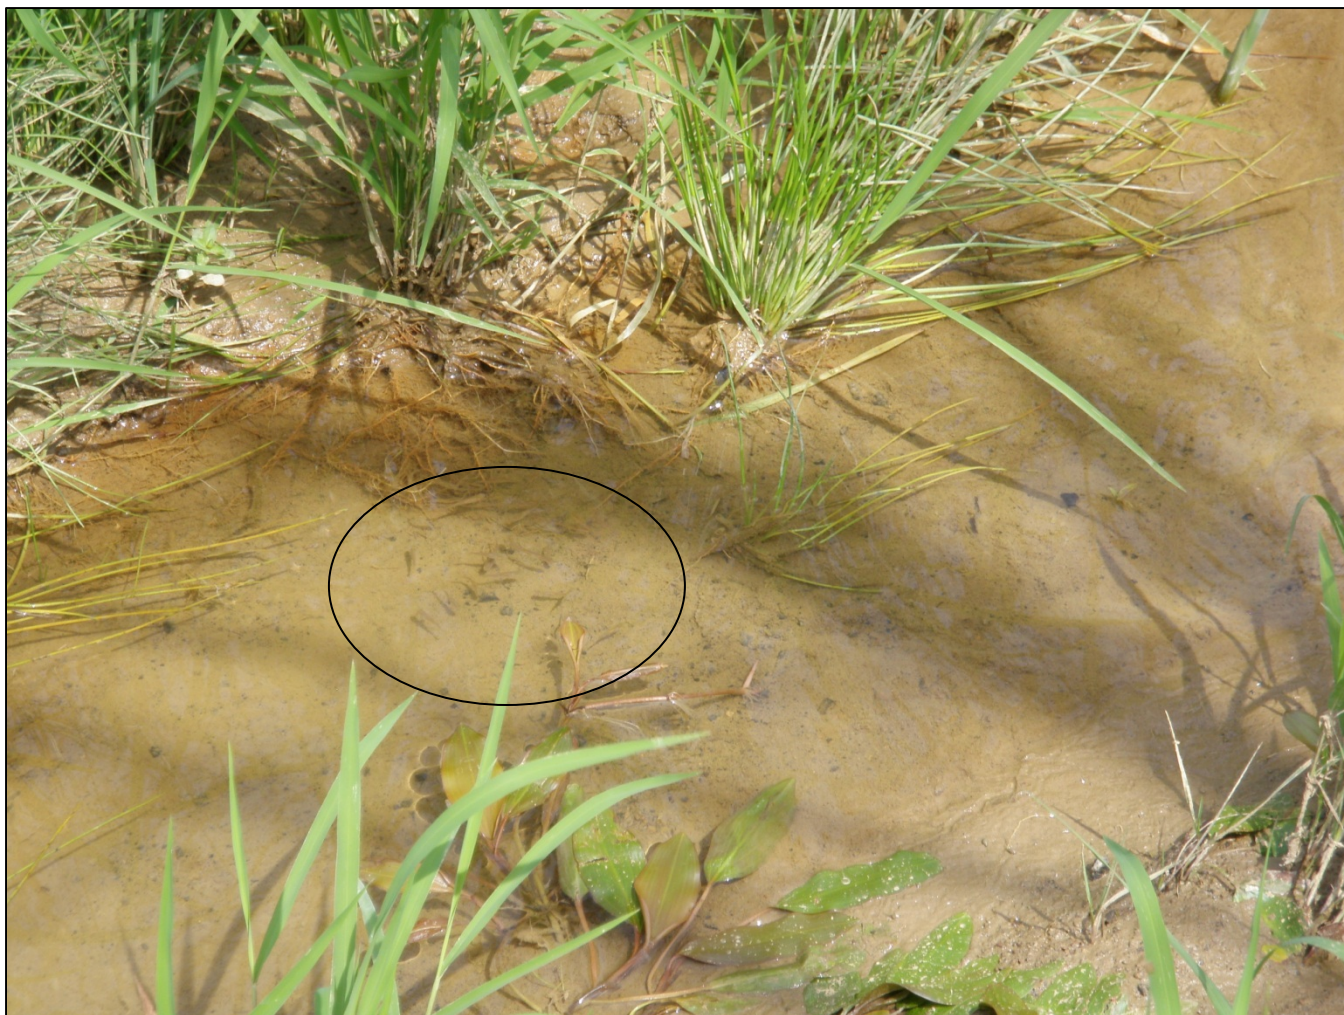
8/2/11 fish observed in Reeds Run at RD0-D1 (circled).
