SR 81 ABANDONED MINE RESTORATION AREA

Final Report
June 2004

Re: Final Report
ME# 350410; Project # NW01771
SR81 Abandoned Mine Restoration
Washington Township, Butler County, PA
540102/FR-trans

SR81 ABANDONED MINE RESTORATION FINAL REPORT

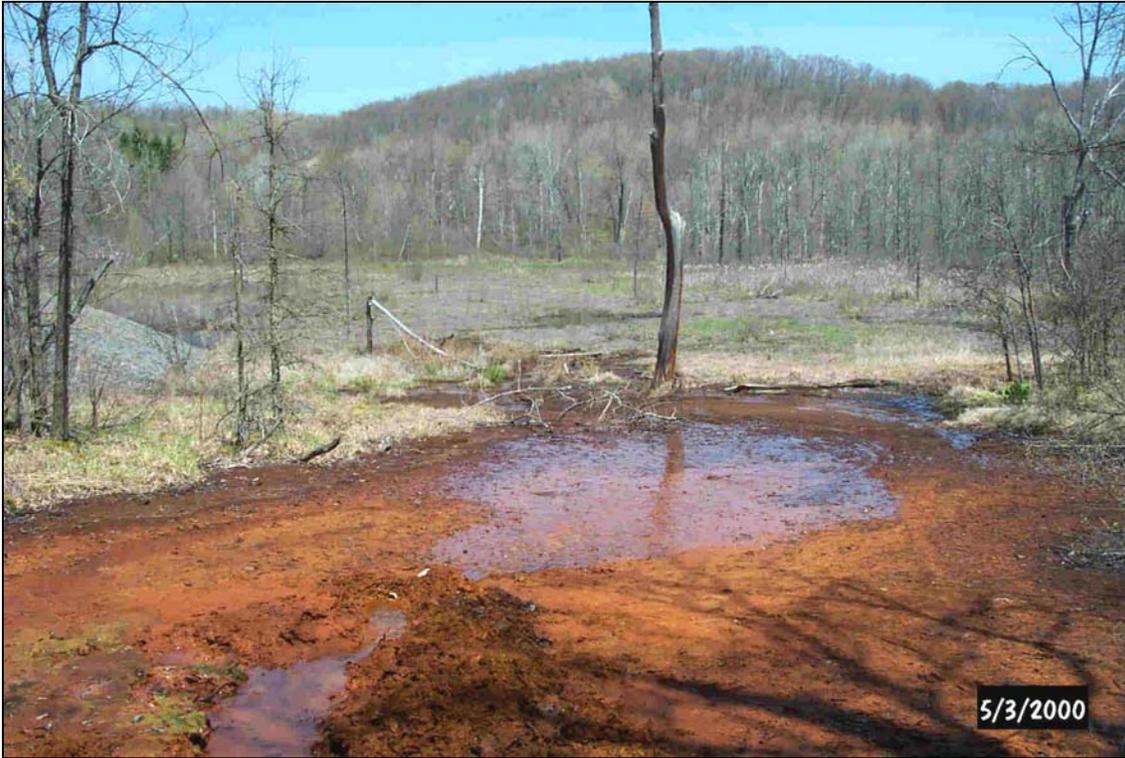
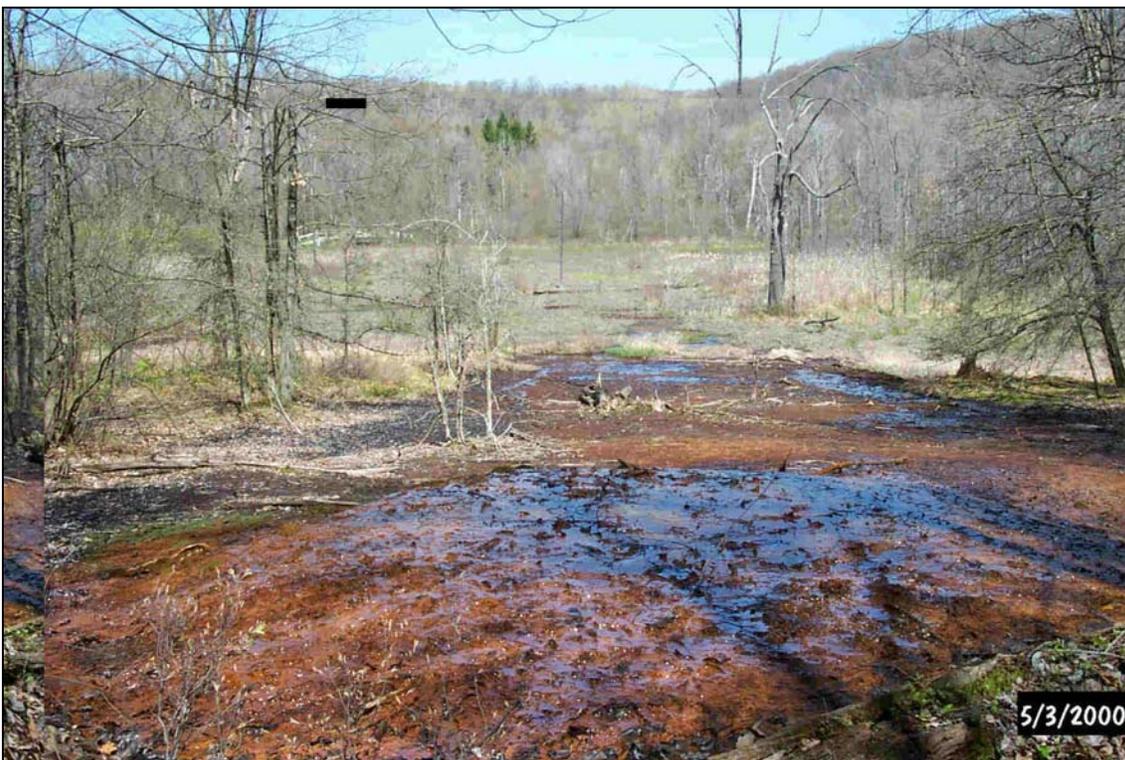
The SR81 **(Above)** and SR81A **(Below)** discharges emanated from a deep mine on the Brookville coalbed (Clarion Formation, Allegheny Group).

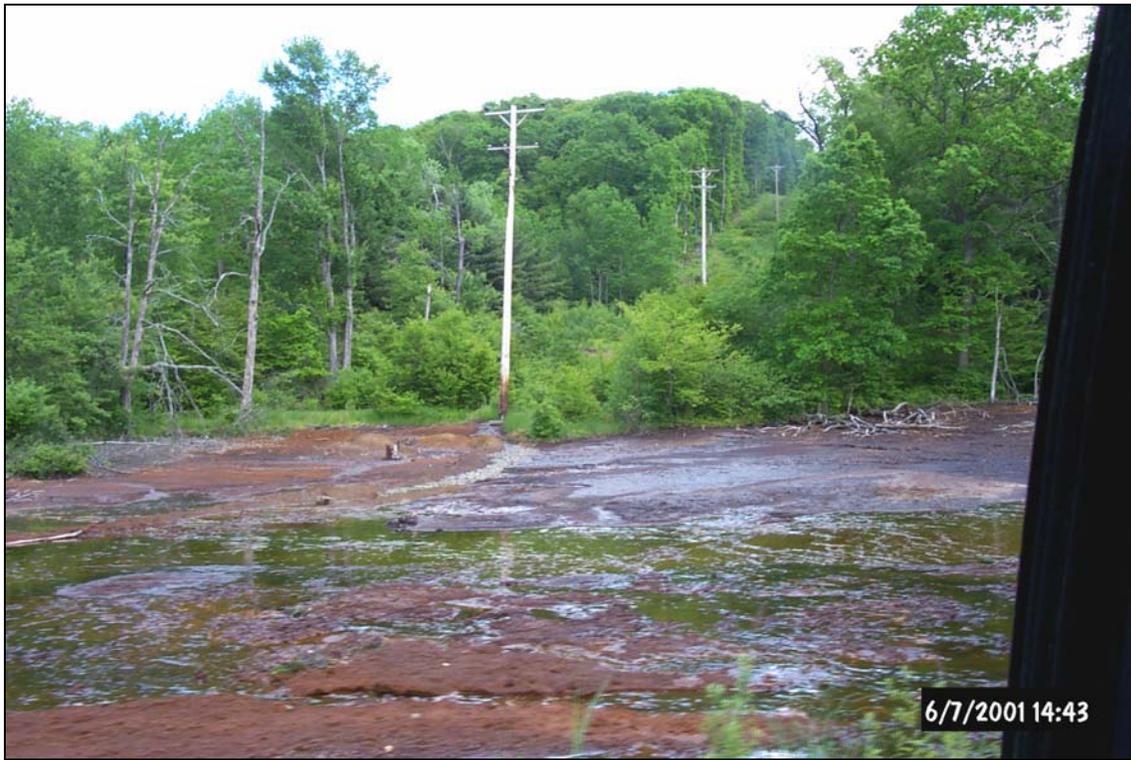
View of a portion of the “kill zone” of the SR81 and SR81A discharges.

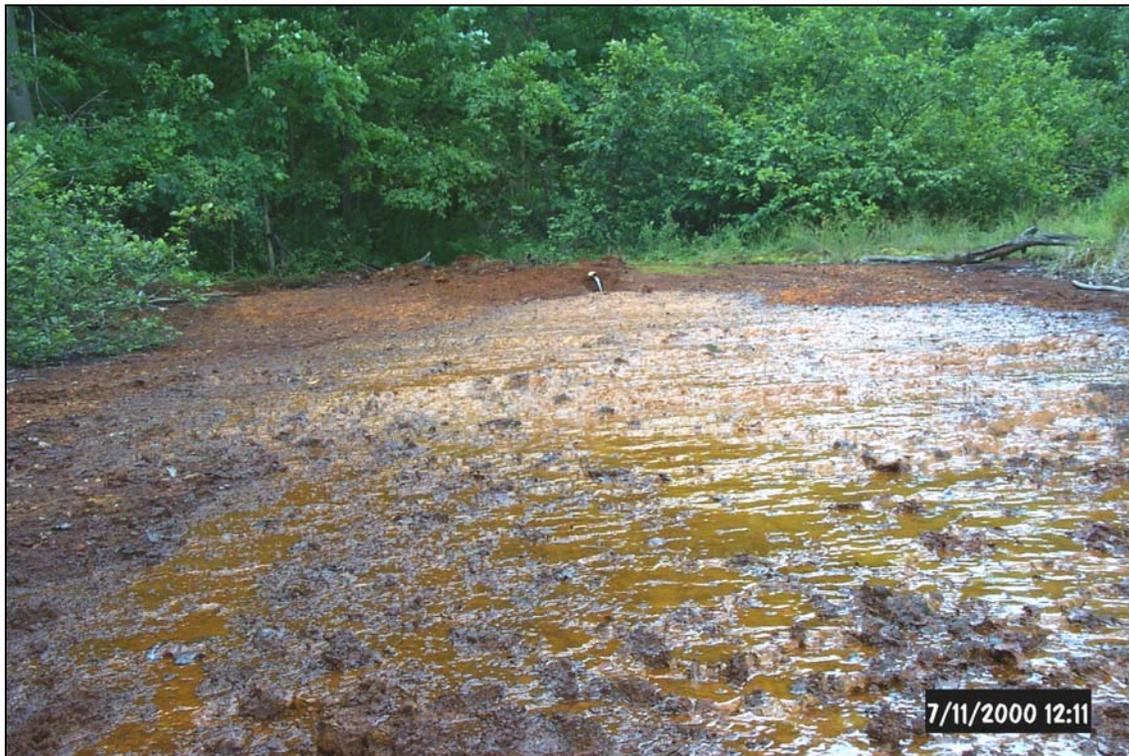
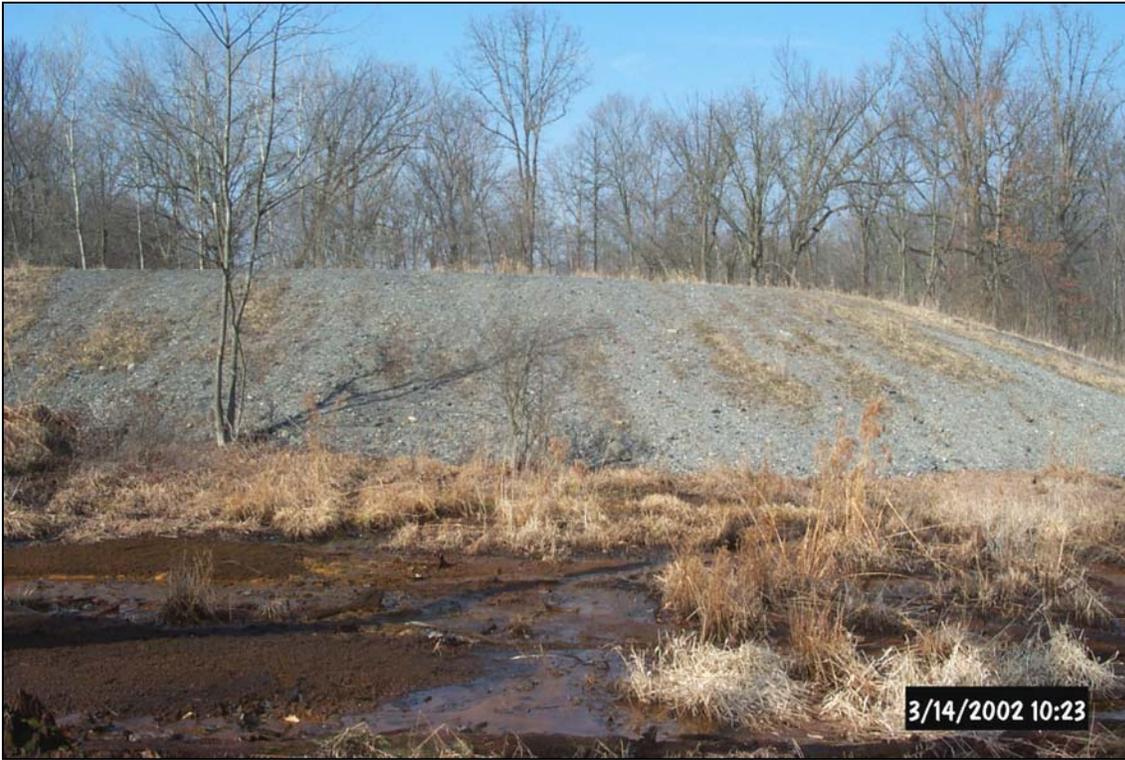
Views of the 4,400 cubic yard gob pile that was located at the site.

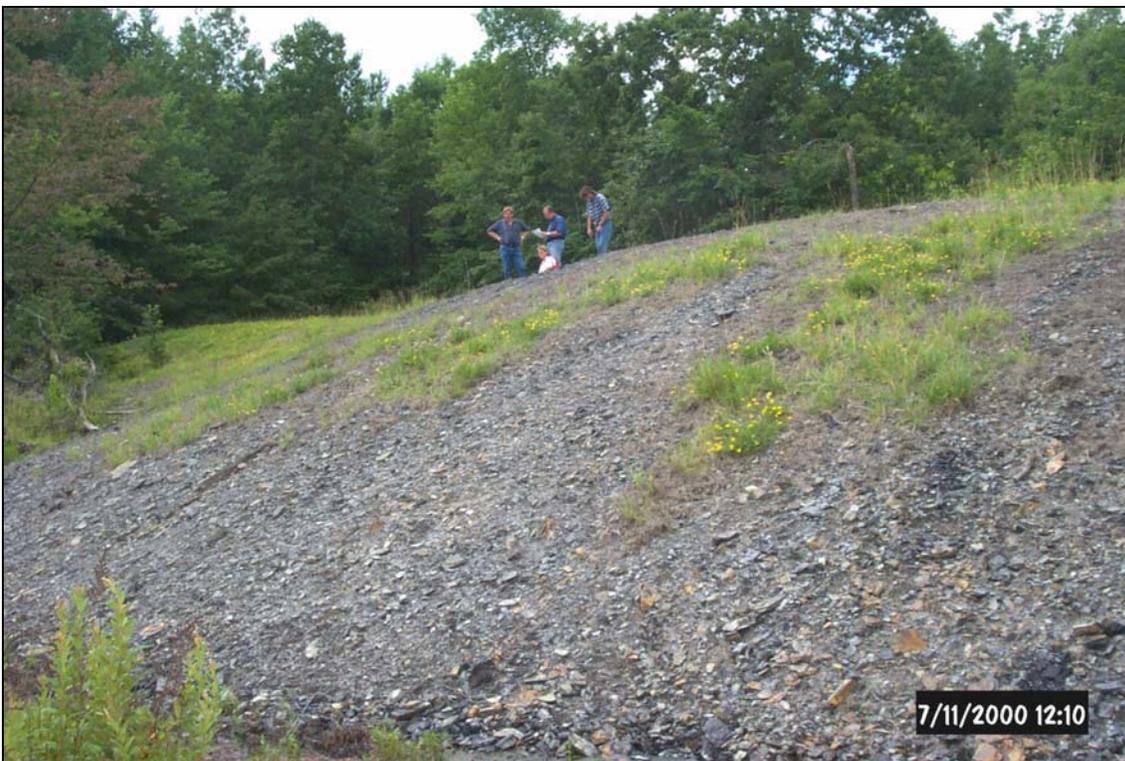
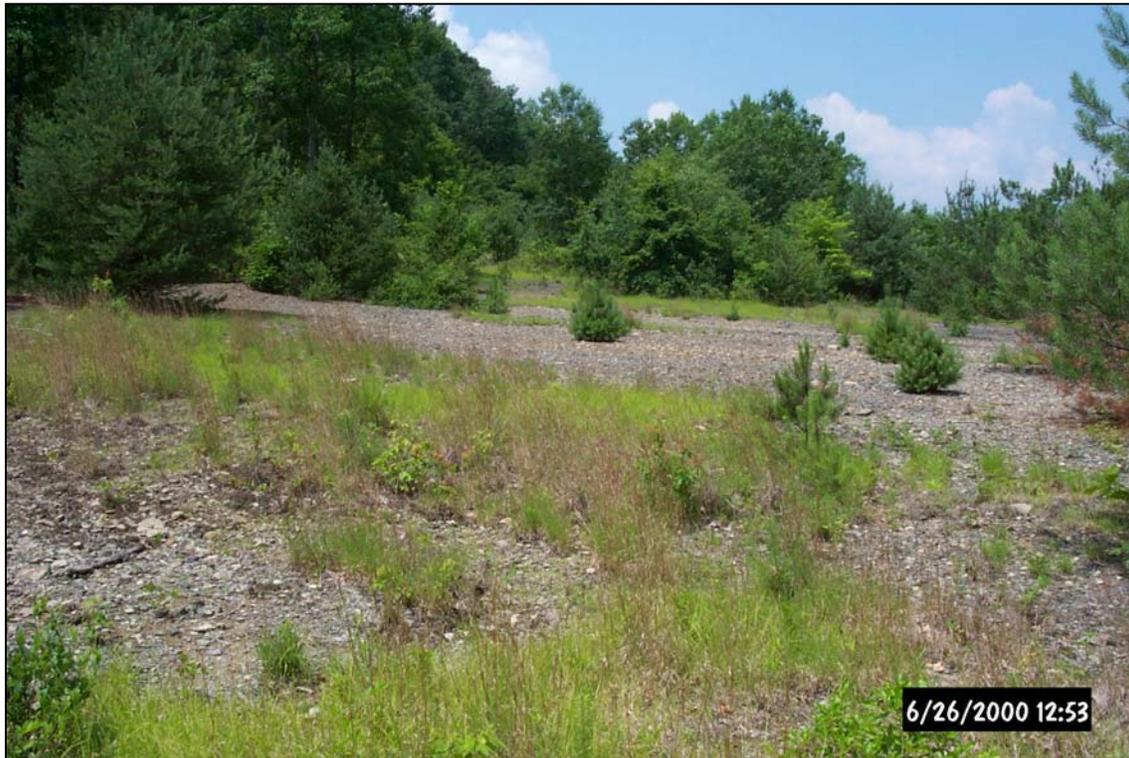
A barren spoil area associated with an abandoned surface mine **(above)** with erosion gullies **(right)** was located near the site. As part of the project, approximately 3,600 cubic yards of gob was mixed with alkaline limestone quarry pond fines. This material was then hauled about 1/2 mile, spread on the barren area, and then seeded and mulched.

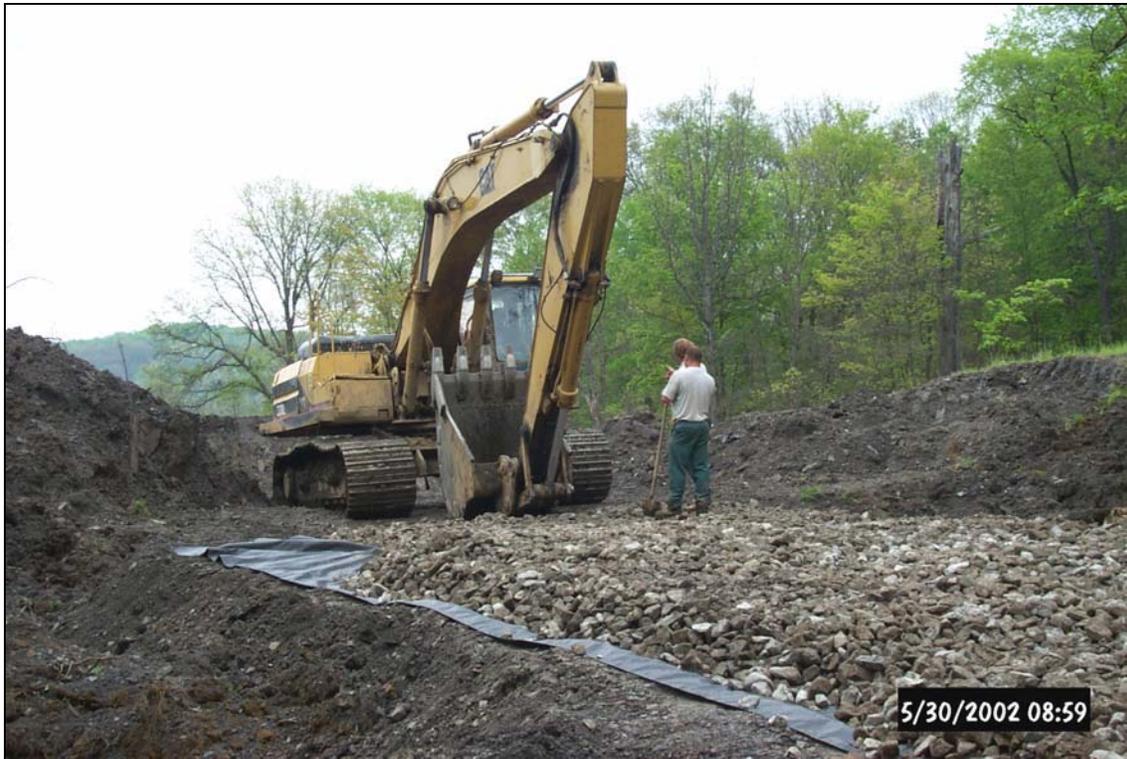
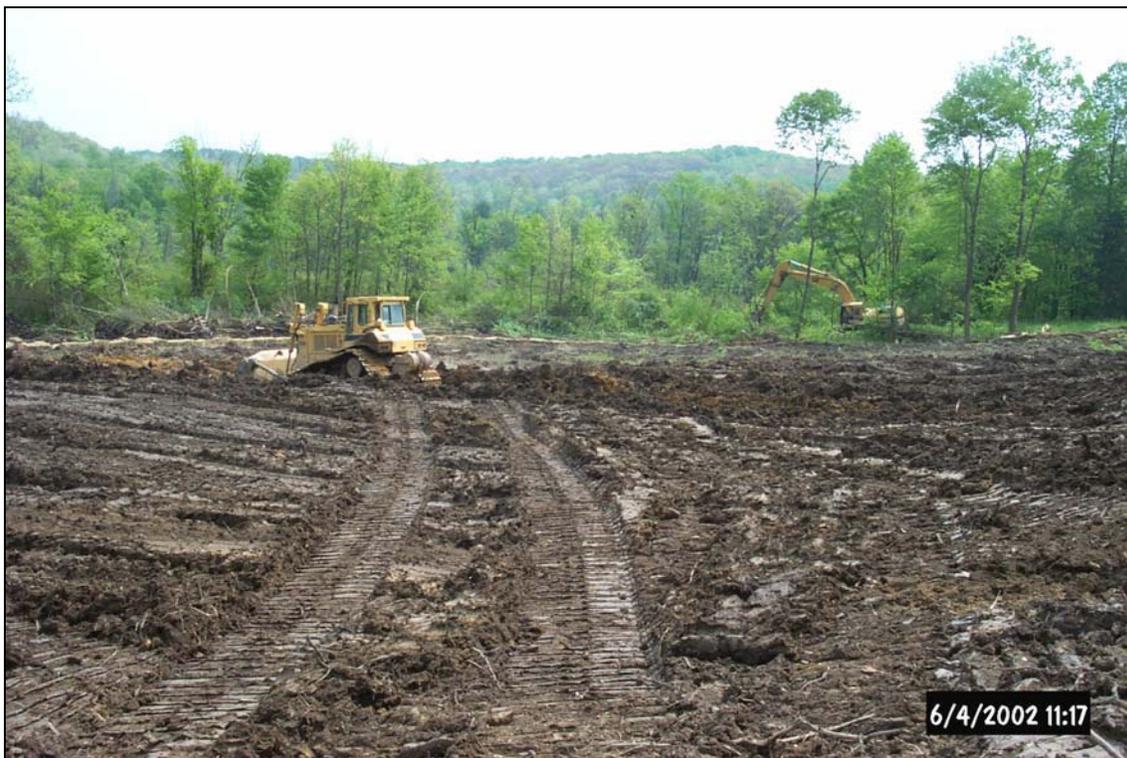
Construction of the SR81 passive treatment system was completed by Amerikohl Mining, Inc. **(Above)** Geotextile and bedding stone are being placed in the Anoxic Limestone Drain (ALD). **(Below)** Construction of the Settling Pond/Wetland Basin is underway.

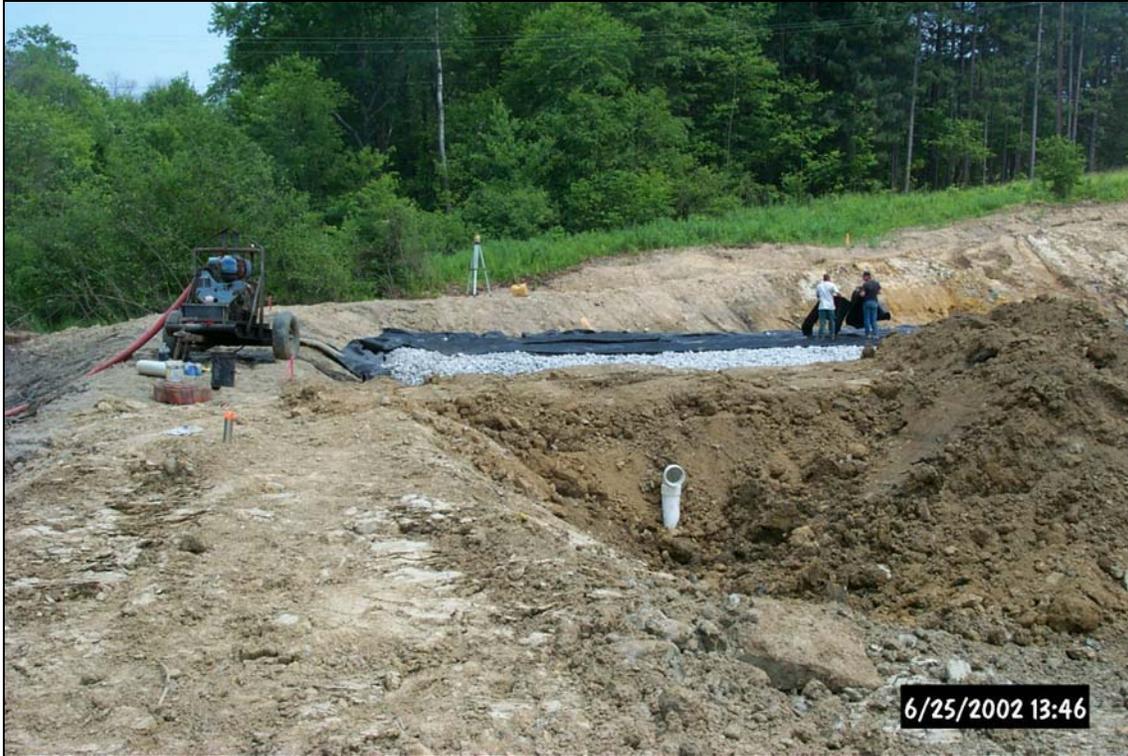
Once the limestone had been placed geotextile was placed on top of the stone and then backfilled with dirt.

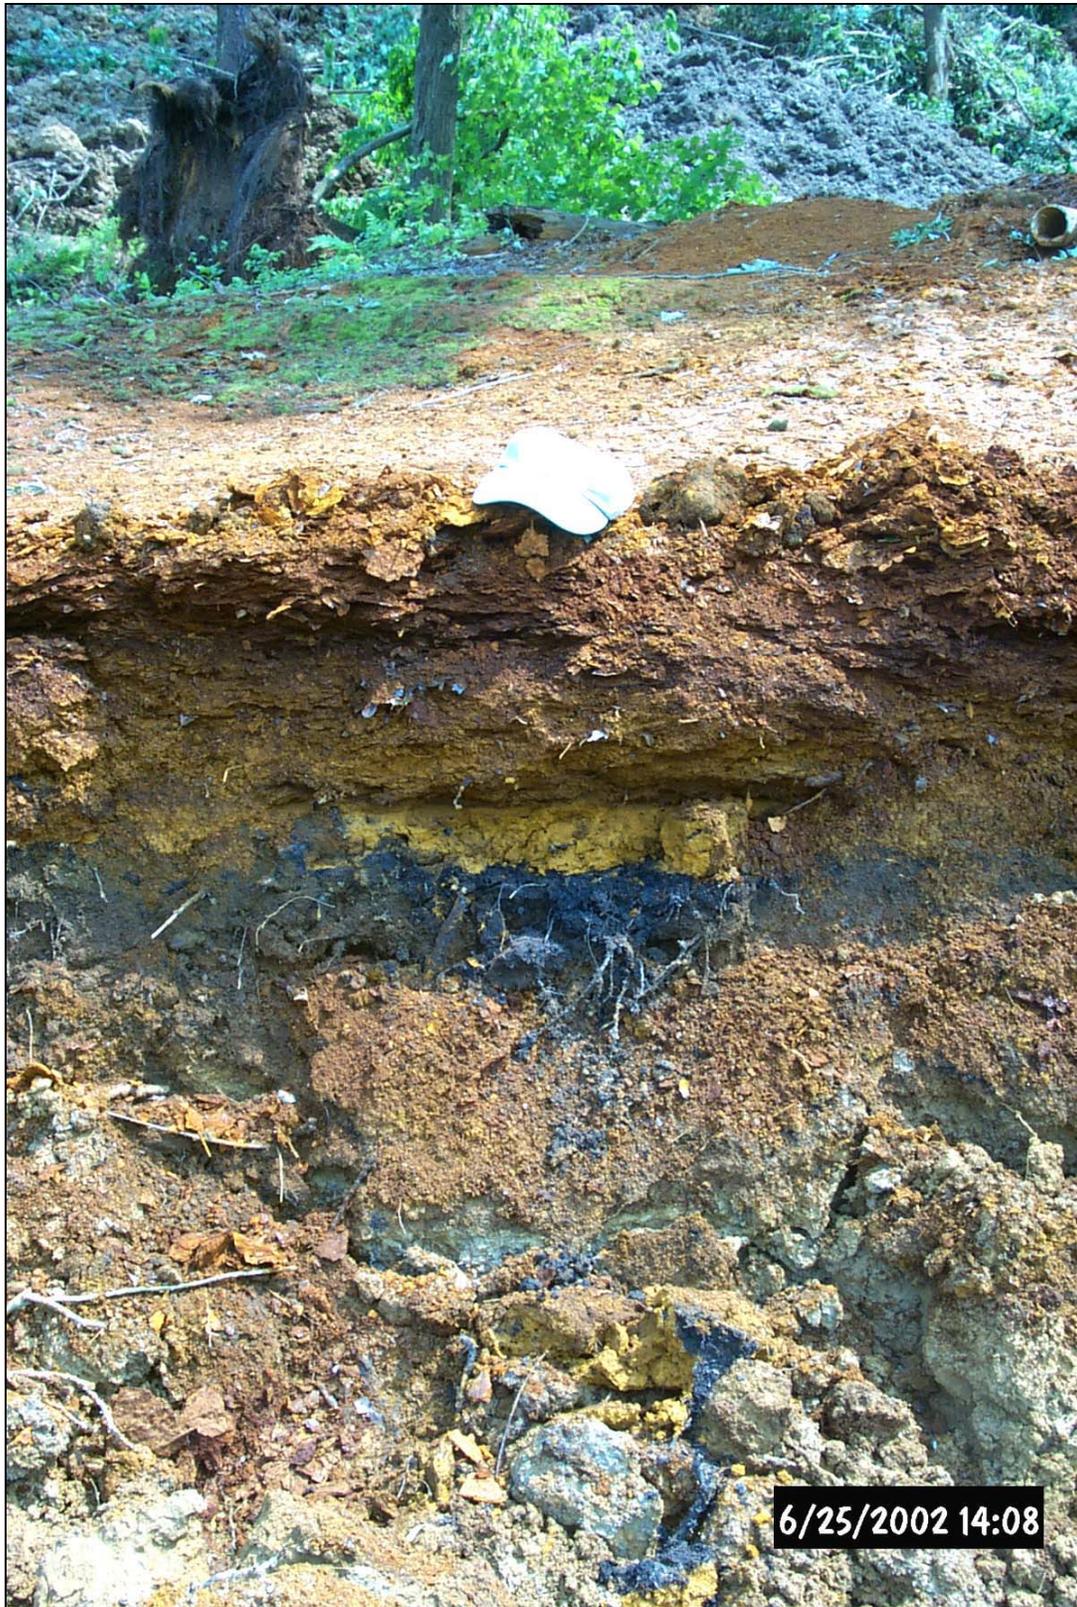
View of the soil profile during excavation of the passive treatment system. The top 1-2 feet was a thick “bed” of iron precipitates that had accumulated over the years from the abandoned mine discharge.

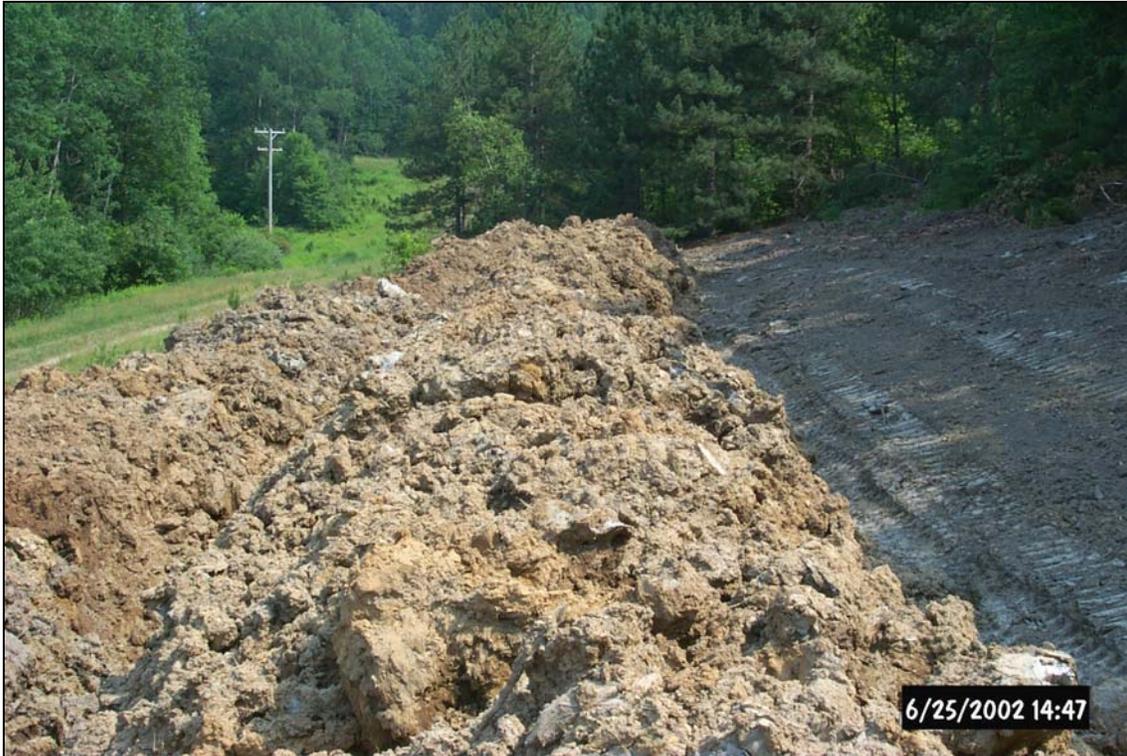
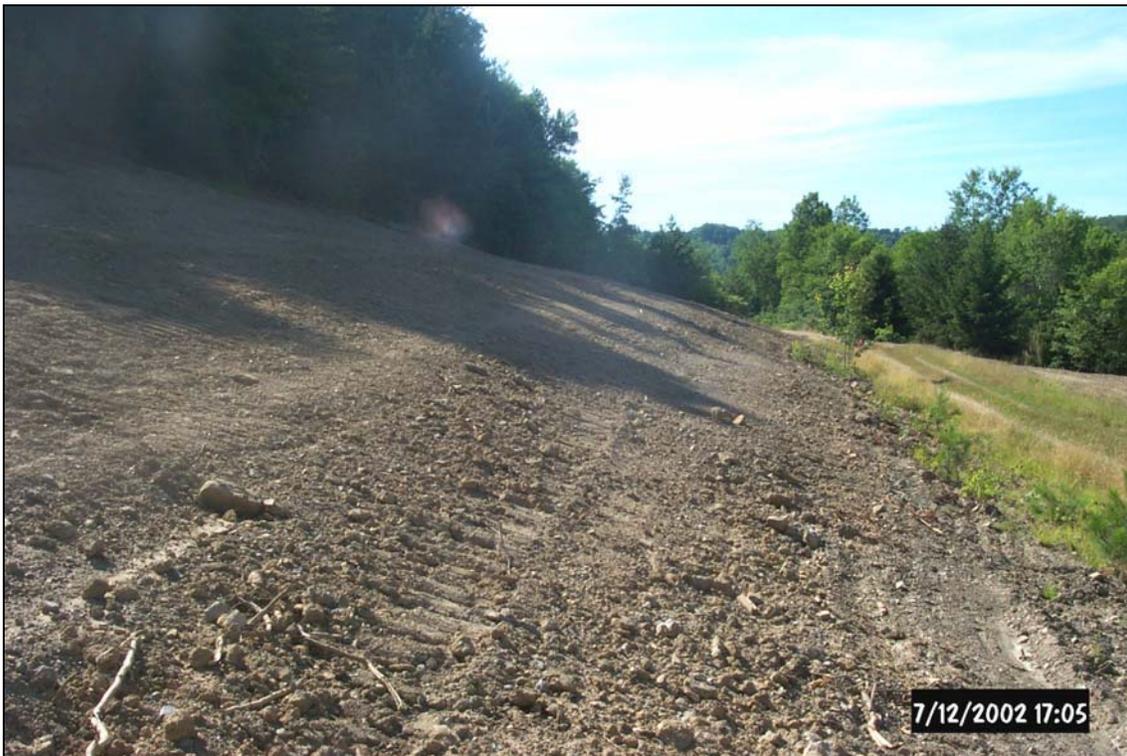
The coal refuse and limestone quarry pond fines were mixed together, placed in the barren area, covered with native soil material (**Above**) and then graded (**Below**).

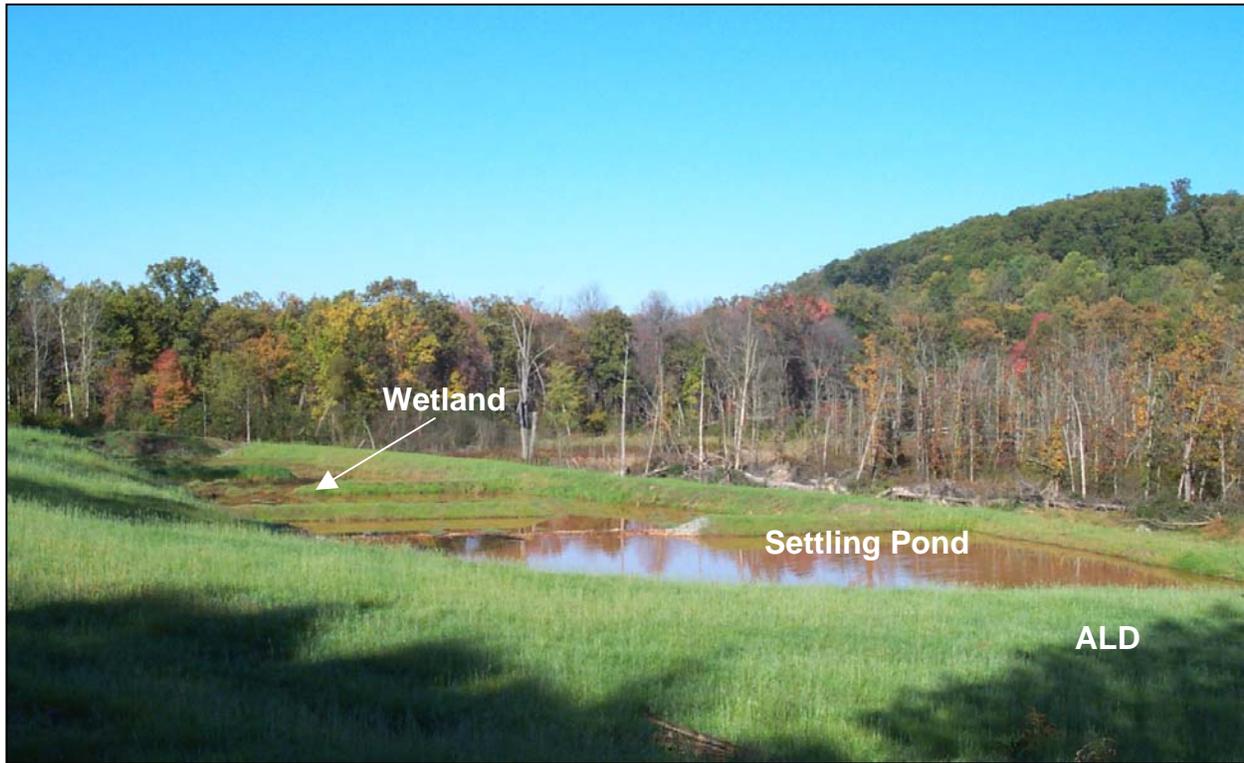
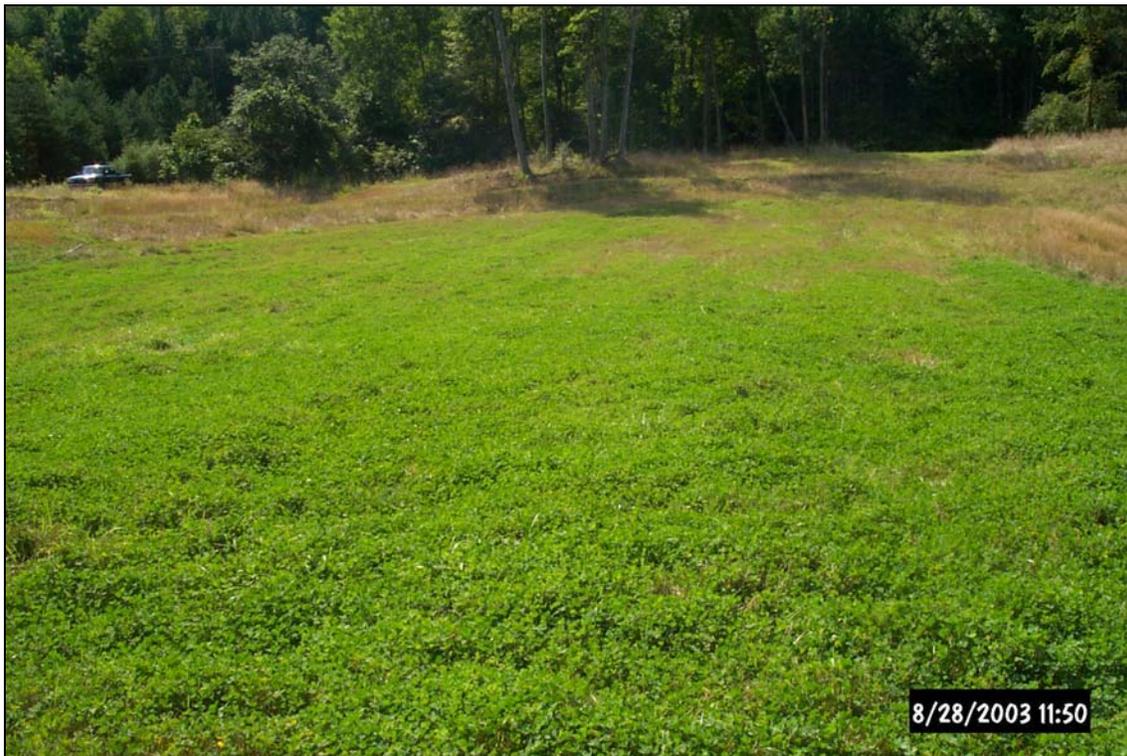
(Above) View of the SR81 passive treatment system, which consists of an Anoxic Limestone Drain (ALD), Settling Pond (SP), and Wetland (WL). **(Below)** View of the location of the Anoxic Limestone Drain, which is buried.

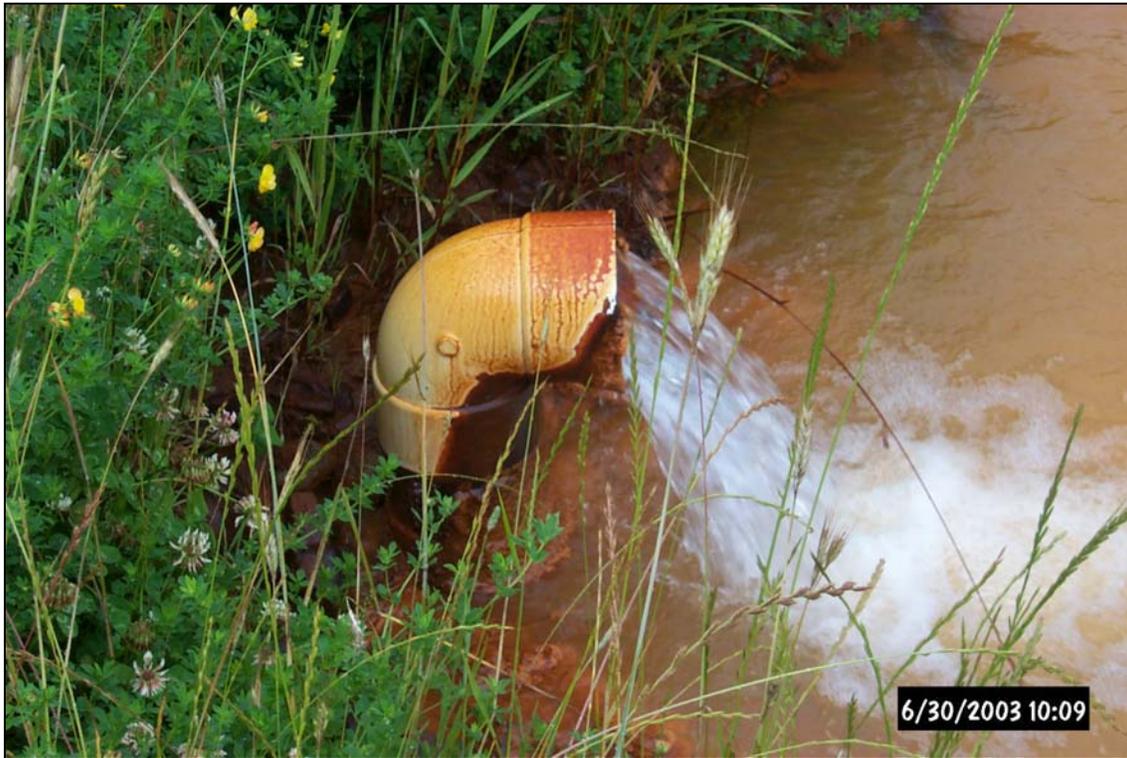
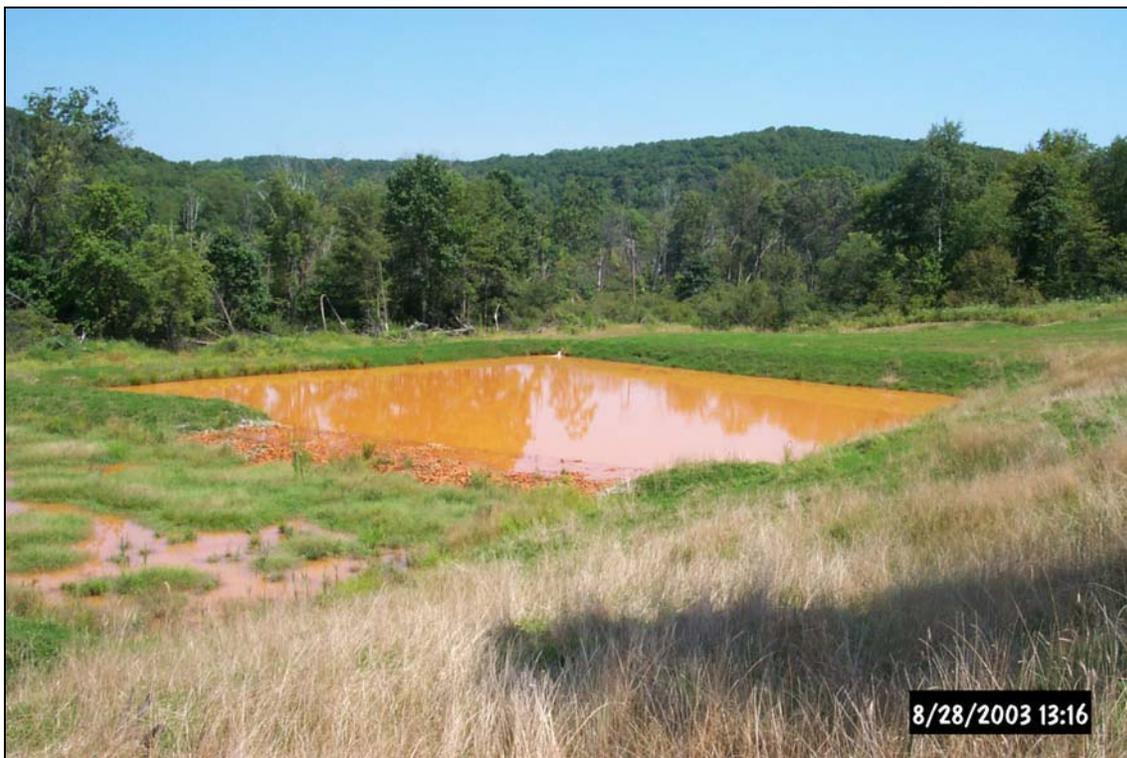
The ALD discharges on average about 200 gallons per minute (gpm) through a 6" pipe (**Above**) into the Settling Pond (**Below**) for oxidation, precipitation, and accumulation of metals.

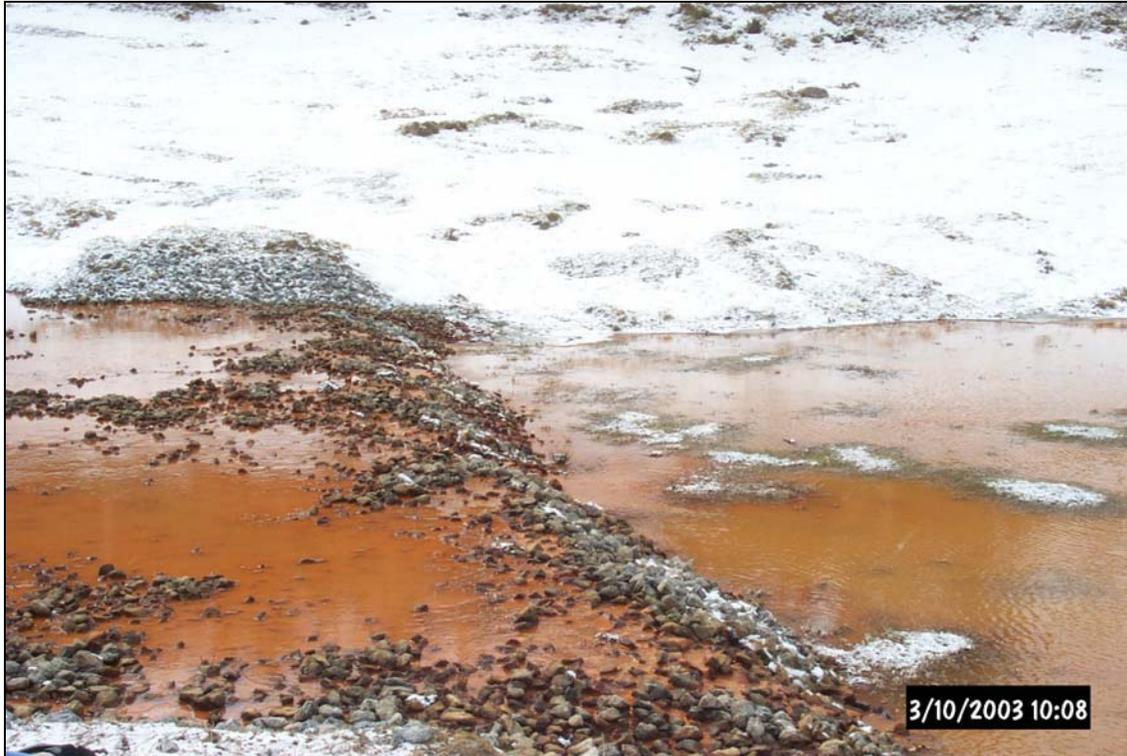
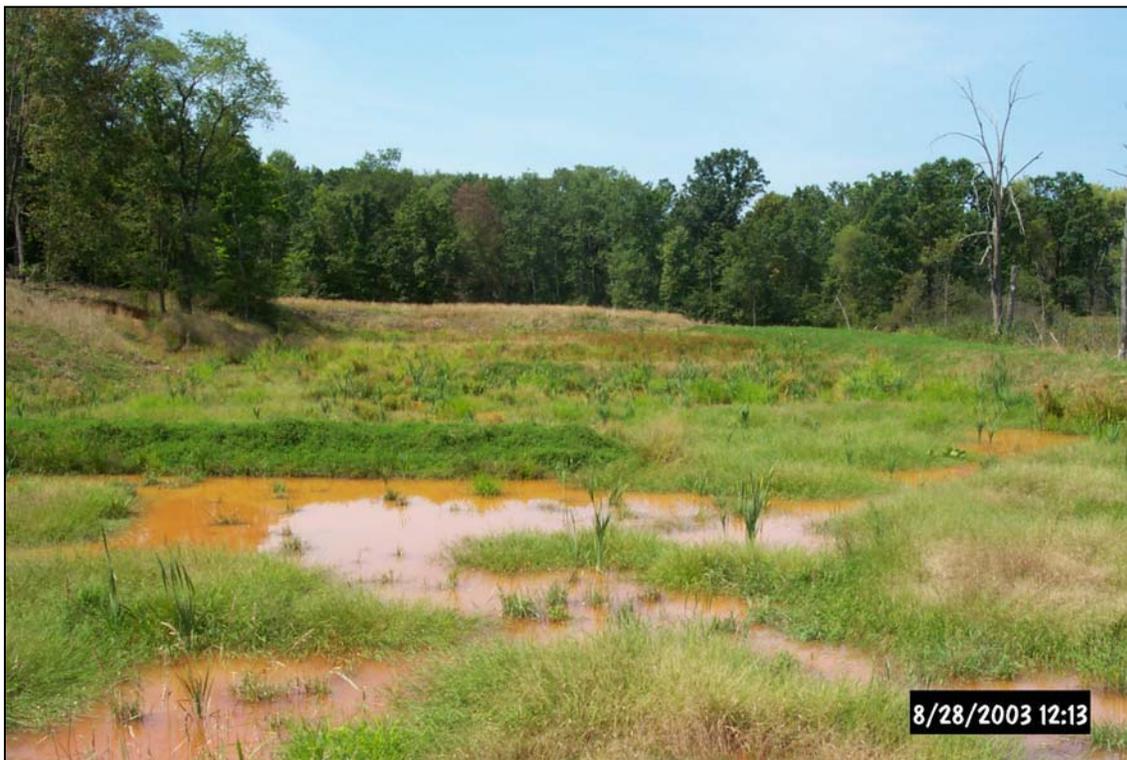
From the Settling Pond the water discharges to the first “cell” of the constructed Wetland (**Below**) over a rock-lined spillway (**Above**) to aerate the water for additional oxidation, precipitation and accumulation of metals.

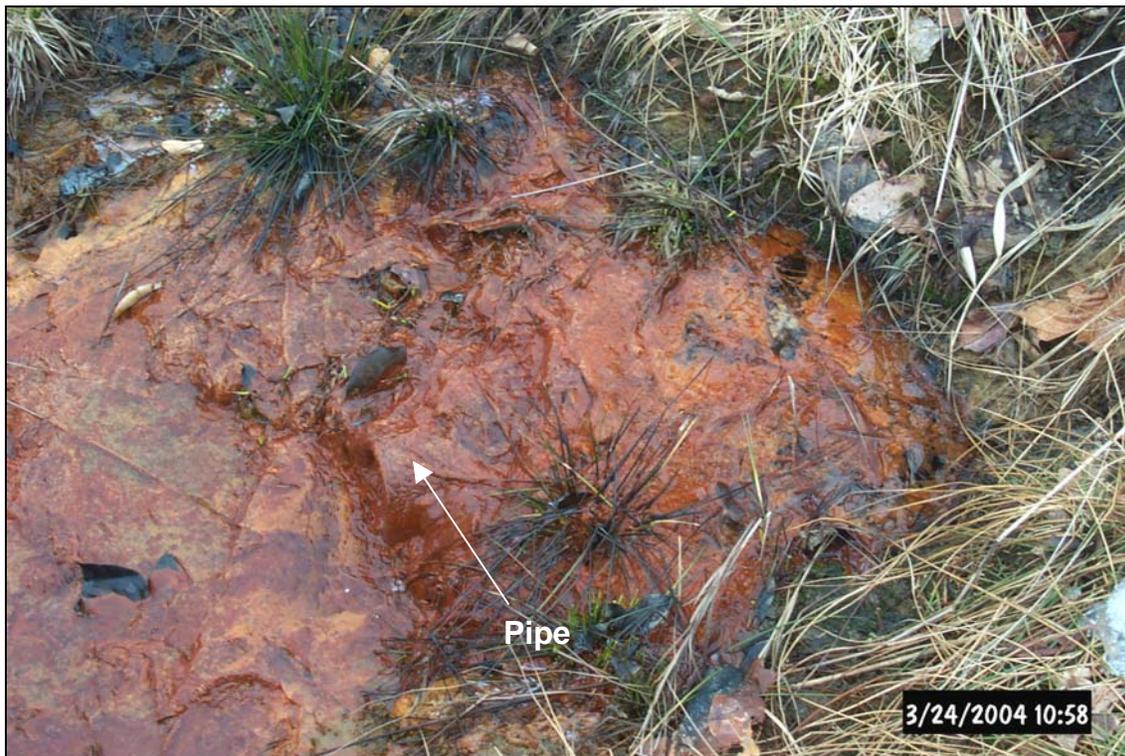
The constructed Wetland (**Above**) is essentially split into “cells” that are divided by earthen flow directional barriers to discourage preferential flow through the wetland. A small seep (**Below**) developed post-construction along the southern bank of the “final cell” of the Wetland averaging about 4 gpm. A small pipe was installed to measure flow that periodically needs to be cleaned out.

Aerobic Wetland (WL): The 28,700-SF constructed Aerobic Wetland receives the flow from the Settling Pond. Four earthen berms, which function as directional baffles to discourage preferential flow paths, were constructed within the wetland. The wetland was planted with a variety of native, hydrophytic, plant species to create a diverse, naturally-functioning, wetland. The constructed wetland discharges through a spillway lined with R-4 limestone riprap into the pre-existing, degraded, natural wetland.

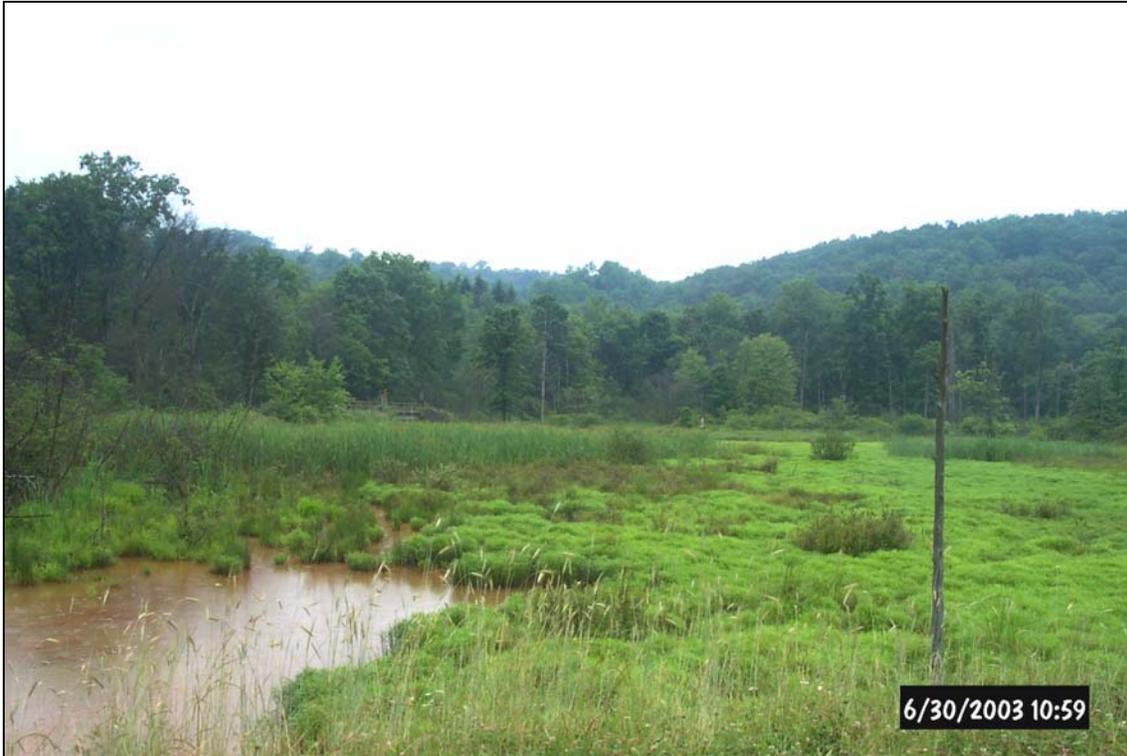
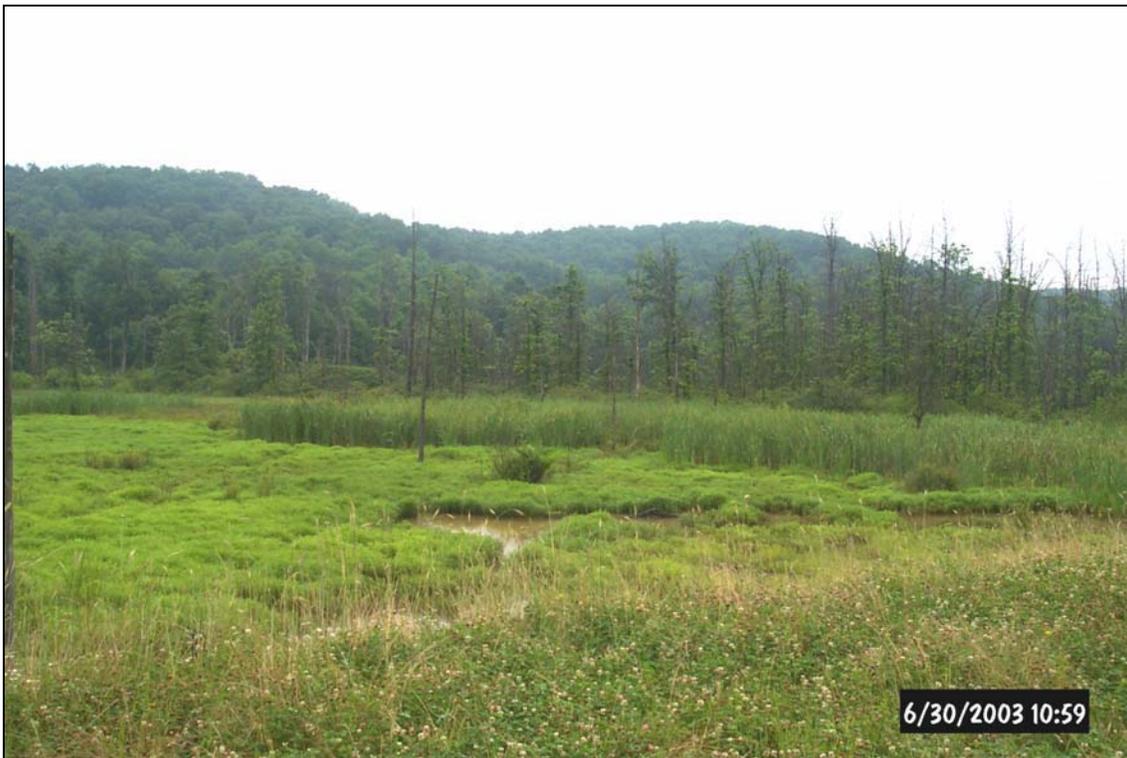
The final effluent from the passive system discharges into a previously existing wetland that provides additional treatment before flowing directly into Slippery Rock Creek.

Natural Wetland (improved): Prior to removing the abandoned coal refuse and constructing the passive system at this site, the abandoned mine drainage created, or significantly fed, a degraded wetland. Upon improving the site drainage quality by passive treatment, the vegetation in the degraded wetland has become more successful while providing additional treatment to the drainage prior to entering Slippery Rock Creek.
