SR 81 ABANDONED MINE RESTORATION AREA

Final Report
June 2004

Re: Final Report
ME# 350410; Project # NW01771
SR81 Abandoned Mine Restoration
Washington Township, Butler County, PA
540102/FR-trans

SR81 ABANDONED MINE RESTORATION FINAL REPORT

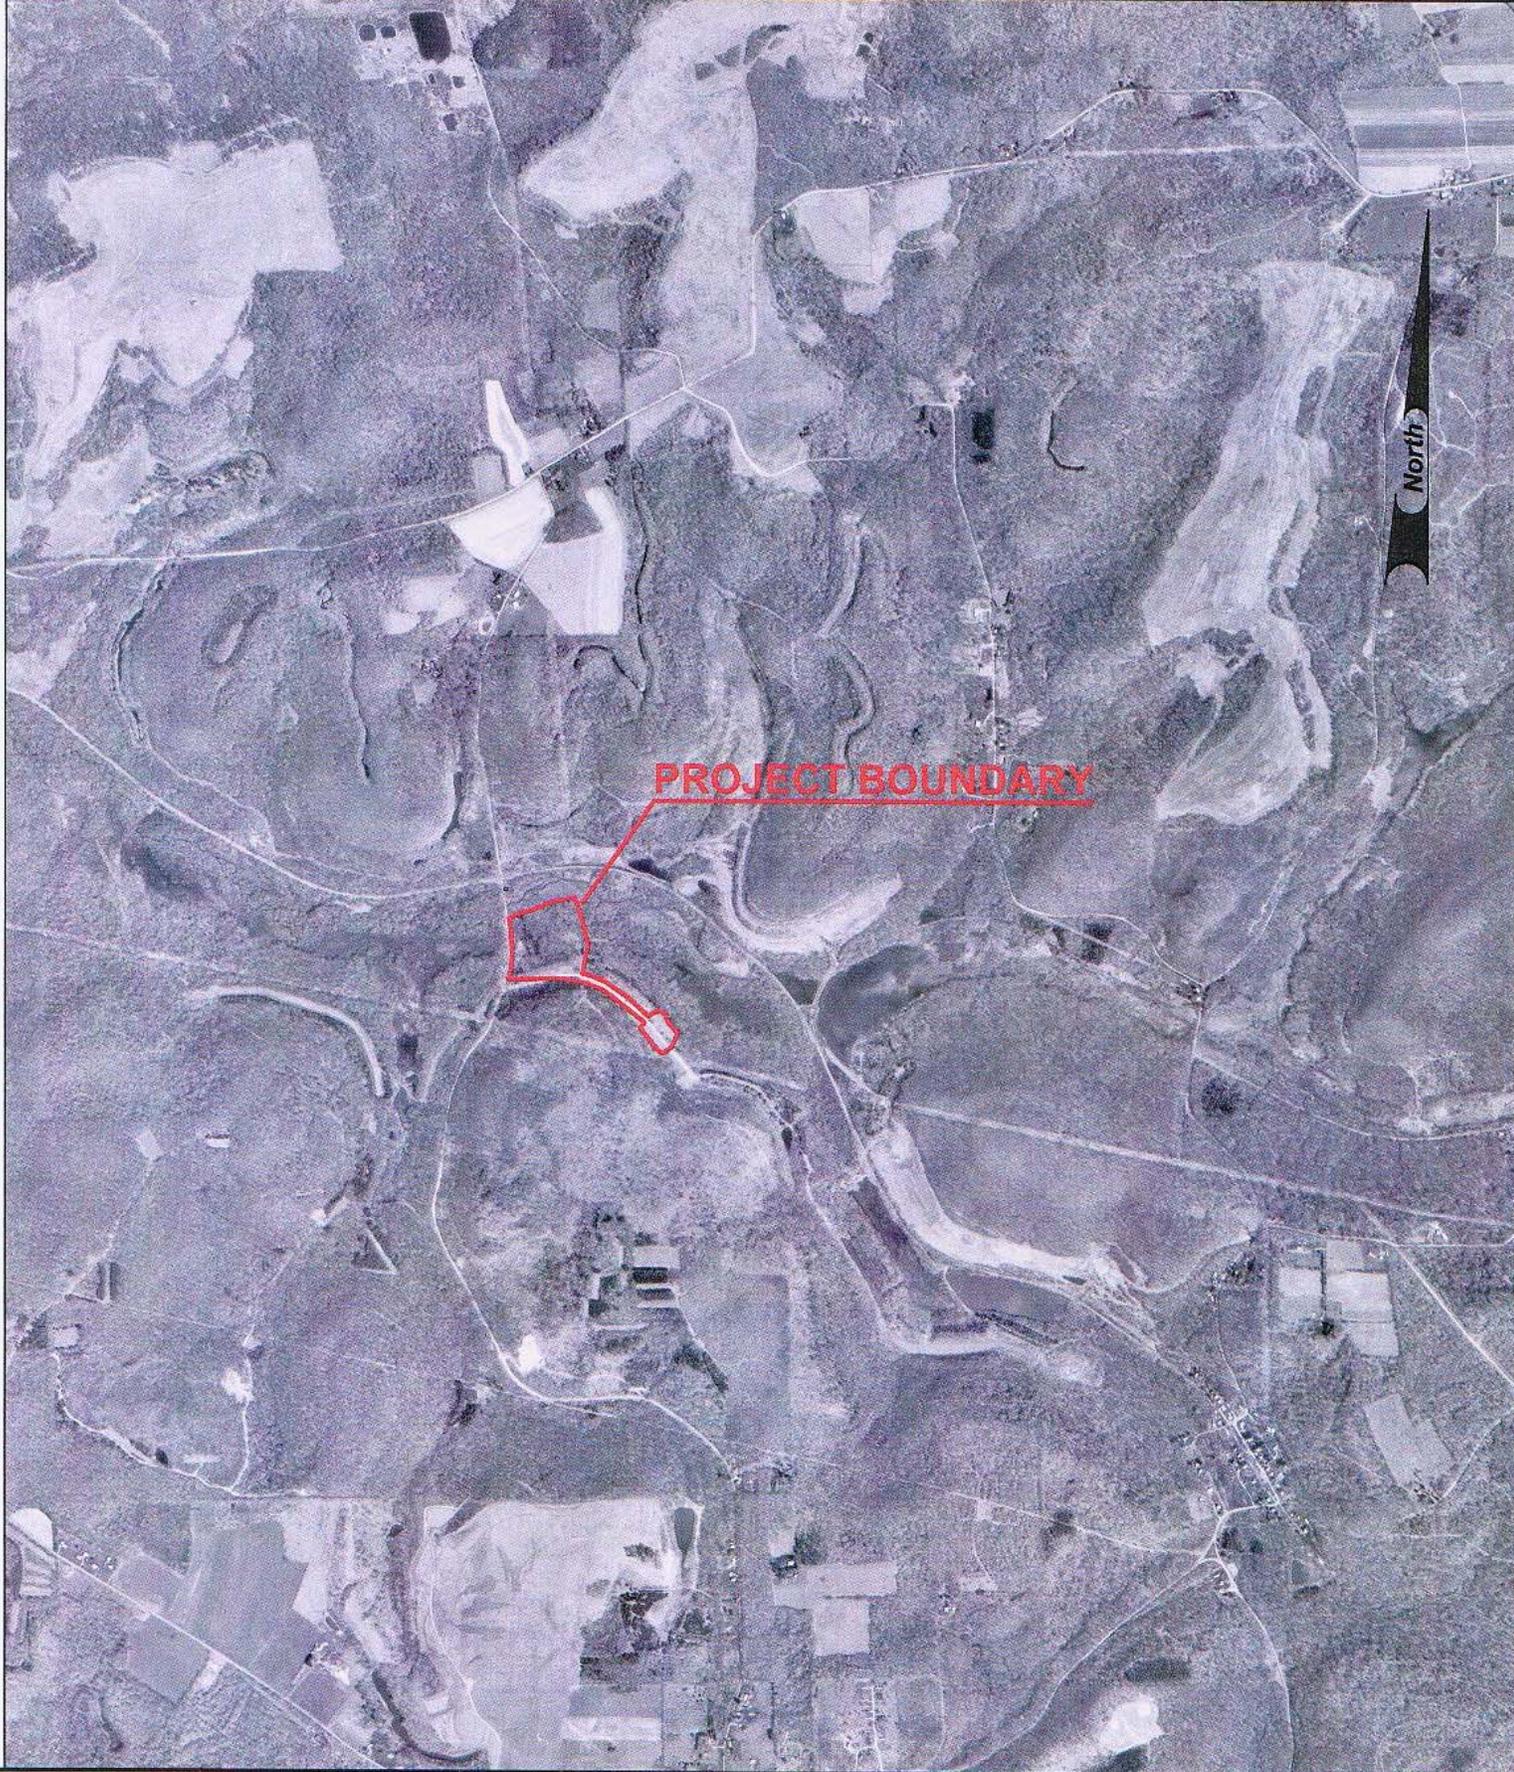
PROJECT LOCATION - USGS DIGITAL ORTHOPHOTO (HILLIARDS, PA)
SR81 ABANDONED MINE RESTORATION AREA

Approximate Center of Project (deg-min-sec)
41-05-24 latitude 79-51-34 longitude

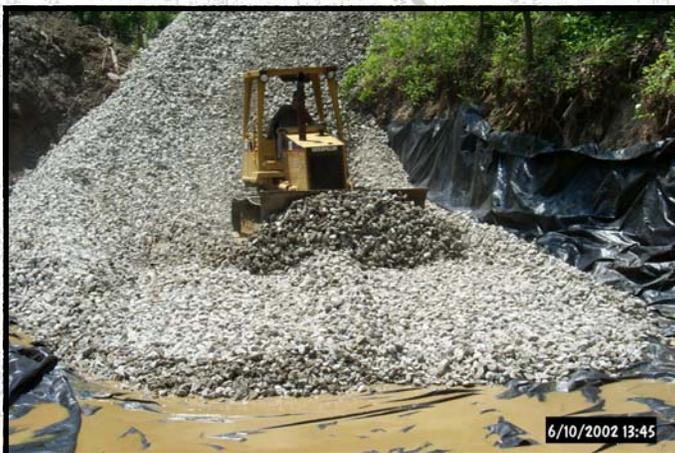
Construction of the 700 ton limestone drain recently began at the SR 96 site. On May 30th and 31st, OSM intern **Steve Short** (a biology student at Grove City College) staked 100 hay bales at the site for E&S Control. June 10th brought the actual construction of the drain. **Jerry and Jason Jesteadt** of **Jesteadt Excavating**, **Steve Short**, and SRI intern **Chris Treter** placed liners, spread limestone, and assembled the piping system. Thanks to Jerry and Jason Jesteadt for helping to build this system!!!!
