**SOUTH SANDY CREEK
WATERSHED ASSESSMENT / RESTORATION PLAN**

South Sandy Creek Watershed Association

L. Robert Kimball & Associates

February 2009

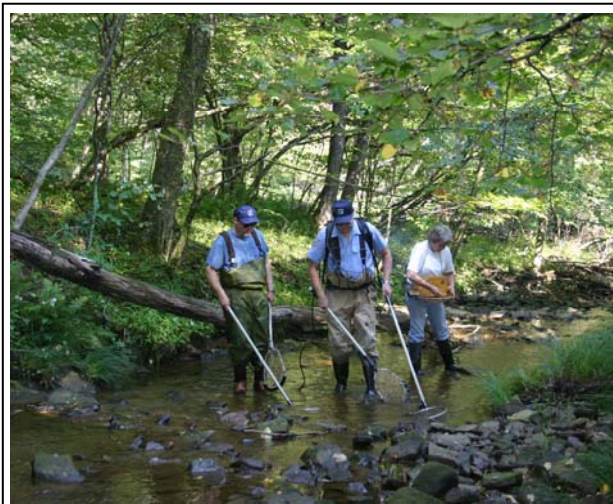
PFBC sampled the main branch of Williams Run at several locations using electro-fishing gear (see Photo 3). One point (river mile 1.62) was sampled in 1998 and again in 2005 to determine any changes (see Table 9). While there was a change, it was for the worse with 2 species of fish found in 1998 and then 0 in 2005.

Photo 3. PFBC & SSCWA sampling Unknown Tributary to Williams Run

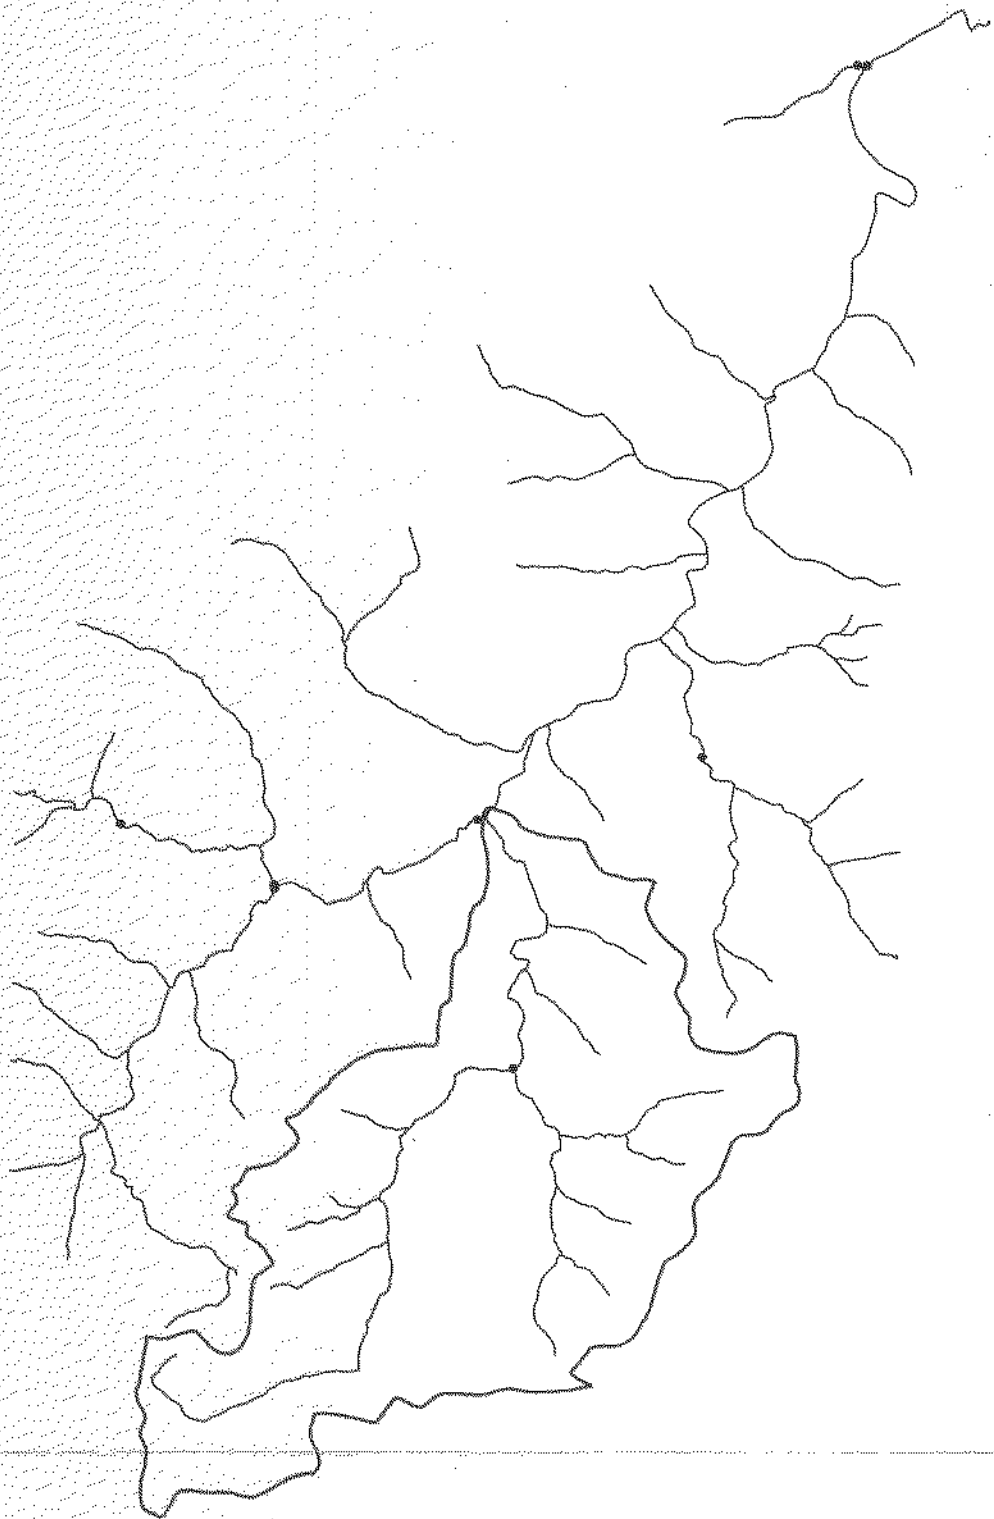
Map 2. Location of State
Game Lands in Williams Run
Watershed

- Brook trout
- ▬ Williams Run
- ▬ South Sandy Creek
- ▭ Williams Run Watershed

With 1,615 acres of Williams Run Watershed located in SGL #39, the majority (76.8%) of the watershed is forested, open land used for wildlife habitat and recreation (see Map 2). Agriculture is present in the watershed and accounts for 12.6% of the land use. Abandoned mine lands accounts for 11.6% and are largely found at Woods Corners and along Allen Road.
