# **AMD in the Upper Lamberts Run Watershed and Potential Solutions**

## **Technical Assistance provided by Trout Unlimited through a PADEP Growing Greener Grant Project TUTAG07**

**Hedin Environmental  
January 20, 2006**

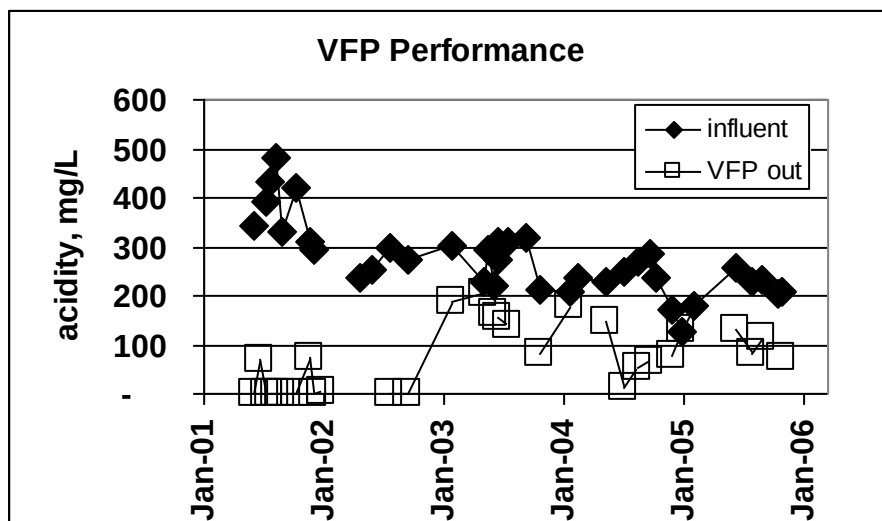
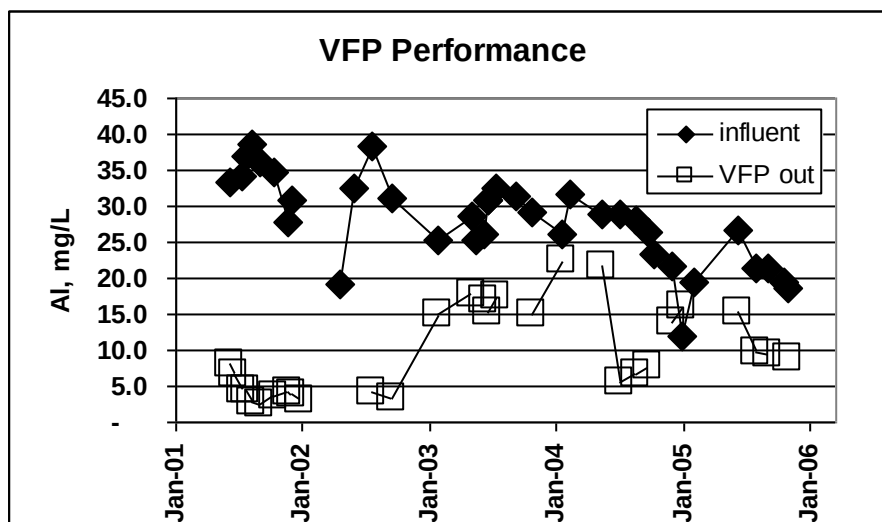
**Figure 3. Performance of the Somerset Conservancy vertical flow pond.**

Table 1 shows the average performance of the passive system since 2001. Figure 3 shows acidity and Al concentrations in and out of the VFP over the four year period. The VFP provided good treatment (complete removal of acidity) for 18 months. In early 2003, the VFP began to discharge acidic water with > 10 mg/L Al. The performance has remained poor since.

The NRCS reports several construction deficiencies that might explain the disappointing treatment. The limestone aggregate was poor quality and was suspected of disintegrating, possibility eliminating porosity and reactivity. The flush system was not installed properly and has never flushed the aggregate as intended. Lastly, the flows and loadings have commonly been twice the design expectations.
