Two Lick Creek Cold Water Heritage Conservation and Restoration Plan

White and Center Township, Indiana County Indiana and Homer City Borough, Indiana County

Prepared by: Ken Sink Chapter of Trout Unlimited

For: Cold Water Heritage Partnership of Pennsylvania

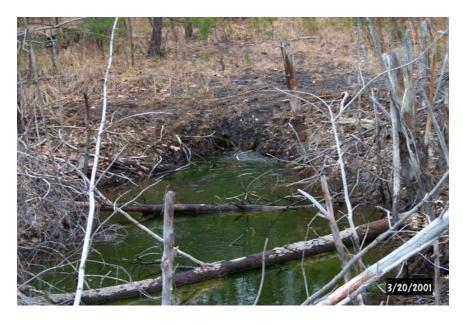
Figure 6. Source of the Lucerne 3A Discharge.

The Lucerne 3A Discharge is the only significant discharge entering Two Lick Creek between the Two Lick Reservoir effluent and the Borough of Homer City (Figure 6). It is of moderate flow, low in pH, and highly acidic with very elevated metal concentrations (Table 3). Consequently, Lucerne 3A was of high priority for treatment for various local agencies and organizations.
