Wingfield Pines Passive Treatment System Investigation Chartiers Creek Watershed, Allegheny County

Technical Report Provided by Hedin Environmental through the Trout Unlimited AMD Technical Assistance Program

May 3, 2013

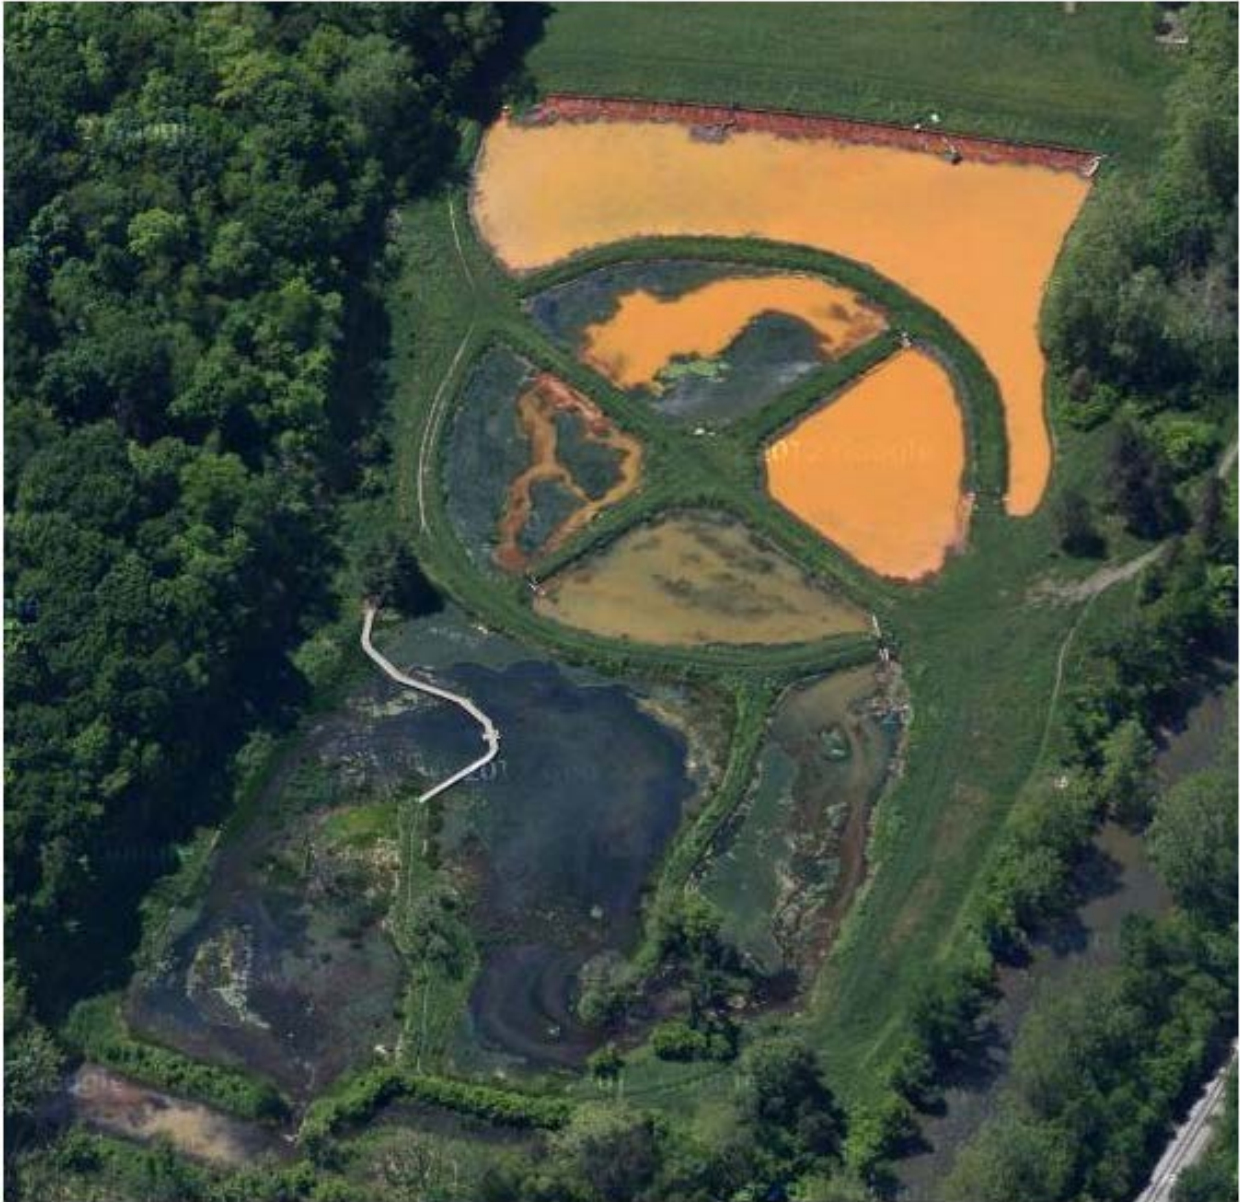
As seen from the aerial photograph of the site (figure 1), there is considerable algal growth in the Ponds 3, 4, 5 and in the first third of the wetland. The primary alga present is muskgrass, *Chara spp.*, which is common colonizer of open alkaline waters. The alga gets its name from its musky smell. Muskgrass is a native to Pennsylvania but is invasive and a common nuisance problem in ponds. Information about muskgrass is available in a Penn State bulletin at this link. <http://pubs.cas.psu.edu/freepubs/pdfs/xh0034.pdf>

Figure 1. The Wingfield Pines passive treatment system on August 12, 2012. Water flow from the top of the photo through the ponds and into the wetland on the bottom of the photo. The growth in the ponds and the first wetland section is largely muskgrass, *Chara spp.*. The muskgrass is a very good filter and its effective removal of Fe solids is apparent by the lack of orange color in the wetland.

There is no easy way to eliminate muskgrass. The Penn State bulletin provides chemical control options, but all have fish risks. The Wingfield Pines system is populated with mosquito fish which appear to be providing excellent mosquito control. The loss of these fish is not recommended. Muskgrass can be physically removed. Jeemco Inc., located in New Wilmington PA, operates an aquatic weed harvester that cuts algae and removes it from the pond. The harvested algae are brought to shore where it can be composted or disposed of. The Jeemco service costs \$150/hour. Harvesting algae from Westminster College's 16 acre lake typically takes 2 weeks. The Wingfield Pines ponds total about 2 acres. It would probably take three days to mobilize and clean out Ponds 3, 4, and 5. The total cost is estimated at \$4,000 – 5,000. ALT would need to have a plan to compost or dispose of the algae. If not properly handled, the muskgrass would probably create an odor problem. It is likely that muskgrass would recolonize the ponds and removal would be necessary again in 2-3 years.

As noted above, the heavy growth of muskgrass appears to have contributed to the development of preferential flow paths down the middle of Ponds 3, 4, 5 and in the wetland. It may be advantageous to install flow barriers in the wetland that divert flow out of established channels. ALT should consider placing diverters made of haybales in the wetland. The two recommended locations for haybale diverters are: 1) across the middle of the first wetland section and, 2) across the wetland upstream of the boardwalk. These barriers could be constructed with about 40 rectangular haybales.

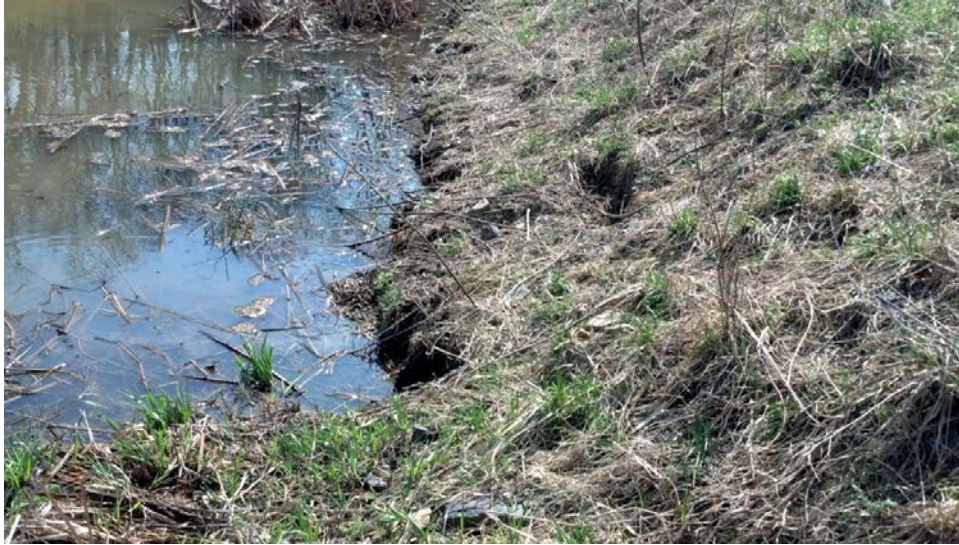
The inspection of the treatment system and walking paths identified numerous locations where muskrats, slumping, and erosion had created unstable conditions on berms (Figures 2 and 3). Erosion was apparent around most of the grates which created tripping hazards (Figure 4). The final effluent structure had water flowing around both sides because of erosion (Figure 5). The locations of all problem areas were mapped onto a system map (Figure 6).

Figure 2. Muskrat damage of a wetland berm.

when stepped on and create a tripping hazard. The holes should be collapsed with a shovel and filled in with earth or stones.

Muskrat burrowing into berms can be controlled by placing barriers along the water edge. The two most common barriers are chain link fence (placed on the ground) and aggregate. Both are placed in a band that extends at least two feet above and below the water line. Making the Wingfield Pines system “muskrat proof” would be a large effort. The ponds and wetland contain about 5,000 ft of berm that is potentially vulnerable to muskrat burrowing. Assuming that the barrier is made with aggregate that is placed in a band that is 4 ft wide and 6 inches thick, then one ton of aggregate will treat about 10 feet of shoreline. The cost to purchase and place the aggregate is likely about \$40/ton and the unit cost is estimated at \$4/ft of shoreline. Treatment of all 5,000 ft of exposed berm would cost about \$20,000. Not all the berm shoreline is being utilized by muskrats. ALT may want to experimentally apply stone to one high problem area and monitor the effectiveness of eliminating muskrat burrowing.

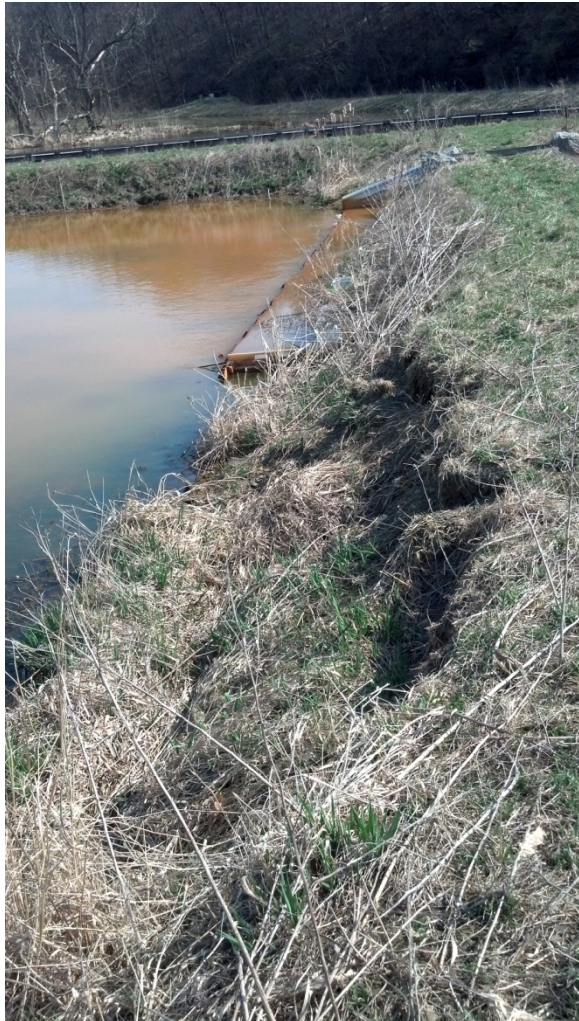
There is some slumping of the berm separating ponds 4 and 5 (Figure 3). Although the slumping has not compromised the integrity of the berm (and is unlikely to do so), it could be repaired and stabilized with earth and stone. There is erosion at the ends of several troughs that could use similar maintenance. Muskrat burrows are a problem in many areas. The borrows collapse

Figure 3. Slumping of the berm between pond 4 and 5 on the pond 5 side.

The total amount of dirt needed for fixing the berms and muskrat burrows is likely 2-3 CY. One small truckload will be adequate.

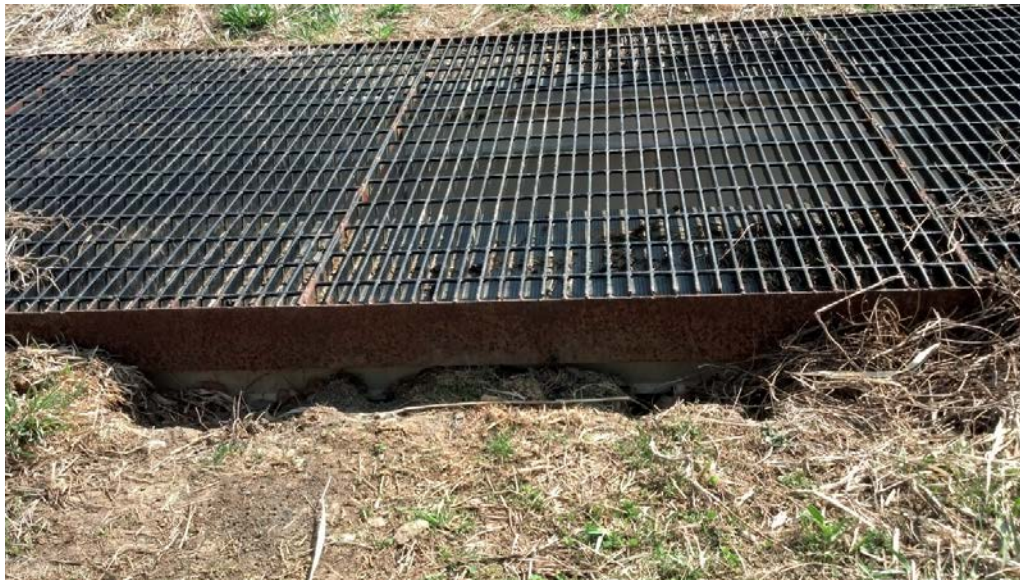
The grates that cross channels that connect pond 1 → 2, pond 2 → 3, pond 4 → 5, and pond 5 to the wetland need maintenance. There is erosion and damage from animal digging on the sides of the grates resulting in a tripping hazard (Figure 4). The holes could be filled with fine gravel which would eliminate the tripping hazard and may lessen future erosion and animal digging. Gravel with a maximum diameter of 1 inch is necessary. AASHTO #9 limestone was tested on one grate and found to be very effective. Approximately 2 cubic yards (2.7 tons) of gravel should be adequate to fix all the grates.

Figure 4. Tripping hazard caused by erosion/animal digging on the sides of the grates.

There is a loose rubber lining between the grates and the aluminum caps that prevents corrosion. This lining should remain in place wherever the grating contacts the aluminum caps.

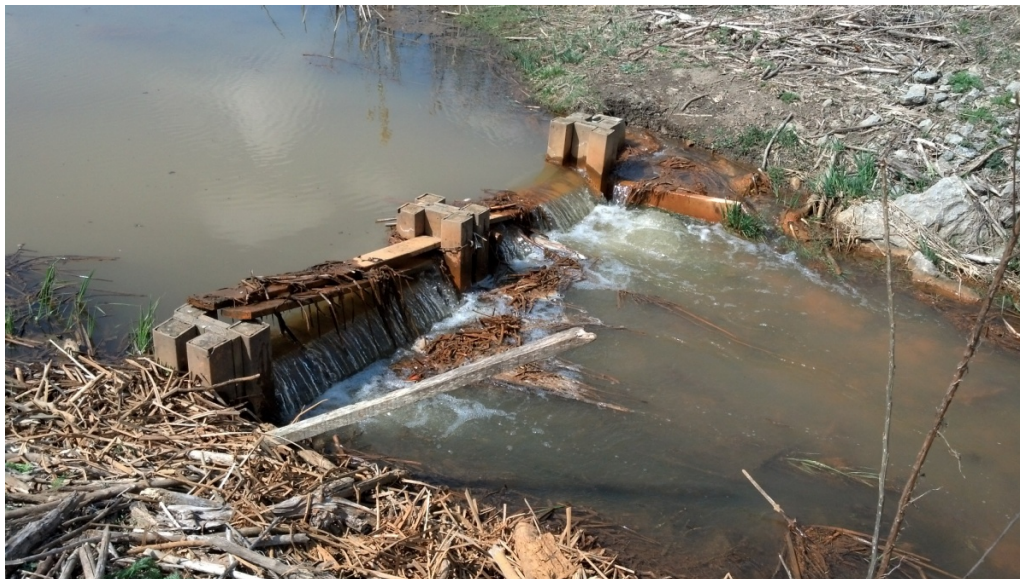
Water is flowing around both sides of the final effluent structure (Figure 5). This needs to be repaired by filling the sides with dirt so that there is no opportunity for water to bypass the discharge structure. Once the fill is in place, large stones should be placed on top to further stabilize the area.

Figure 5. Erosion around the final effluent structure is allowing water to bypass around.

The effluent structure is designed to allow adjustment of the water depth in the wetland by adding/removing boards. The boards that are not being used should be stored in the site storage shed. A chain that was intended to lock in the boards was not effective. The chain can be removed.

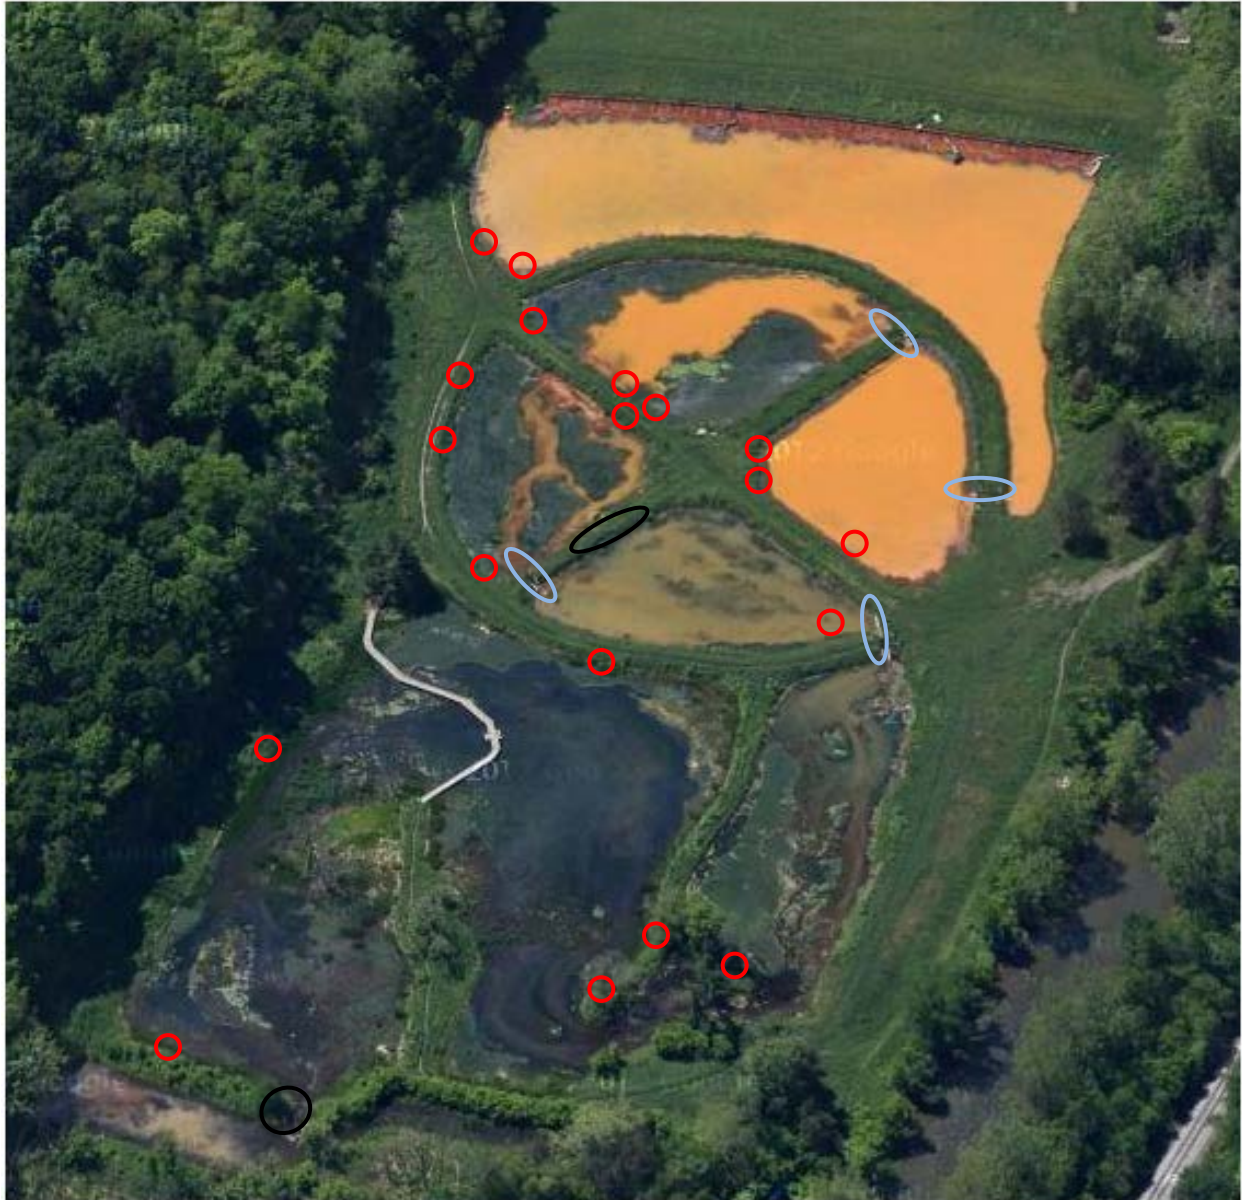
Figure 6. Problem areas at the Wingfield Pines site. Red circles indicate muskrat damage, blue circles indicate erosion around grates, and black circles berm slumpage or erosion.
