Weaver Run D10 Passive Treatment System
SRI O&M TAG Project #42 Request #1
OSM PTS ID: PA-315

Requesting Organization: Kiski-Conemaugh Stream Team
Receiving Stream: Weaver Run
Watershed: Paint Creek
Municipality/County: Paint Township, Somerset County
Latitude/ Longitude: 40°12'43.9596"N / 78°49'21.9468"W

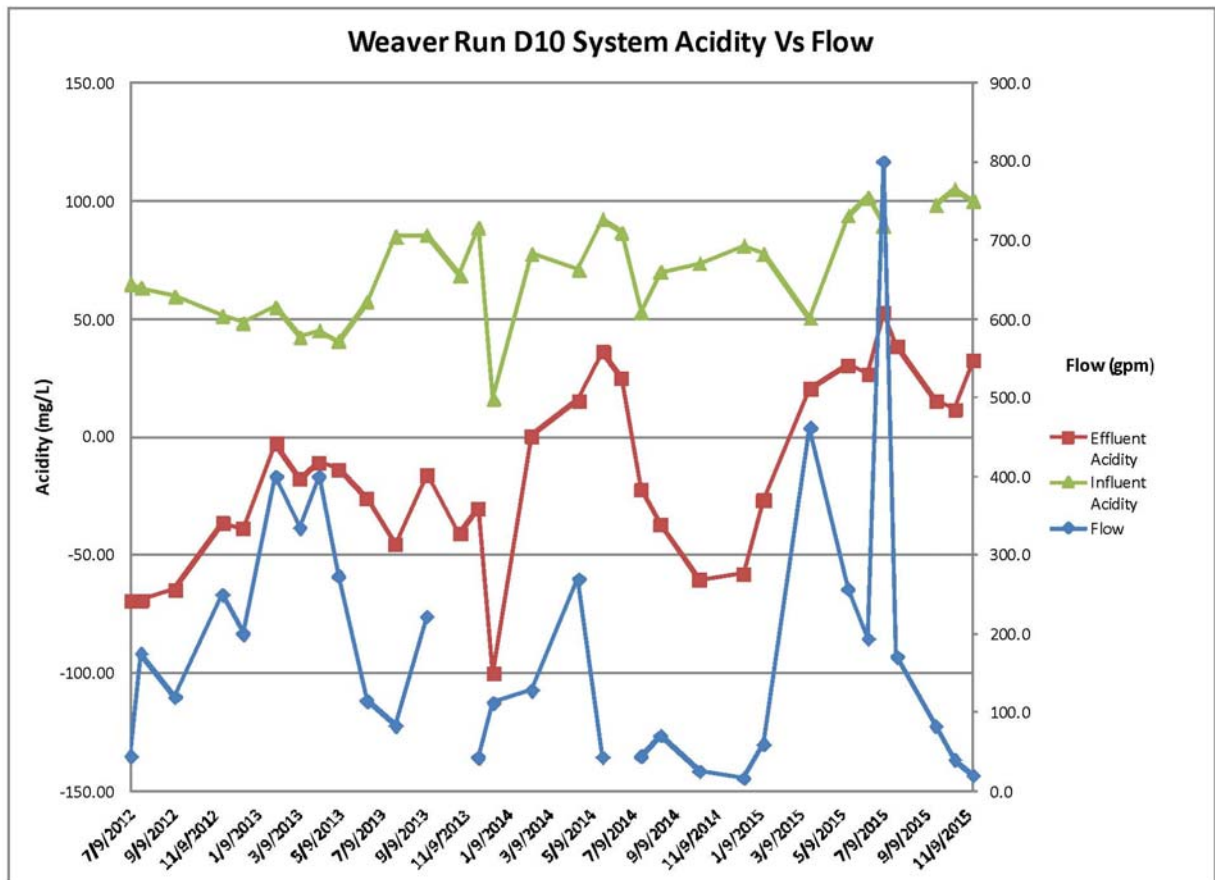
In addition to water quality improvements, drainage issues around the site were addressed. A water bar was added to the parking area to direct runoff away from the access road. Parallel to the access road, a drainage ditch was dredged and extended. Potholes in the access road created due to runoff

were filled. The condition of the berm was evaluated and appeared to be stable, with vegetation present on most parts of the slopes on site.
