# Kiski-Conemaugh Basin Treatment System O&M Assessment Report

December 2017

Prepared by  
Stream Restoration Incorporated and BioMost, Inc.

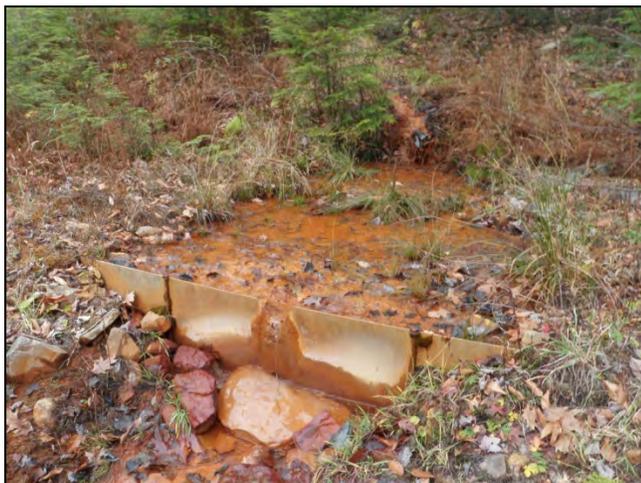
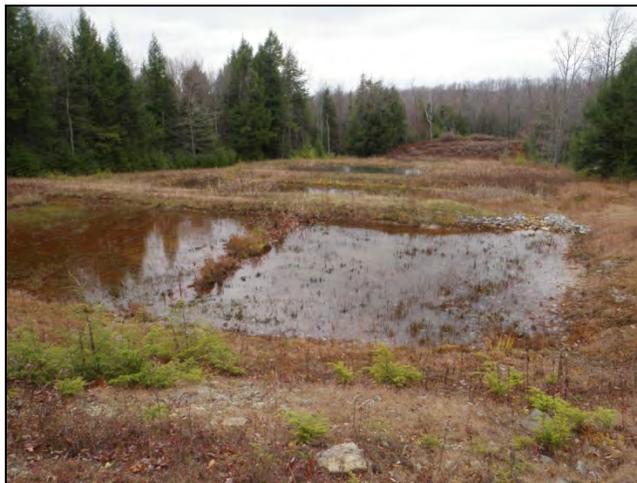
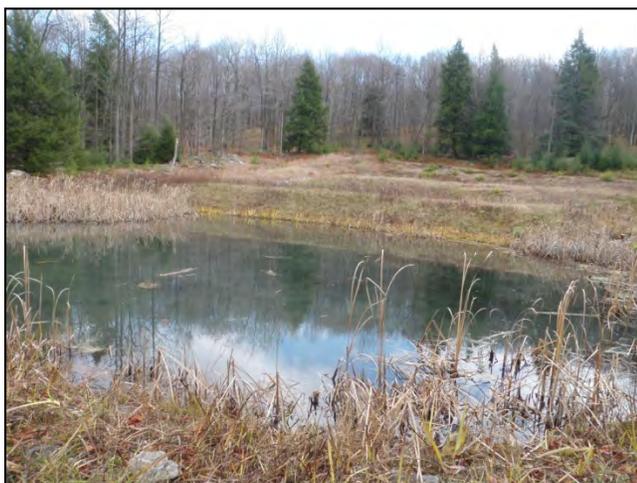
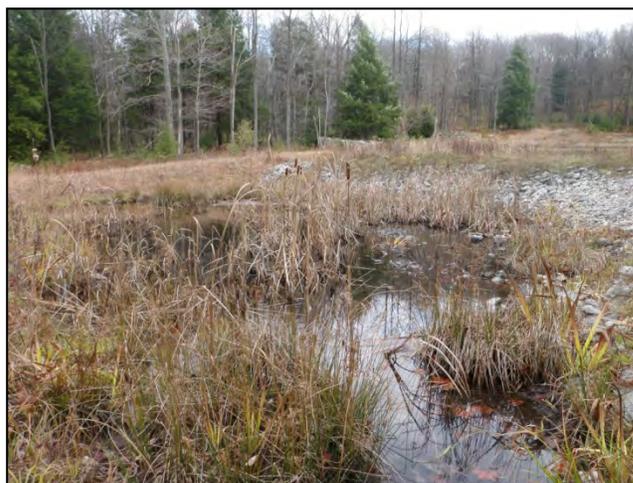
### **Bear Rock Run System 1 Photos**

The AMD flowing into the Bear Rock Run System 1 is sampled at a weir (Top Left) which has accumulated sludge, sediment and debris and needs to be cleaned out. The effluent weir (not shown) is leaking and needs to be repaired. System 1 consists of 2 Oxidation Ponds (Top Right), an Anaerobic Cell (Bottom Left), and a shallow limestone lined pond (Bottom Right). The amount of limestone is unknown. The water appears to be largely flowing on top of the limestone lined pond (Bottom Right) and much vegetation is growing in the bed as well.

- Clean the sludge, sediment & debris behind the influent water weir
- Repair effluent weir

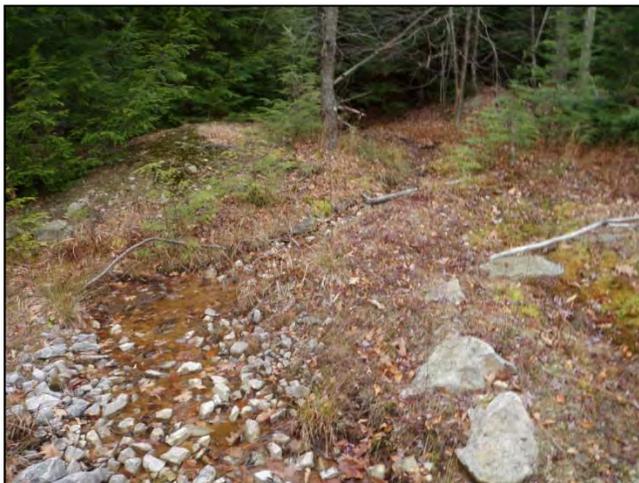
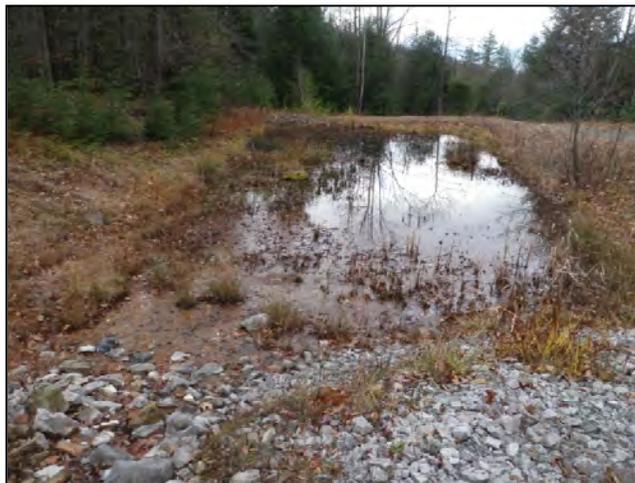
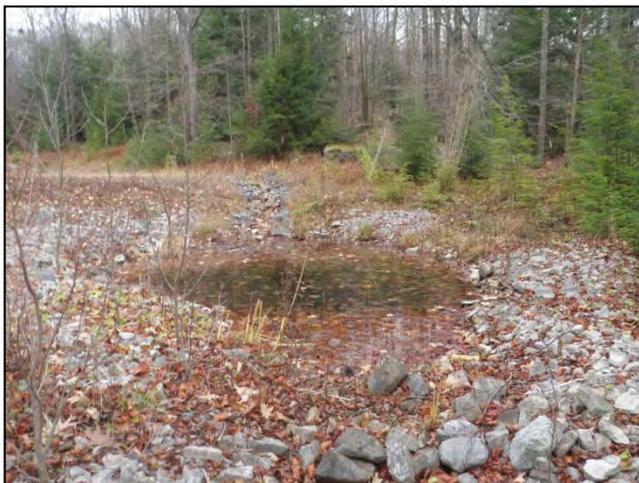
### **Bear Rock Run System 2 Photos**

At the Bear Rock Run System 2, a limestone channel (Top Left) conveys the mine drainage to the passive treatment system. The water flows into a shallow settling pond/wetland (Top Right) and then into a limestone lined pond (Left). The water is flowing on top of the limestone-lined pond, which may indicate that the stone is plugged and needs to be cleaned.

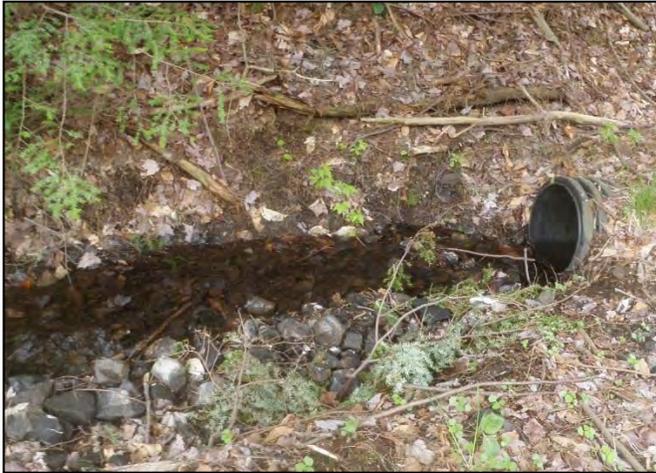
### South Fork AMD60 Photos

The South Fork AMD60 discharge is collected by a white perforated PVC pipe (a portion visible Top Right) that was placed within a rock-lined channel (Top Left). Any water not collected by the pipe is bypassed to the stream by the black culvert pipe (Top Left and Right). The collection pipe is easily covered and plugged by leaves and debris. The collected AMD is conveyed around a pump house to the influent distribution pipe with bottom perforations (Bottom Left) which also can be easily clogged with leaves and debris. The water then flows through the limestone bed (Bottom Right) which has geotextile placed on top of the limestone to prevent clogging with leaves and debris.

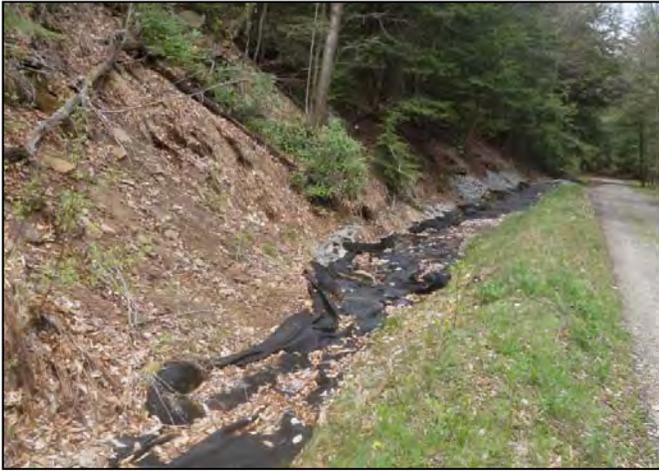
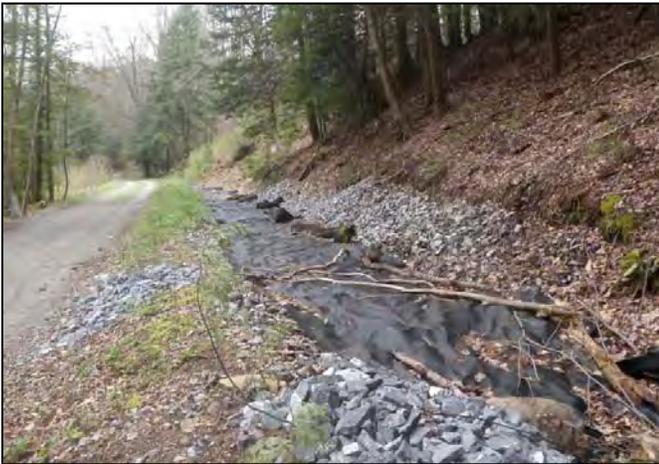
### South Fork AMD67 Photos

The South Fork AMD67 system consists of a long narrow limestone trench used to treat a small seep(s). Space was limited due to the hillside and access road (Top Left). The system is experiencing significant erosion of the cut slope and some large boulders are falling down (Top Left & Right). There have been attempts to stabilize the hill side and a number of compost filter socks have been placed at the toe (Bottom Left & Right) to help prevent sediment from entering the trench. The trench has been stirred a couple of times. At one point, geotextile was placed over top of the stone to help protect the bed from becoming plugged.

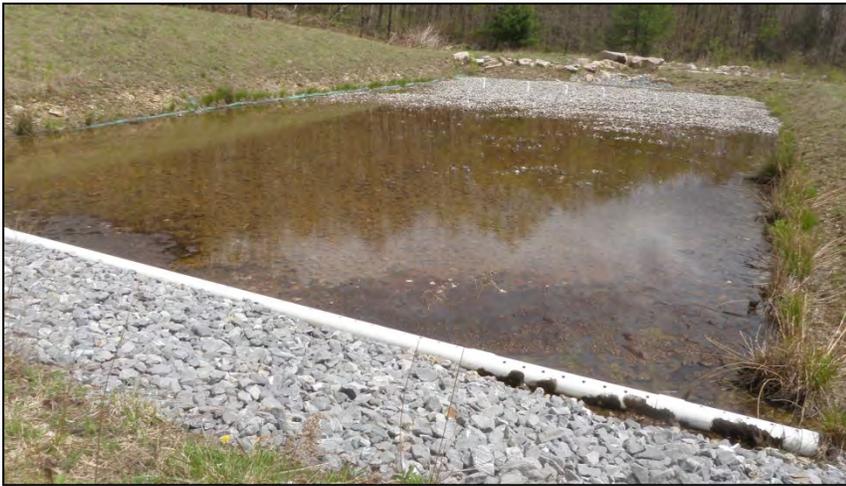
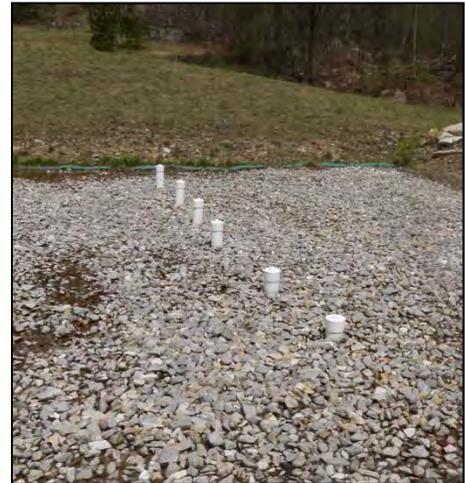
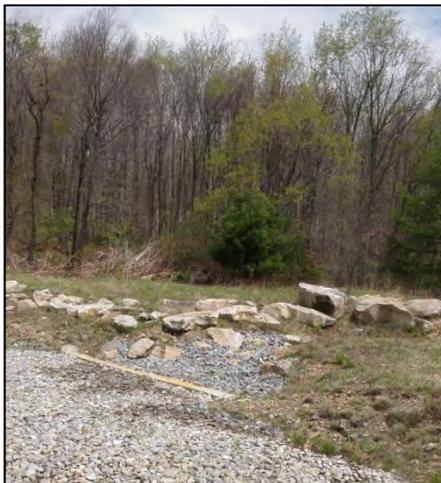
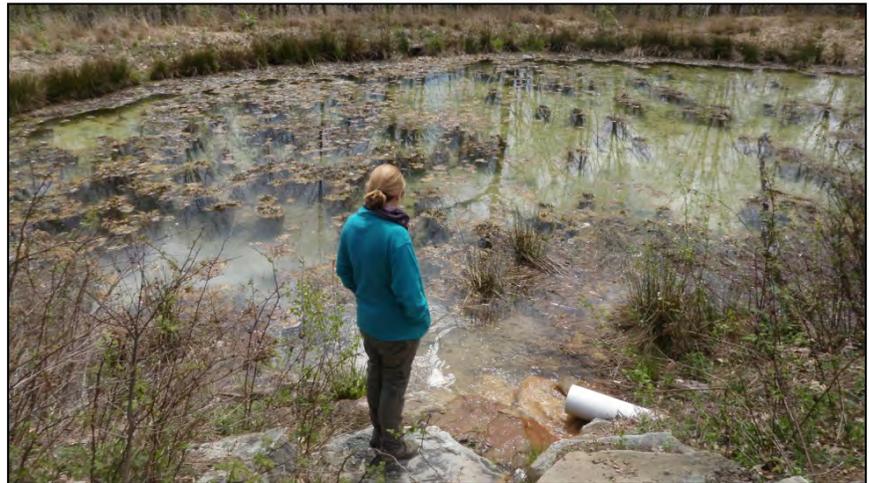
### South Fork Brence AMD85 Photos

At the South Fork Brence Pond (AMD 85), the limestone bed is becoming plugged with metal precipitates as evidenced by increasing water level (Top Left). In recent months stoplogs from the Agri Drain box have been removed to prevent water from exiting through the emergency spillway (Bottom Left). Water enters the system via a perforated distribution pipe (Top Left) and the effluent is collected by a "pipe tree" manifold system (Top Right). Flow enters the settling pond directly across from the outlet (Bottom Right) and likely could use a baffle curtain to prevent short-circuiting. The pond also contains a lot of algae and plants and may need to be cleaned in the near future.

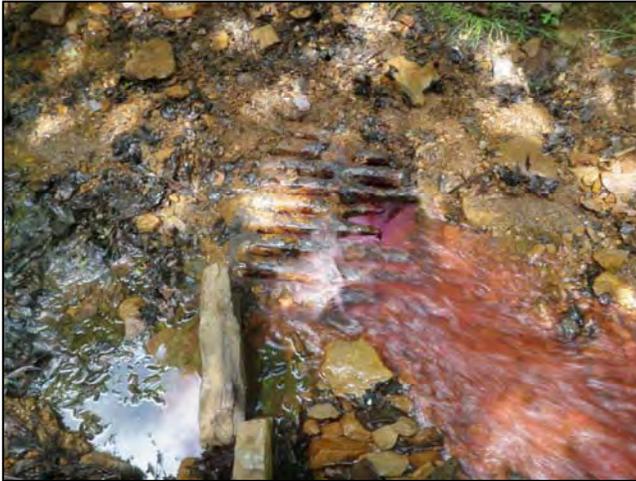
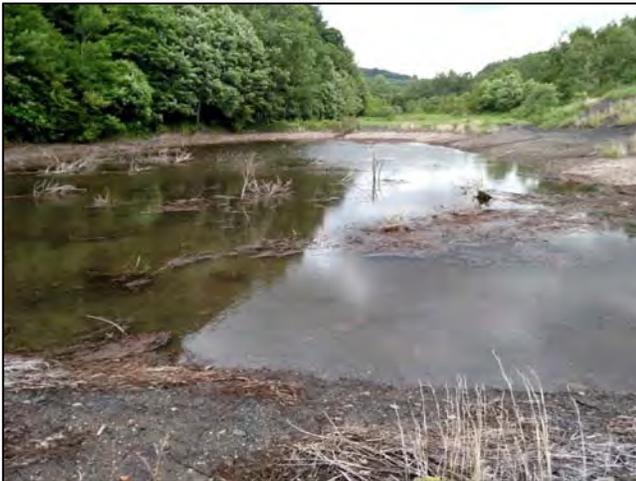
### AMD & ART Photos

The Vintondale #3 abandoned mine discharge flows out of the underground mine, over a hill, through a culvert under the road and is collected by a grate-covered catchment basin (Top Left). When the grate is covered by leaves and sediment or during high flows, a portion or all of the water can bypass the system. After cleaning the grate, the water flows into the basin and treatment system. As the photo demonstrates, the grate has been corroded by the water and pieces are now missing, allowing more debris, rocks, etc. to enter the system. A better collection system is needed. From the catchment basin, a pipe conveys the water to the treatment system. The pipe largely lies along the ground and is broken or leaking in various locations. Local teenagers have taken the initiative to try to “bandage” the pipe (Top Right) in places with limited success. All of the ponds within the treatment system were constructed within coal refuse (Bottom Left). Since the ponds were not lined, they leak very badly. Even when over 200 gpm was entering the system, no water was being discharged at the final effluent (Bottom Right). The ponds need to be lined in order for the water to be fully treated.

- Complete a design to rehabilitate and upgrade the existing system;
- Replace the existing collection and pipe conveyance system;
- Install liners (type to be determined) in all ponds;
- Reconfigure treatment ponds 1 through 6 to provide additional treatment capacity

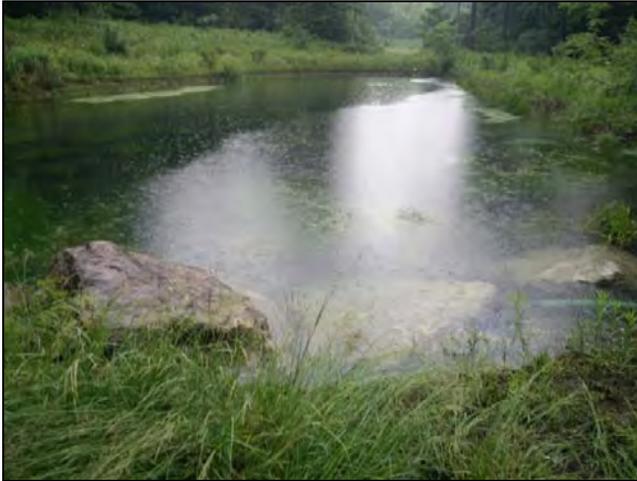
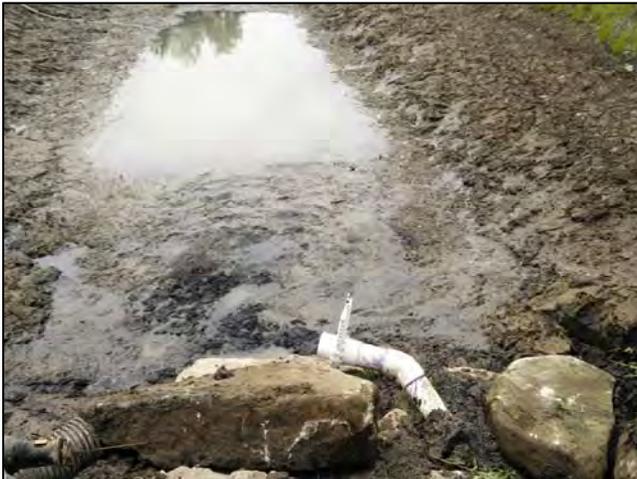
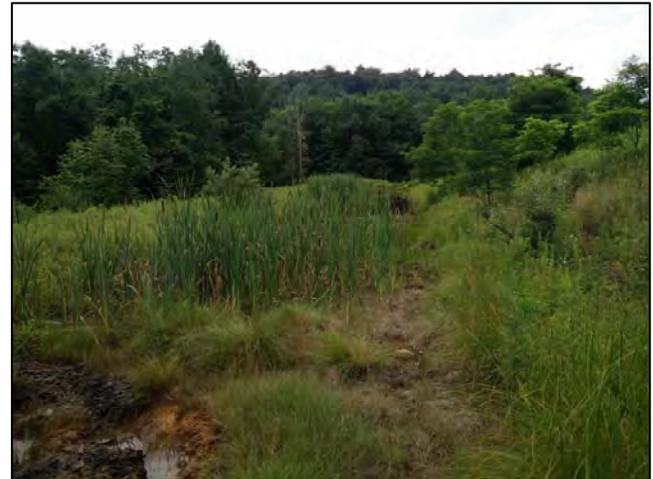
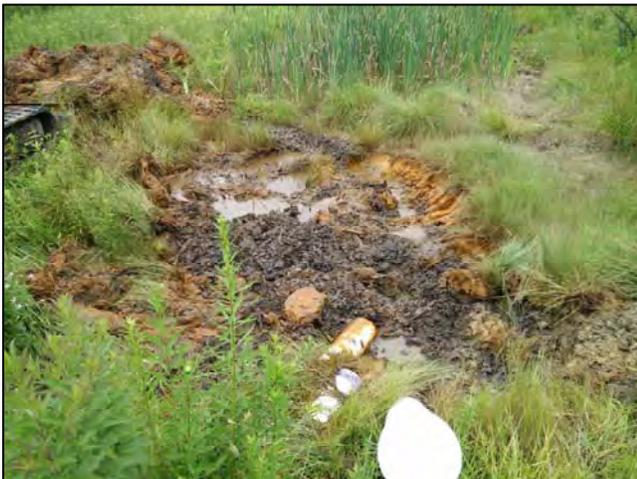
### Coal Pit Run Upper and Lower Systems Photos

The permeability of the Coal Pit Upper Vertical Flow Pond had decreased and was flowing over the berm (Top Left). The pond was drained and stirred (Top Right). The valve for flushing the pond had broken and was replaced (Middle Left). Vegetation, sludge, and debris had accumulated around the influent pipe of the Lower system (Middle Right) which made sampling difficult. The material was removed (Bottom Left).

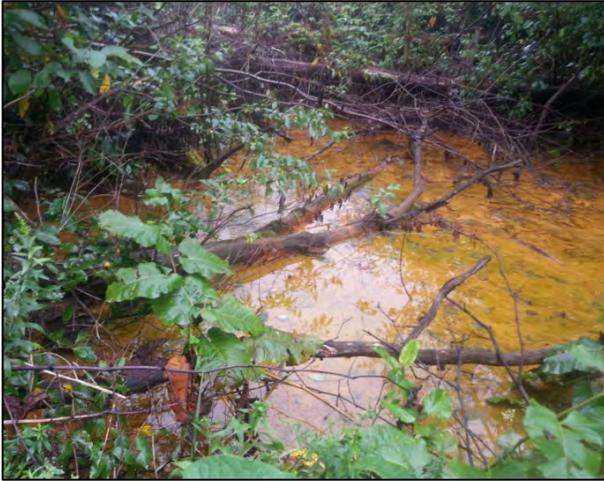
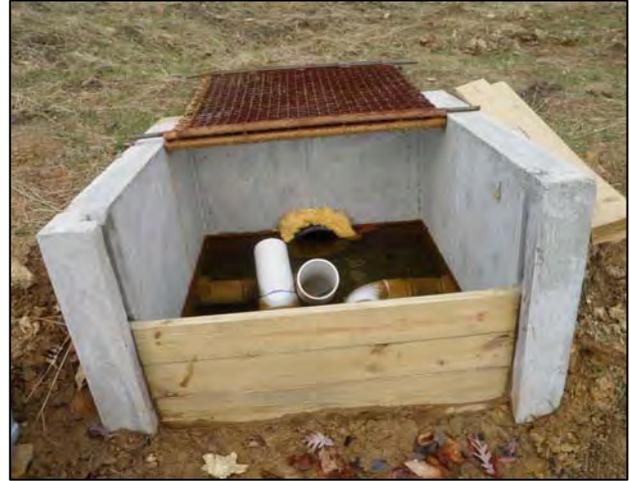
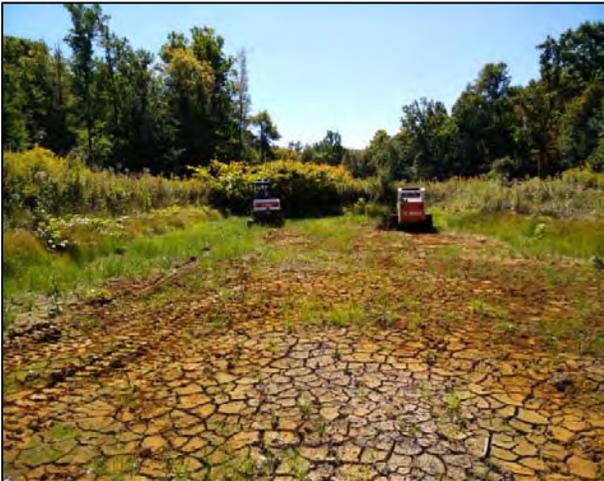
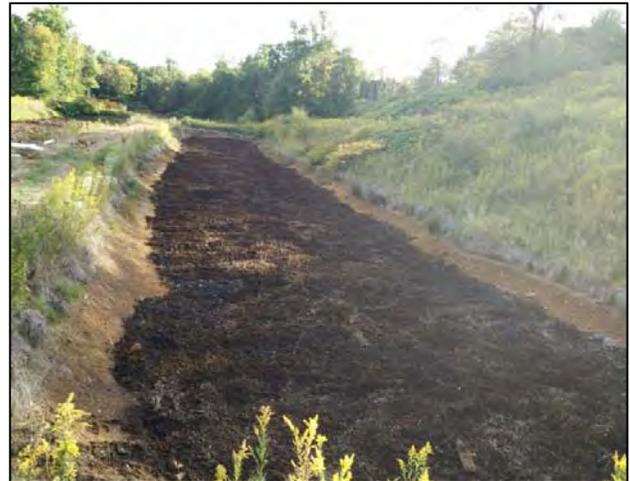
### Laurel Run #1 (North) Photos

The underground collection system had become plugged causing AMD to upwell to the surface and bypass system (Top Left). A new collection and flow splitter system was installed by Amerikohl during mining (Top Right). After replacing the valves, a skid-loader and small excavator were used to stir the upper 2 to 3 feet of the treatment media of the existing Vertical Flow Ponds to increase permeability and promote better utilization of the treatment media. Compare before stirring the media (Middle Left) with after stirring (Middle Right). As part of the surface mine permit conditions, Amerikohl converted a settling basin to a third Vertical Flow Pond (Bottom Left) to provide greater treatment capacity especially during high flow periods.

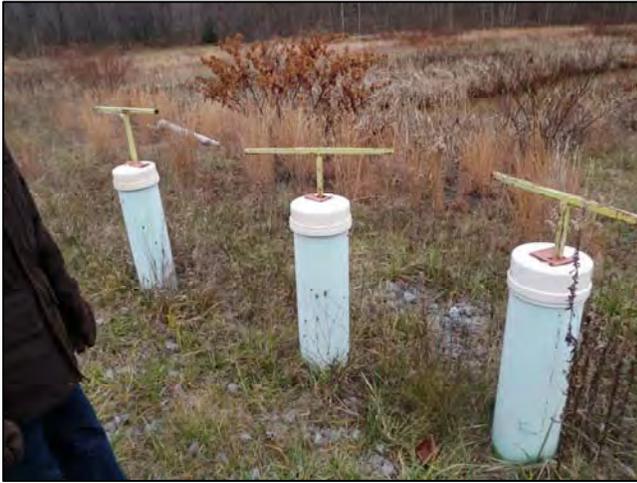
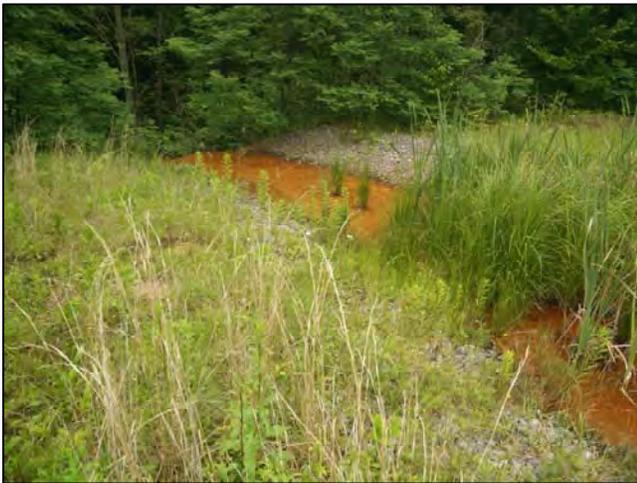
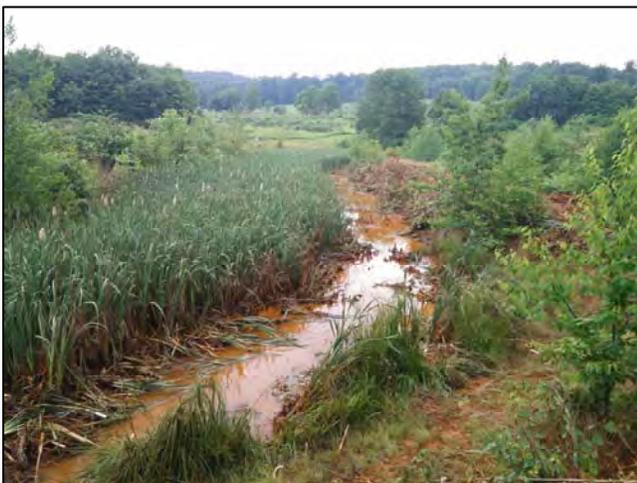
### Laurel Run #2 (South) Photos

A set of valves (Top Left) control the abandoned underground mine discharge to the Laurel Run #2 passive system. The Vertical Flow Ponds discharge to a settling pond (Top Right) followed by a wetland before discharging to the stream (Center Left). The vegetation within the wetland was so successful (Center Right) it caused the water to dam up and flow out of the emergency spillway therefore bypassing treatment. The SRI TAG program was utilized to clean out vegetation to open up pathways (Bottom Left) and restore flow through the system.

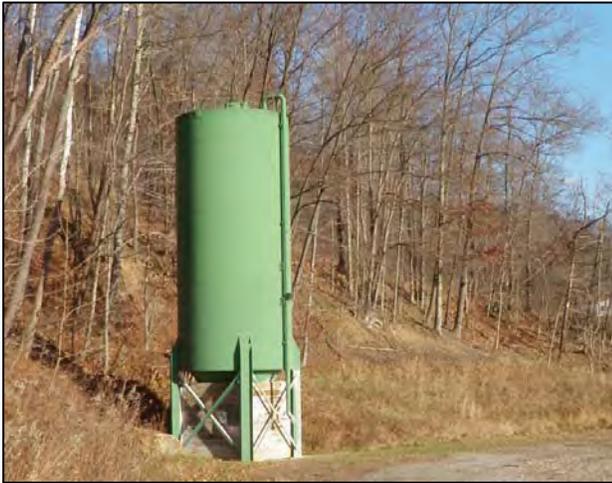
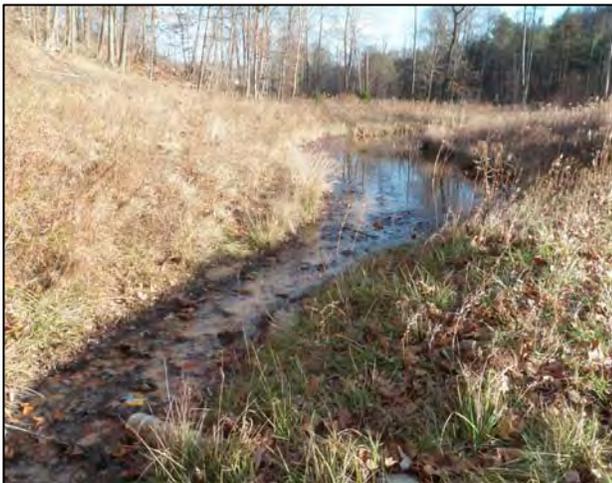
### Lucerne 3A Photos

The Lucerne 3A treatment system consists of a lime doser (Top Left) and settling pond/wetland (Center Left and Right). A broken valve (Top Right) was replaced through SRI's O&M TAG grant. The system could greatly benefit from having additional treatment pond area for settling of solids. Use of the large existing mitigation wetland (Bottom Left) would be ideal. It may be possible to expand the existing treatment system to the east and south. Adding windowed baffle curtains would also be beneficial to help settle solids.

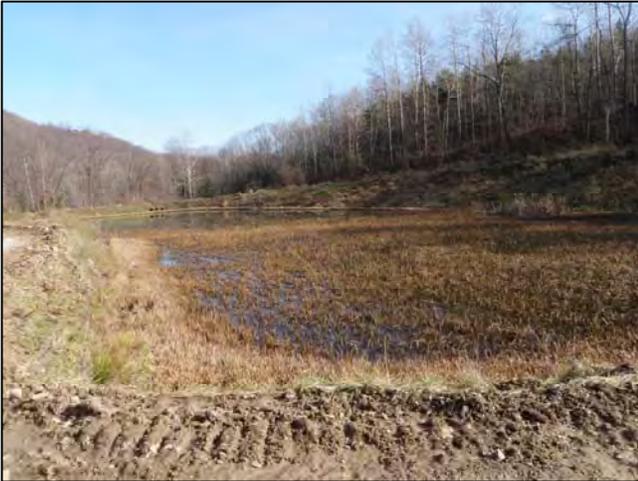
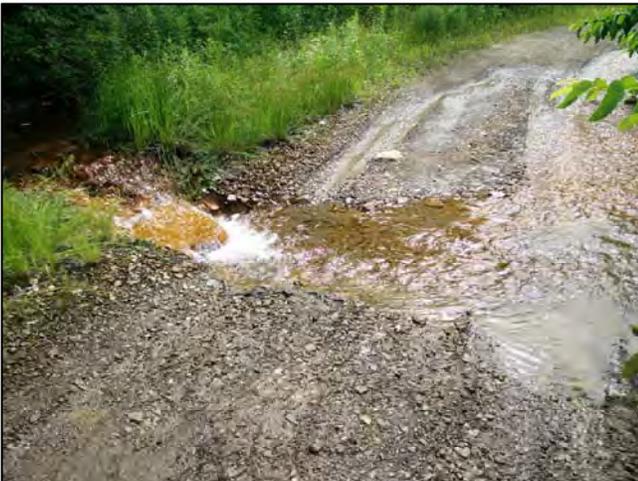
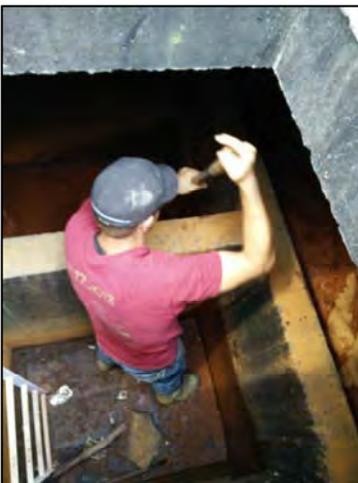
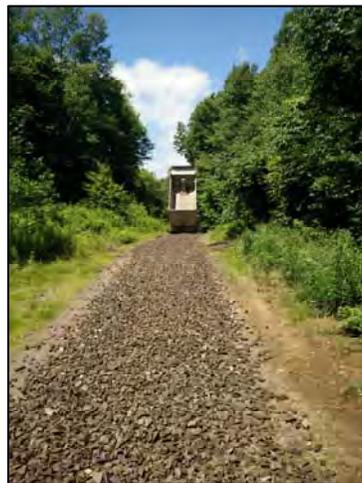
## Penn Hills #2 Photos

At the Penn Hills #2 system, the BCWA was concerned about vegetation growing within the Vertical Flow Reactors (Top Left) and the deterioration of pond liners (Top Right). An untreated mine discharge was flowing across and eroding the long access road (Center Left) to the system. A culvert was installed and the road repaired (Bottom Right) under SRI's O&M TAG program. An unknown pond structure which received AMD was overflowing and impacting the access road around the system (Center Right). This was also fixed through the O&M TAG program. Iron in the flow splitter box was also removed (Bottom Left) to return even flow distribution to the VFRs.

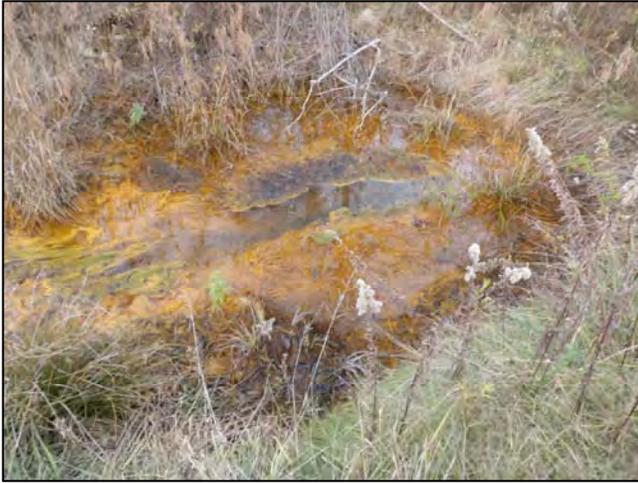
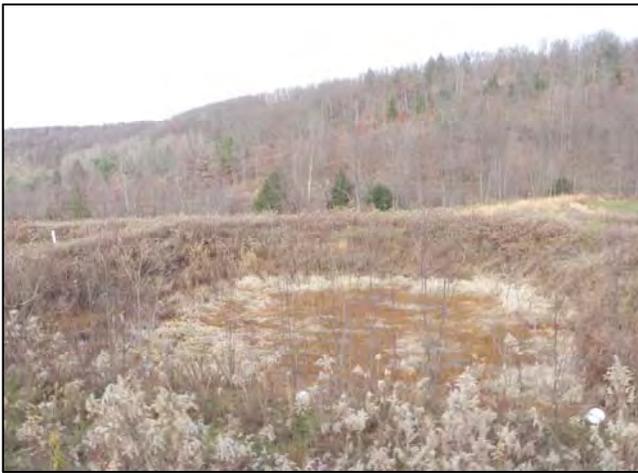
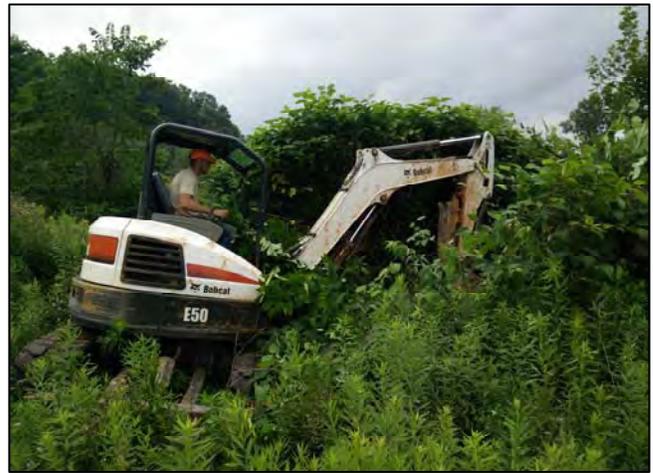
At the Richards Passive Treatment complex, the intake and conveyance pipe had become plugged (Top Left) causing most of the water to flow through a culvert and bypass the treatment system (Top Right). Additional plugged pipes from the flow splitter prevented water from getting to two of the VFR ponds (Center Left). An overgrowth of vegetation was causing difficulties for StreamTeam to sample, which needed to be removed (Center Right). After vegetation removal occurred, valve boxes were able to be located (Bottom Left).

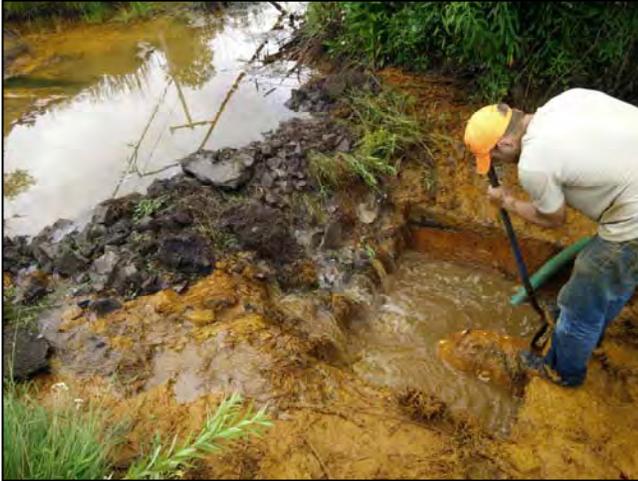
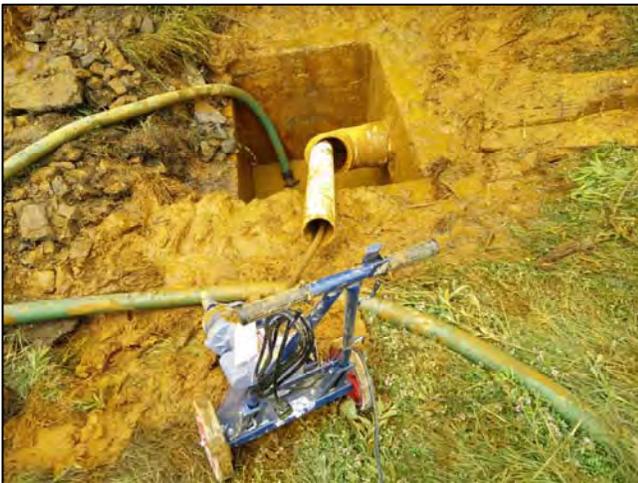
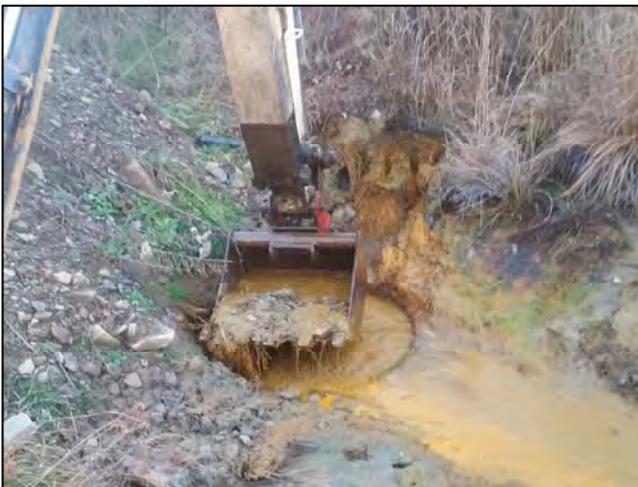
Water within the drop inlet box had to be pumped in order to access and clean the box (Top Left). The conveyance pipe to the treatment system was plugged (Top Right) as well as the piping from the flow splitter box to two of the VFRs. These were cleaned out using a power snake (Center Left). Debris that had accumulated with the mine discharge pipe was also removed (Center Right). Seeps from the leaking Settling Pond and potential other sources flow into South Branch Two Lick Creek (Bottom Left).

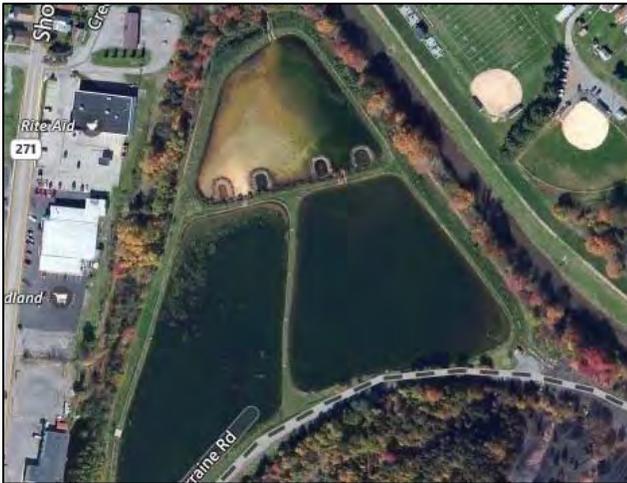
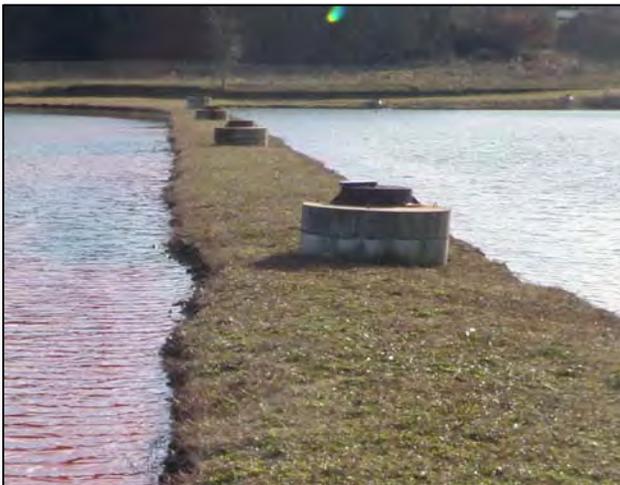
After two years of operation, the treatment effectiveness of the Webster passive treatment system (Top Left) suddenly and dramatically declined. The flow distribution piping system for VFP1 is currently underwater (Top Right) indicating the media or piping system may be plugged. A flow splitter device was not used at the site. Instead the AMD has to flow across the 3.5 acre VFP1 into VFP2 via valved pipes in manholes located in the berm between the ponds (Bottom Left). Unfortunately, these manholes were not built flush with the ground so trucks and equipment cannot easily reach critical parts of the system to conduct maintenance. Fencing around the outer perimeter (Bottom Right) causes similar problems in some locations.

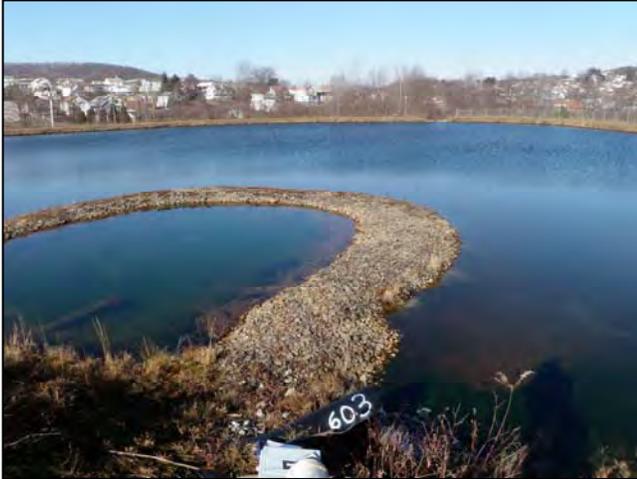
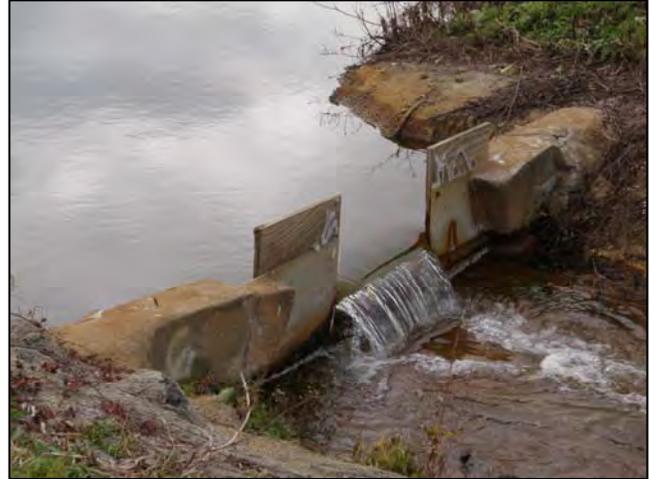
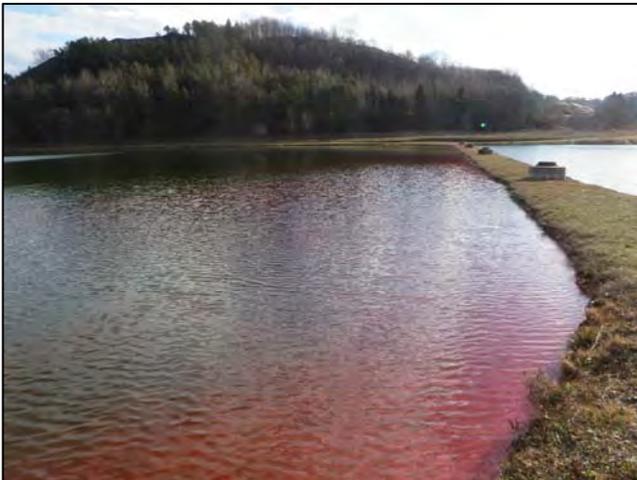
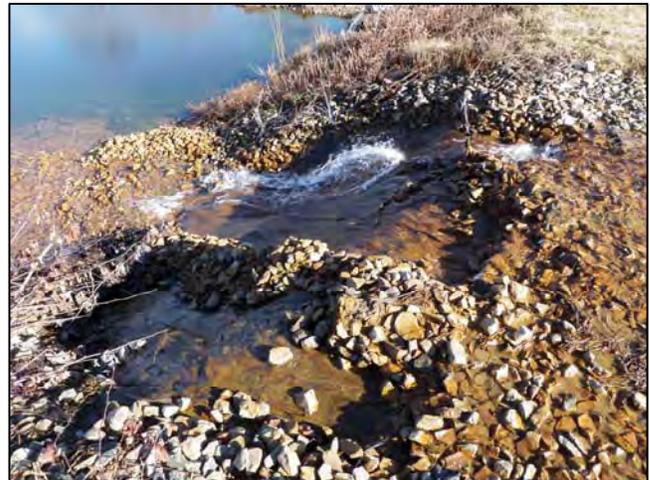
Another design issue that impedes maintenance is that the water elevation in the wetland is higher than both the underdrain and the outlet of the flush pipe (Top Left), making draining the VFPs by gravity impossible. Adding to the problem is the weir (Top Right) which has increased the water level further. The water depth of the wetland is also too deep for wetland plants to survive, including cattails. Dye tests of both ponds were conducted, but were largely ineffective. In VFP2, the dye test (Bottom Left) did indicate that the water was not spreading out over the pond and was mostly flowing along the berm and over the emergency spillway (Bottom Right). Erosion at the emergency spillway indicates that at times much higher flow rates occur at this location.

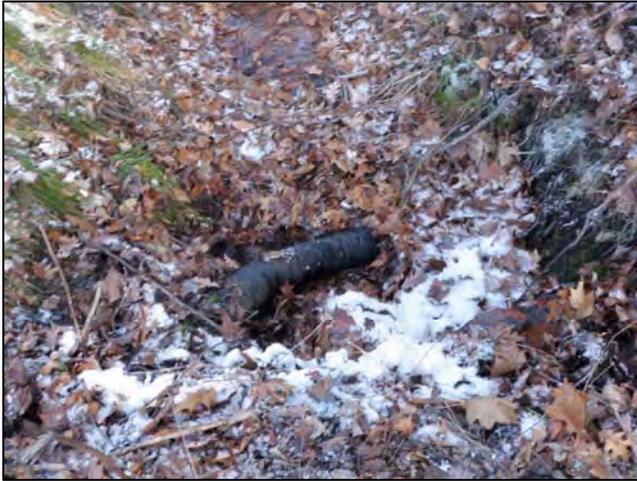
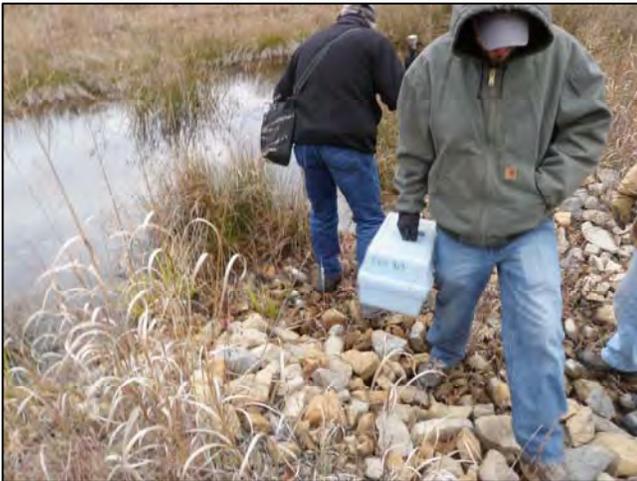
At the Yellow Creek 1A passive system, mine drainage is collected by a perforated pipe (Top Left) and then conveyed under the highway to the collection pond of the treatment system. A dike was also built to keep clean water out of the system. As lower flow rates are entering the system, the collection system probably needs to be repaired. Water from the collection system then flows into the wetland (Top Right). Accumulation of vegetation and debris possibly combined with elevation problems of the spillways are likely the cause of water flowing out of the emergency spillway of the collection pond (Bottom Left) causing more water to bypass the system. The treatment media within the VFR (Bottom Right) likely needs to be stirred and possibly replaced.

Over the life of the system, the Yellow Creek 1A passive system has often not performed well, except for the last 5 years. This is likely due to a much lower flow rate now entering the system. The reason for the lower flow rate is not currently entirely known, but is at least partly due to water bypassing the system. There may be an issue with the collection pipe, which would need to be cleaned out and repaired. A more thorough investigation should probably be conducted. The change in performance at lower flow may indicate that the system was previously undersized, which may have been unavoidable due to the constraints of the access road, water line, gas line, stream, and wetlands. The age and condition of the treatment media is currently unknown. An attempt to stir the treatment media could be conducted to try to improve permeability and treatment effectiveness before or while trying to seek funding to rebuild the system. Other simple O&M tasks would include removing debris and vegetation from spillways and channels that are impeding water flow, adjusting spillway elevations, or installing elbows to control water elevations. Once the O&M is completed, additional monitoring should be conducted to evaluate the improvements and identify additional needs. A more thorough evaluation should be conducted to evaluate the existing design and potentially develop a different design before seeking funding to rebuild. During the evaluation, it is recommended to measure the elevations associated with the collection pond, wetland, VFR, and emergency spillways. SRI's O&M TAG program could be utilized to complete these tasks.

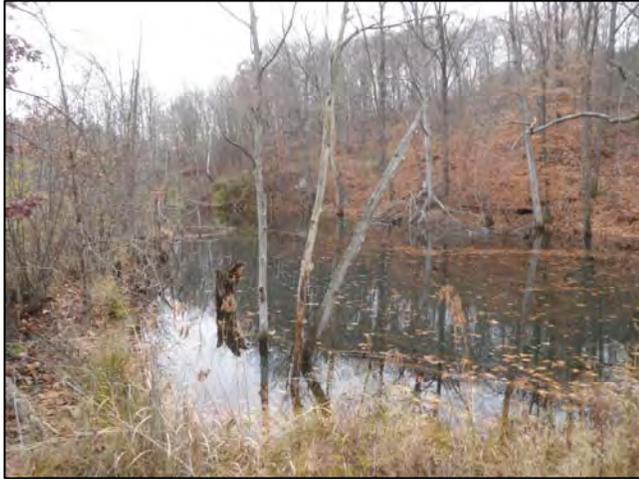
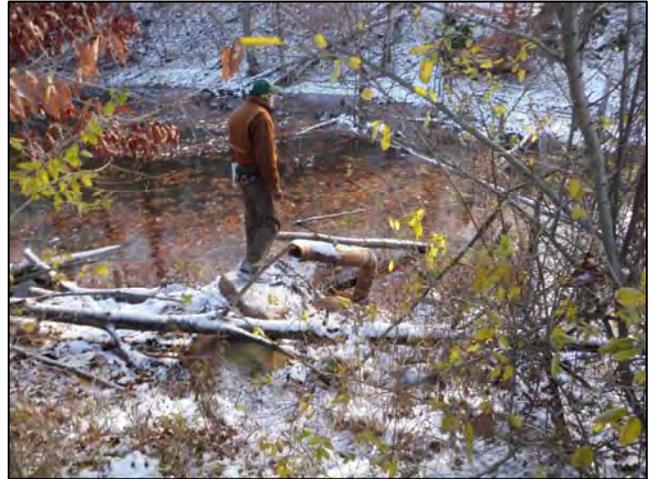
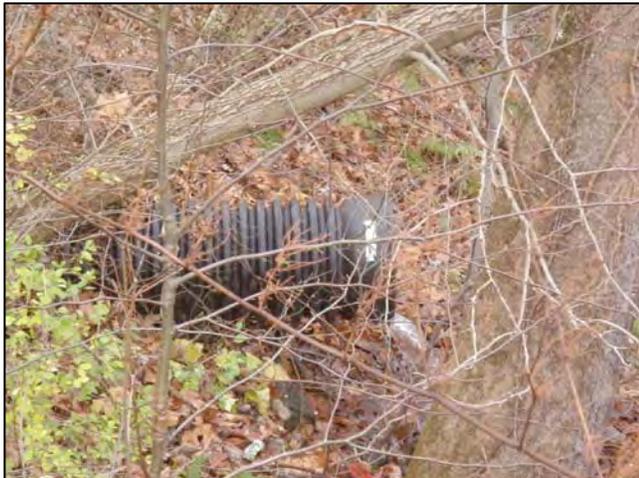
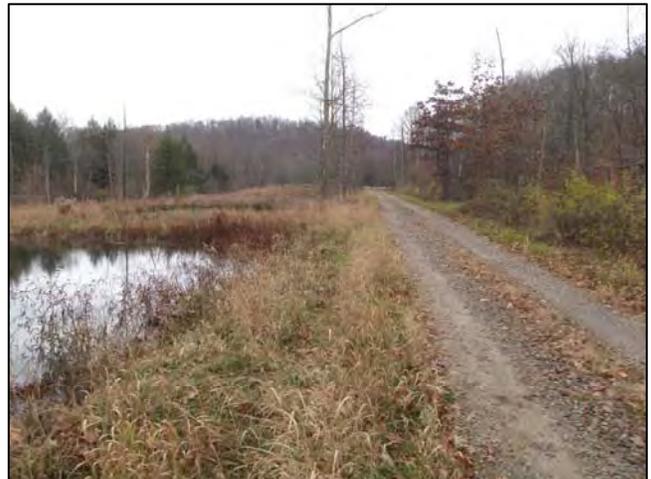
At the Yellow Creek 1B passive system, the mine drainage is first collected in a series of ponds (Top Left) and then conveyed under the access road to the Vertical Flow Reactor (Center Right). A gas and water line run parallel with the road. A pipe found at the collection ponds (Top Right) is likely overflow from the 1A system. Permeability problems within the VFR are causing water to bypass the system through a culvert pipe (Center Left). The effluent of the 1A & 1B systems share an outlet channel to Yellow Creek that is clogged with cattails (Bottom Left).

Over the life of the system, the Yellow Creek 1B passive system has often not performed well except for the last several years. This is likely due to a much lower flow rate now entering the system while most of the water is bypassing the system. This would tend to indicate that the system may be undersized, which may have been unavoidable due to the constraints of the access road, water line, gas line, stream, and wetlands. The age and condition of the treatment media is currently unknown. An attempt to stir the treatment media could be conducted to try to improve permeability and treatment effectiveness before or while trying to seek funding to rebuild the system. A more thorough evaluation should be conducted to evaluate the existing design and potentially develop a different design before seeking funding to rebuild. During the evaluation, it is recommended to measure the elevations associated with the collection pond, VFR, and overflow pipe. SRI's O&M TAG program could be utilized to complete both of these tasks.

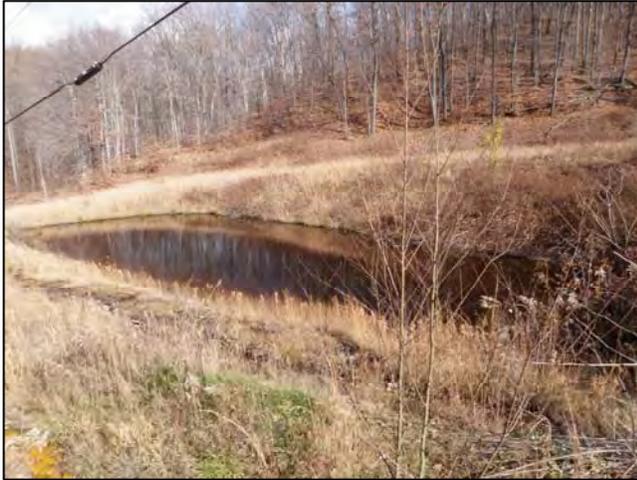
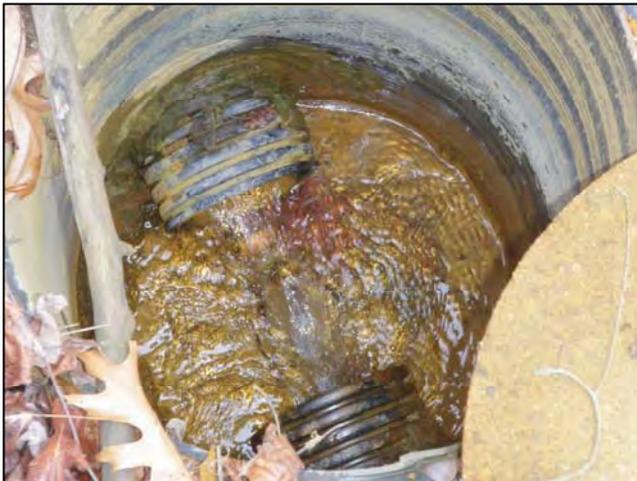
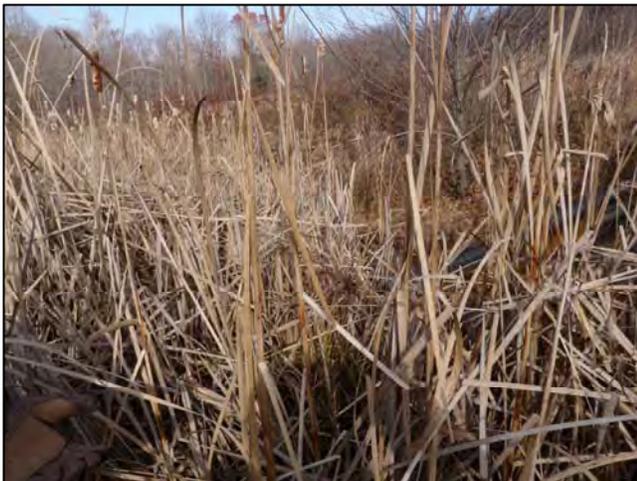
Mine drainage from multiple entries of the Judy #14 mine is first collected in a pond (Top Left) before being conveyed to the 2A & 2B system. Some of the water is bypassing the system (Top Right). A flow splitter device (Center Left) is used to direct AMD into both parts of the system, but reportedly has some issues. VFR 2A (Center Right) is experiencing permeability issues. Dense cattails (Bottom Left) growing in a channel creates a dam that causes the water to overflow and bypass a portion of the treatment system.

- Cattails and other debris should be removed from the ditch located between 2B VFR and the Settling pond.
- The flow splitter to the 2B system needs to be repaired and cleaned out and may need to be excavated & replaced in order to direct flow to the system. If replaced, the system should provide the ability to increase the amount of flow to the 2B system.

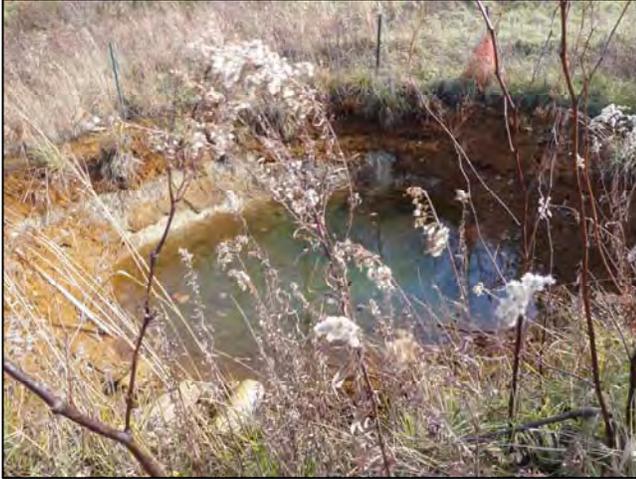
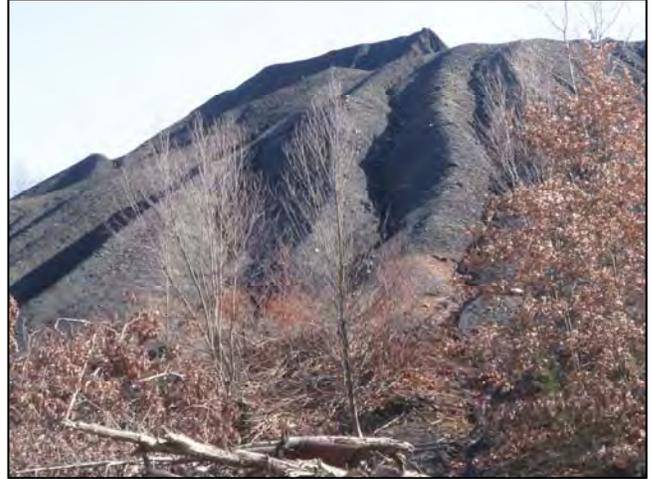
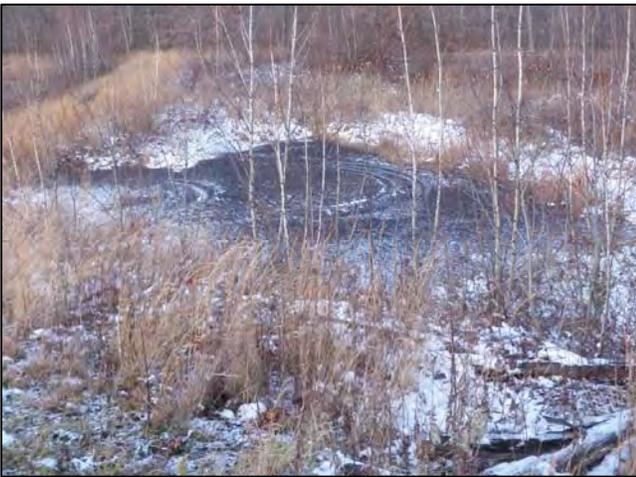
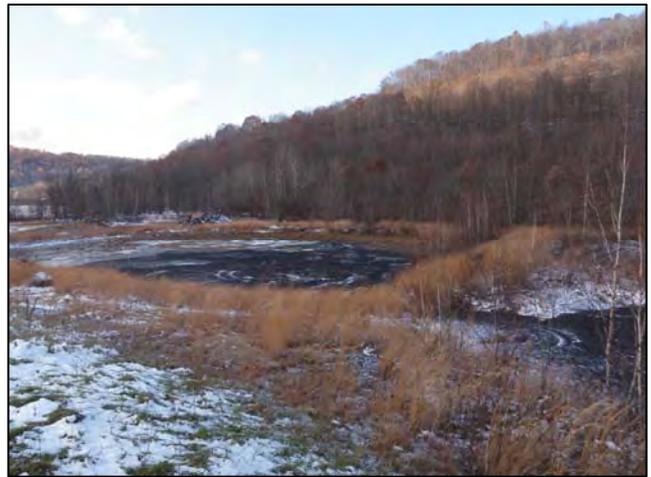
At the Yellow Creek 2C system, the water emanates from the underground mine into the collection pond (Top Left). Reportedly, there is some sort of issue with the conveyance pipe and/or valve that prevents water from entering the passive system. At the time of the site investigations, the water level within the collection pond was below the discharge pipe so water was not able to flow and therefore could not be verified. The Tide coal refuse pile (Top Right) sits across from the system. Erosion of the pile has resulted in the accumulation of a large amount of coal refuse in the settling ponds (Bottom Left and Right). The coal refuse needs to be removed from the system and water directed to the Vertical Flow Reactor.

- Install a diversion ditch to prevent further coal refuse from entering the system.
- Remove coal refuse from settling pond.
- Fix and/or replace the valve and pipe from collection pond to the system as needed.
- Since water has not been flowing through the system for many years, it would make sense to stir the VFR while equipment is on-site.
