# Kiski-Conemaugh Basin Treatment System O&M Assessment Report

December 2017

Prepared by  
Stream Restoration Incorporated and BioMost, Inc.

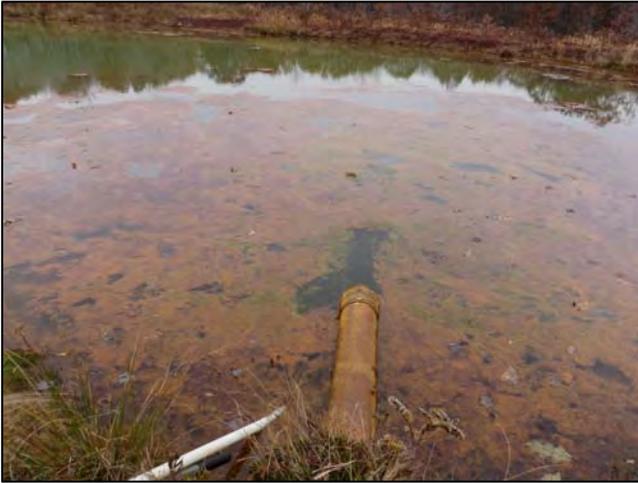
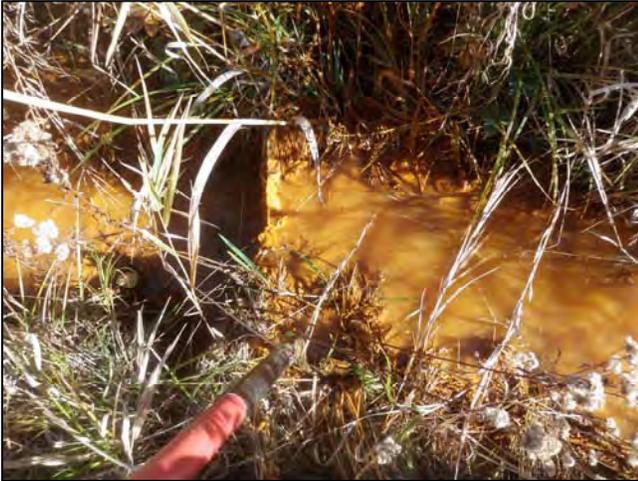
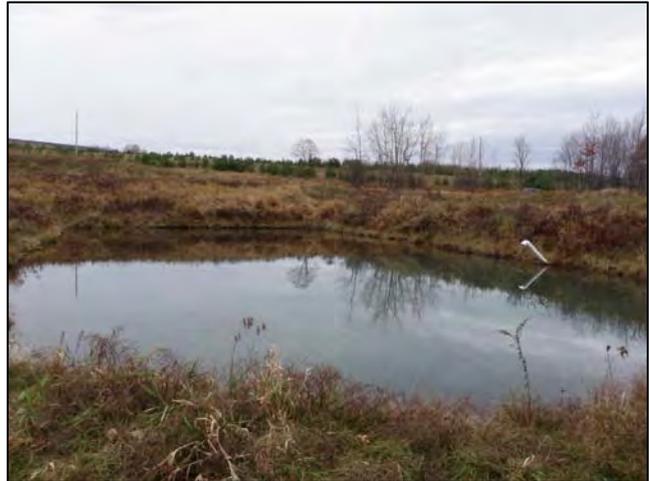
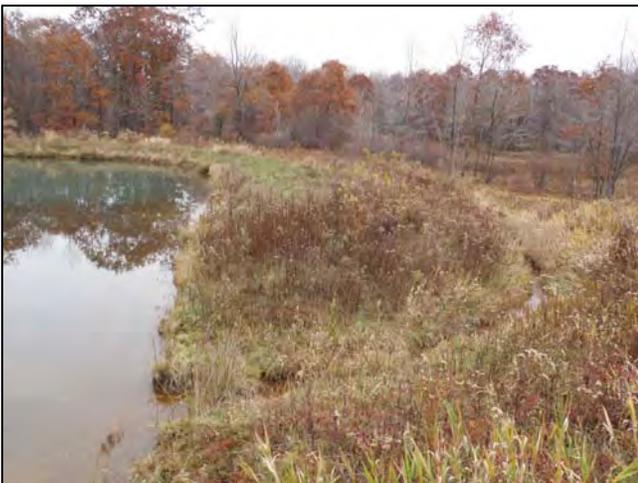
At the Cottagetown passive treatment system, two pipes (Top Left) convey AMD to pond #1 (Top Right). Those pipes were not visible during the inspection due to the high water level within the pond, which was caused by the buildup of iron sludge, vegetation and debris in the channel from the pipe to the weir (Center Left). The effluent pipe of the VFP hangs out over the third pond (Center Right) so much that sampling is very difficult. The effluent of the system (Bottom Left) flows in a channel into a “wetland” and mixes with other sources of mine water before discharging to the stream.

Based upon the available water quality data, the system appears to be functioning well despite the age, water quality and assumed lack of maintenance. It is unknown whether any organization is currently inspecting, monitoring, and/or maintaining the site. If there is currently no viable organization responsible for the site, the Somerset County Conservation District or Shade Creek Watershed Association would be the logical choice to take over responsibility. Current known maintenance issues include the site being overgrown with vegetation, making traveling around the site difficult and potentially hazardous. The site should be mowed. In addition, the accumulation of vegetation, sludge, and debris between the effluent pipe of pond #1 and the VFP will likely be an on-going problem and will need to periodically be removed to prevent water from becoming dammed up and bypassing the system. Also, as the VFP is now about 18 years old and the design life is unknown, there will likely be a need to replace the media in the near future.

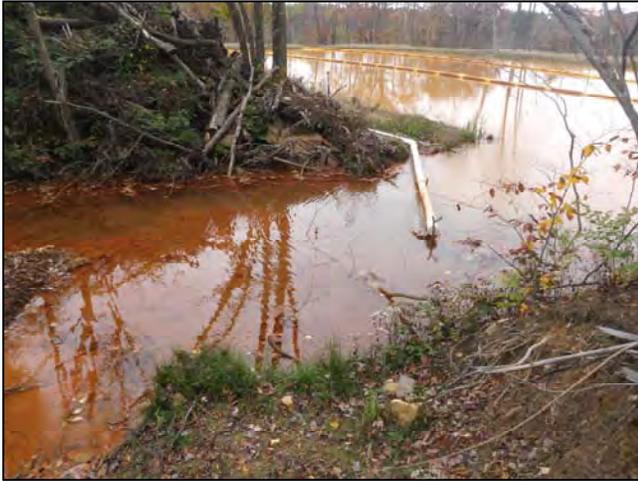
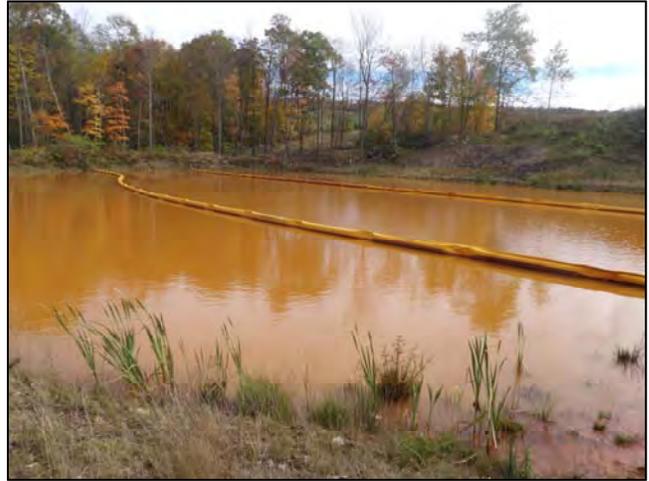
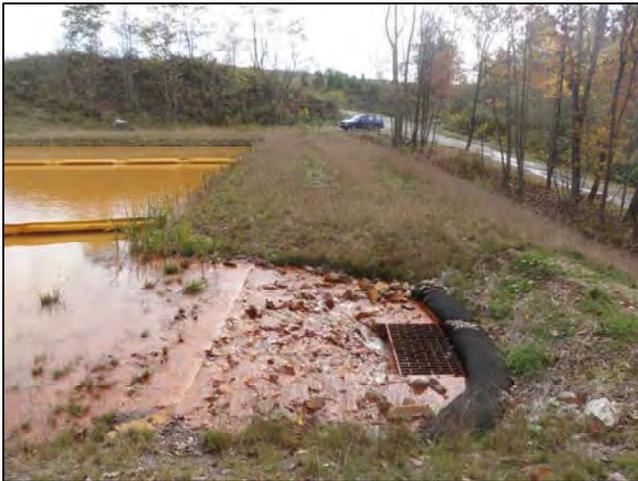
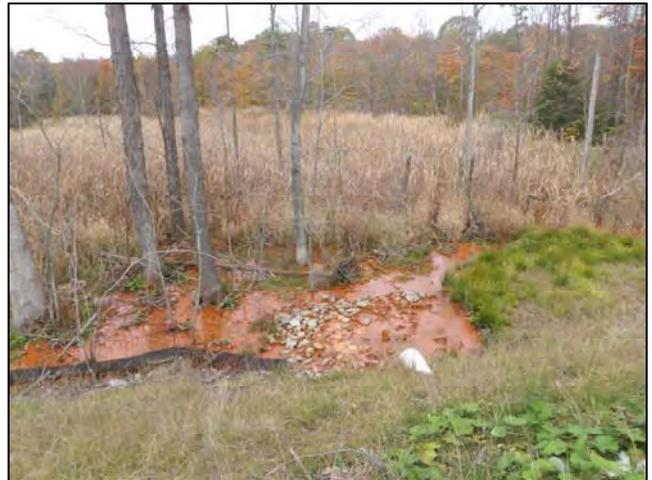
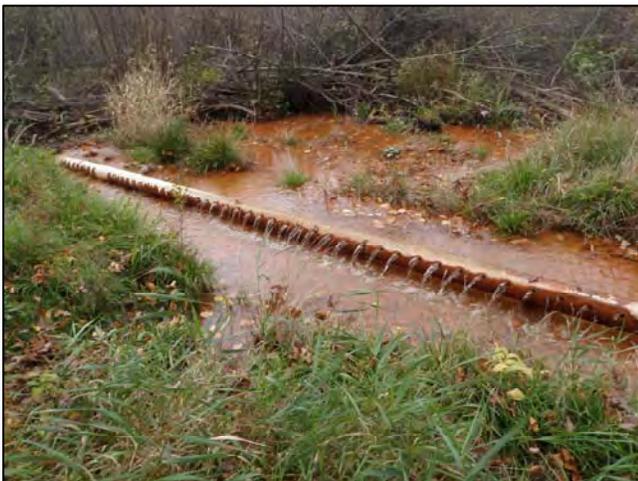
At the Hinemyer passive system, alkaline water was conveyed from the nearby PBS Coals, Inc. treatment system via pipe to mix with acidic H1 (A-1) discharge (Top Left). The water then mixes and flows into a single baffled settling pond (Top Right). Under normal flow conditions, the system discharges through 2 different grate covered inlet boxes (Center Left). One outlets to a wetland area next to the treatment system via a pipe (Center Right). The other outlets to another wetland area on the opposite side of the road via a perforated PVC pipe (Bottom Left.)

- Measure and report flow during every sampling event for the influent and effluent sample points;
- If possible, try to collect effluent samples of the existing wetland to determine if additional treatment may be needed.
- The system should be reevaluated after additional data is obtained;
- There is probably sufficient elevation change to install a trompe for additional aeration

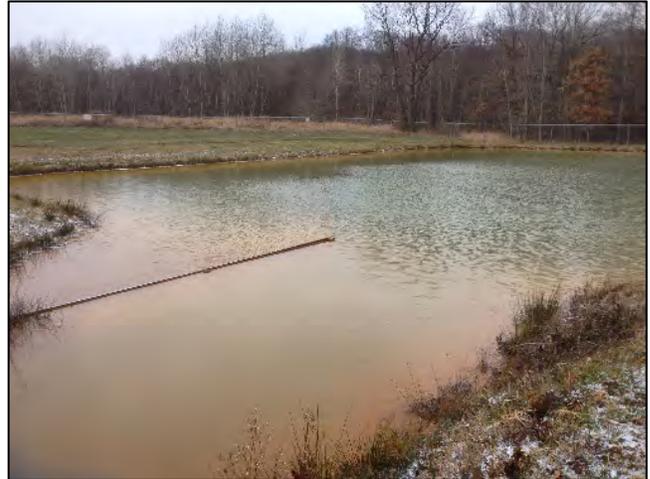
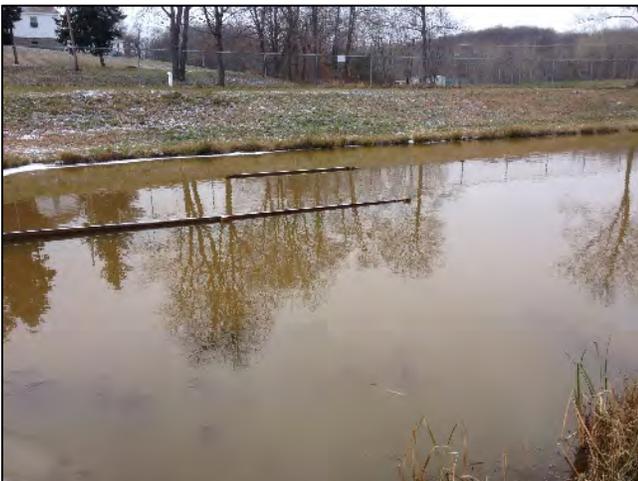
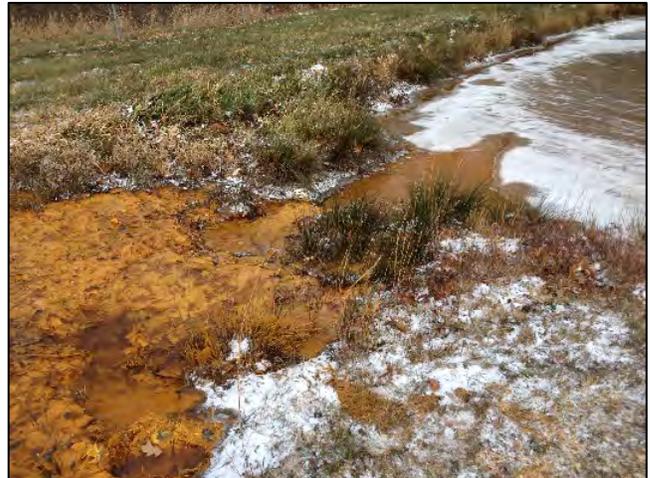
- The baffles in both the first aeration pond and the final settling pond have been over-topped. The wooden structures are failing and allowing short-circuiting to occur in both sections of the system.
- A large amount of sludge has accumulated in the spillway between the aeration pond and the VFP. This may also be causing water to back up in the first pond.
- The flume at the final outfall is both hard to access and is difficult to measure flow.
- StreamTeam volunteers have noted an active bee nest reoccurring in the brick box and metal pipes that make up the raw-discharge housing.

At the Jenners passive system, the AMD emanates from an old municipal water supply well (Top Left). A build up of iron sludge and failing wooden baffles may be causing short-circuiting within the first settling/aeration pond (Top Right and Bottom Left). The wooden baffles could be replaced with directional curtain baffles. Iron precipitates within the spillway between the first settling/ aeration pond and the vertical flow pond (Bottom Right) are likely increasing water levels within the ponds.

- Baffles should be replaced or repaired; however, the effluent water quality does not currently appear to be impacted. The wooden baffles could be replaced with directional curtain baffles.
- Iron sludge and debris should be removed from the spillways which are contributing to increased water levels within the ponds.
- A large amount of iron is being deposited on the surface of the VFP. Eventually the accumulation may reduce permeability, which could cause water to back up and bypass the system. This iron may need to be removed before the design life of the VFP is reached.
- Access to the flume should be improved

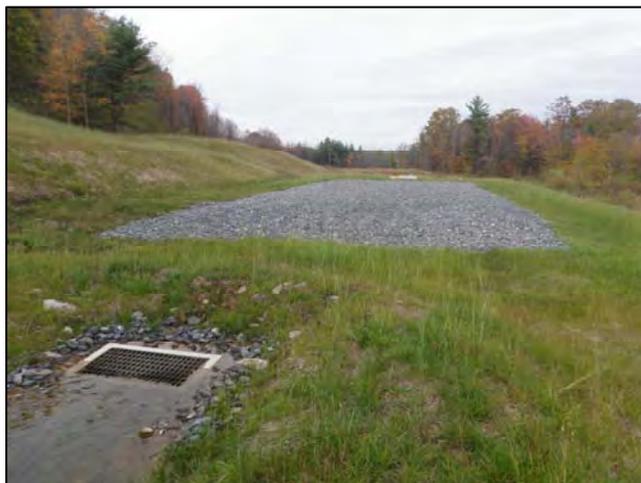
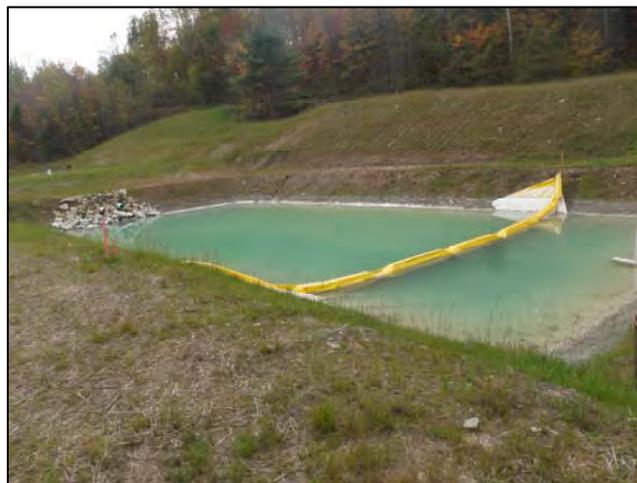
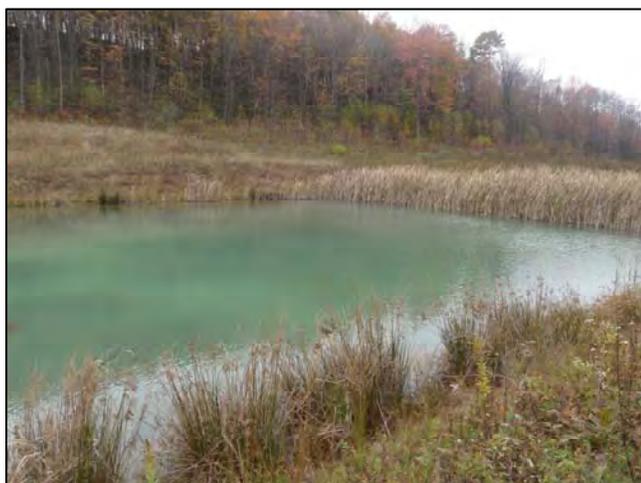
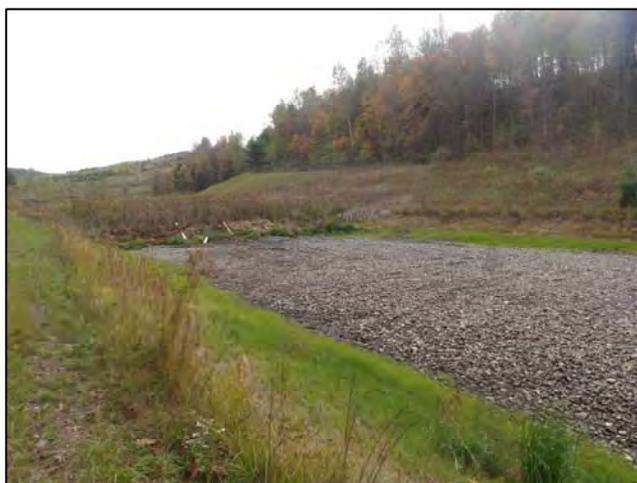
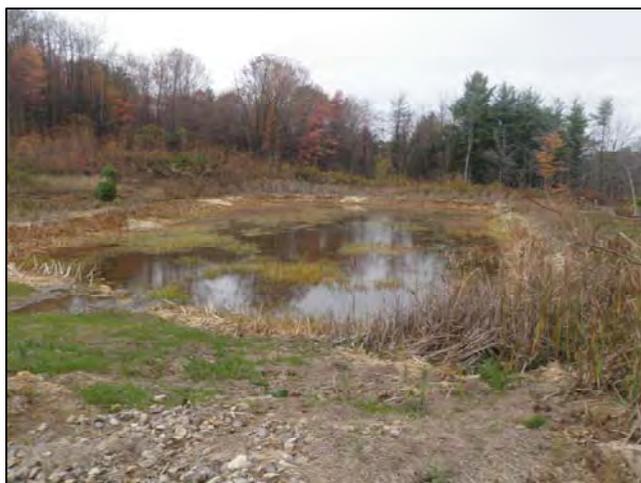
The original passive treatment system functioned well for the first couple of years and then performance quickly and dramatically declined. This would tend to indicate development of short-circuiting pathways. The rehabilitated system now appears to be working well; however, this conclusion is based upon one sampling event shortly after the rehabilitation was completed. The design drawings indicated that an up-flow, auto-flushing limestone bed was utilized in the new system. The up-flow systems have been known to experience major maintenance problems, especially in relation to plugging of the treatment media at the bottom of the pond near where the water enters the stone, which can cause the water to backup and even bypass the system. It is recommended that the system be regularly inspected at least once per quarter to ensure proper function. If the up-flow system becomes a problem, the system could be modified to an auto-flushing VFP by eliminating the inlet box and extending the channel to the limestone pond so that the water enters at the top of the stone.

The Lamberts Run passive treatment system was rehabilitated and expanded in 2013. The AMD is conveyed by a channel to an inlet box where the water then enters an auto-flushing, up-flow limestone bed (Top Left) which flushes into a baffled settling pond (Top Right). Water then flows into the original settling pond/wetland (Center Left) which then flows into the Vertical Flow Pond (Center Right) where the compost had been removed and which may have been converted into Horizontal Flow limestone bed. The water then flows through a settling pond/wetland before discharging to the stream (Left).

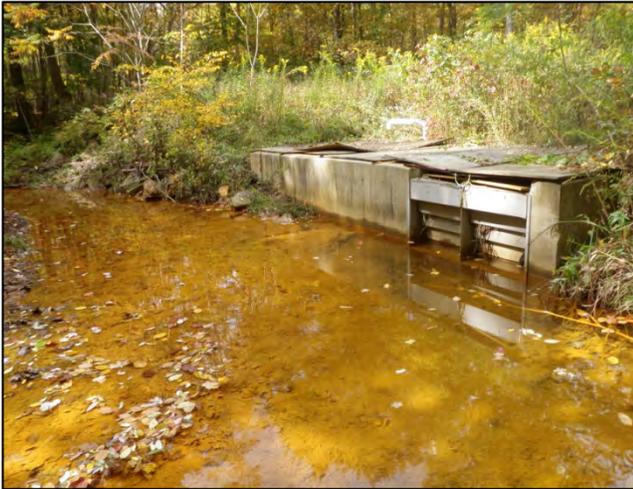
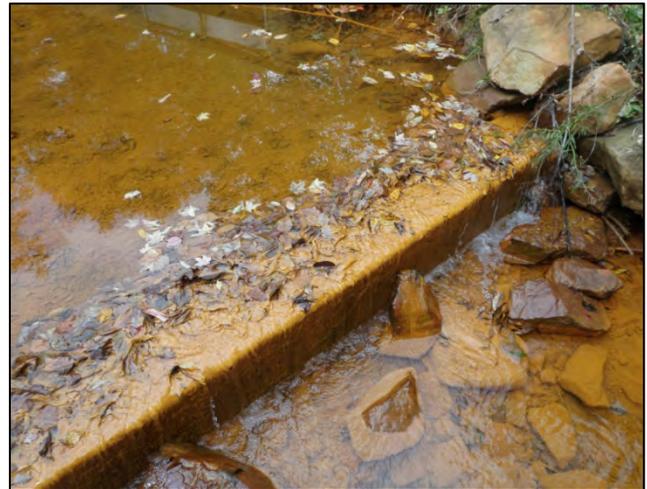
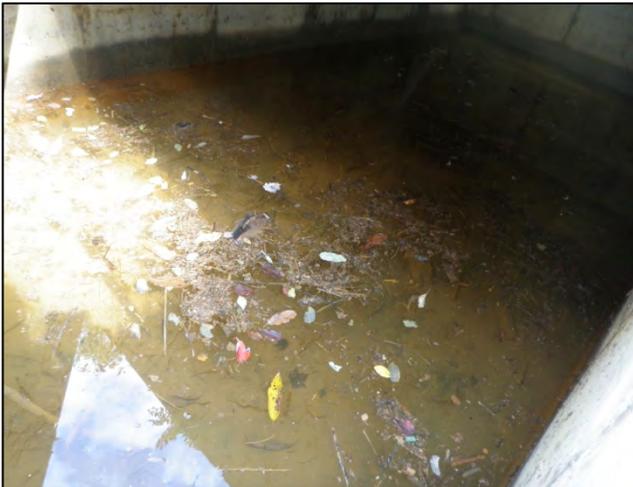
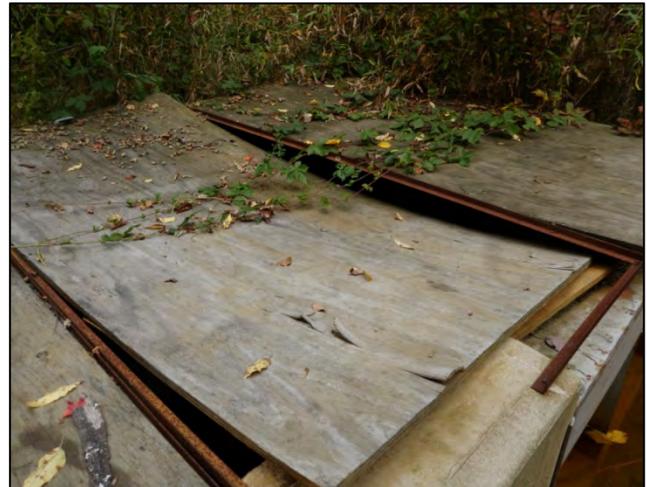
While the AMD that flows through the system is effectively being treated, there is indication that additional problems remain following changes made to the intake system in 2014. As additional investigations have not been completed by SRI and BMI nor sufficient updated information obtained, it is uncertain as to whether the small amount of flow being treated is due to additional/remaining problems with the intake and conveyance pipe or problems with the treatment system itself, which may be inhibiting water flowing through the system and causing the water to bypass the system. Further investigation is recommended. SRI's O&M TAG program could be utilized to complete the investigations. Additional work may be needed at the intake to improve capturing the water. The conveyance pipe may also need to be cleaned. Once sufficient flow is being captured and conveyed to the system, if water is bypassing the system, then that would provide evidence of issues such as plugged pipes, water being dammed by vegetation/debris, and/or reduced permeability of treatment media.

At the Oven Run A Passive Treatment System, a stream intake structure (Top Left) was built to divert up to 200 to 300 gpm of the stream to the passive system, but the flow rate entering the treatment system was significantly less, which may be in response to several issues. It is possible that the conveyance pipe from the intake to the system is plugged and needs to be cleaned by a power-snake, water jetter, etc. Several cleanout manholes can be utilized to provide access to the conveyance pipe. A build-up of sediment and debris in front of the dam (Top Right) may be limiting the flow entering the intake. In addition, the sediment and debris inside the intake structure (Bottom Left) may also be limiting the flow into the system. Also, consider replacing the compromised wooden covers on the intake structure (Bottom Right) as part of general site maintenance and safety.

- Clean sediment and debris from intake structure.
- Replace the cover on the intake structure for safety considerations.
- Clean conveyance pipe with a power snake, water jetter, or similar equipment.
- Consider removing sediment and deepening the area in front of the dam.
- In the future, evaluate and consider moving the intake closer to the system if possible. (Landowners, elevation change, construction conditions, etc. may be potential issues preventing relocation.)
- Potentially increase the height of the dam.
- Re-evaluate the system after water is returned to the system

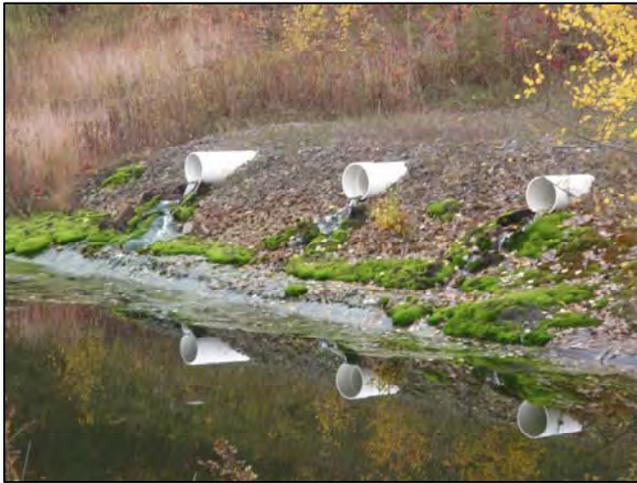
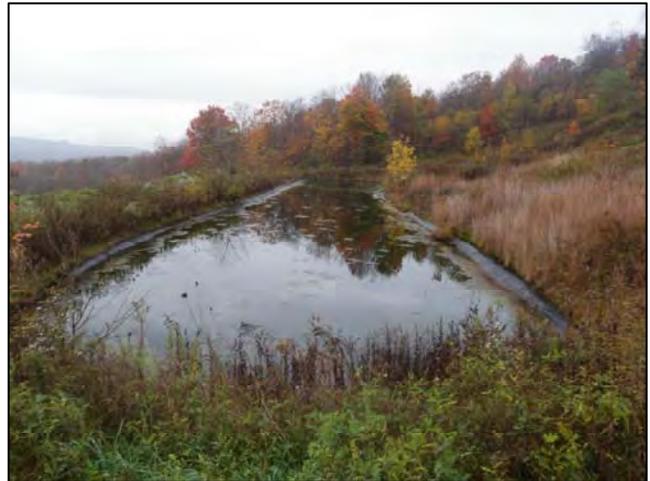
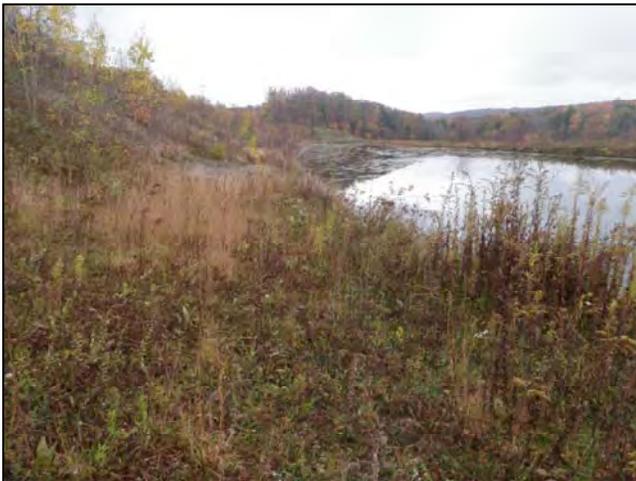
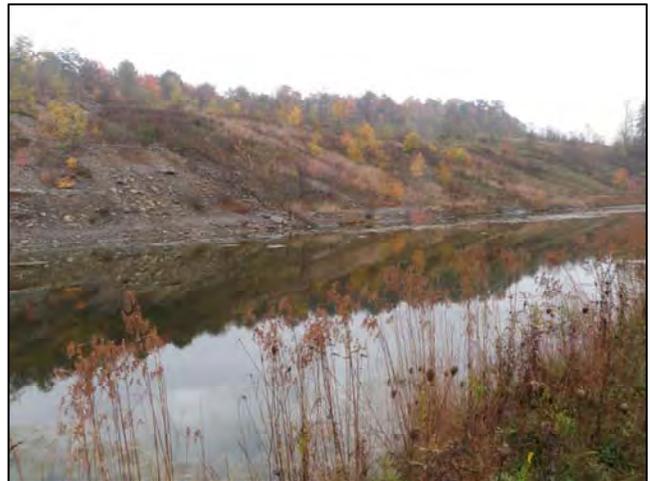
At the Oven Run B system, AMD enters through three sealed deep mine entries (Top Left) which flows into a collection pond (Top Right). It may be possible to convert a portion of the collection pond into an OPC for low pH iron removal, which might be able to be extended along the eastern side of SAP1 (Bottom Left), but the length and width would likely be limited by a rock outcropping (Bottom Right).

Oxidation Precipitation Channel to remove a portion of low-pH iron prior to entering SAP1. Ideally, if possible, the collection pond could be modified into a large limestone channel that would convey the flow to SAP1. Due to the large size of the SAPS ponds at the site and the high flow rate, there is greater risk and greater impact of short-circuiting. To address the issue, an Agri Drain Smart Drain or automatic flushing siphon system could be installed to replace the existing Agri Drain control structures for at least SAP1 and possibly SAP2, which would provide for batch treatment of the mine drainage and regular flushing of the media. Baffle curtains should probably be added to the settling basins if the Smart Drain or siphons are installed to help settle solids. There may be a need to remove the compost and clean the treatment media. The piping throughout the treatment system should be cleaned or possibly replaced. If an extensive rehabilitation is conducted, it may be possible to effectively divide SAP1 into two auto-flushing systems. One potential problem with utilizing the auto-flushing system that needs to be considered is whether there is enough capacity within the settling pond to handle the flushing event. It may be necessary to utilize less stone or perhaps turn part of SAP1 into a flush pond. A more thorough engineering evaluation should be conducted. SRI's O&M TAG program could be utilized to complete the evaluation. In addition, as this is a BAMR project, BioMost, Inc. is currently on BAMR's list of approved contractors to provide services in which design improvements could be completed.

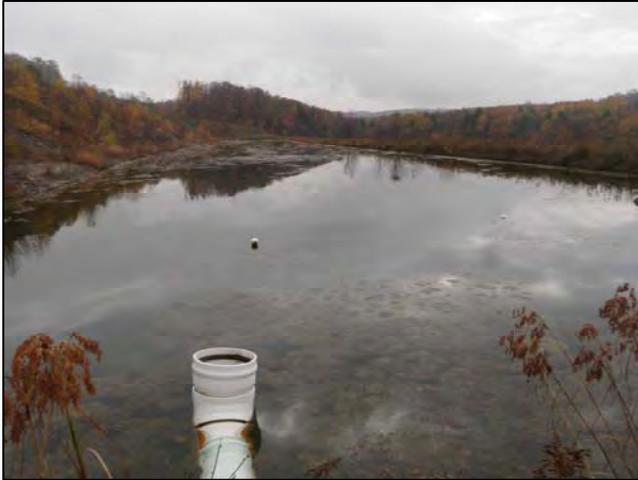
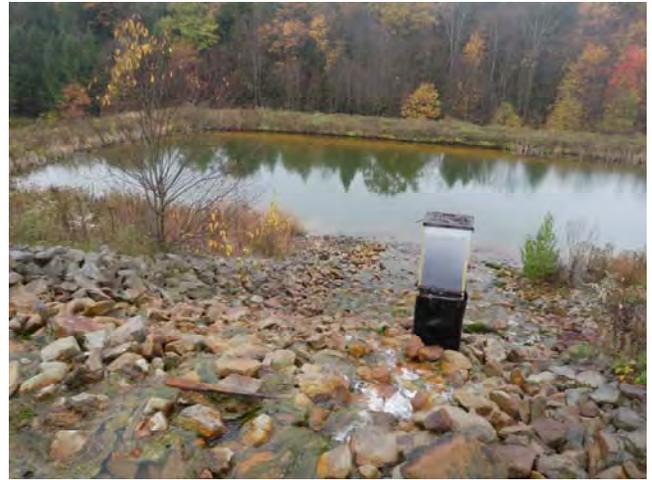
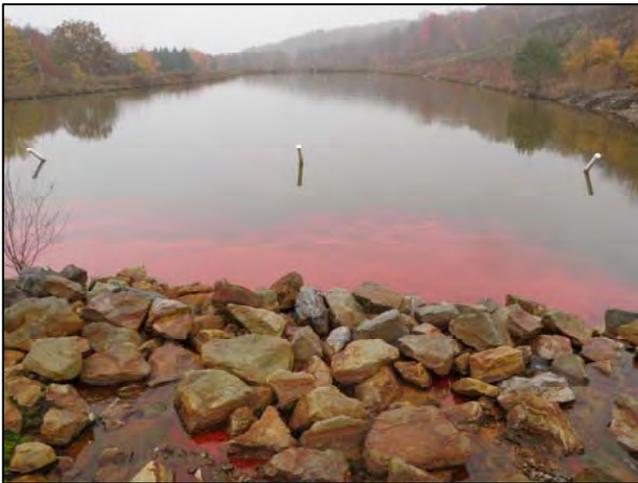
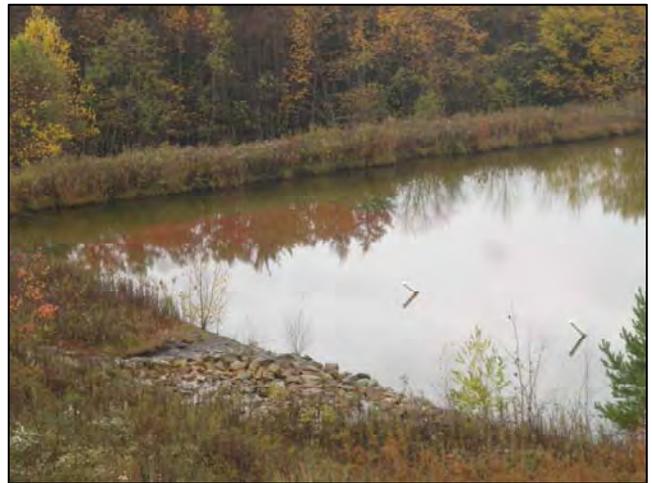
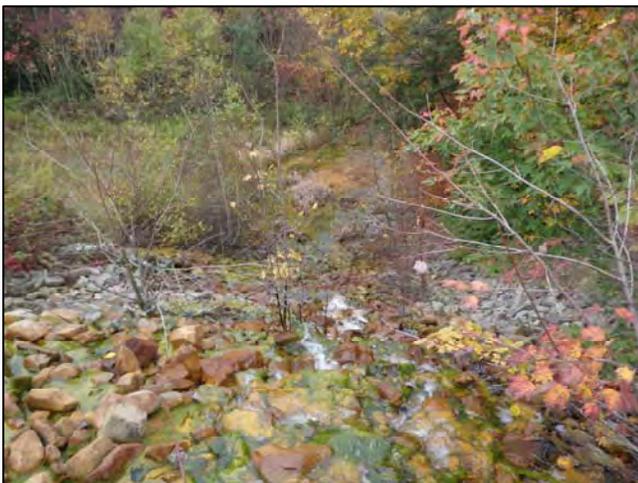
An initial short-lived dye test of SAP2 was conducted to see if short-circuiting could be easily observed. Due to time constraints and the size of the pond, the dye test could only be observed for a short period of time. During the approximately 1.5 hours, no dye was observed in the effluent pipe. Observations of the dye plume on the surface of the pond indicated that the flow was moving towards the western 1/2 of the pond and not flowing through the eastern 1/2 of the pond. This may be due to the location of the flushing pipe, which is also located on the same side of the pond. In addition, water from the final settling pond (Pond 3) was flowing out of both the emergency spillway and the effluent pipe indicating that the pipe may be partially plugged with low pH iron and/or debris or the valve is broken.

SAP1 (Top Left) is a huge pond which is susceptible to short-circuiting, especially along cleanouts that extend through the treatment media. The permeability of the media is now so low (likely due to low pH iron) that the water discharges to Pond 2 through the emergency spillway instead of the outlet (Top Right). A dye test of SAP2 was attempted (Center Left) but not conclusive; however, it indicated that the water appeared to flow along western side (Center Right) where the flush header was located. Final effluent of the system is currently discharging mainly over the emergency spillway with some flow through the pipe, indicating the outlet pipe is partially plugged or valve is broken.

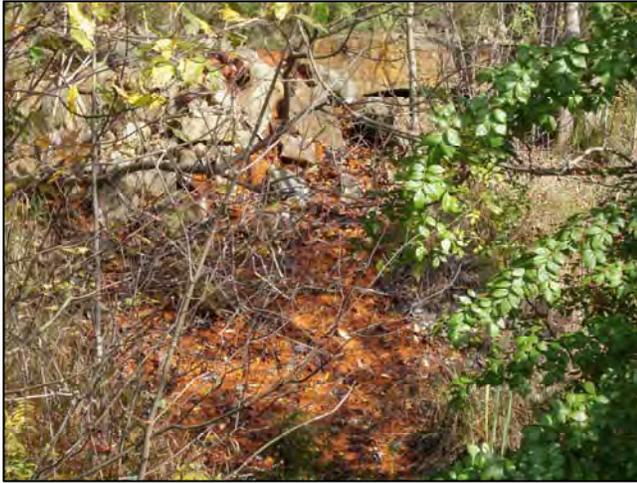
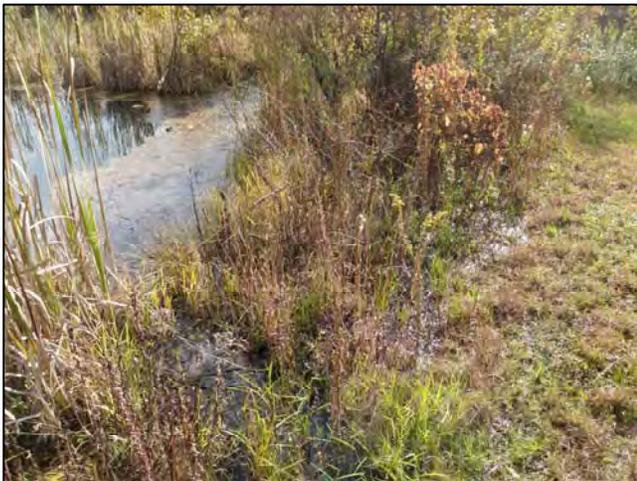
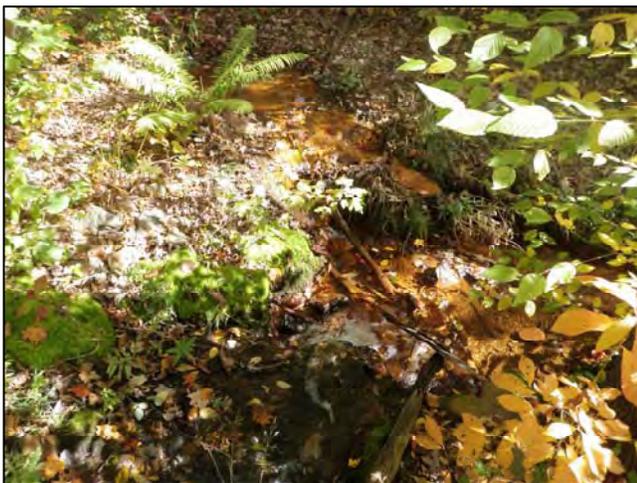
AMD is conveyed by a channel (Top Left) to the Oven Run D System (Top Right). A buildup of debris, vegetation, etc., was causing water to flow over the berm of Settling Pond #2 (Center Left). This was fixed during the inspection. Water flowing out the system from Settling Pond #3 (Center Right) is generally of good quality, but then mixes with untreated AMD (Bottom Left) before flowing into an unknown body of water and eventually discharging to the Stonycreek River.

Based upon the available information, the Oven Run D passive system itself has performed fairly well since installation, but this may not account for water that is potentially bypassing the system. During the site inspection, no major issues were observed and historical data indicated the system was working well. A buildup of vegetation and debris (possibly caused by an animal) was found in the spillway of Settling Pond #2, which was causing some water to bypass a portion of the system, but this was removed that day. Untreated AMD was mixing with the effluent of the system. It was unknown whether this was a separate source of AMD or if it was a portion of the discharge bypassing the system. Water sampling conducted after the site inspection indicates there has been a decrease in performance the last couple of years. As the system is now 20 years old, this may just be an indication of the treatment media being spent. Flushing and/or stirring of the treatment media could be conducted prior to replacement and potentially extend the life of the system. Further investigation is recommended. SRI's O&M TAG program could be utilized to conduct maintenance or complete further investigations.

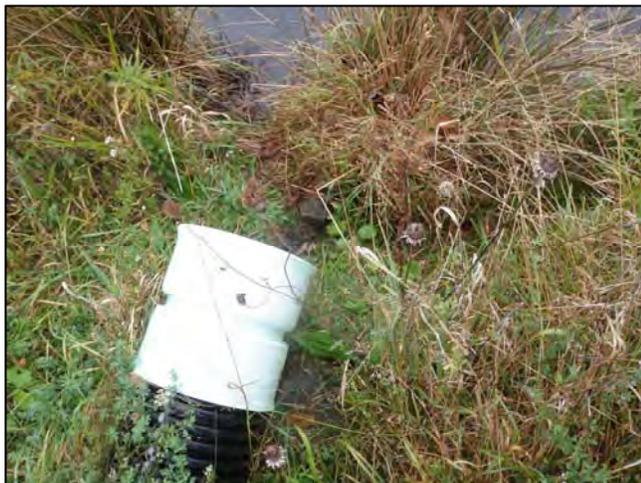
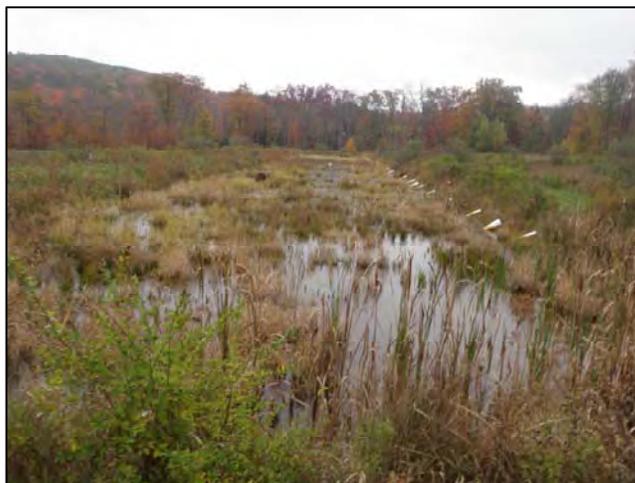
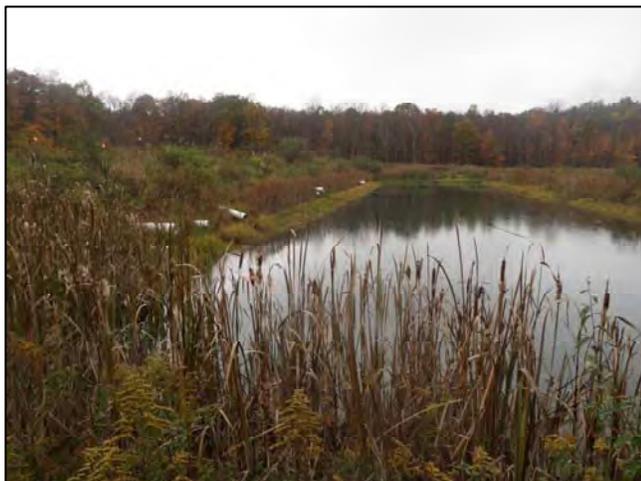
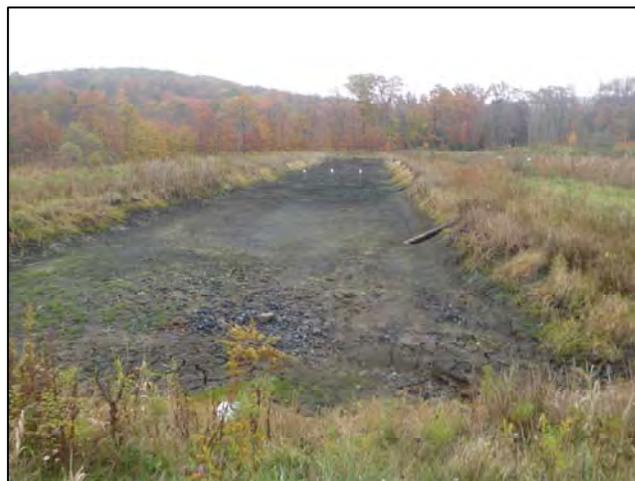
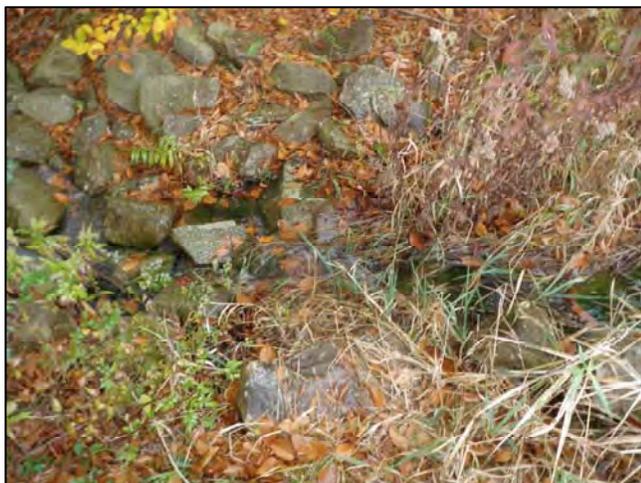
Based upon the very limited site inspection, water quality data, and information from Greg Shustrick, the Oven Run E system appears to be working well. One potential concern is the use of valves to control flow into the system, which limits the amount of water that can be treated. Always adjusting the valves to reduce/increase flow to produce good water quality could potentially hide the actual treatment effectiveness and initiate needed maintenance. In addition, using valves to control flow in a passive system is difficult. It can lead to instances when more flow could be going into the system and being effectively treated, but because of how the valve is set, less flow enters the system. Or, as during the site inspection, in generally low flow conditions, no water was entering the system when all of it could have been treated. If there is a desire to control flow into the system, other methods are available to better control flow including flow splitter boxes with a weir like structure and overflow. A new method to capture and introduce flow to the system is recommended.

At the Oven Run E passive system, water was not flowing (Top Left) which made evaluating the system in the field difficult. While some ponds still had water such as SAP1 (Top Right) and Pond 2 (Center Left), SAP2 was completely dry (Center Right). Low pH water was found flowing in a channel located on the east side of the system. Later, it was discovered that intake valves had been closed.

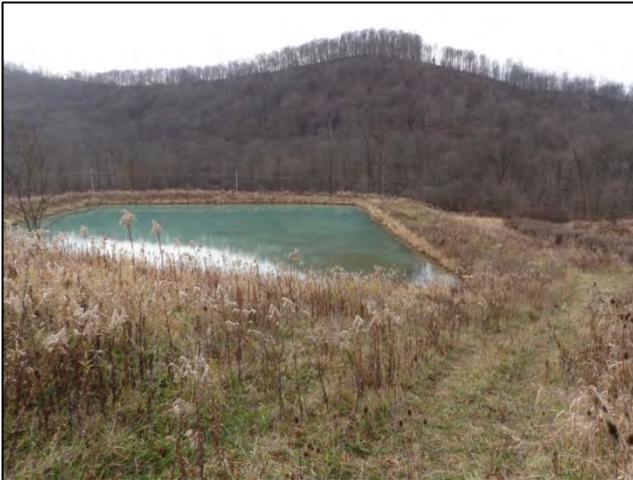
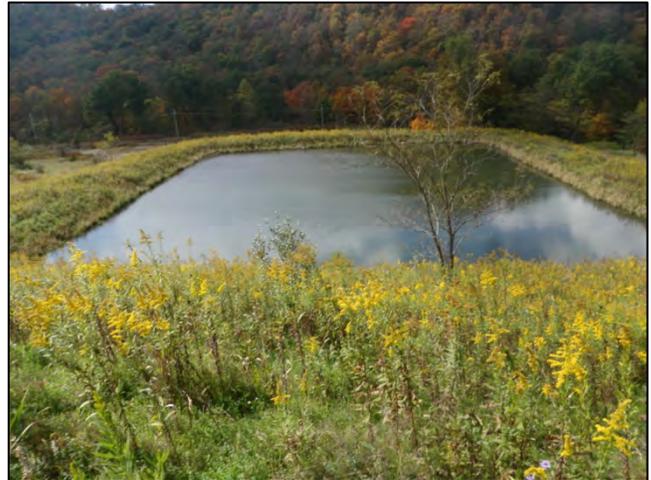
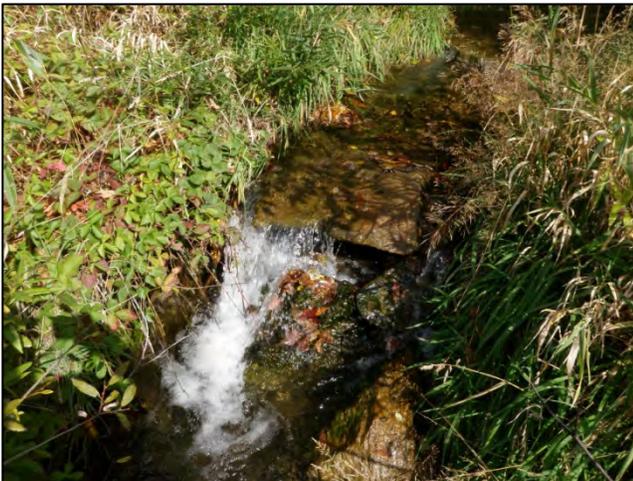
Overall, the Oven Run F passive system has produced good quality water for the water that has flowed through it. During the 2013 inspection, water was found to be bypassing the treatment system. It was uncertain how long this was occurring or if this was typical or not. The SCCD was notified. In 2014, the SCCD received \$704,000 grant to address O&M issues within the Oven Run Watershed including making repairs to the system. At a minimum, a clogged pipe and a gate valve at the inlet has already been fixed which has increased flow to the system. It is uncertain if other measures have been taken to improve treatment effectiveness. Once maintenance has been completed, additional monitoring should be conducted to determine if additional action is needed. As the system is now over 15 years old, there may be a need to replace the treatment media. Stirring the treatment media and/or washing the limestone could be conducted as an attempt to improve existing treatment and/or extend the life of the treatment before trying to obtain funding for a complete rebuild or while waiting.

During the initial site visit on 11/20/12, the Oven Run F Passive Treatment System (Top Left and Right) appeared to be functioning well. Greg Shustrick expressed concerns about the media becoming plugged; however, there were no obvious signs of decreased water treatment or water overtopping the berms. After reviewing available water quality data, BMI revisited the site to further investigate the apparent reduction in effluent flow rates. During the site visit, mine water was found to be flowing in a channel between SAPS2 and Settling Pond 2 (Bottom Left). The water was traced (Bottom Right) to the source, which was a pipe located near the influent pipe. This was believed to be an overflow or by-pass pipe. The Somerset County Conservation District was contacted and they have since acquired funding to complete repair work.

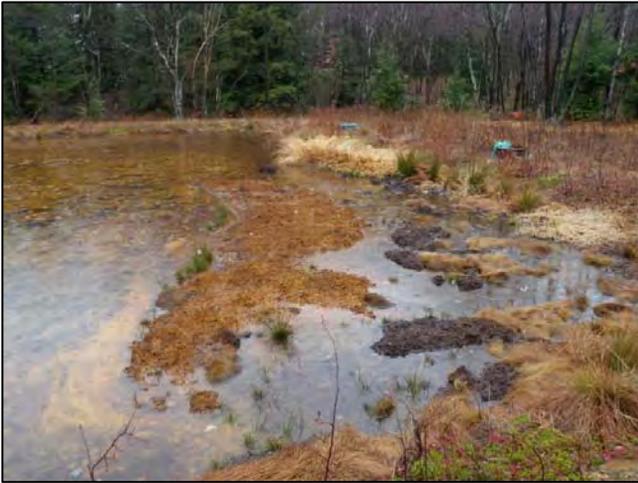
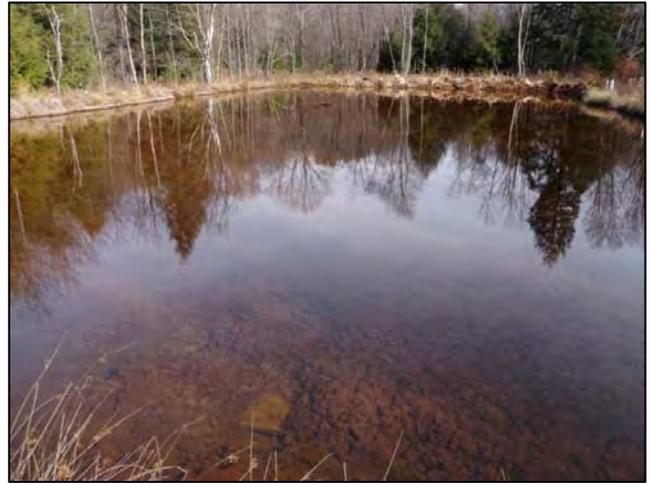
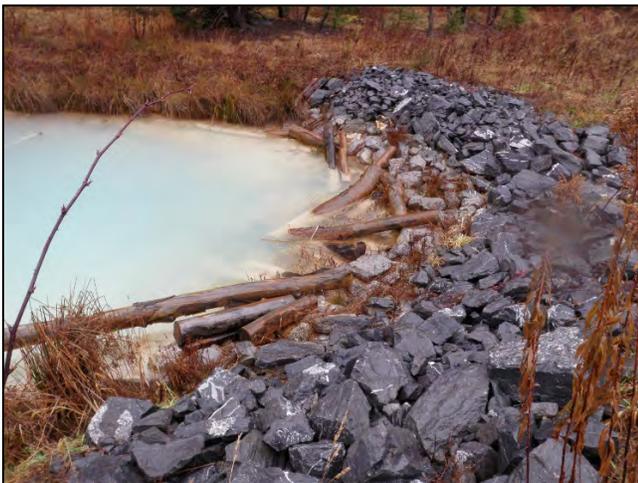
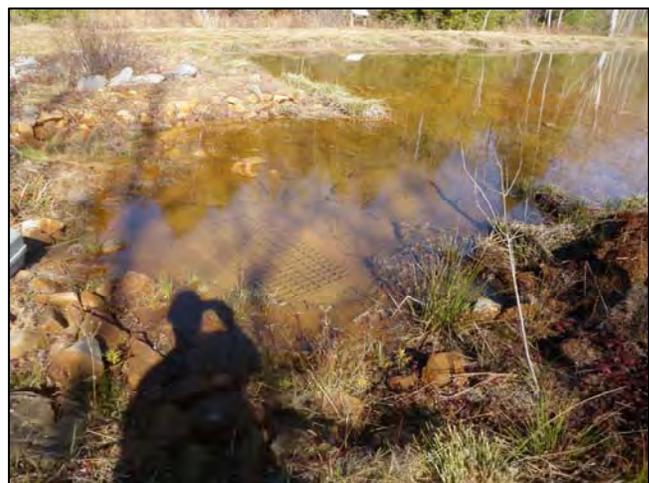
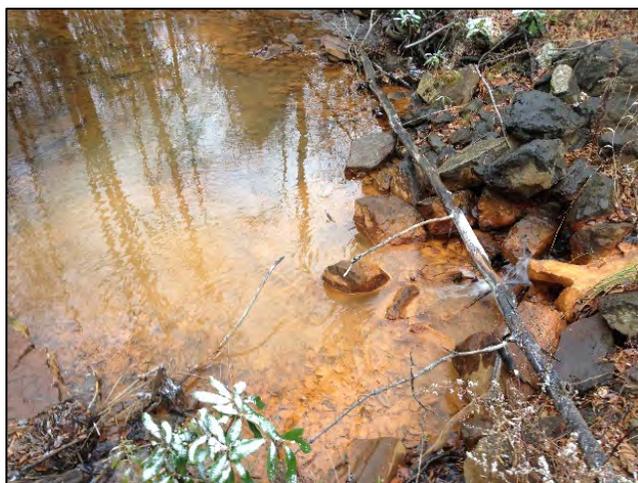
Maintenance had previously been conducted under the SRI O&M TAG program in fall of 2012 after being contacted by the Shade Creek Watershed Association. The system was reported as having poor performance, likely due to short-circuiting being caused by a displacement of compost to the far side of the pond. First, the VFP was drained and the compost material was re-distributed across the pond. Then the compost was mixed into the top layer of the limestone to help reduce short-circuiting. The VFP emergency spillway outlet height was lowered and a ramp was installed into the VFP to provide easier access in the future. Logs that were floating were removed from within the settling pond and Bioreactor. Access points were installed for future maintenance activities to the settling pond. Water samples collected at the final effluent shortly after the maintenance was conducted indicated the system performance was significantly enhanced and produced net-alkaline water; however, total iron concentrations even though decreased by about 60%, remained elevated. The dissolved iron concentration is expected to be substantially lower as significant iron solids were observed in the effluent. The large amount of iron solids may have been due to the recent stirring event as this has been seen at other systems.

The SCWA stated that the VFP was being flushed on about a weekly basis. Frequent flushing could be contributing to the high iron solids especially if the system is not able to effectively settle the solids. The settling ponds are largely full of material and may be reducing the ability to settle solids. SRI recommended that the flushing frequency be decreased in order to evaluate if flushing was contributing to the significant iron solids content within the final effluent. Once monitoring has been conducted, the system can be further evaluated to determine if additional actions can be taken.

At Reitz #1, portions of the compost layer had been disturbed and transported across the pond (Top Left) by a large flow event or possible high winds resulting in the compost layer being significantly thinner near the inlet (Center Right) which was likely leading to short-circuiting. In addition, a large quantity of logs (Center Left) from the Bioreactor had floated up out of the media and needed to be removed. The compost was leveled and mixed into the top layer of limestone aggregate (Top Right) and logs removed. There is concern about the water level in the VFP and the potential of the AMD overflowing and bypassing treatment (Center Right). In addition, at times, high iron content is still being discharged to the stream (Bottom Left). Installing baffle currents in the settling pond and better use of the Bioreactor space could be helpful.

- A vegetated wetland could probably be created at the end of the system utilizing the existing bioreactor to help remove more total iron and total manganese from the outflow. It could especially improve iron removal because iron is likely mostly particulate by that point.
- Alternatively, a portion of the Bioreactor could be converted into a Horizontal Flow Limestone Bed (HFLB), which would act as a filter for solids, as well as promote additional hydrolysis of metals, and provide additional alkalinity generation.
- Trimming of brush to allow for educational paths to be visible and open for public.
- Conduct regular water monitoring including flow measurements.

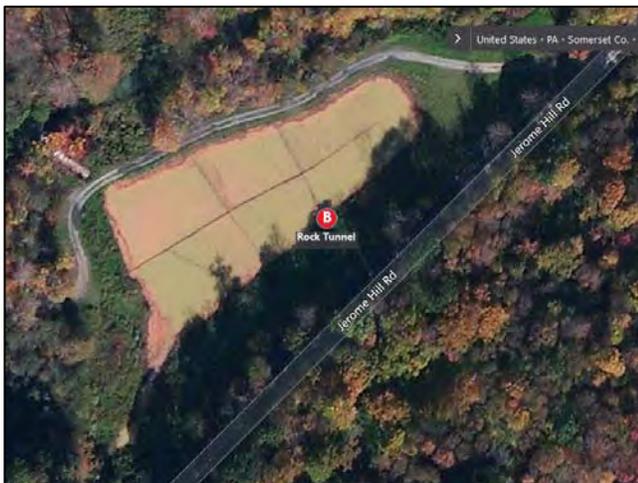
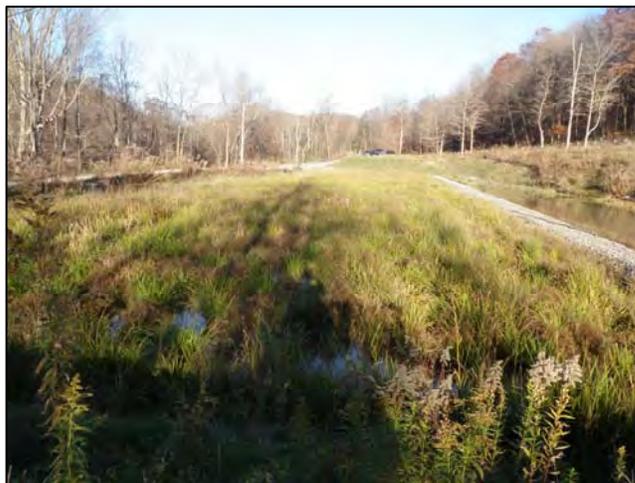
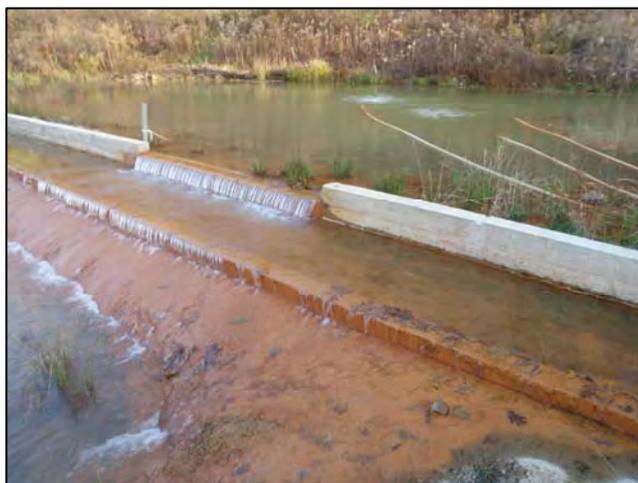
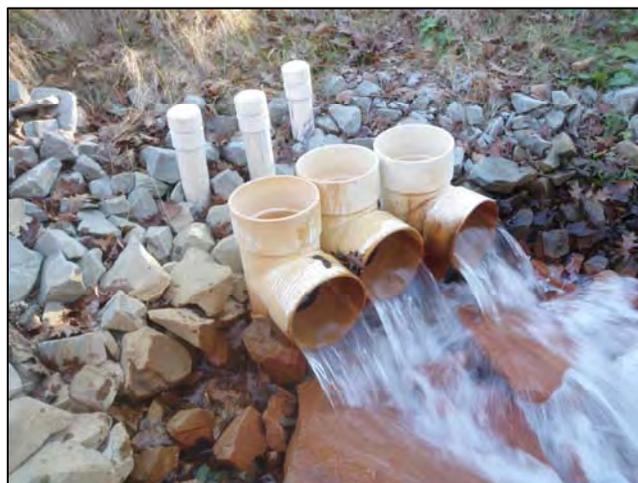
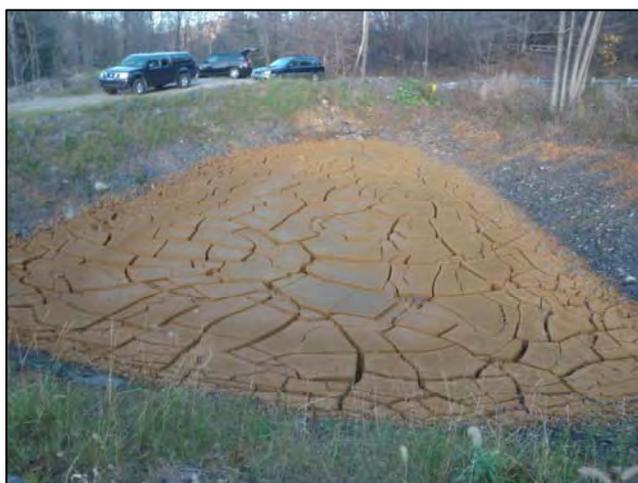
## Rock Tunnel Photos

The original treatment system was undersized for the flow and loading of the discharge due to the various construction limitations related to the stream, roads, wetlands, etc. The Somerset County Conservation District received funding to rehabilitate the system, which included level spreaders, aeration troughs, and 3 trompes as well as converting most of the available area into a well established wetland. Treatment effectiveness has increased as a result; however, a large portion of the water bypasses the system most of the year and does not receive treatment. The system would still benefit by expanding the available area for treatment. Further evaluation would be needed to determine if there is additional land available to expand the system. One option may be to pipe the effluent and/or the bypassed water to the other side of the stream and/or further downstream.

The Rock Tunnel system was undersized and utilized wooden baffles (Top Left) resulting in poor iron removal. The Somerset Conservation District acquired funding to rehabilitate the system, which included converting most of the pond into wetlands (Top Right). Level spreaders and aeration troughs were added (Center Left) as well as three trompes (Center Right) to improve iron oxidation. A sludge pond was also added to provide on-site sludge storage capacity.
