# Kiski-Conemaugh Basin Treatment System O&M Assessment Report

December 2017

Prepared by  
Stream Restoration Incorporated and BioMost, Inc.

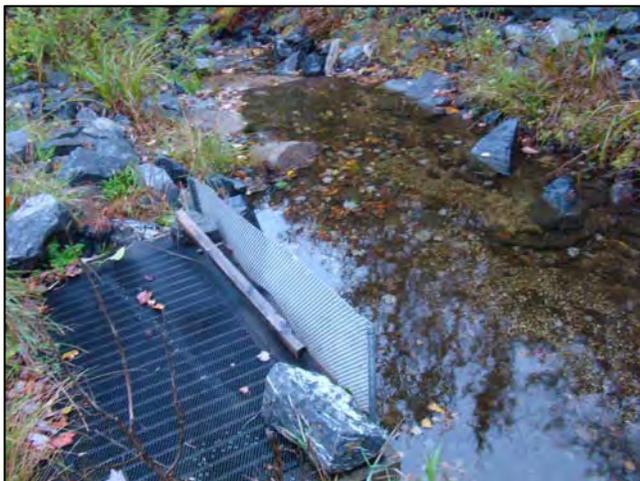
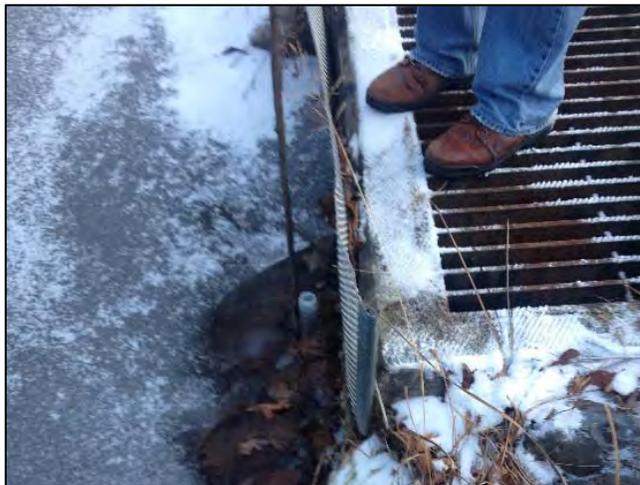
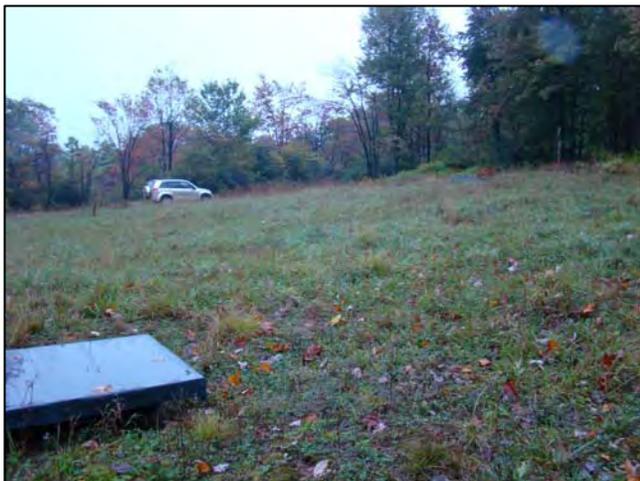
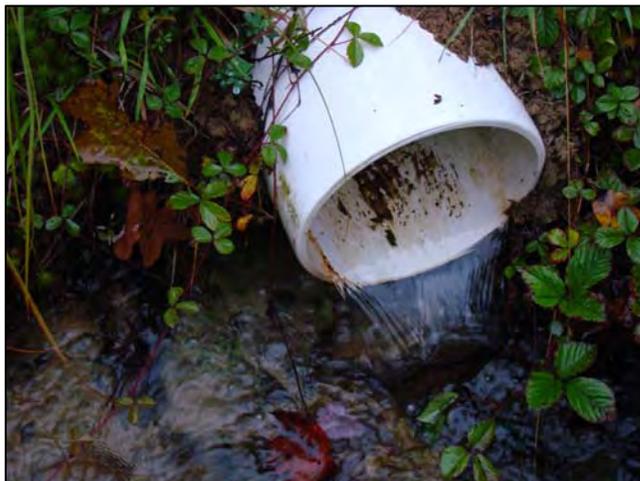
### Shingle Run Photos

Based upon the available information, the water that flows through the limestone drain is significantly improved, but a lack of flow data and design information, etc. makes a full assessment difficult and incomplete. The following are recommendations for the site:

A concrete inlet box with a mesh screen is used to capture a portion of the water flowing in Shingle Run (Top Left) and then is conveyed to a buried limestone drain (Bottom Left). The effluent then discharges back to Shingle Run further downstream (Bottom Right). The mesh screen is designed to prevent rock and debris from entering the system, but at times becomes clogged (Top Right). Regular inspections and cleaning are necessary to ensure sufficient water is entering the system.

- Contact the Shade Creek Watershed Association or Kiski-Conemaugh StreamTeam to gain vehicular access to the site.

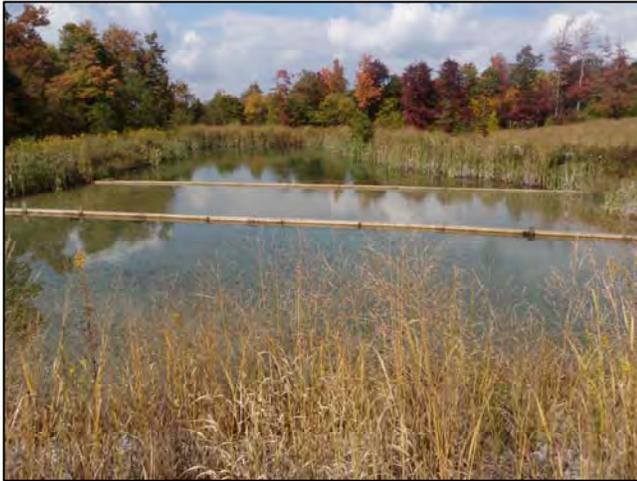
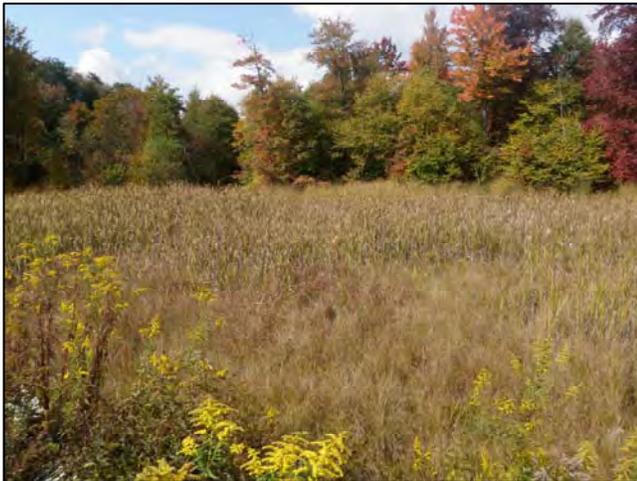
### Swallow Farm Photos

- The settling pond and wetland following the limestone bed were reported to be leaking.
- A number of small seeps emanate along the stream bank and flow directly into Coal Run. DEP has suggested collecting the seeps and piping the water into the limestone bed.
- Since the water is mostly treated by the limestone bed, the SCWA would like to install a valve on the limestone bed and direct the effluent directly to the stream.

While the Swallow Farm passive system is obviously experiencing problems with leaking ponds, overall the system is effectively treating the mine drainage that is entering the system. The system would likely perform better in terms of settling metal solids if the entire system was utilized. Without flow measurements and water quality data of the entire system, a complete evaluation is not actually possible. The following are recommendations for the Swallow Farm system:

At the Swallow Farm passive system, mine drainage is collected and then directed into a limestone bed with wooden baffles (Top Left). A weir and effluent spillway maintains a water level above the top of the stone (Top Right). The effluent of the limestone bed is considered the effluent of the system even though there is settling pond and wetland (Bottom Left) which are reported to leak and despite water still flowing out of the system (Bottom Right). As the system has been successful, it may be possible to collect additional seeps and direct them into the limestone bed.

- Eventually treatment will likely decline and there may be a need to wash the stone.

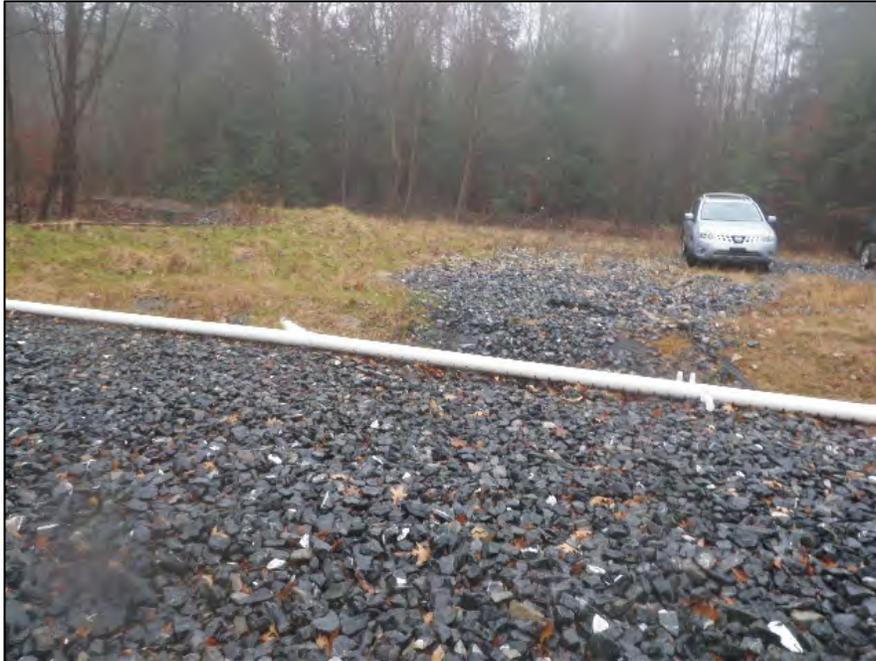
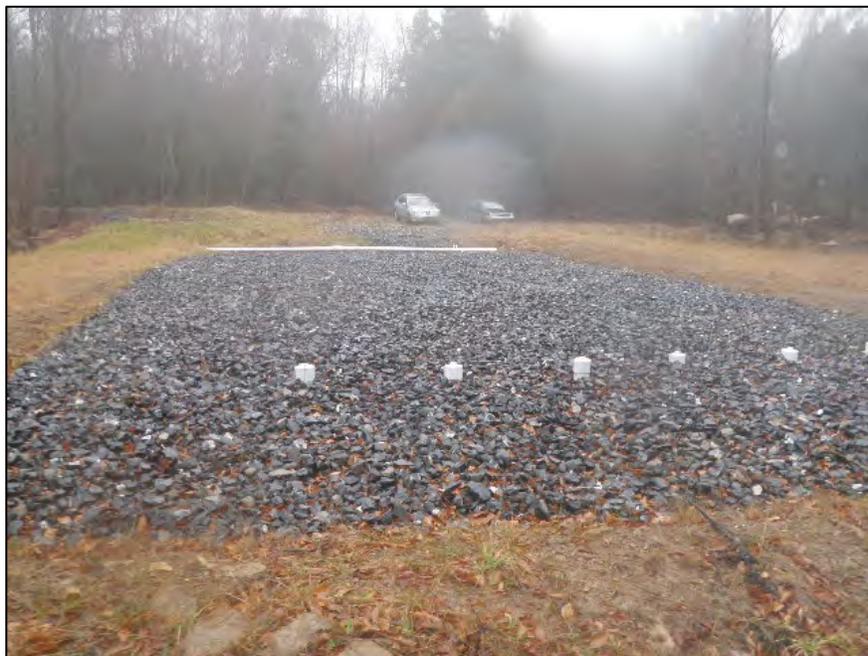
### Weaver Run D8A Photos

A site visit was conducted on December 17, 2015 with Missy Reckner of the Paint Creek Regional Watershed Association and Kiski-Conemaugh StreamTeam. According to Missy, the system is not currently experiencing any known maintenance issues. During the site visit, no known maintenance issues were observed.

View of the inlet distribution pipe (Top) and of the entire Weaver Run D8A limestone bed (Bottom).

As there are currently no known maintenance issues and the system is successfully treating the discharge, the only recommendation at this time is to continue regular inspections and water monitoring of the system and to complete maintenance as needed. Eventually the limestone bed will become plugged with metals and the stone will need to be cleaned and metals removed. As there is no structure to flush into, flushing of the bed is not recommended at this time.

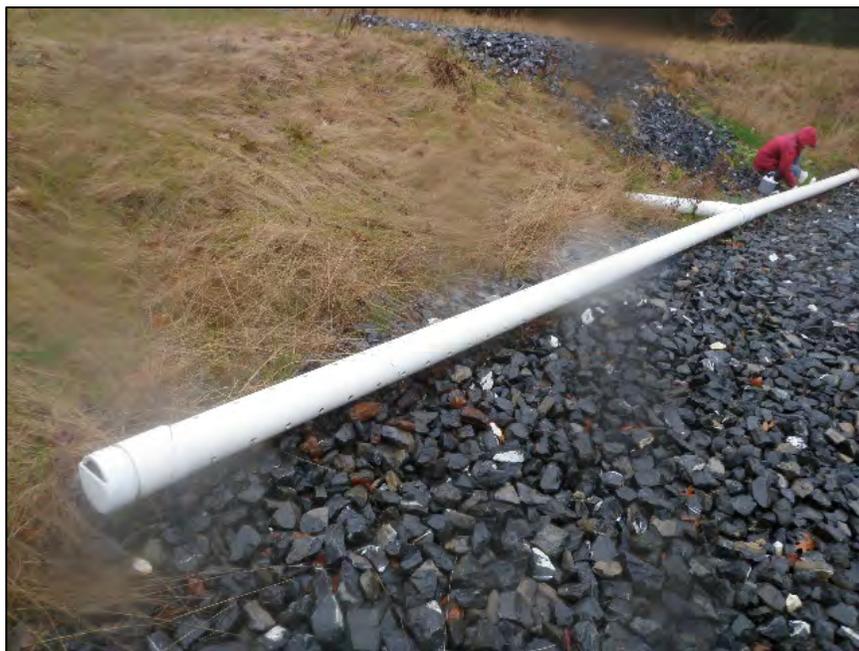
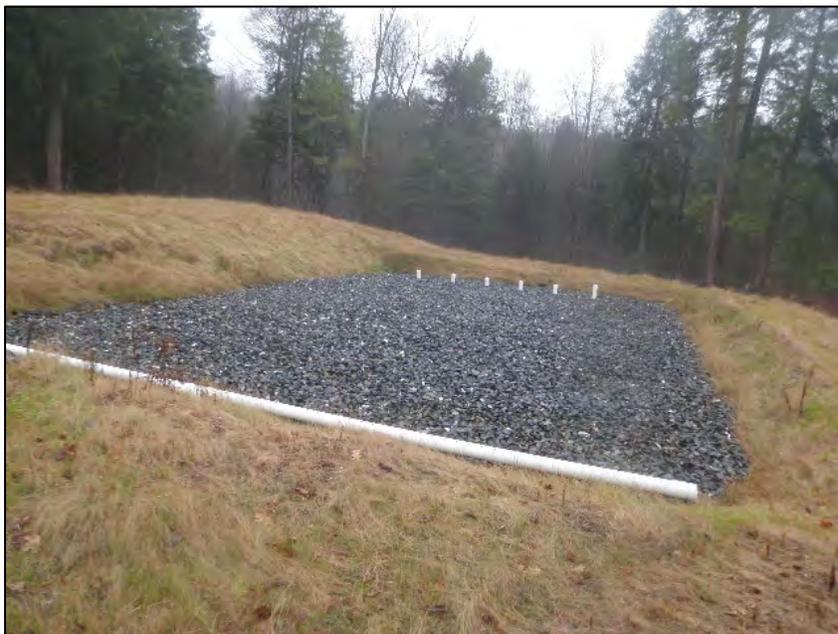
### Weaver Run D8B Photos

A site visit was conducted on December 17, 2015 with Missy Reckner of the Paint Creek Regional Watershed Association and Kiski-Conemaugh StreamTeam. According to Missy, the system is not currently experiencing any known maintenance issues. During the site visit, no known maintenance issues were observed.

View of Missy Reckner of the Kiski-Conemaugh StreamTeam collecting water samples at the inlet distribution pipe (Top) and of the entire Weaver Run D8B limestone bed (Bottom).

As there are currently no known maintenance issues and the system is successfully treating the discharge, the only recommendation at this time is to continue regular inspections and water monitoring of the system and to complete maintenance as needed. Eventually the limestone bed will become plugged with metals and the stone will need to be cleaned and metals removed. As there is no structure to flush into, flushing of the bed is not recommended at this time.

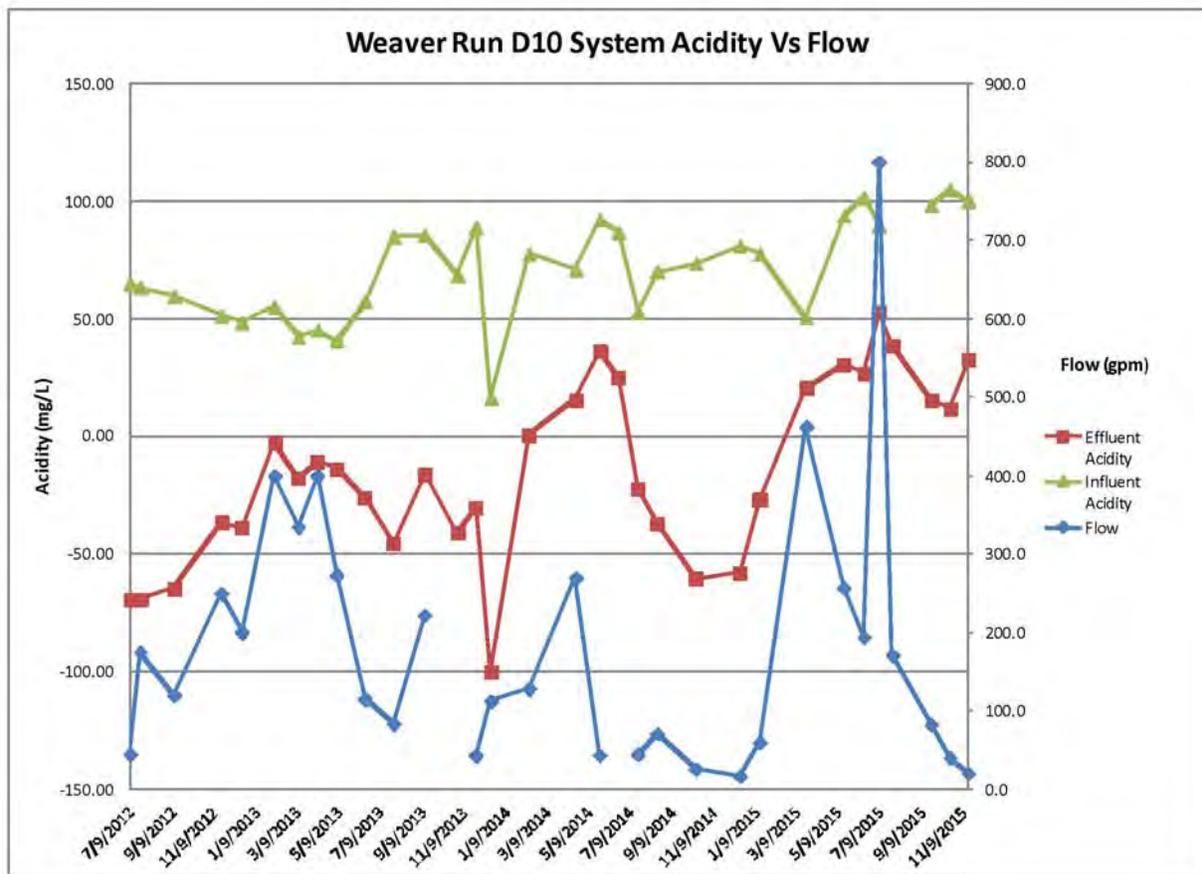
Upon a closer evaluation of the data, it can be seen that the water monitoring indicates variable treatment over much of the short life of the system. Hot acidity values of the effluent range from -100 to 52 and those samples collected since March 2015 have all been net-acidic, indicating a change in treatment effectiveness. A few additional interesting aspects of the data were observed. A graph of the influent and effluent acidity values compared to flow is provided below. In general, the acidity of the effluent of the system appears to be related to the flow rate. As the flow rate increases, the effluent tends to be more acidic while when the flow rate decreases, the water tends to become more net-alkaline. This would tend to make sense as alkalinity generation is closely tied to retention time within the limestone bed. That was until a

large flow spike occurred in July 2015. After the flow spike, the flow rate quickly drops down, but the effluent acidity remains high. The extremely high flow event may have caused or enhanced any short-circuiting that was already occurring. Another interesting observation is that towards the second half of 2015, the acidity of the influent AMD tends to be higher, which could also be impacting the overall performance of the system. It is difficult to say whether the higher acidity values are a long-term trend or just a temporary change in water quality due to a disturbance in the mine pool.

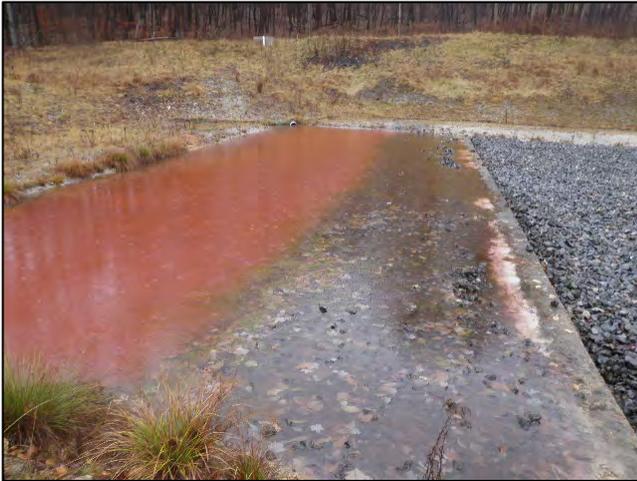
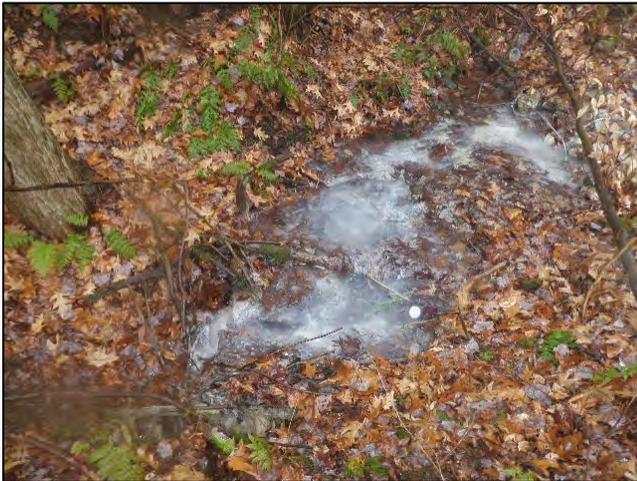
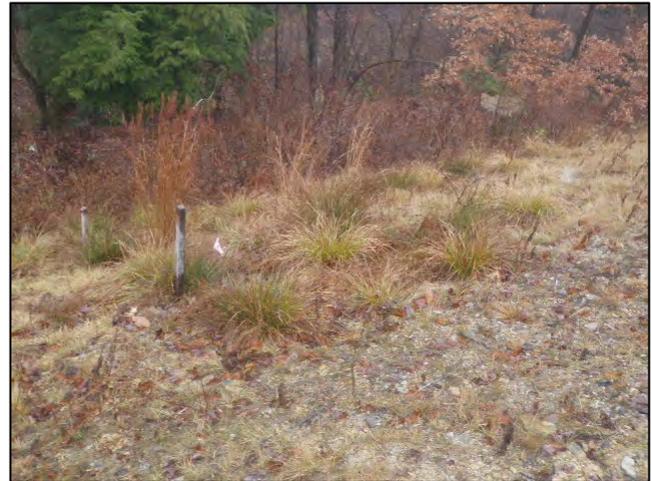
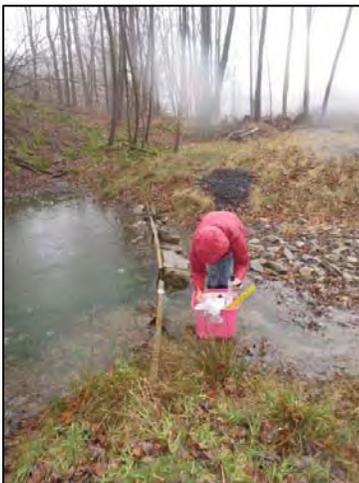
### Weaver Run D10 Photos

In November of 2015, Missy Reckner requested Technical Assistance related to the treatment system. Her primary concerns were decreased treatment performance, difficulty flushing, differences in flow rates in and out of the system, potential short-circuiting, continued leakage, and possible slope instability of the outer berm. Missy also questioned the quality of the limestone that was being used at the site. A site visit with Missy was conducted on December 17, 2015. The group had placed stakes in the ground and were periodically measuring the distance between them to see if the ground has been moving. Measurements so far are somewhat inconclusive, but may indicate some slight movement. She had also pointed out locations along the concrete level spreader that were cracked/broken and places where repairs had been attempted. Very little water was actually flowing over the level spreader. Most of the water was flowing underneath.

plume initially and quickly went towards the middle and northern end of the Forebay and began to make its way into the limestone bed within about 20 minutes, but then the dye stopped moving forward and developed a very discernible line across the Forebay. This point is believed to represent the approximate location of where the water is entering the stone and where the algae is growing on top of the stone, thus absorbing the dye. No dye was ever observed in the effluent before leaving the site. However, this was not necessary to determine short-circuiting. While waiting for the dye test to progress, pH measurements of the water within the 8 ports of the “pipe tree” were measured where possible. The ports were numbered 1-8 from the south to north with 8 being closest to the outlet of the bed. As can be seen in the table below, ports 1-4 all had good pH values, but port 8 had a very low pH value. Unfortunately the caps on ports 5, 6, and 7 were stuck and could not be removed for monitoring. Assuming that ports 1-4 are receiving flowing water, this indicates that the water entering in port 8 has much shorter retention time and is likely short-circuiting.

There are a variety of problems occurring at the Weaver Run D10 treatment system. In order to address these issues, the following recommendations are grouped together based upon the issue.

The Weaver Run D10 limestone bed is experiencing a variety of issues. Dye testing (Top Left) and monitoring at the pipe tree (Top Right) indicated that short-circuiting was occurring and the level spreader was not functioning. Without a settling pond there is no place to settle aluminum solids (Center Left) during normal operation or flushing events. Installing a settling/flush pond is recommended. Wooden stakes were installed along the steep outer berm (Center Right) to monitor the seeps and potential slumping. Disparity in flow data may be due to the condition of the weir (Bottom Left) and/or differences in flow measuring techniques.

- Currently, there is not a pond to direct the flush water from the limestone bed. Unless absolutely necessary, it is not recommended to flush to the stream as this partly defeats the purpose of the treatment system. We recommend that an additional pond be constructed for the purpose of flushing as well as for the settling of metals during normal operation. Alternatively, it may be possible to utilize filter bags during flushing events, but these are often difficult to use and sometimes are not very effective.
- If flushing must be conducted without using a method to capture the metal solids then it would be best to conduct the flushing during high flow periods or events.

- It has now been a couple of years since the seeps and initial slumping were discovered. More than likely, there is not any significant risk of failing. Fixing the berm would likely be quite expensive and would require seeking a larger grant source. At this point in time, it is recommended to continue to monitor the berm for signs of movement.
- Installation of a rock drain could be a viable alternative to rebuilding the entire berm.

In May of 2017, maintenance was conducted through the SRI O&M TAG program to address the water quality issue. The level spreader was removed. The limestone was stirred, washed and redistributed to eliminate the Forebay. A perforated flow distribution pipe was installed. The system will need to be re-evaluated after several water monitoring events are completed.

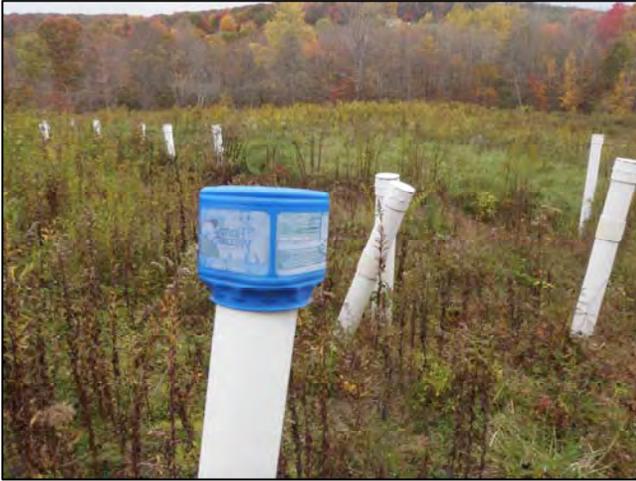
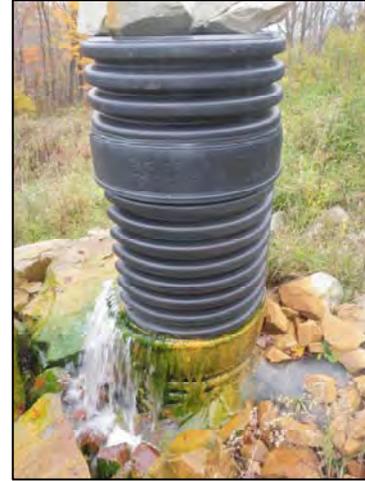
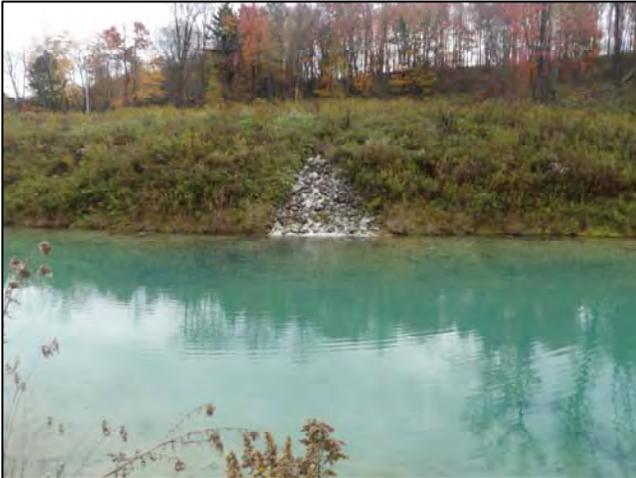
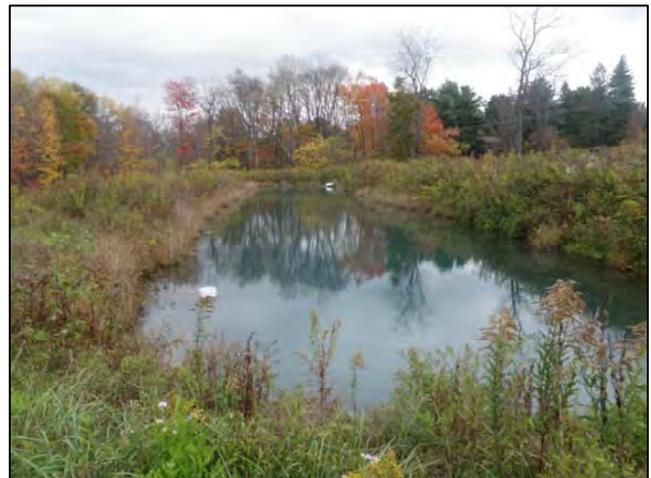
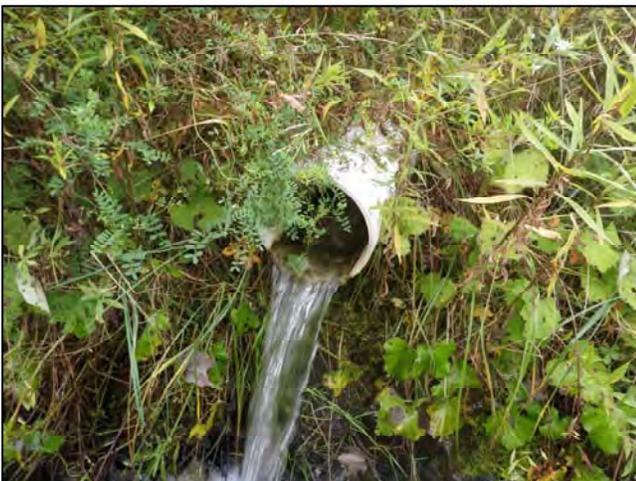
### Adams #6 Photos

At the Adams #6 passive system capped riser pipes with unknown purpose are associated with an ALD (Top Left). One of the pipes has a coffee can instead of a cap, which could be allowing oxygen to enter and CO<sub>2</sub> to escape. Despite being designed to treat over 350 gpm, more water was bypassing the system (Top Right) than the 50 gpm flowing through (Bottom Left). Aluminum solids were visible in the spillways and ponds (Center Left). Windowed baffle curtains could help settle solids in the long ponds (Center Right).

- One of the caps on the riser pipes was missing and a coffee container was in place instead. It is unknown if any of the others are loose as they were not checked. All should be on tight and any missing should be replaced. This could be the source of oxygen into the system and could be causing CO<sub>2</sub> to escape, reducing limestone dissolution and alkalinity generation.
- If the system has not been regularly flushed for the last few years, a cheap initial effort could consist of flushing the ALD completely down for a few days then closing the valves to allow the water to refill the ALD and then repeat. Repeating this process several times over a period of a month or two may flush the metals, increase permeability, and rejuvenate the limestone. Water monitoring should be conducted in between each step to see if treatment improves. If treatment improves and the system

In December 2016, SRI received an update from the Wells Creek Watershed Association that in 2014, the WCWA placed high quality limestone in an existing small pond located below the bypass to provide some treatment of that water. In addition, a collection pipe header was installed in the bypass pond to handle flows of 4,000 to 5,000 gpm during max flow events. Further investigation is needed to determine if the increase in bypassed flows is due to problems with the influent distribution header or other causes. If the ALD is converted to an auto-flushing limestone bed, the complex influent header system could likely be removed and may help to eliminate some future problems. SRI's O&M TAG program may be able to provide further assistance.

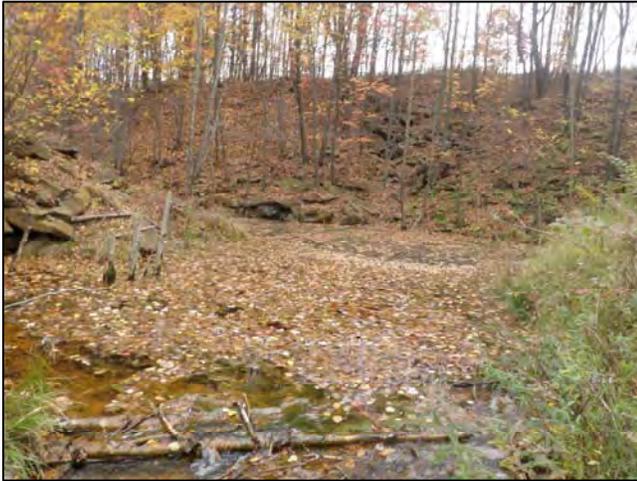
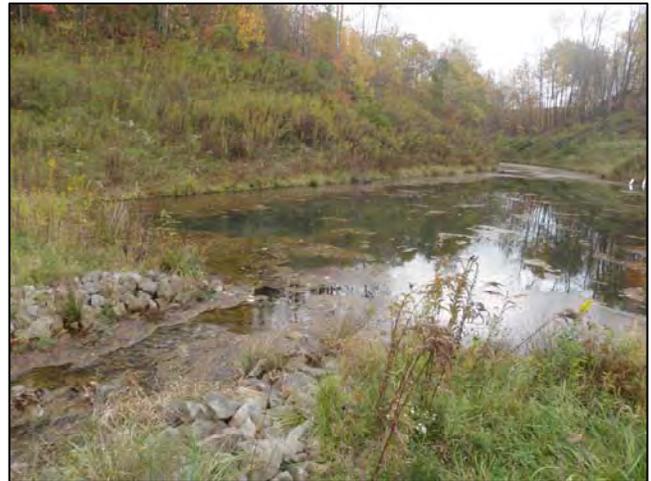
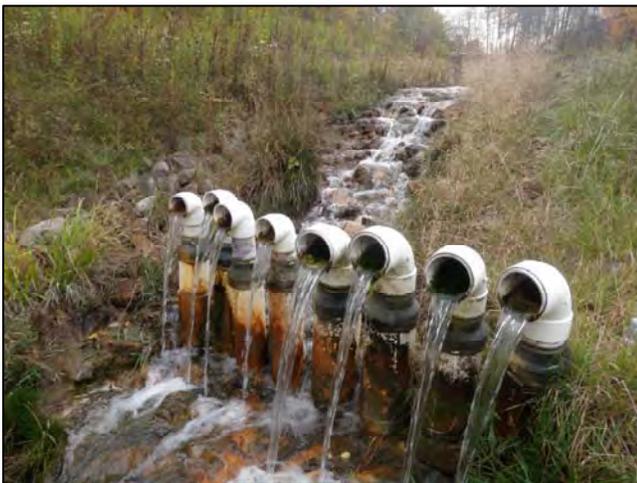
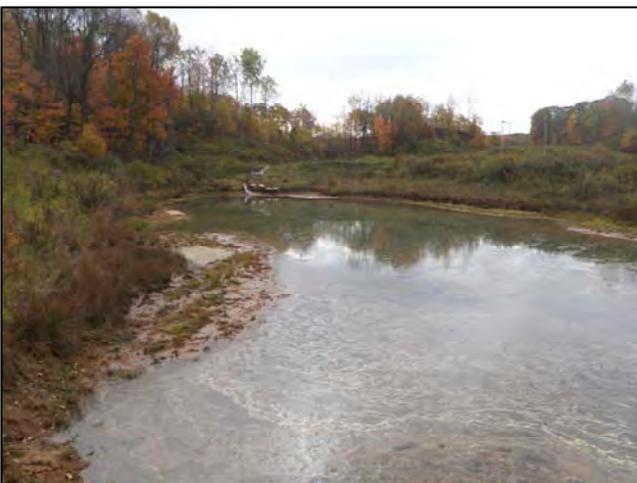
### Adams #7 Photos

At the Adams #6 passive system, a large flow underground mine discharge (Top Left) has pooled and then flows into a VFP. Much of the water is flowing over the emergency spillway, which is located directly across from where the AMD enters the VFP (Top Right). Water bypassing the VFP through the emergency spillway mixes with the effluent of the VFP (Center Left) before flowing into the Settling Pond (Bottom Left) helping to treat the bypassed flow. The VFP has an unusually large number of cleanout pipes (Center Right). Work has been conducted by the WCWA to improve treatment.

In December 2016, SRI received an update from the Wells Creek Watershed Association that in 2014, Adams #7 was rehabilitated due to low infiltration rate into the VFP treatment. They replaced the top 12" of high quality limestone and mushroom compost with 12 to 18" of high quality limestone and 12" of mushroom compost. The work has reportedly improved the permeability and water quality of the effluent is improved and more consistent throughout the year.

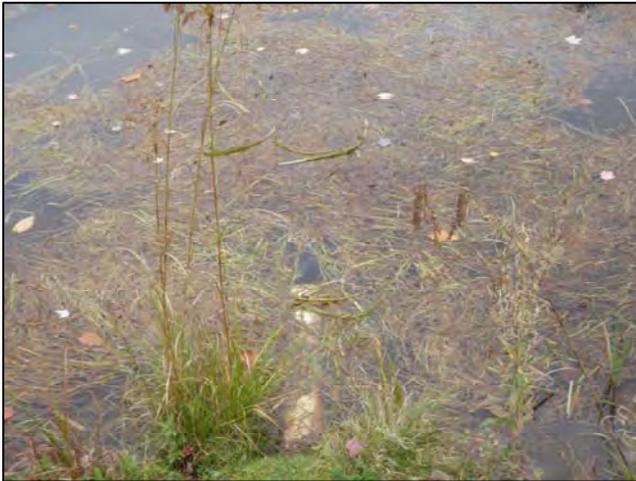
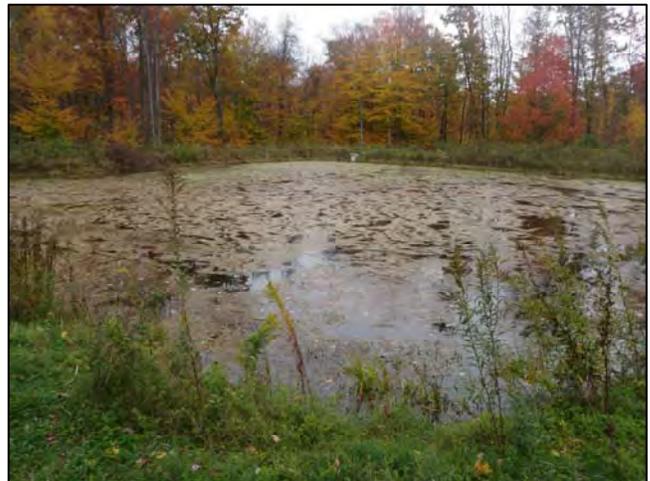
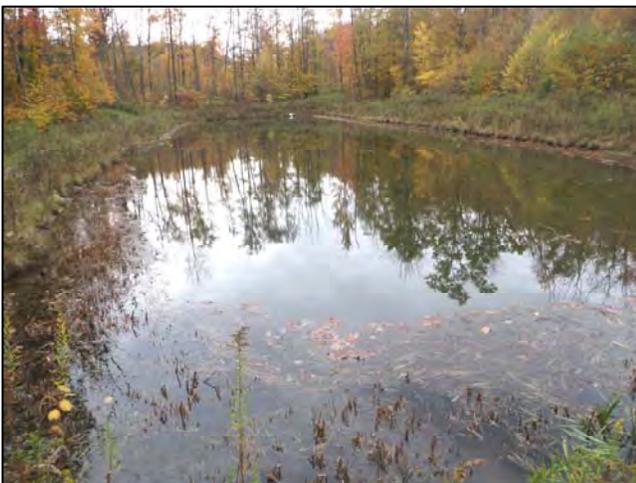
### Onstead Photos

At the Onstead passive system, the influent piping carrying the AMD to the system was under water (Top Left) which may be an indication of hydraulic issues which could be caused by plants and algae growing in the Vertical Flow Pond (Top Left and Right) or may be an indication of reduced permeability of the treatment media. From the VFP, the water flows into a settling pond (Bottom Left) which contains a rock baffle (Bottom Right), which the purpose of is not clearly known. The water level may be too high. If intended to help settle solids, the use of windowed baffle curtains could achieve similar and likely better

water appeared to be flowing through the media. If permeability does become a problem, remove the algae and stir the treatment media. Regular water monitoring should be conducted.

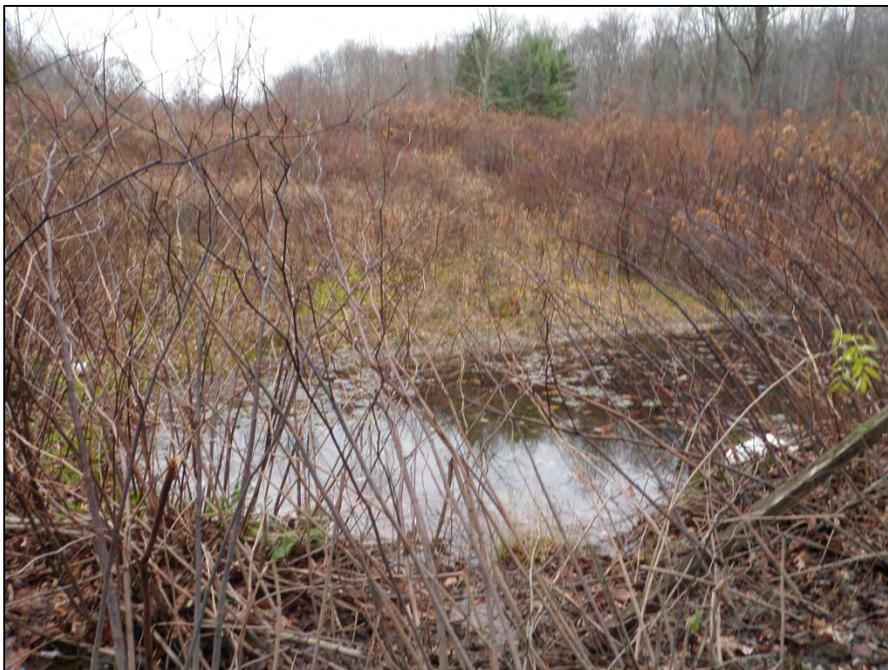
Based upon limited information, the Gray Run passive system is not satisfactorily treating the water, but is neutralizing about 75% of the acidity and is removing a large portion of the iron and aluminum. As the system is nearly 20 years old and there is a lack of historical data, it is uncertain whether the system has always produced similar quality water or if the lack of full treatment is an indication of needed maintenance or possibly even new treatment media. Based upon the design plans there was only about 3 feet of limestone used in the SAP. When it is time to replace the treatment media, the system should be evaluated to determine if there is enough space available to increase the amount of treatment media and whether an Auto-flushing Vertical Flow Pond can be utilized. As it appears that the system is not currently being monitored, an effort should be made to find an organization to take over the O&M at the site. In addition, an effort should be made to clean up the site in order to allow easy travel around the system for inspections, monitoring, and maintenance.

At the Gray Run passive system, fencing, downed trees, thick thorny vegetation, etc., made traveling around and seeing the system difficult. The system which is nearly 20 years old consists of a SAP or VFP (Top) and a settling pond (Bottom) which are not fully treating the water.

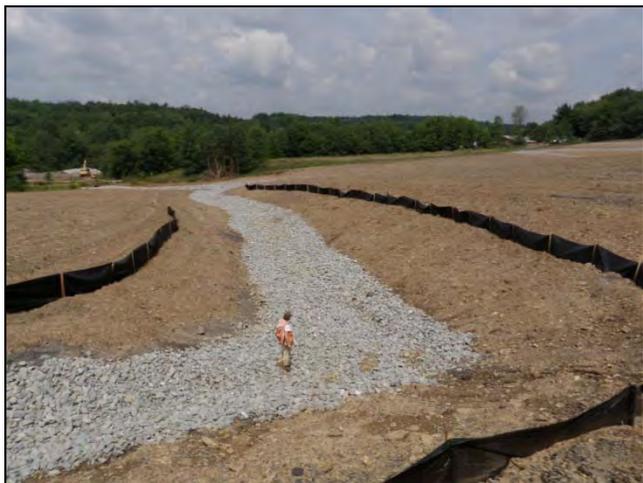
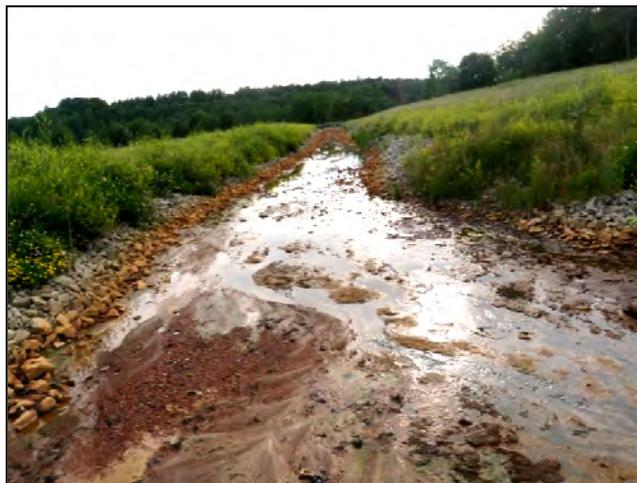
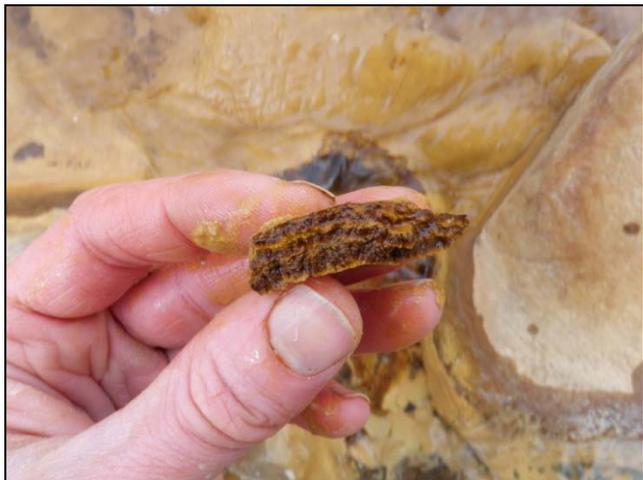
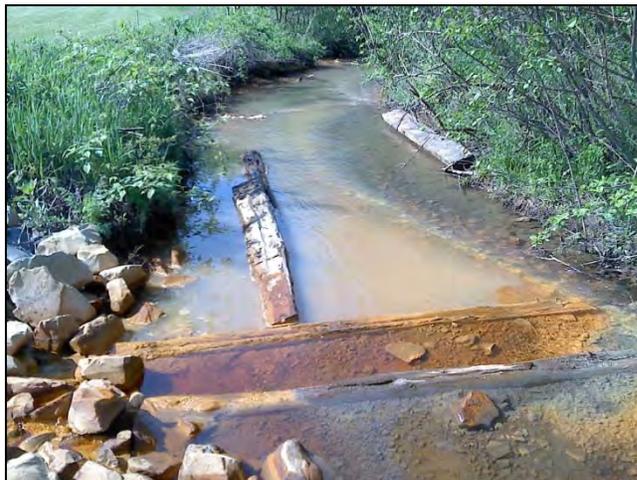
## Neal Run Photos

While the OPCs at Neal Run are removing a large portion of the iron, the water quality is still extremely degraded and is severely impacting the stream. Additional treatment is needed. In March 2016, SRI completed the Aultmans Run Watershed AMD Assessment & Implementation Plan that proposed additional treatment components including an Auto-flushing Vertical Flow Pond, settling pond, and Jennings-type mixed media Vertical Flow Pond. SRI and AWARE are currently seeking funding to install the treatment system. Due to the severity of the water quality, a long-term O&M fund should be obtained if possible. In addition, the orphaned data in the SIS database needs to be fixed.

At the Neal Run site, three OPCs (Top Left) were installed as part of a coal refuse removal project to treat an extremely polluted mine discharge. While the OPCs have been very successful at removing a lot of iron in a short period of time (Top Right and Bottom Left) the water is still extremely polluted and significantly impacts Neal Run (Bottom Right). Additional treatment is needed. SRI and AWARE are currently seeking funds to expand the treatment system.

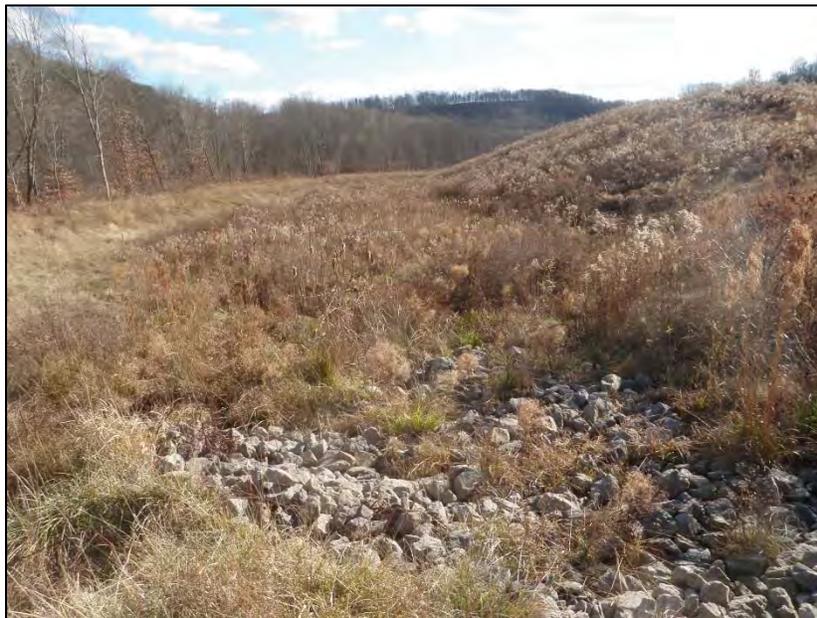
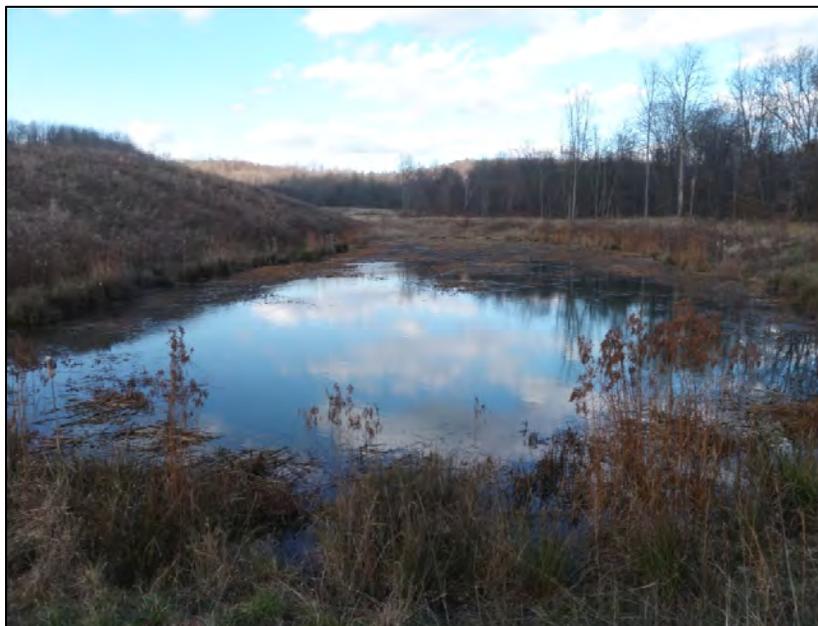
### Reeds Run Photos

Water monitoring has indicated that the Reeds Run land reclamation project was very successful in improving water quality. The effluent of the wetland does indicate slight degradation from remaining coal refuse, but overall water quality is good with just slightly elevated iron concentrations. Water monitoring should continue to make sure that the alkaline material mixed with the remaining coal refuse is not consumed. If this happens, there may be a need in the future to add an alkalinity-generating component such as a limestone bed, but currently this is not necessary. Problems with orphaned data within the SIS database made obtaining and evaluating water quality data time consuming and difficult and should be fixed as soon as possible.

At the Reeds Run project, any remaining coal refuse that was not marketable was covered and revegetated (Top). In addition, a wetland was constructed including vegetated areas (Top) and open water habitat (Bottom). The wetland was to provide water treatment of seeps located within the project area before discharging to Reeds Run.

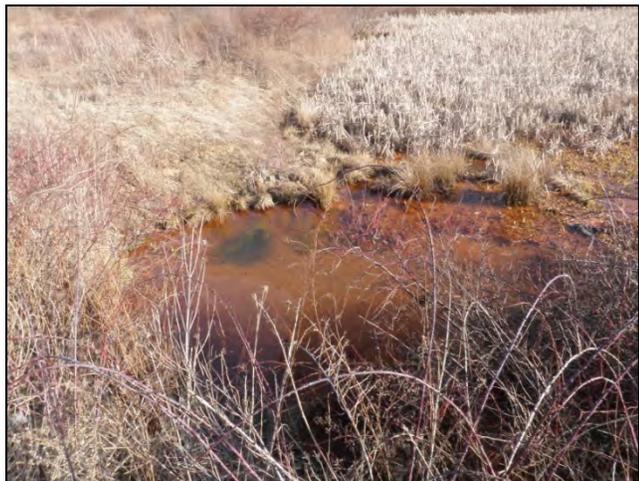
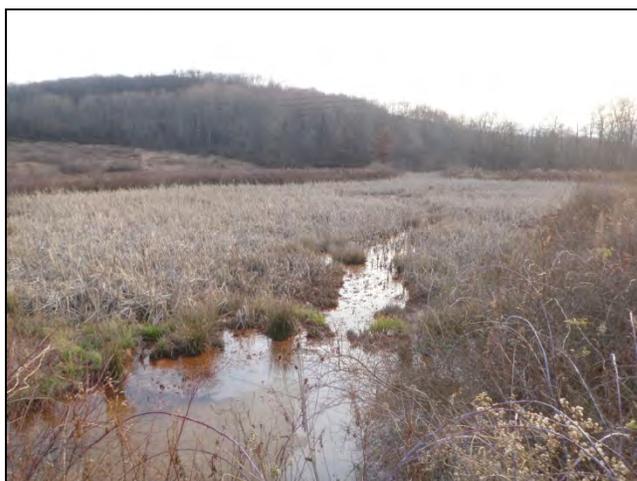
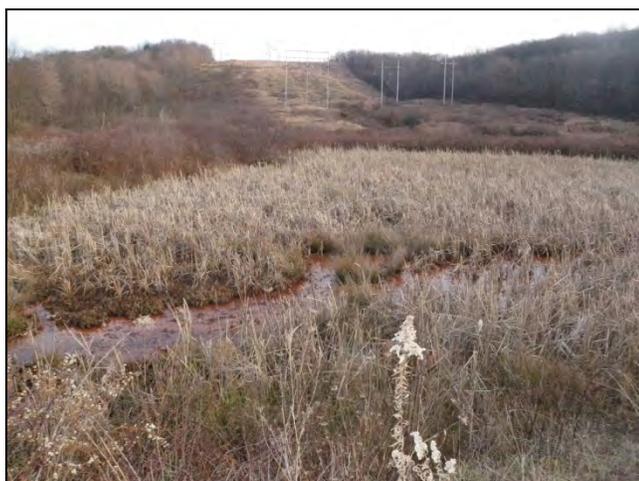
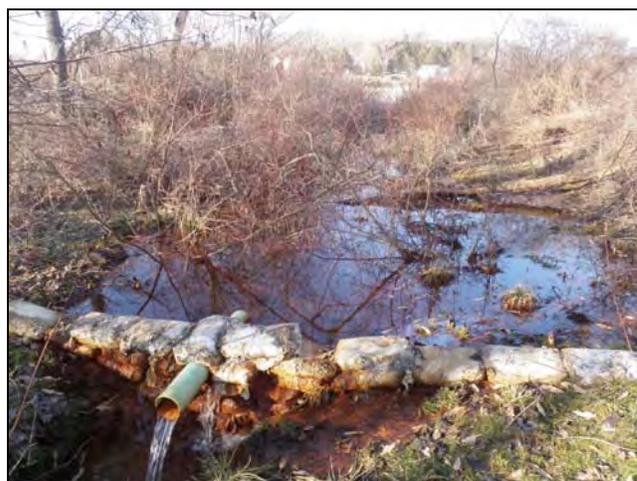
### SR286 Photos

- The concrete bag “dam” installed to protect the outlet pipe was leaking, but may seal itself over time.
- Channels within the wetland could be observed. It was uncertain if short-circuiting was still taking place or if they were a remnant of the past issues. There may be a need to conduct additional work.

At the SR286 passive treatment system, a discharge enters the system via a pipe installed by PennDOT conveying mine drainage under Route 286 into a small Forebay with level spreader (Top Left). The AMD then flows into a constructed aerobic wetland, which has become channelized (Top Right and Bottom Left). From the wetland, the water flows through a channel wetland that discharges to Aultmans Run. A berm made out of bags of concrete was created to house the effluent pipe (Bottom Right) used to measure flows, which kept getting washed away.

While more recent water quality was not available, over the life of the system, SR286 is removing about 70% of the iron on average. It is uncertain how much of the remaining iron is in the solid form and just needs additional settling/filtration. During the site inspection, channels were observed within the wetland, which would indicate short-circuiting. It may be possible to improve treatment performance by disrupting the channels or taking other measures to help distribute flow to better utilize the wetland area. Compost filter socks, haybales or even baffle curtains could be used to help accomplish this task. It is recommended that AWARE/StreamTeam continue to monitor the raw discharge, the treatment wetland effluent, and the wetland channel effluent on at least a quarterly basis to document the effectiveness of the system. Problems with orphaned data within the SIS database made obtaining and evaluating water quality data time consuming and difficult and should be fixed as soon as possible.

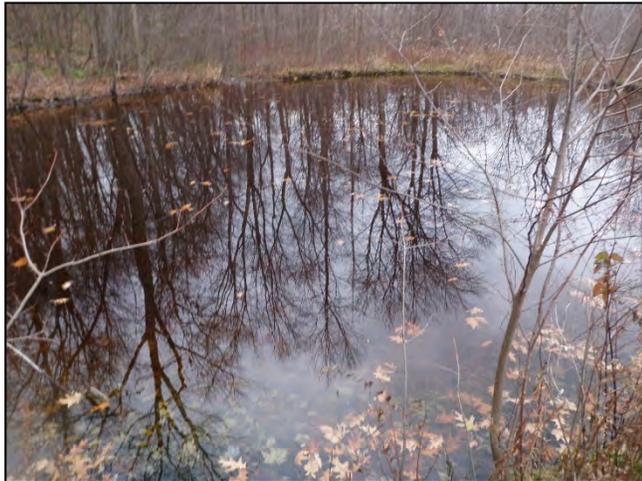
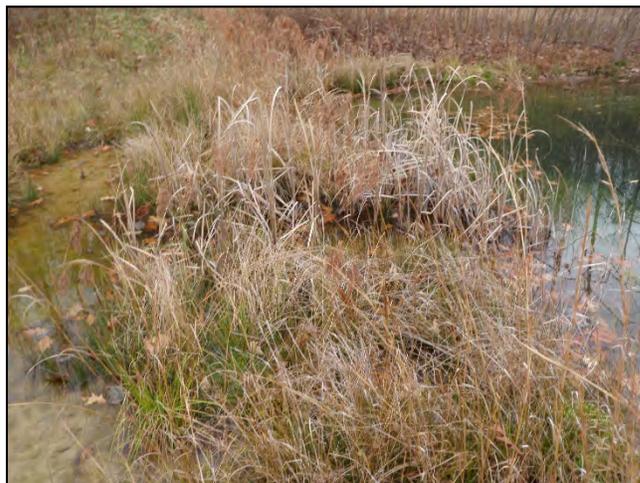
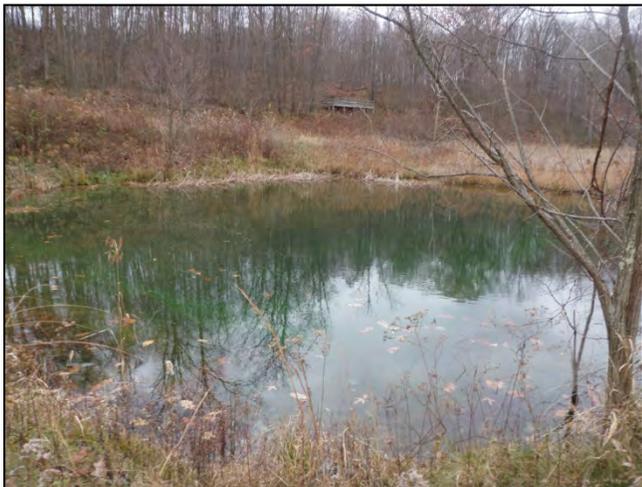
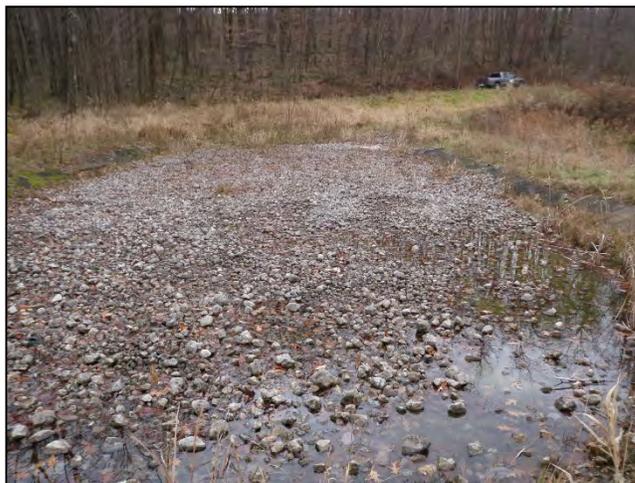
### Friedline Photos

- The water level was very high within SAPS1 to the point where a portion of the water was flowing out of an emergency spillway and bypassing most of the system and then flowing into PND4. This indicates a reduction in permeability of the treatment media and/or a plugged underdrain. The high water level also made collecting a sample of the raw water difficult and flow could not be measured. Low pH iron could be observed on top of the treatment media, which could be the cause of low permeability.
- Josh noted that during storm and other high flow events that Pond 1 also sometimes overflows. There was quite a bit of vegetation in the spillway between PND2 and SAPS2 that could be causing the water to back up.

- The water level within SAPS2 also appeared high, which would likely be due to decreased permeability of the treatment media and/or clogged underdrain. The water might be backing up into PND2 causing the higher water level in that pond.
- Vegetation in the final effluent spillway should be removed.
- Josh also reported that there were problems with the effluent flow pipe and that the LWA wanted to replace the pipe with a weir.

The Friedline discharge flows into SAPS1 (Top Left) where low pH iron is accumulating on top of the treatment media and may be responsible for the low permeability conditions that are causing the water to overflow through the emergency spillway. Vegetation in the spillways (Top Right) needs to be removed as it causes the water to backup and overflow the berm. The water level in SAPS2 (Bottom Left) is also high (probably due to low permeability) and may be causing water to back up into PND2. The slag bed (Bottom Right) may be plugged and may need to be stirred and cleaned.

- Install an Oxidation Precipitation Channel (aka Terraced Iron Formation) that would capture the AMD further uphill and would utilize natural biogeochemical processes to remove iron at low pH. This will allow more of the iron to be removed in a channel as opposed to accumulating on top or within a Vertical Flow Pond. This should reduce maintenance needs and potentially increase the life of the system.
- Install an Auto-Flushing Limestone-Only Vertical Flow Pond that would utilize either a siphon or solar powered SmartDrain to allow frequent flushing of the limestone pond.
- Install a Jennings mixed media Vertical Flow Pond for high alkalinity production.
- Install a Horizontal Flow Limestone Bed as the last component for additional alkalinity production and manganese removal.
