# Kiski-Conemaugh Basin Treatment System O&M Assessment Report

December 2017

Prepared by  
Stream Restoration Incorporated and BioMost, Inc.

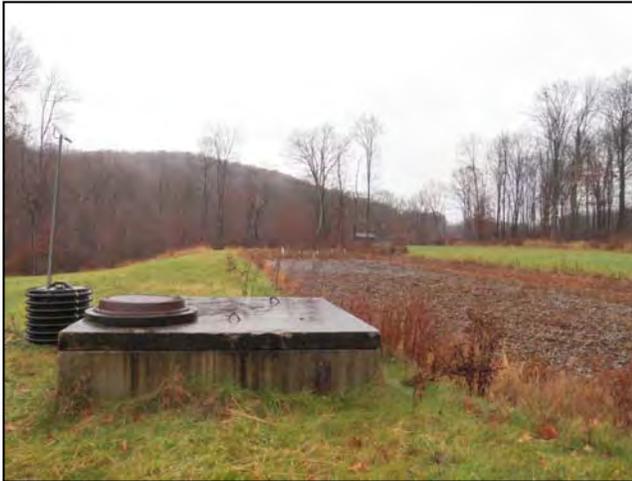
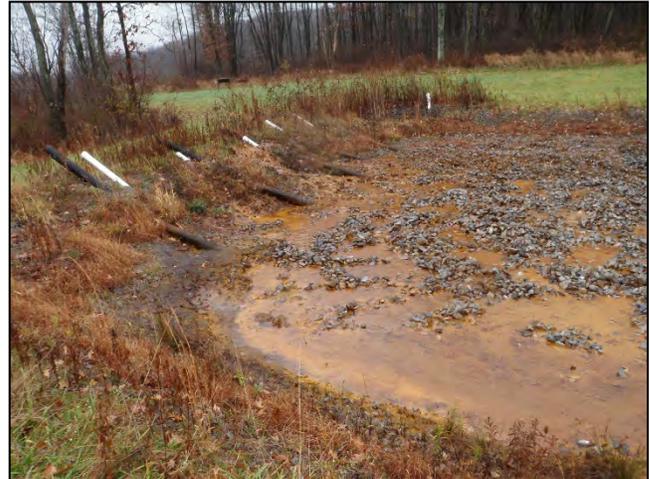
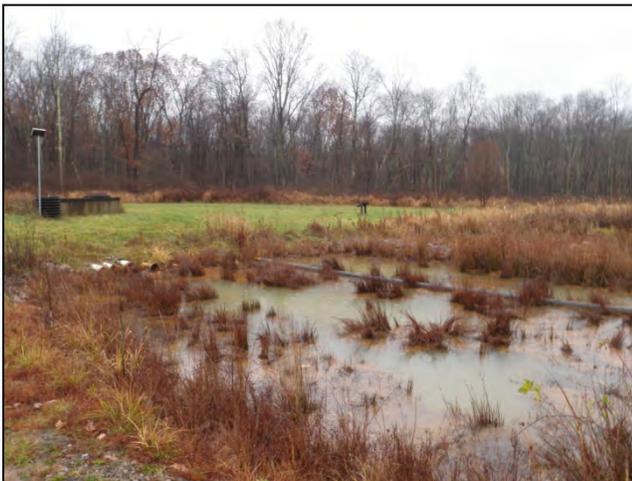
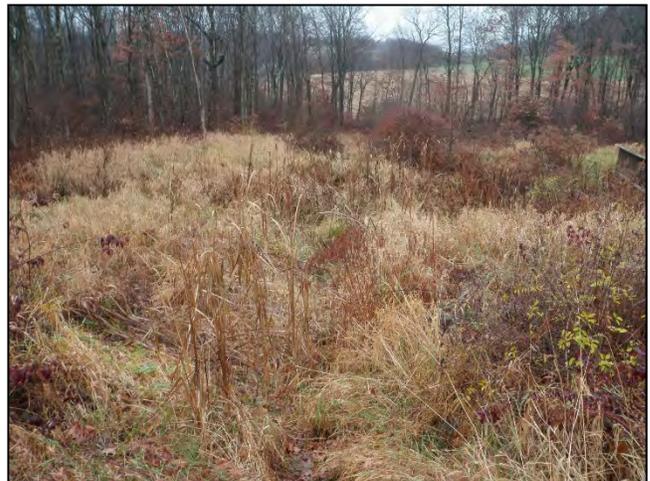
### Keystone Phase 1 & 2 Photos

The Limestone Upflow Pond (LUP) (Top Left and Right) receives AMD from the Salem #2 mine. A solar powered SmartDrain (Top Left) was installed to replace a siphon based auto-flushing system. Metal accumulation within the LUP (Top Right) is observable and may be inhibiting proper function of the pond. The LUP flushes into a settling pond/wetland (Bottom Left). A baffle curtain is used to help settle solids before entering the wetland. Treated water discharges to McCune Run via a long Open Limestone Channel (Bottom Right) that is currently over grown with wetland vegetation.

Recommendations were going to be made for this system, but during the project it was discovered that the PA DEP had already redesigned the Keystone treatment system with construction anticipated to be completed in 2017. The new mine seal and conveyance system has already been completed. The new treatment system will consist of a settling pond, flushable limestone bed, settling pond, wetland, and manganese removal bed in series. The system should be re-evaluated after construction is completed.

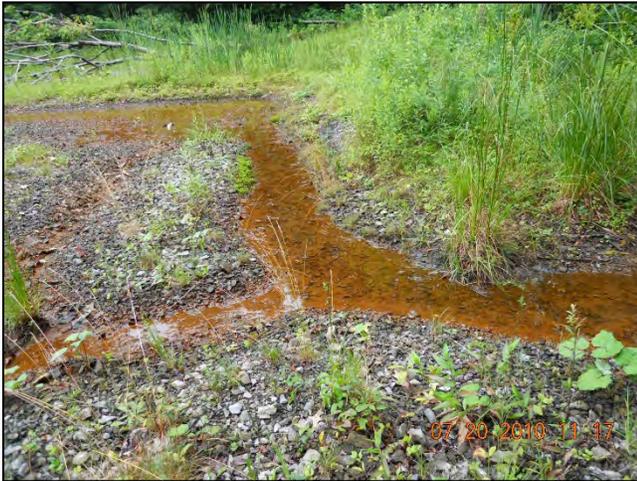
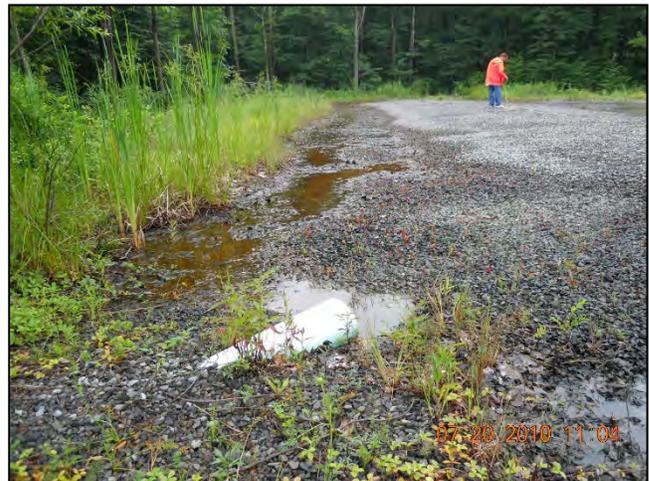
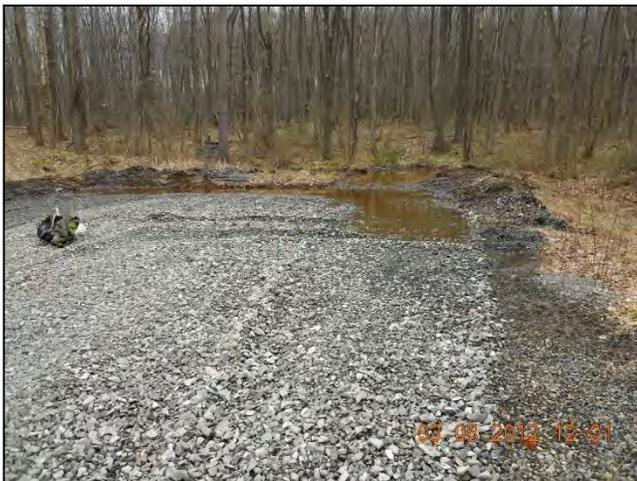
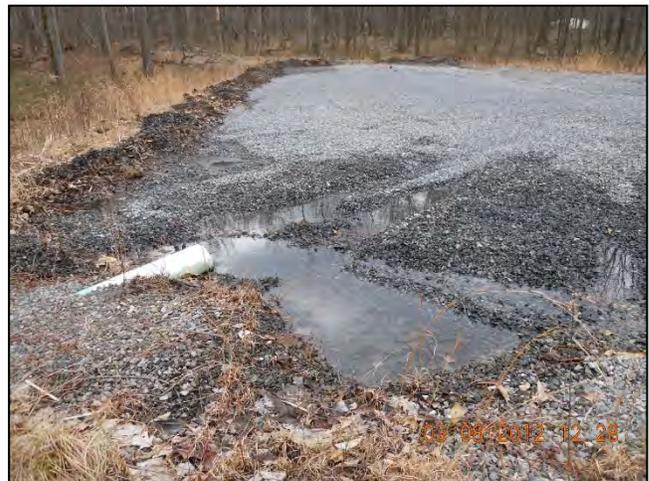
### Laurel Run Pyrolusite® System Photos

After many years of operation, the AMD flowing into the Laurel Run Pyrolusite® bed (Top Left) began to flow in a channel on top of the limestone in a lower portion of the bed short-circuiting towards the outlet of the bed (Top Right). Uneven stone caused the channelization, but the accumulation of iron and debris prevented the water from entering the bed. The iron was removed. The limestone bed was stirred and leveled and an infiltration trench was excavated at the inlet of the bed (Bottom Left and Right). The maintenance activities restored the proper pathways and rehabilitated the bed's ability to treat the water. (Photos provided by the PA DEP)

Currently the system is working well; therefore the only recommendation is to continue monitoring the system on a regular basis and conduct maintenance as needed. The bed will likely need to be stirred again in the future. This passive system has been included in the O&M trust fund established by the PA DEP.

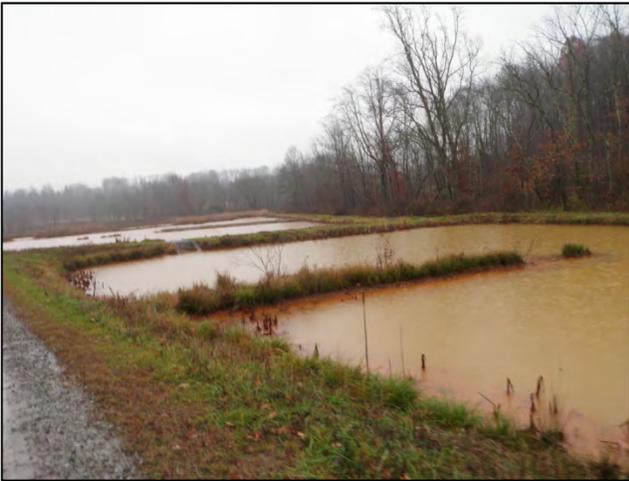
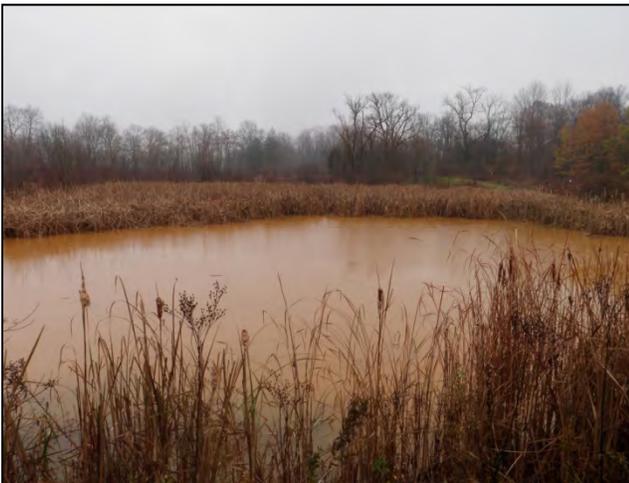
## Monastery Run Improvement Project Photos

- Iron solids have been accumulating within Wetland #2 and #3 systems and will need to be removed.
- Low berms, the build-up of vegetation and the accumulation of iron has resulted in water overflowing the berms in the Wetland #2 system.
- Some of the valves need to be replaced.

At the Monastery Run Improvement Project (Top), the Wetland #1 system (Middle Left) had maintenance conducted around 2012, including removing iron solids. Because there was not a market for the material, the iron oxide has been stockpiled (Middle Right) for future use. Recently acquired funds will be utilized to conduct additional maintenance, including removing accumulated iron solids (Bottom Left), replacing valves as needed, and raising berms to prevent overflowing and short-circuiting (Bottom Right).

Since the site visit was conducted, Saint Vincent College has continued to pursue funding and conduct maintenance. A sludge line was installed along Wetland #2 & Wetland #3 to the sludge drying bed. Sludge from Wetland #3 was pumped to the sludge drying bed. The northwest berm of Wetland #2 was repaired and built up to increase the elevation and cattails were removed from ponds to prevent overflowing of berms and potentially improve treatment.

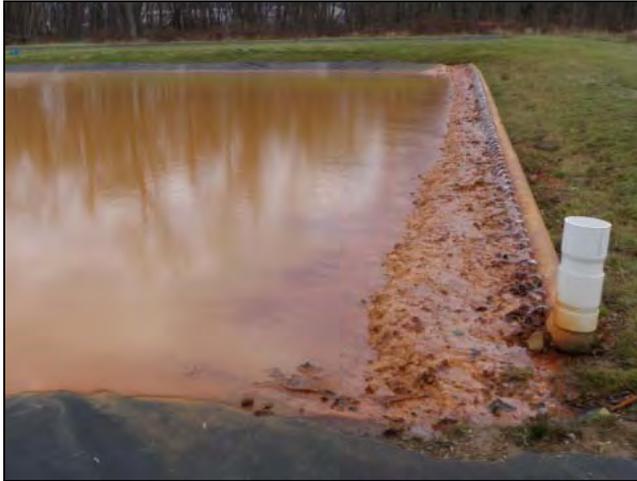
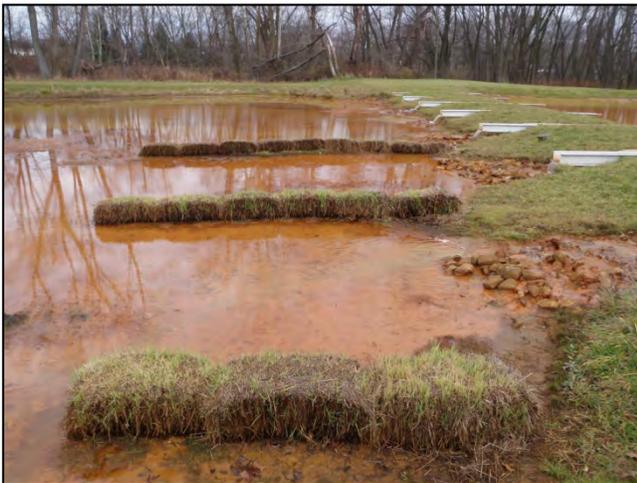
### Upper Latrobe System Photos

A site visit was conducted on November 19, 2013 with Josh Penatzer of the Loyalhanna Watershed Association (LWA). Josh indicated that for the most part, the system was working well, but noted that they have been having problems with short-circuiting issues within the wetland. They are currently using haybales to address the issue, but they break down over time and need to be replaced. During the site visit, a recommendation was made to consider compost socks, custom made baffle curtains, or possibly using plastic z-piling instead of haybales if constant replacement becomes difficult. These options could also be employed in other parts of the wetland to encourage full utilization of the treatment area. While the site investigation was conducted in mid-November, there was little evidence of wetland vegetation present within the wetland, which could also affect treatment performance.

At the Upper Latrobe passive treatment system, the discharge is split between two settling ponds. A perforated influent pipe stretches across the width of each pond (Top Left) to distribute and aerate the flow. Metal troughs (Top Right) spaced within the berms are intended to convey water evenly from one pond to the next. Haybales (Bottom Left) were strategically placed within the wetland to help address short-circuiting that was occurring, but they need to be periodically replaced. Installing baffle curtains, plastic z-piling, compost filter sock or utilizing persistent vegetation in the wetland (Bottom Right) would likely improve treatment performance.

Overall the treatment system appears to be doing well. At times, slightly elevated concentrations of 2-5 mg/L of total iron remain; however, available ferrous iron and Total Suspended Solids values indicate these concentrations are due to suspended iron solids. Whether the increased iron solids are due to short-circuiting or not is difficult to state with certainty at this time, especially since there was little data with flow measurements available. Compost socks, custom made baffle curtains, or possibly plastic z-piling could be used within the wetland to discourage short-circuiting from occurring and encourage the settling of iron solids. If vegetation within the wetland is not successful there may be a need to conduct additional plantings. Planting more persistent vegetation may also be helpful to provide better year-round solids removal. In addition, the system should be regularly inspected and water monitoring, including flow measurements, should be conducted. The existing O&M plan should be followed and maintenance should be conducted as needed.

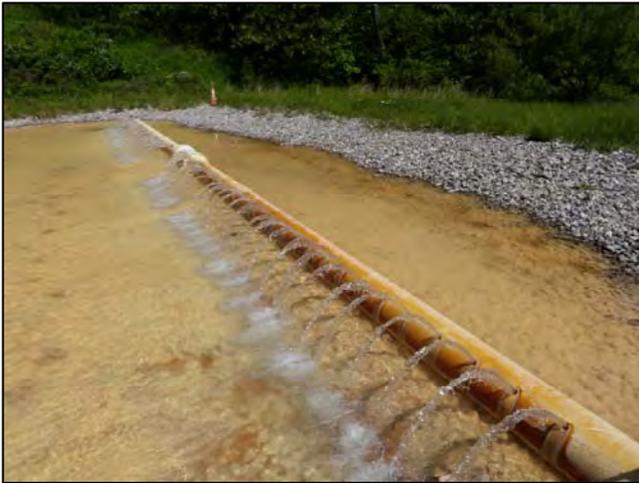
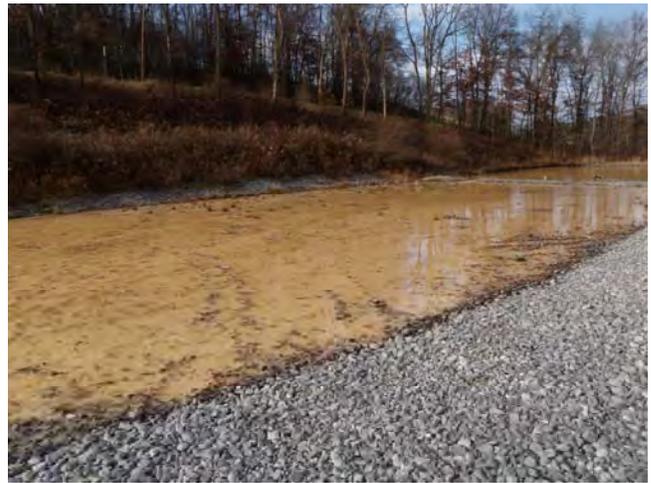
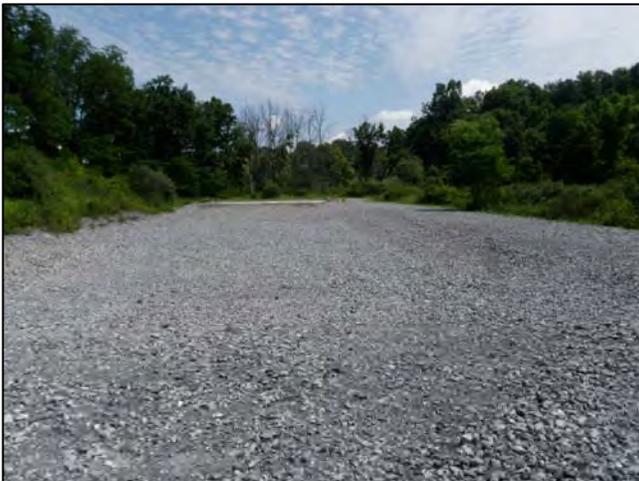
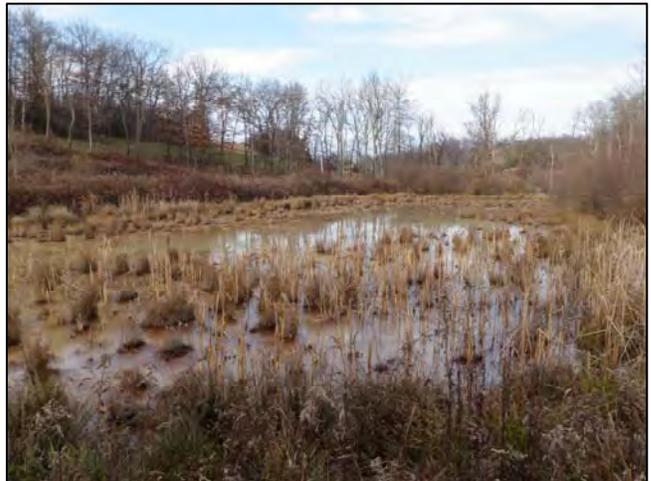
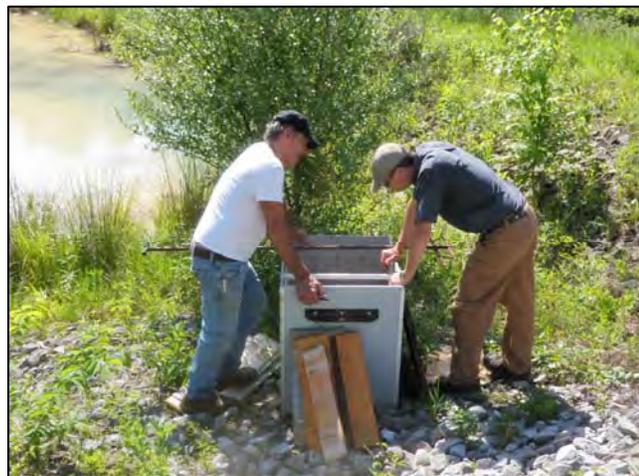
### Big Run #2 Photos

At the Big Run #2 passive system, a perforated pipe (Top Left) was installed to evenly distribute water across the width of the limestone bed. The limestone bed accumulates iron and aluminum solids (Top Right), which periodically need to be removed (Center Left) in order to maintain treatment effectiveness. The limestone bed discharges to a wetland (Center Right). The limestone bed can be flushed by removing stoplogs (Bottom Left), but could be converted into an auto-flusher by installing a siphon or SmartDrain device.

- If possible, retrofit the limestone bed with either a siphon or Agri Drain SmartDrain (solar powered) to create an auto-flushing limestone bed. It would be beneficial to improve or replace the existing underdrain system. The retrofit will allow for more frequent flushing to occur without the need for a person to complete the task and may increase treatment by potentially increasing retention time. An Agri Drain SmartDrain will provide more control of the frequency of flushing events. A siphon flushing mechanism will be controlled by flow rate.

- If a siphon or SmartDrain is not installed, the current Agri Drain box could be replaced with a valve that could easily be opened to simplify flushing of the bed as opposed to removing/replacing the stoplogs.

- Install baffle curtains and/or filtering media to assist removing solids in wetland.
- The system would greatly benefit from additional settling capacity, but there does not appear to be room to do so.

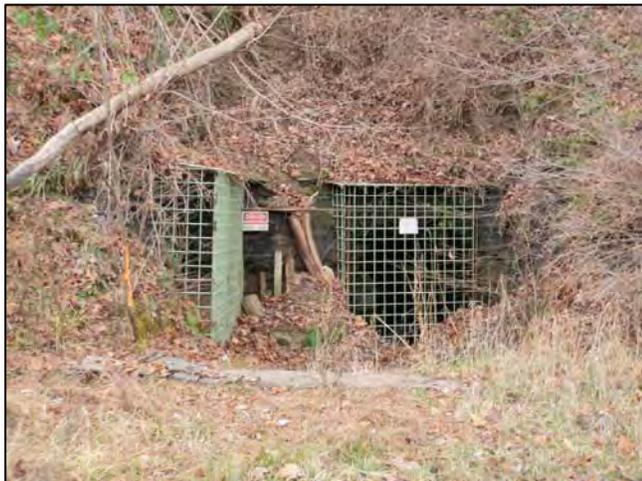
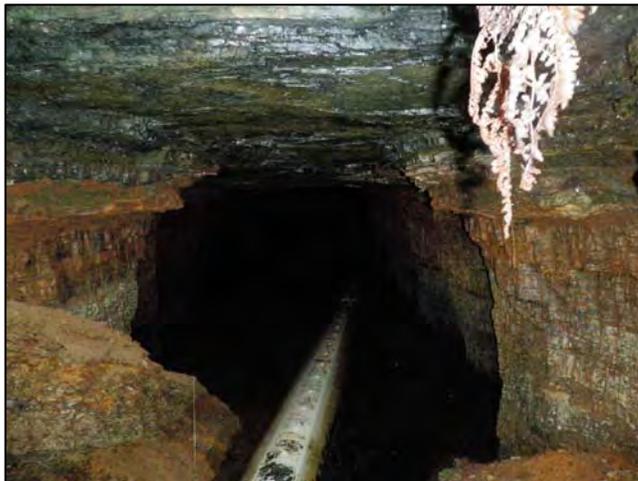
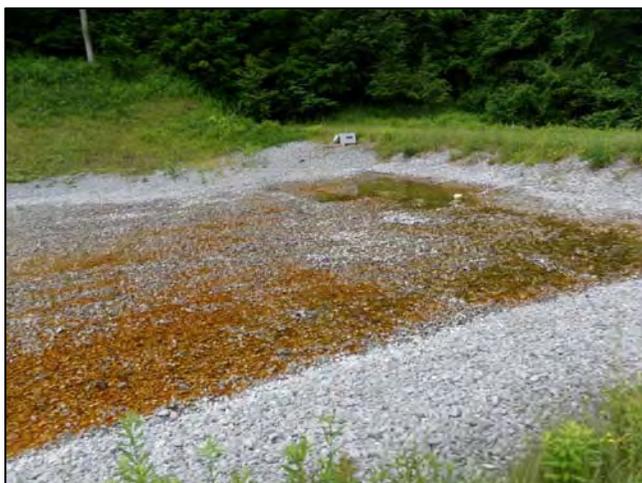
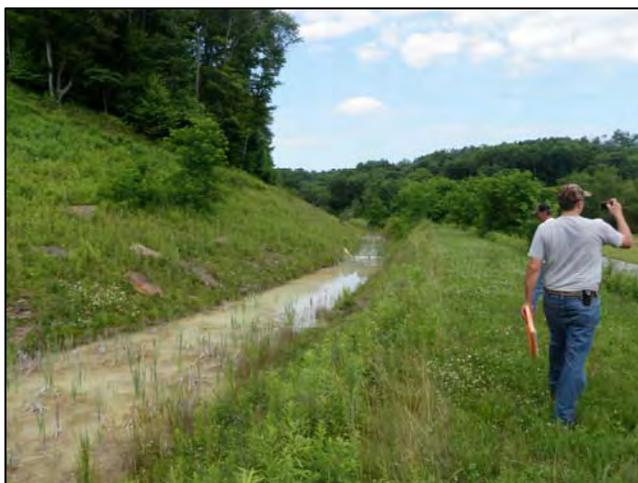
### Big Run #7 Photos

The Big Run #7 mine discharge emanates from an abandoned underground mine entry (Top Left). A pipe (Top Right) was inserted into the mine to collect and convey the discharge to the treatment system. The AMD is directed into a flushable limestone bed (Bottom Left) that is flushed by removing stoplogs inside of an Agridrain box. Due to the accumulation of iron and aluminum, the limestone has to be regularly stirred and cleaned. Converting the limestone bed to an auto-flusher may help to improve treatment and reduce maintenance. Water from the limestone bed flows into a settling pond/channel wetland (Bottom Right). The water is then conveyed to the Big Run #3 system.

- Retrofit the limestone bed with either siphon or Agri Drain SmartDrain (solar powered) to create an auto-flushing limestone bed. It would likely be beneficial to improve or replace the existing underdrain system. The retrofit will allow for more frequent flushing to occur without the need for a person to complete the task. An Agri Drain SmartDrain will provide more control of the frequency of flushing events. A siphon flushing mechanism will be controlled by flow rate.

- It may be possible to add limestone to the pond to increase contact time.
- While it currently does not seem to be causing a problem, during the retrofit, it may be beneficial to move the influent flow distribution pipe to be above the stone instead of within the stone. There is the possibility of the stone becoming plugged around the perforations and preventing water from flowing into the system, which would then cause the water in the mine to back up and flow out in a different location.

- There may be a benefit to overall water quality by regularly removing sludge from the settling pond/channel wetland to increase storage capacity, which may help to settle solids.

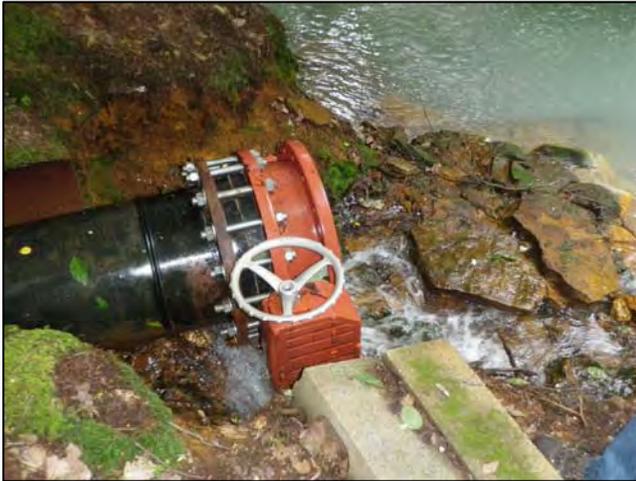
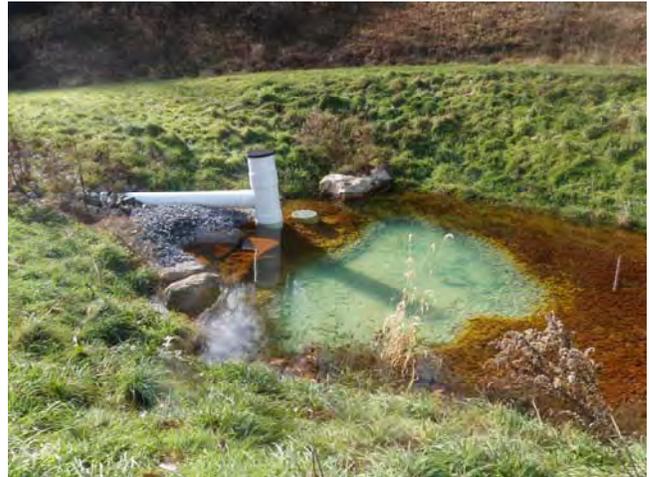
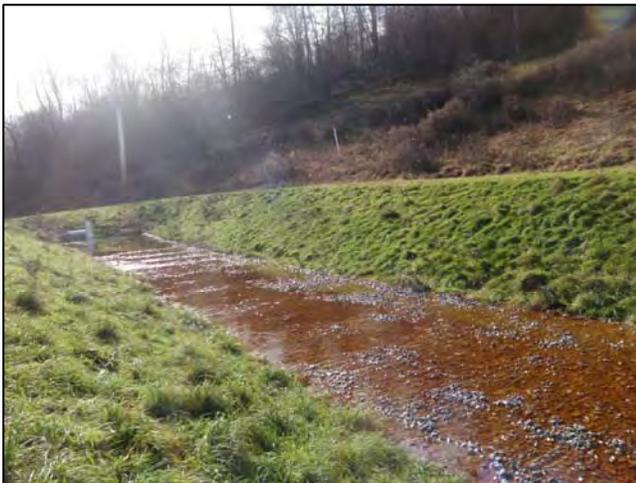
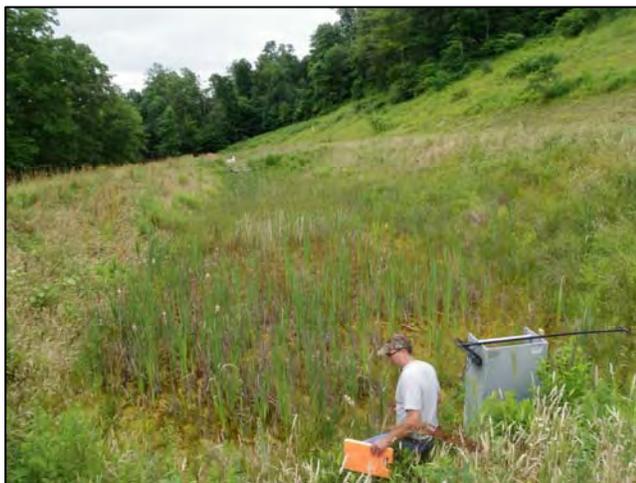
### Big Run #8 Photos

- The #8 drainage tunnel bypass valve is broken and needs repaired.
- The limestone beds regularly plug due to the accumulation of low pH iron and aluminum precipitates and require periodic stirring/cleaning of the limestone.
- The limestone beds do not have an underdrain and currently cannot be flushed.
- The #7 and #8 discharges are believed to be hydrologically connected. When the flow out of #8 is restricted due to permeability problems of the first limestone bed, flow is reported to back up in the mine and significantly increase at the #7 discharge.

A large collection pipe and valve (Top Left) was needed to capture the AMD for the Big Run #8 system. The valve is leaking and should be repaired. The AMD enters a limestone bed with no underdrain and plugs quickly due to low pH iron and aluminum requiring frequent cleaning (Top Right and Center Left). The water then flows into a settling pond/wetland (aka Pond 2) (Bottom Left) and then into another limestone bed (Center Right) which also frequently plugs. Plugging became such a problem that a trench was cut through the treatment media. Converting the first bed to an OPC and the second bed to a flushable limestone bed may help to improve treatment and reduce maintenance.

- Fix broken valve. This could be difficult with the amount of water at the site.
- It may be possible (depending on current design, elevation, room, etc) to convert Limestone Bed #1 to an Oxidation Precipitation Channel (OPC) to promote iron removal at low pH. Might be able to move stone to create terraces or, preferably, remove a large portion of the stone and add to one of the other Big Run limestone ponds. May be able to enlarge the surface area of the OPC to maximize iron removal.

- Establish an O&M fund to pay for frequent maintenance activities.
- Measure flow rates whenever possible.
- Alternatively, the limestone beds could be converted to settling ponds and the limestone removed from Ponds 1 & 3 could be added to other Big Run ponds. There may be the possibility of either moving the Big Run #3 lime doser or adding additional chemical treatment closer to the beginning of the system to make it a completely chemical system

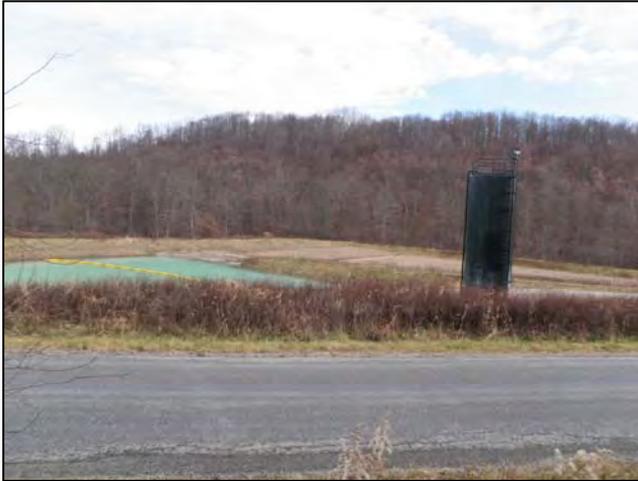
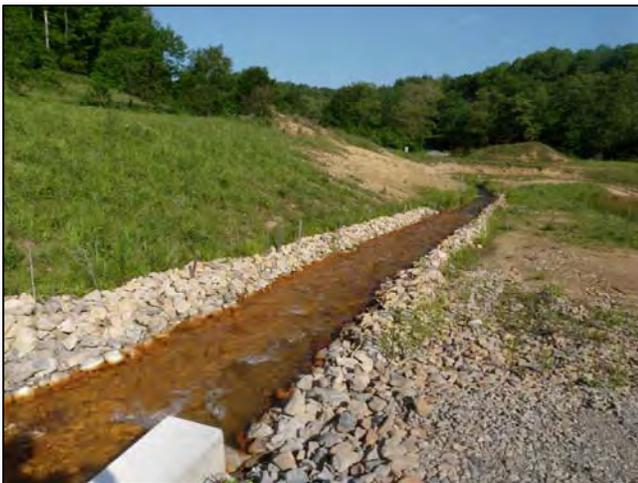
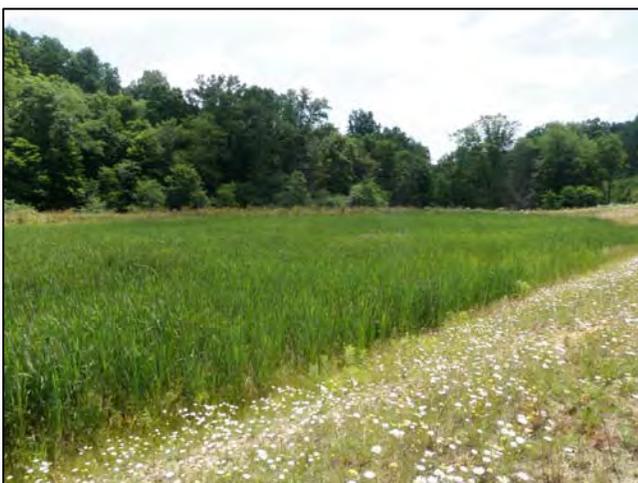
### Big Run #3 Photos

The Big Run #3 system (Top Left) receives partially treated mine water from the #7 and #8 passive systems and untreated discharge #7A. The chemical based system consists of a lime silo (Top Left) containing a “Sweedish” tipping bucket lime doser (Top Right), a mixing channel (Center Left), a settling pond with baffle curtain (Center Right) and a constructed wetland (Bottom Left). The #3 system faces a variety of O&M challenges, some of which may be addressed by improving the #7 and #8 systems as well as adding additional passive components.

- While further evaluation is needed, it may be possible to install additional passive treatment components that would reduce or eliminate the need for lime. A Jennings VFP prior to the wetland and/or a horizontal flow limestone bed at the end of the wetland could provide additional alkalinity generation and remove solids prior to discharging to the stream.
- Depending on site conditions, BioMost may be able to install a MixWell or trompe powered Air Mixer to improve lime utilization, which will result in less sludge.
- Potentially add an additional windowed baffle curtain to assist in settling solids.
- Construct a pond for sludge dewatering and storage. There may be potential to utilize a sediment basin installed at a recent nearby surface mine operation.
- There may be the potential to pump sludge into the underground mine workings, but further evaluation would be necessary.

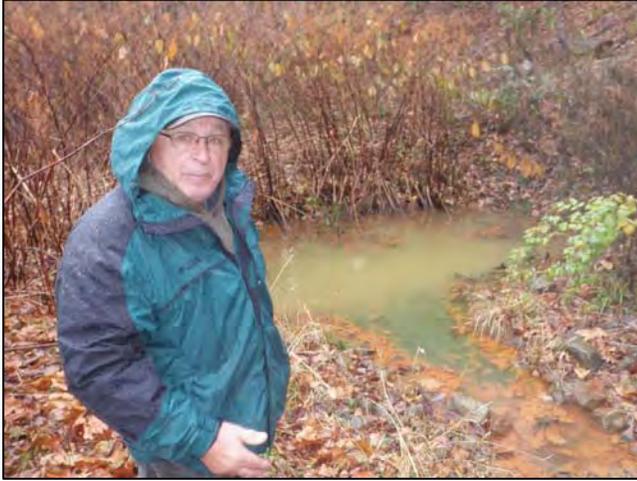
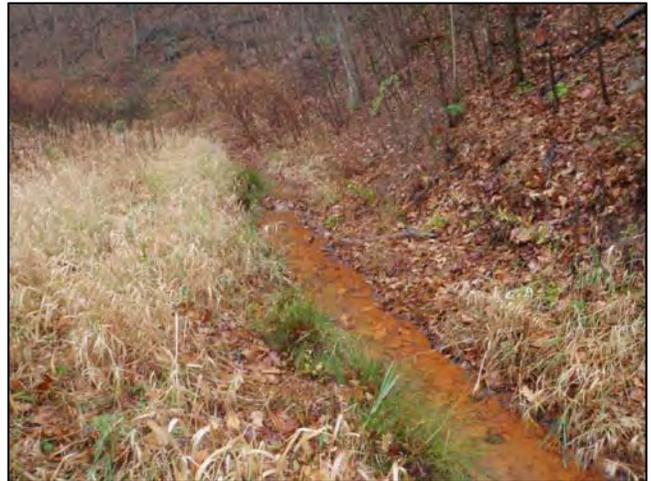
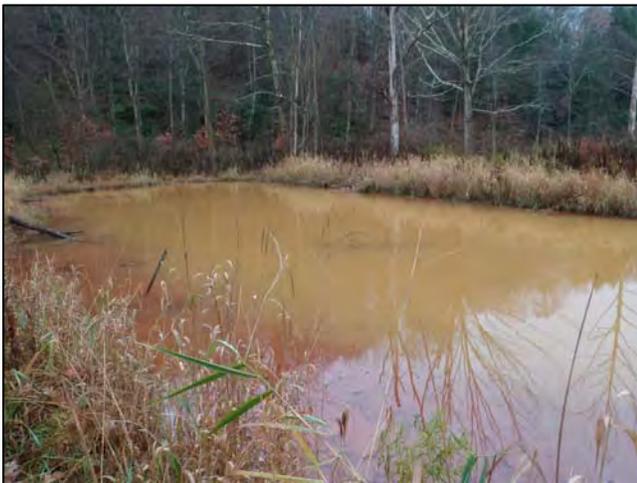
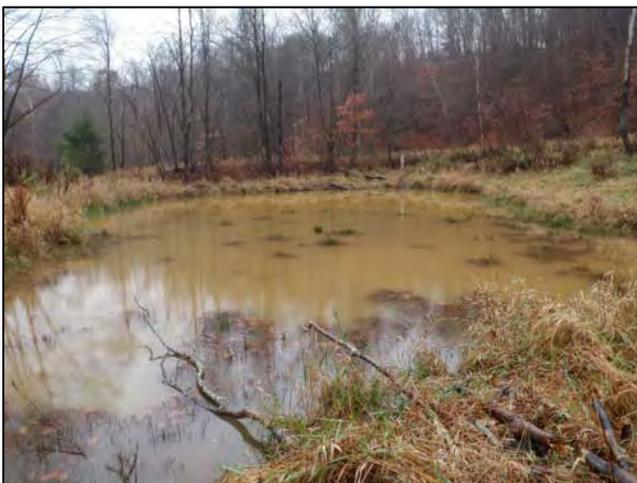
### Booker Photos

Volunteer John Linkes regularly inspects and samples the Booker Discharge (Top Left) passive treatment system. The only maintenance needed since construction was cleaning out the limestone channel (Top Right) that conveys the discharge to treatment system. Overall the system is working well. Due to the shape of the ponds and the location of inlet and outlets, Pond 1 (Center Left) and Pond 3 (Bottom Left) may be short-circuiting. Installing directional baffle curtains to disrupt short-circuiting and windowed baffle curtains to assist with settling solids could help improve treatment. Pond 2 (Center Right) is shallow enough that wetland plants could be planted if desired, which could help with removal of iron solids.

- Planting of Pond 2 with wetland plants or seed to establish a wetland if desired. This would likely help to filter solids from the water and improve treatment.
- Installing directional baffle curtains in Ponds 1 and 3 may help reduce short-circuiting, lengthen retention time and assist in oxidation of iron and settling of solids.
- Installing windowed baffle curtains in Pond 3 may help to settle additional solids.
- Installation of a trompe or other aeration device may help to improve treatment; however, the other recommendations should be completed first as they are cheaper and easier to implement.

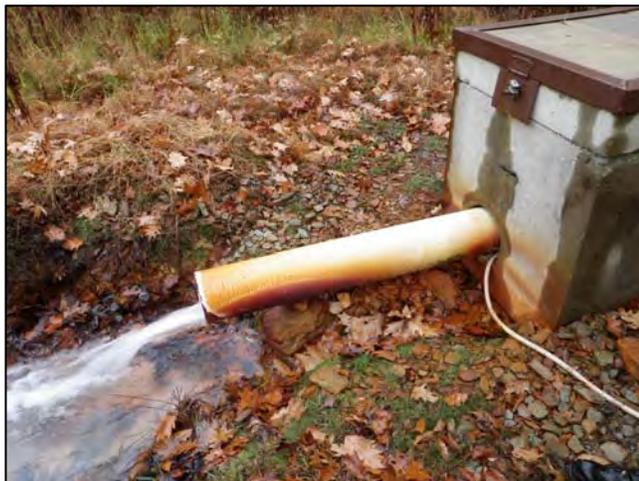
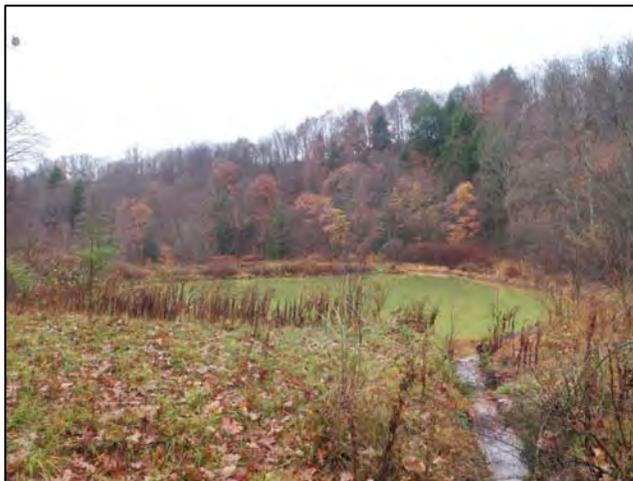
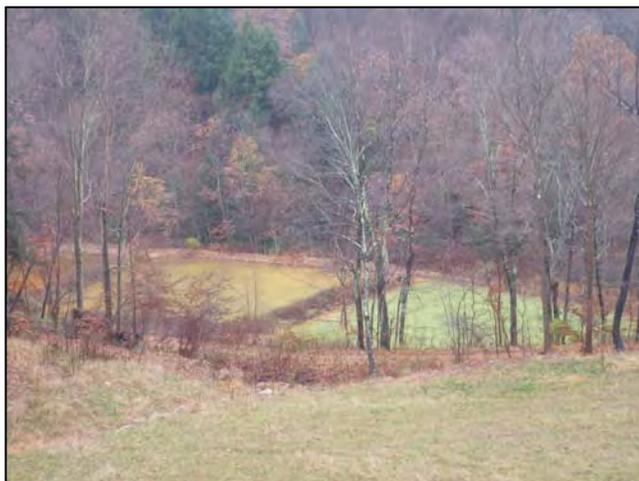
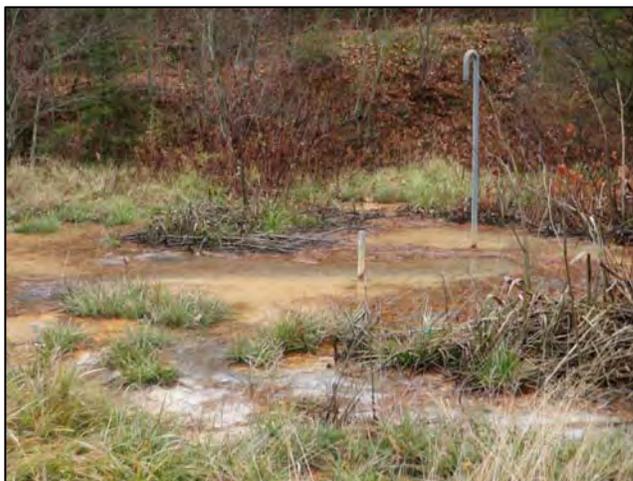
The Jamison Borehole discharge (Top Left) on this day was being controlled and the flow rate significantly reduced, which caused most of the flow to emanate at an old airshaft (Bottom Right). Under normal flow conditions, the AMD enters three settling ponds (Top Right and Bottom Left) which are undersized and do not have an alkalinity-generating component, allowing for little treatment to occur.

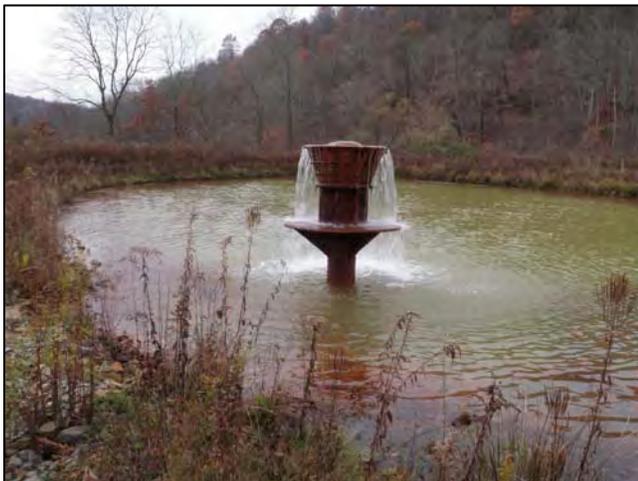
At the Kolb passive system, a large underground mine discharge has been collected and conveyed by pipe to two aerobic settling ponds in series. A large fountain (Left) was installed to provide aeration and degassing of CO<sub>2</sub> to promote oxidation of dissolved iron, while baffle curtains (Right) were installed to help settle solids. The treatment system would benefit from being expanded to include a constructed wetland and using persistent vegetation.

While the Kolb system is removing a large amount of iron, a significant iron load is still entering the stream. In order to improve treatment, the system could likely be expanded into the neighboring field to provide additional iron precipitation and settling/filtration of solids. Constructing a wetland utilizing persistent vegetation such as cattails is recommended to provide filtering capabilities throughout the year. Haybales and/or filter fence could also be potentially used in places. Installing a trompe may be helpful in providing additional aeration and CO<sub>2</sub> degassing to increase iron oxidation rates, especially if the system cannot be expanded into the adjacent field. Installing additional windowed baffle curtains in strategic locations may also help to promote settling of solids. As flow data is generally lacking, an effort should be made to measure flow every time samples are collected in at least one location.
