LOWER LOYALHANNA CREEK WATERSHED

Section 3 – Lower Loyalhanna Creek Watershed

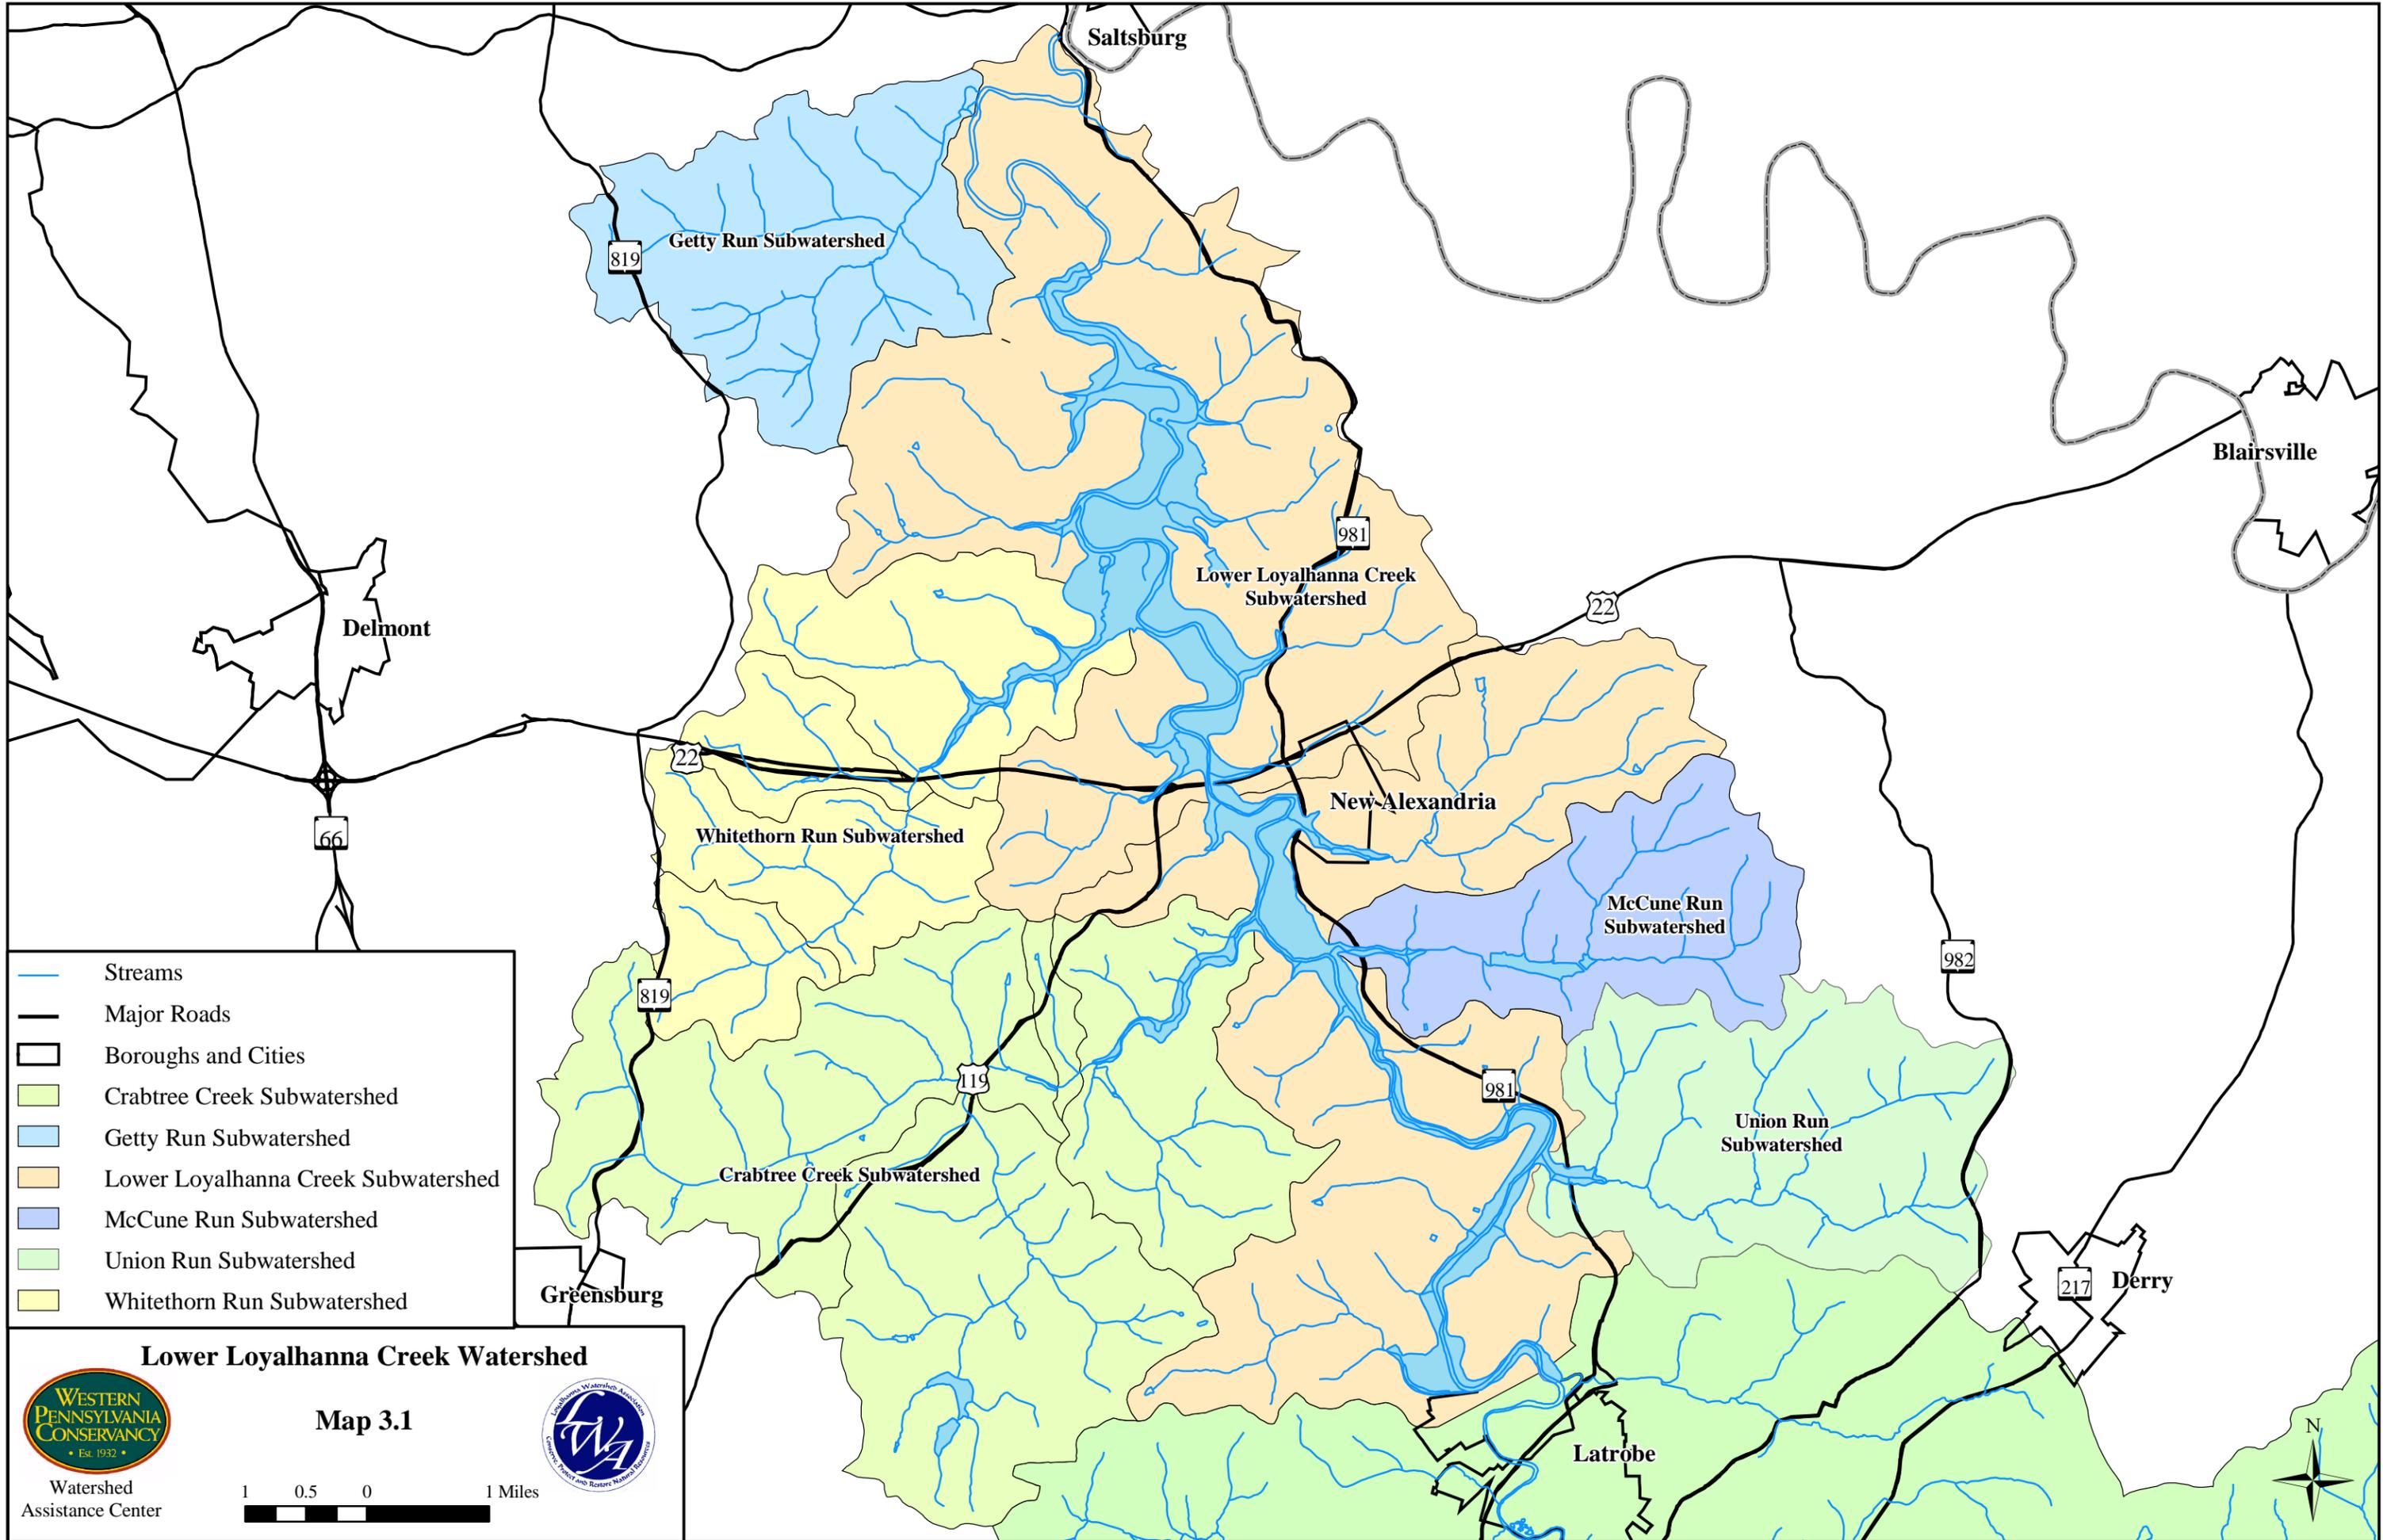
Figure 3.1: Lower Loyalhanna Creek Overall Ratings

The visual assessment of the Lower Loyalhanna Creek section was completed in the summer of 2004. As depicted in Figure 3.1, 42% of the lower section received a good rating, 35% received a fair rating, and 23% received a poor rating. An average score of 6.85 was given to the entire lower section, which is a fair rating overall.

Assessment ratings for the Lower Loyalhanna Creek section reflect the impacts of AMD and riparian zone degradation throughout the entire section. Individual stream ratings are reflected in Map 3.2.

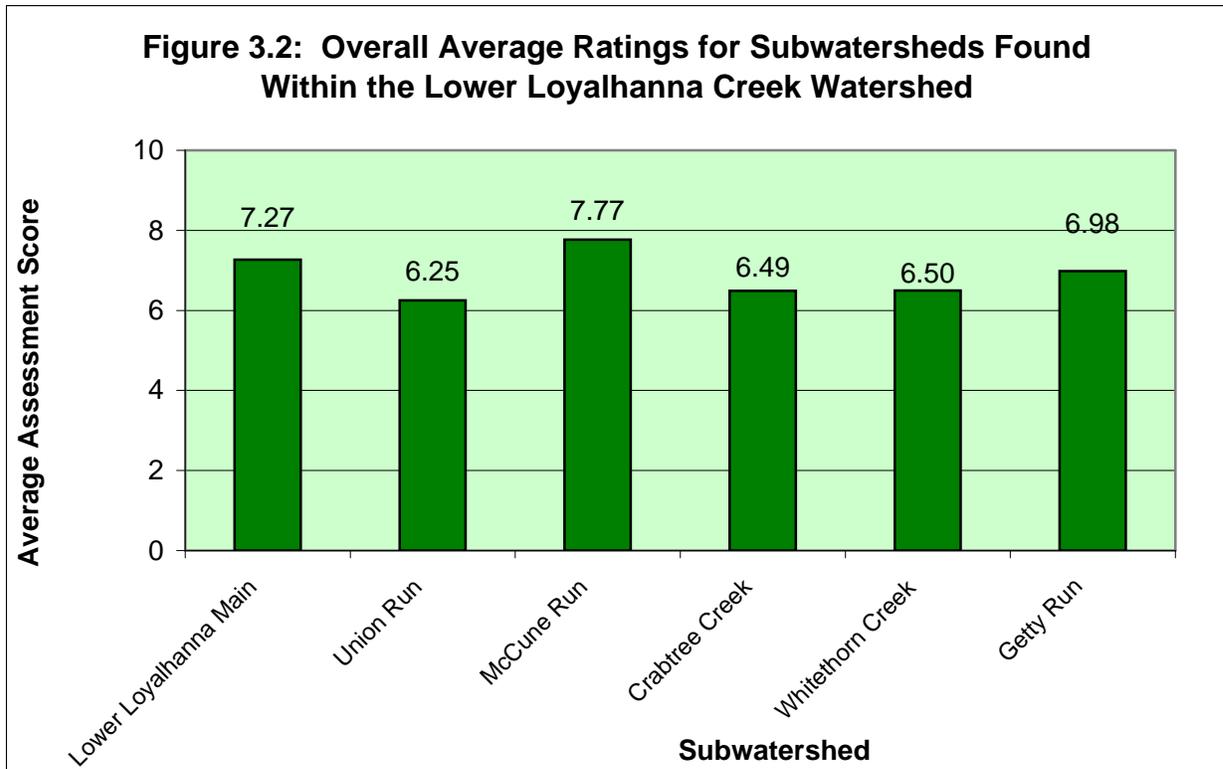
Figure 3.2 exhibits the average overall rating for each subwatershed located within the Lower Loyalhanna Creek Watershed section.

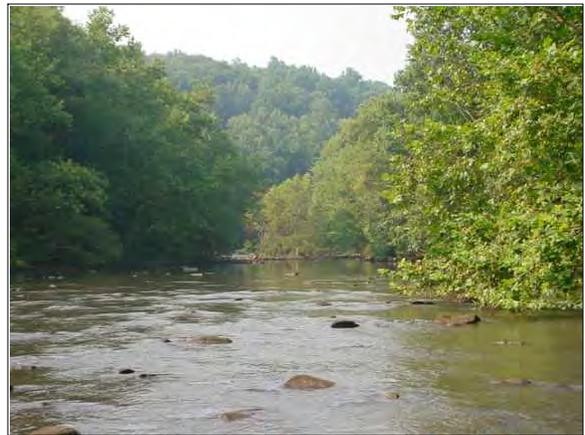
Loyalhanna Creek main stem downstream from the outflow of the Loyalhanna Dam

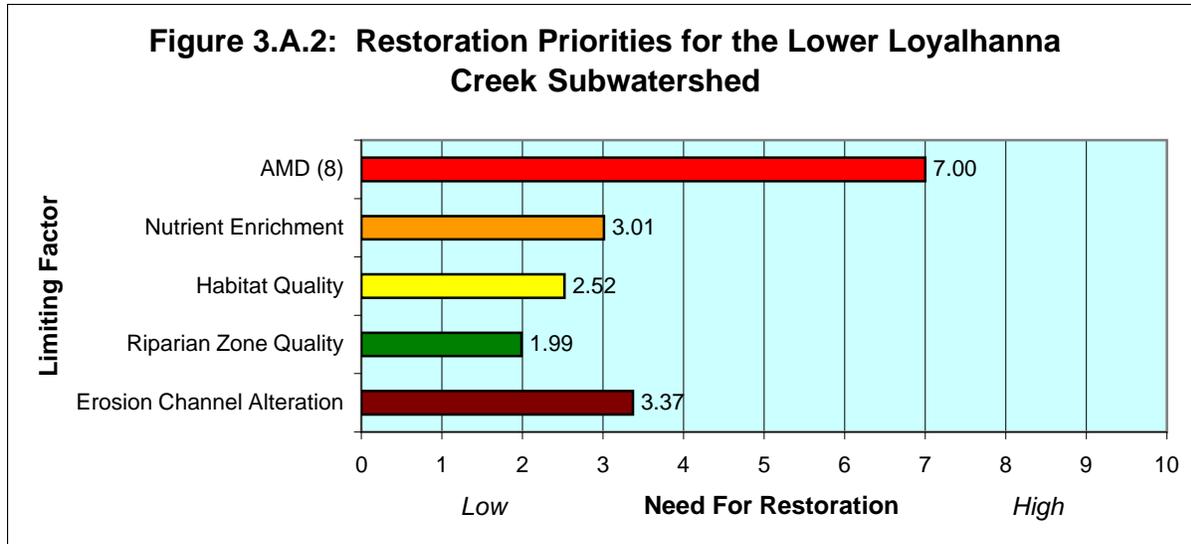
Figure 3.A.2 exhibits overall restoration priorities for the entire subwatershed. As indicated, the limiting factor that received the highest restoration priority rating was AMD. AMD is present throughout 50% of the Lower Loyalhanna Creek main stem. The most seriously impacted main stem segments are downstream of Crabtree Creek and downstream of Getty Run. There are three small tributaries that are impacted by AMD and one discharge that flows directly into the main stem. Erosion and channel alteration also rated high for restoration priority. This rating reflects the presence of sediment throughout the substrate of the Loyalhanna Creek main stem.

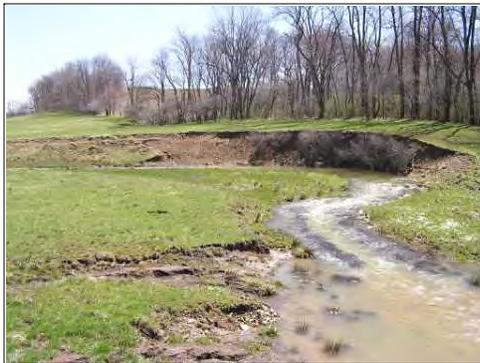
At the intersection of Androscopic Road and Bonocy Road, the main stem flows through a forested area. It is also at this point where two abandoned mine discharges enter Union Run. One originates from a suspected abandoned high wall and the second flows from a drainpipe with an unknown origin. Both discharges are acidic and both were catalogued during Project Scarlift. Continuing west, Union Run emerges from the forested area and into a large pasture. Absolutely no vegetation or canopy cover is present along the streambank. The substrate is comprised entirely of sediment and the water is still orange and white in color. A severely eroded bank is located on the downstream section of the field immediately before Union Run passes underneath Uschak Road. At the Uschak Road Bridge, the pH of Union Run was 4.7 during assessment fieldwork.

Union Run looking upstream from the Uschak Road Bridge

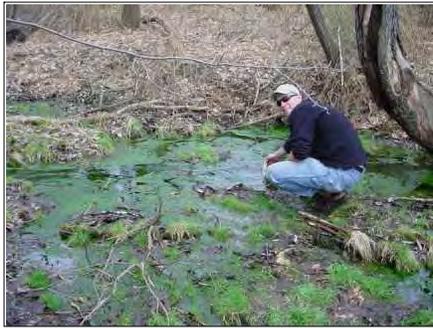
The headwaters of the Superior Branch located north of the small town of Superior

Downstream from where SuperiorUNT1N enters the main stem of the Superior Branch, the water becomes cloudy and more orange in color. Seeps continue to enter the stream from the streambanks that remain littered with waste coal. The area surrounding the streambank was surface mined in the 1970s and it appears that little was done to reclaim this section after mining was complete.

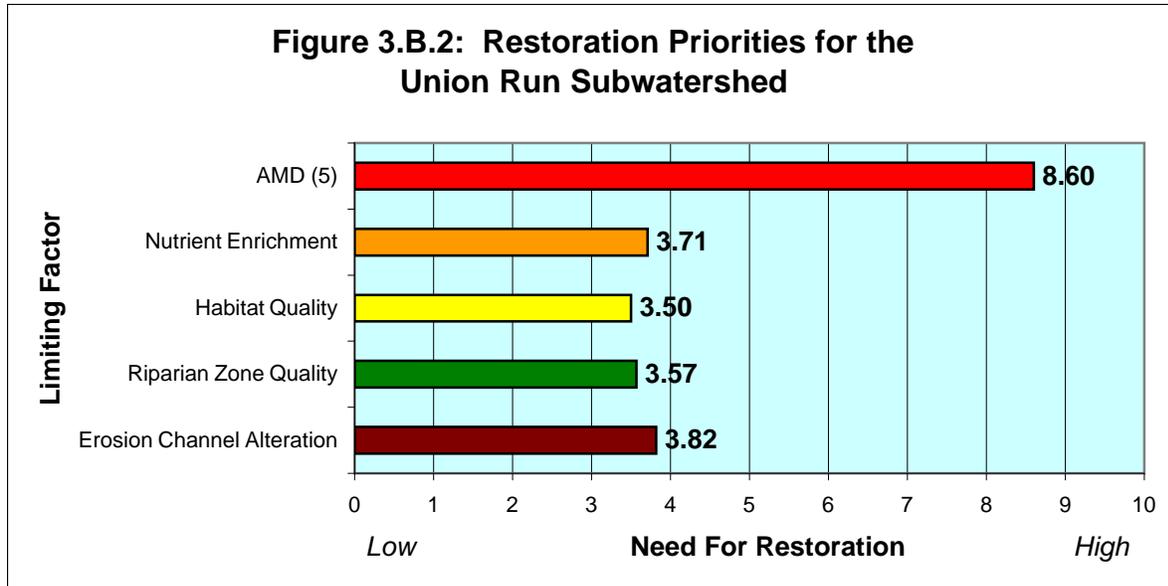
Figure 3.B.2 exhibits overall restoration priorities for the entire subwatershed. As indicated, the limiting factor that received the highest restoration priority rating was AMD. There are five stream segments that are impacted by AMD. Those stream segments include a large portion of the main stem. In addition to AMD, the Union Run Subwatershed received a high priority rating for erosion and channel alteration. This is a result of erosion occurring on sections of stream impacted by grazing livestock and lack of riparian vegetation.

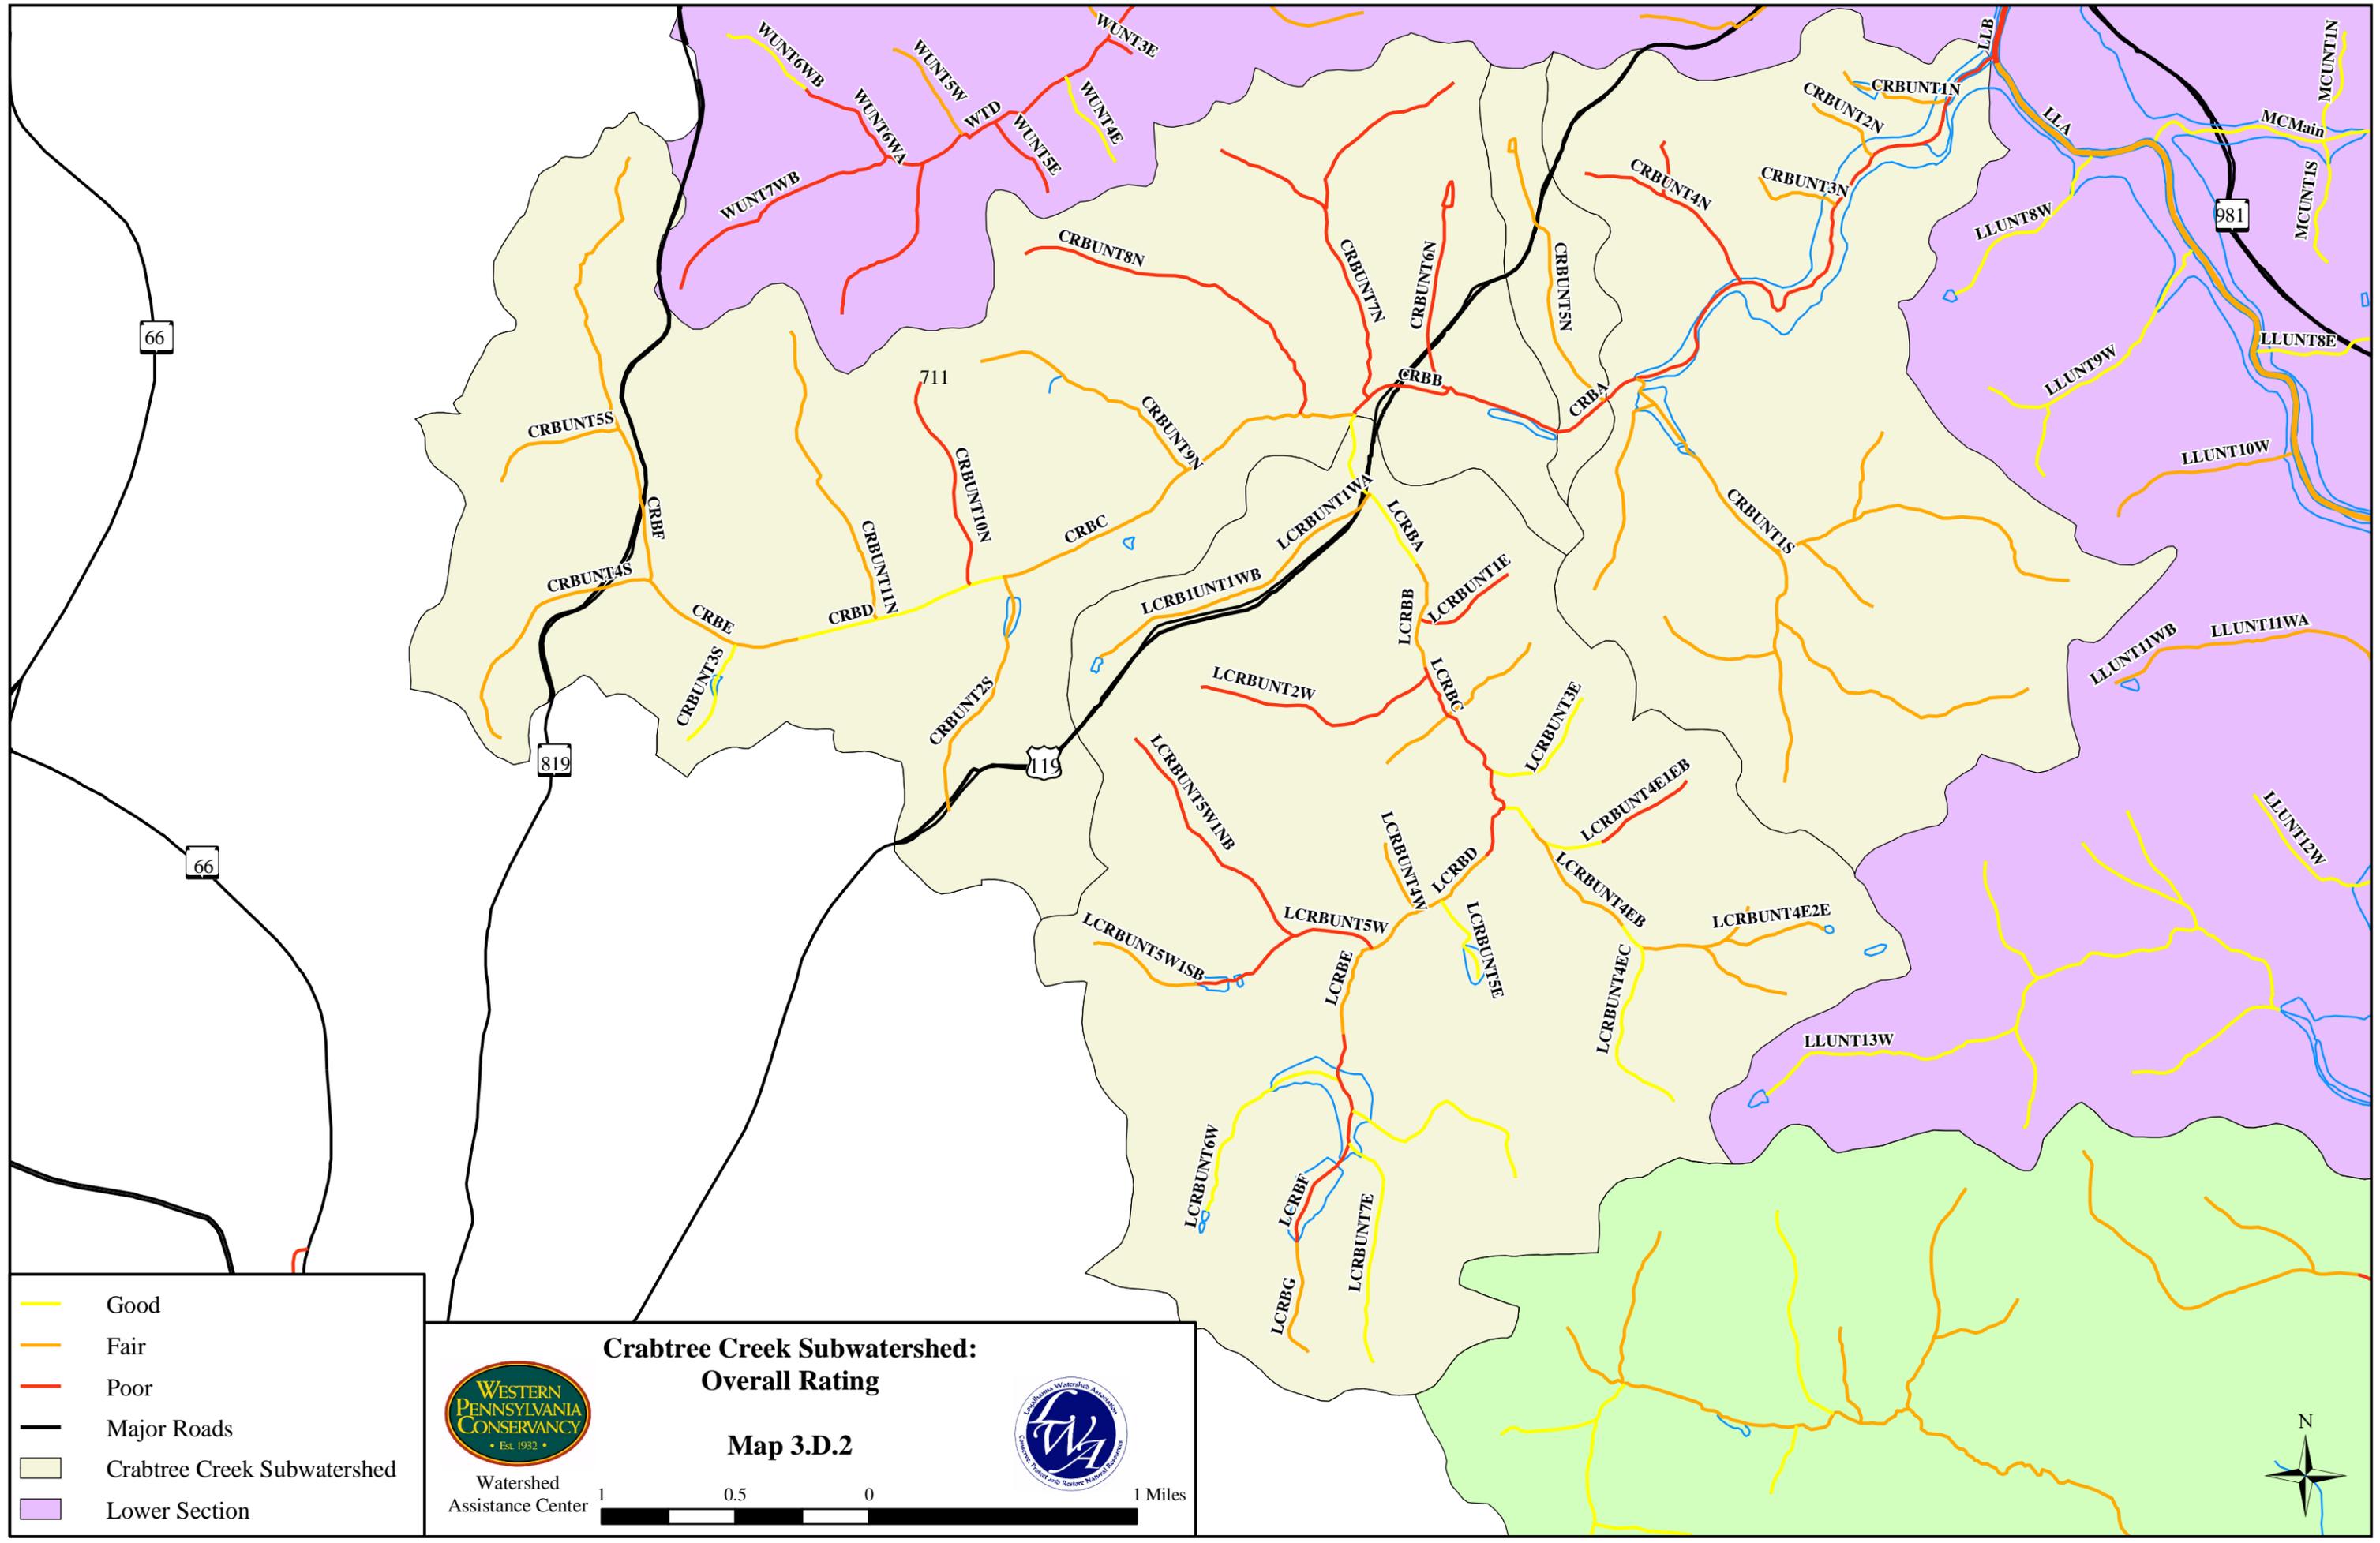
**Crabtree Creek Subwatershed:
Overall Rating**

The visual assessment of the Crabtree Creek Subwatershed was completed in May of 2004. A total of 52 stream segments were assessed. As depicted in Figure 3.D.1, 21% of the subwatershed received a good rating, 48% received a fair rating, and 31% received a poor rating. An average score of 6.49 was given to the entire subwatershed, which is a fair rating overall. The overall fair rating primarily reflects the impacts of AMD and nutrient loading. Individual stream segment ratings are depicted in Map 3.D.2.

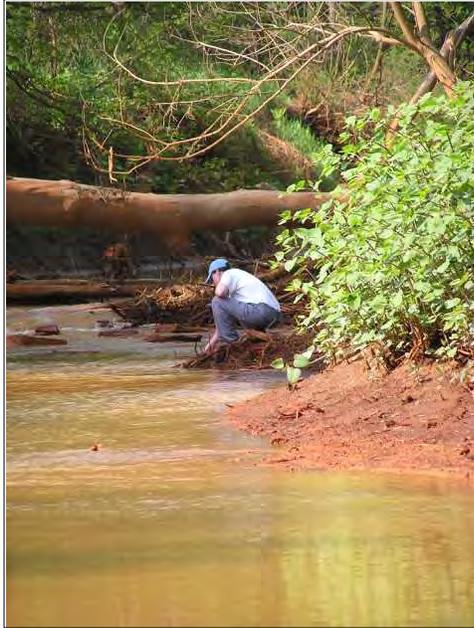
Assessment volunteer taking a field pH at the mouth of Crabtree Creek

The mouth of Crabtree Creek is located on flood-control property approximately 500 feet downstream from the Oasis Bridge on the main stem of the Loyalhanna Creek. Where Crabtree Creek meets the Loyalhanna Creek, a large plume of orange water appears. At the mouth of the stream, the field pH was 7.1. Iron oxide sediment is collected in and around the mouth and along the streambanks making the mouth difficult to access.

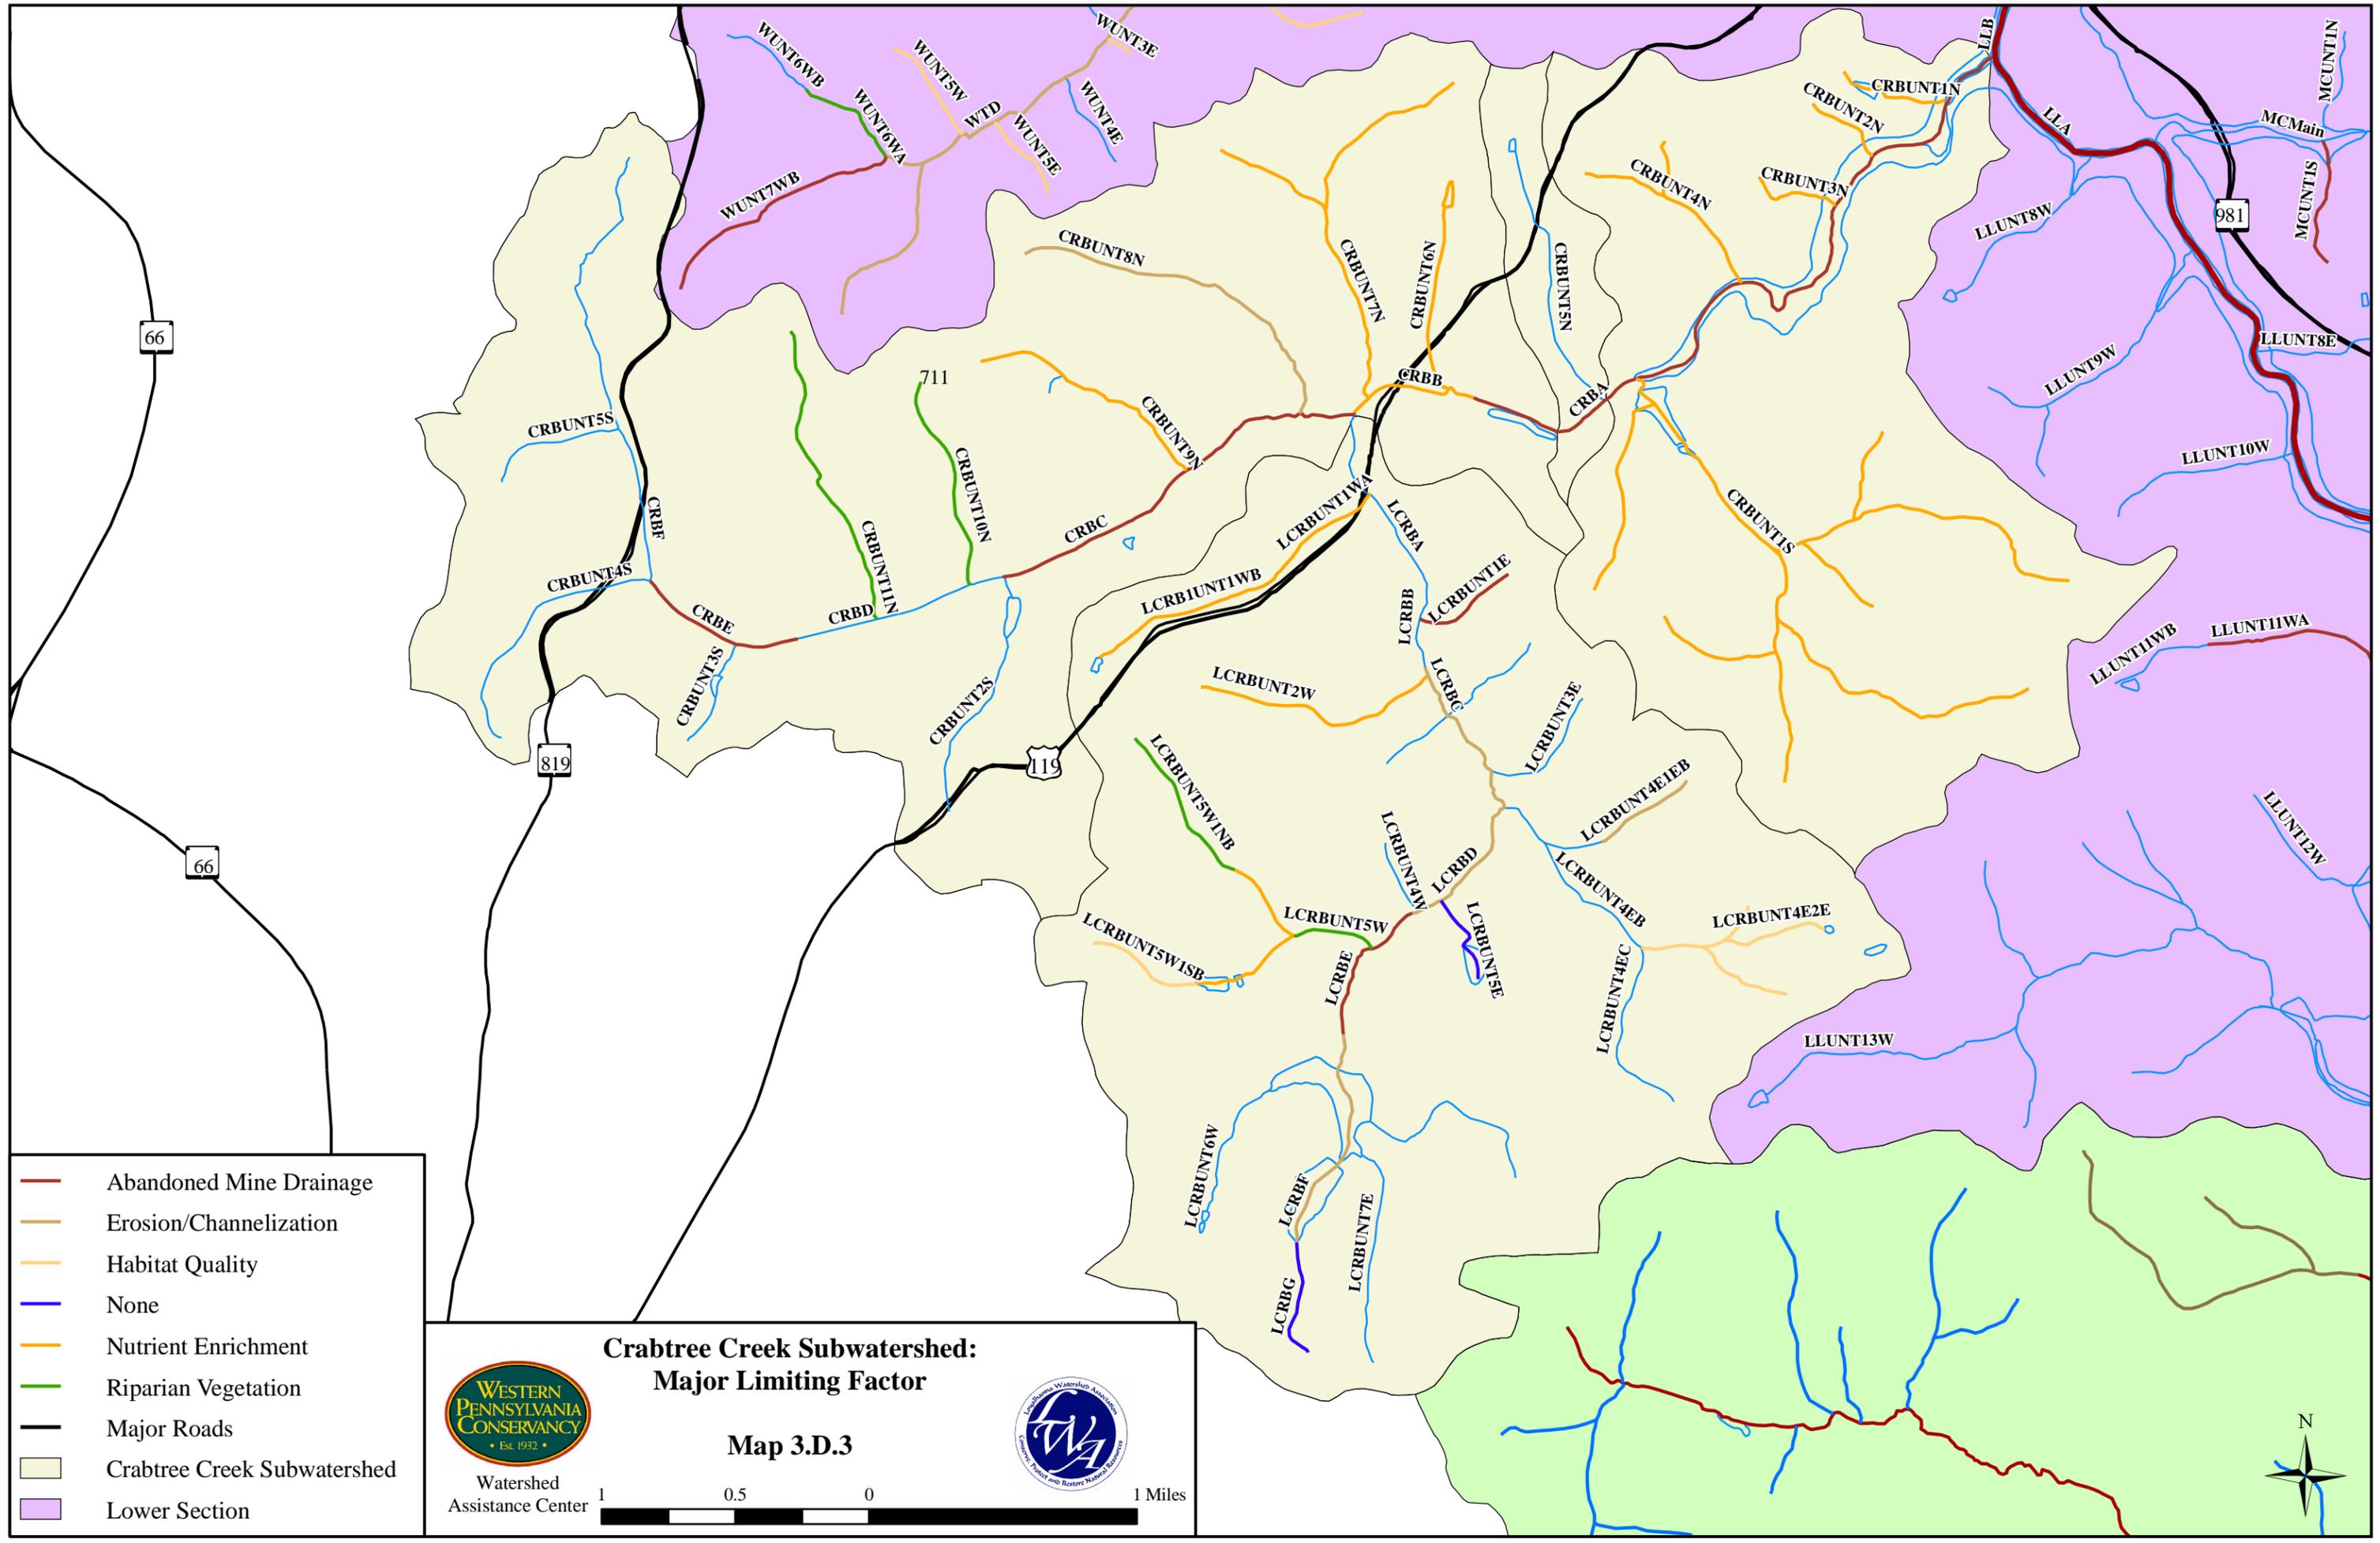
**Crabtree Creek Subwatershed:
Major Limiting Factor**

Figure 3.D.2 exhibits overall restoration priorities for the entire subwatershed. As indicated, the limiting factor that received the highest restoration priority rating was AMD. Eight stream segments showed impact from AMD sources. Approximately one-third of the Crabtree Creek main stem is impacted by one AMD discharge. In addition to AMD, restoration priority was also high for nutrient loading, as well as erosion and channel alteration. This reflects the presence of agricultural impacts throughout the subwatershed.

Twenty-eight stream segments received visual assessment scores identifying limiting factors. The limiting factors identified included erosion and channel alteration, compromised fish and macroinvertebrate habitat, riparian vegetation degradation, nutrient loading, and AMD. Please refer to Table 3.D.2 and Map 3.D.3 for impact description and stream segment location.

Table 3.D.2: Impacted Stream Segments and Restoration Suggestions for the Crabtree Creek Subwatershed				
LIMITING FACTOR: Riparian Vegetation Degradation				
Stream Segment Name	Description of Impact	Remediation Strategy	Possible Funding Sources	Priority Rating
CRBB <i>Main stem segment that flows from the confluence with Little Crabtree Creek to the Crabtree Fire Hall.</i>	The stream flows through a residential area. There is some vegetation surrounding the stream, but mostly tall grass and occasional shrubs. There are very few trees to provide shade and cover.	1. Work with the community to use trees and shrubs to shade the stream through the downtown area. Possible Partners: Crabtree Borough, WCD, Private Business Owners, Crabtree Fire Company, DEP	Local, State	Low – Medium
CRBUNT4N <i>Small tributary that flows through a mix of forest and pasture.</i>	Grazing livestock and pasture surround the upper portion of the tributary. Riparian zone is compromised in this area with very few trees and plants surrounding the stream.	1. Work with landowner to install agricultural BMPs in order to recover the riparian area and eliminate livestock access to stream. Possible Partners: WCD, USDA, WPC, DEP	State, Federal, Private	Low

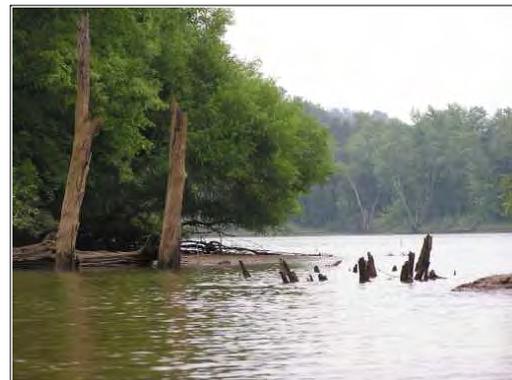
The confluence of Whitethorn Lake and the Loyalhanna Creek

Creek is due to the Loyalhanna Dam. Wet areas, wood debris, macrophyte beds, and numerous isolated pools surround the lake. It appears that the lake acts as a sediment and nutrient trap. This is apparent because of its sediment-covered banks, muddy color, and abundant algae.

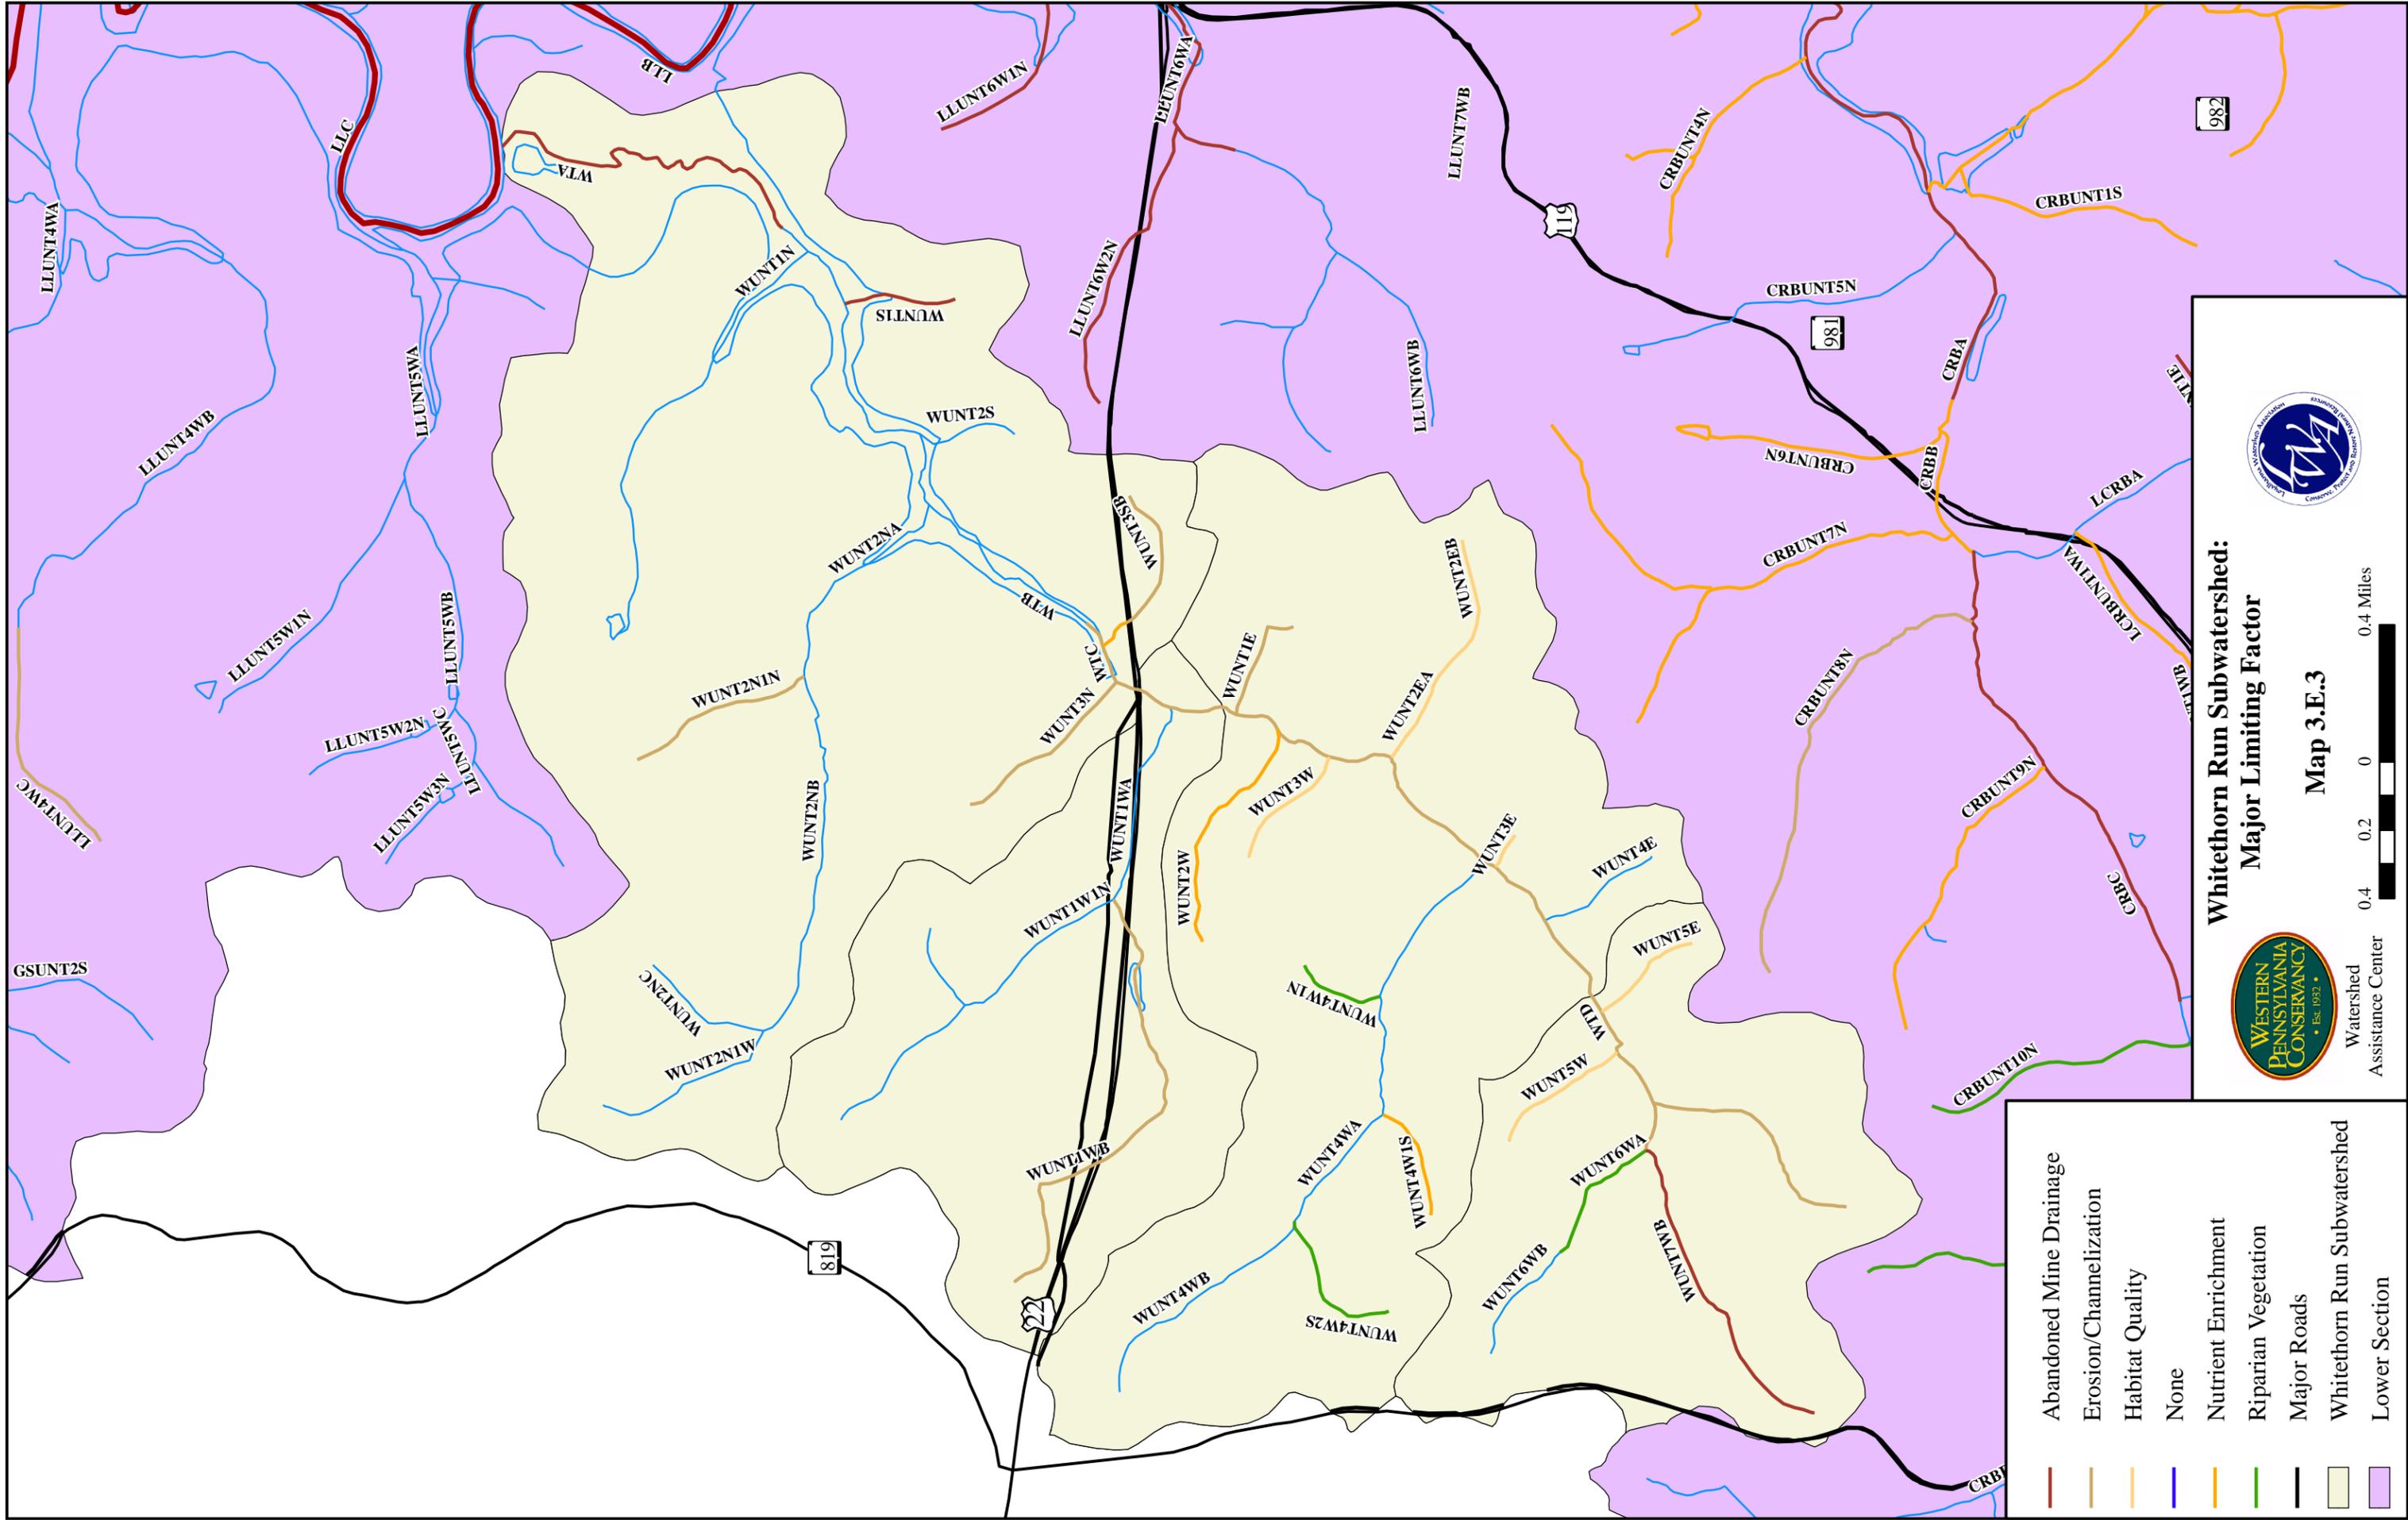
**Whitethorn Run Subwatershed:
Major Limiting Factor**

Figure 3.E.2 exhibits overall restoration priorities for the entire subwatershed. As indicated, the limiting factor that received the highest restoration score was AMD. Five stream segments were impacted by AMD. The most significant impact from AMD within the subwatershed is located in the headwaters. It is at that point that a discharge enters the stream, impacting water quality for close to a mile. The other AMD sources are seeps that only impact a concentrated section of stream and are quickly diluted. In addition to AMD, restoration priority was also high for compromised fish and macroinvertebrate habitat, or habitat quality, as shown in Figure 3.E.2. This reflects the common occurrence of sediment in the substrate of stream sections throughout the subwatershed.

Twenty-one stream segments received visual assessment scores identifying limiting factors. The limiting factors identified included AMD, nutrient loading, compromised fish and macroinvertebrate habitat, riparian zone degradation, and erosion and channel alteration. Please refer to Table 3.E.2 and Map 3.E.3 for impact description and stream segment location.

Table 3.E.2: Impacted Stream Segments and Restoration Suggestions for the Whitethorn Creek Subwatershed				
LIMITING FACTOR: Riparian Vegetation Degradation				
Stream Segment Name	Description of Impact	Remediation Strategy	Possible Funding Sources	Priority Rating
WTUNT1E <i>Small tributary that flows into the main stem. It is located close to the Route 22 and flows through a pasture.</i>	Riparian vegetation is mowed grass, or grazed by livestock who have direct access to the stream. Some canopy cover is present.	1. Work with landowner to install agricultural BMPs in order to recover the riparian area and eliminate livestock access to stream. Possible Partners: WCD, USDA, WPC, DEP	State, Federal	Low

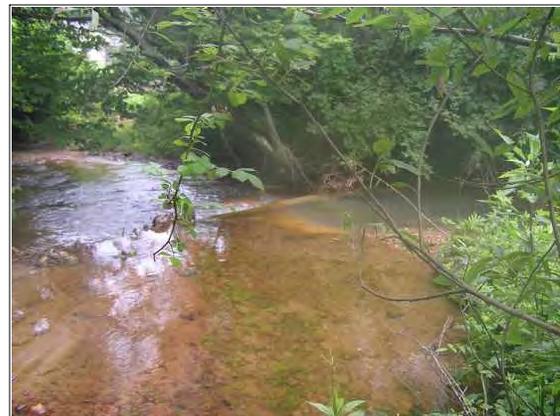
Approximately 100 yards upstream from its mouth, Getty Run passes underneath the railroad grade, which has been converted into a hiking and biking trail. At this point the stream is still orange in color and has a pH of 2.9. The cobble substrate is covered with bright green algae. The area surrounding the stream is vegetated with small hardwood trees, shrubs, and Japanese knotweed.

The confluence of the Getty Run main stem and Getty Run South Branch
