# **Laurel Run #1 Passive System Rehabilitation**

Center Township, Indiana County, PA  
40°30'29.7"N 79°06'46.4"W

## ***A Blacklick Creek Watershed Association Project***

### **Final Report**

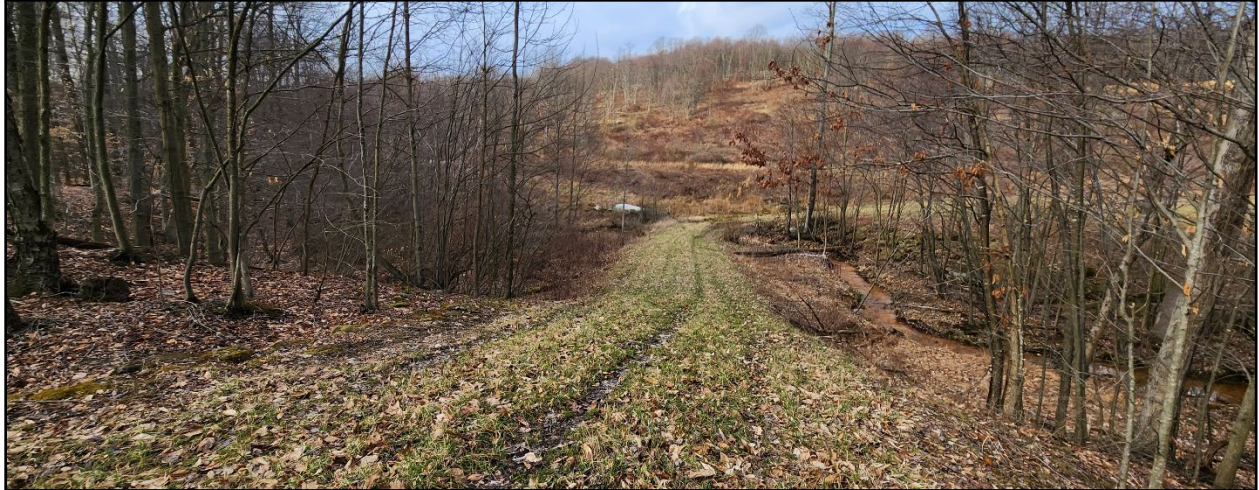
**Top:** Access road to the Laurel Run #1 system in 2023 (prior to rehab).

**Middle & Bottom:** Laurel Run (stream) flowing past the treatment system in 2023. The stream was impacted due to a large portion of the discharge bypassing the system.

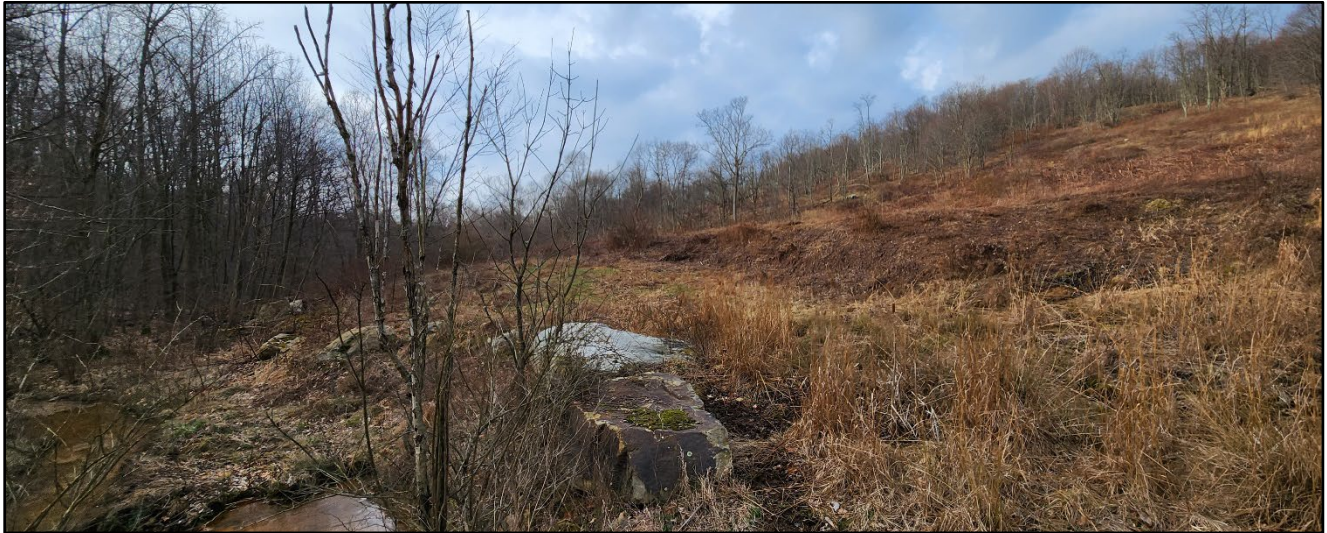
**Top:** View of the Laurel Run #1 passive treatment system from the entrance at the bottom of the hill prior to rehab (2023).

**Bottom Left:** At some point, the original underground mine drain and collection system failed causing multiple AMD seeps to form across the site. One of the AMD discharges that had formed, bypassing the treatment system and entering directly into the stream prior to rehabilitation (2023).

**Bottom Right:** Another AMD seep that had formed at Laurel Run #1. An attempt was made to direct it into the flow splitter box of the system (2023).

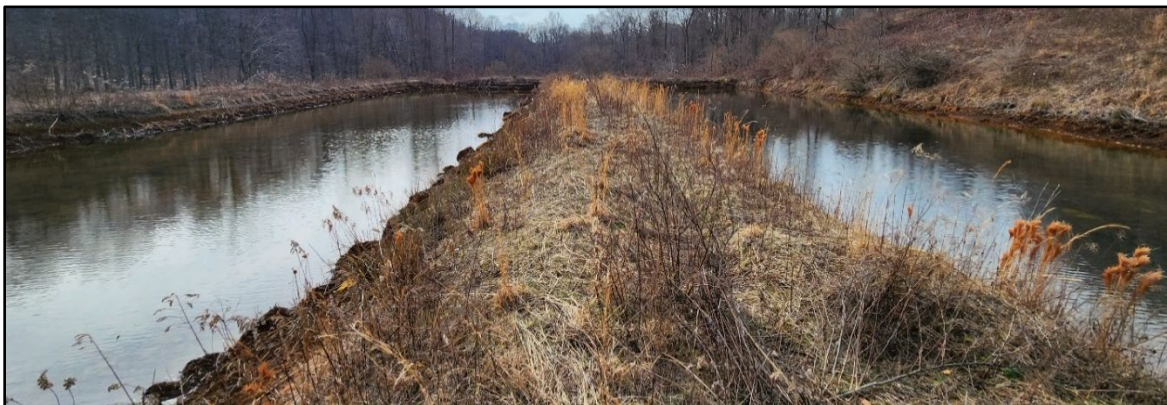
**Top:** Flush pond of the original passive system in 2023. The flush pond was too small to be effective and not useful for Jennings style vertical flow ponds so was removed during rehab. The area was utilized for part of JVFP1.

**Middle:** The longer of the two original vertical flow ponds (VFPW aka VFRA) at Laurel Run #1 with the flush pond to the left. The photo taken in 2023 prior to rehab shows the long, rectangular shape which was potentially partly responsible for the cause of gas traps and short-circuiting issues within the VFPs.

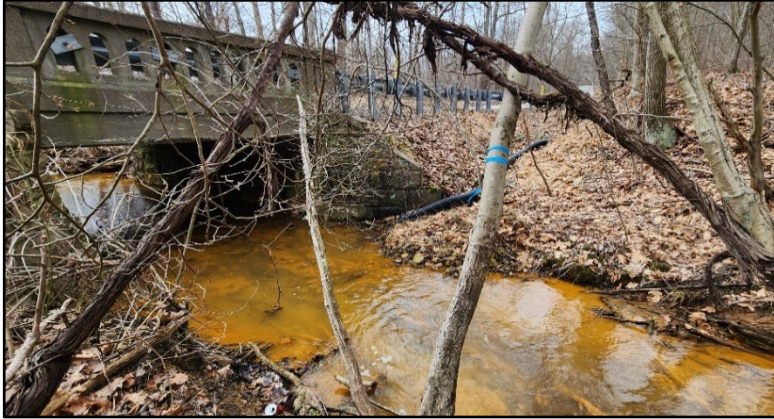
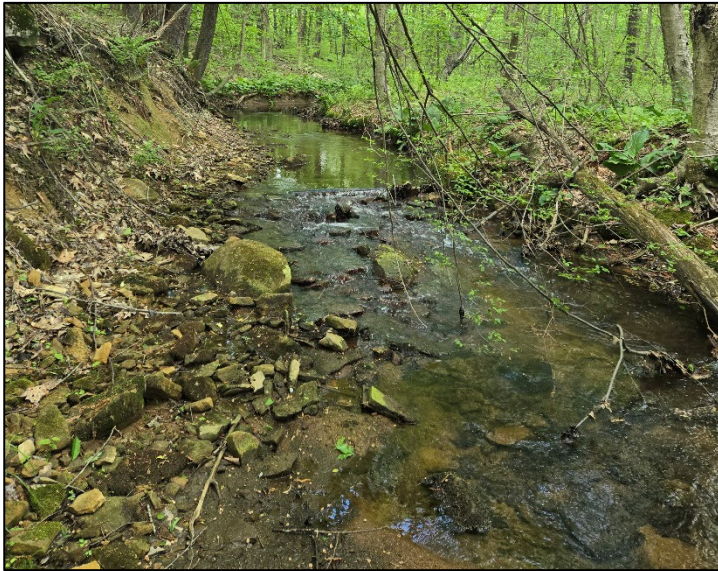
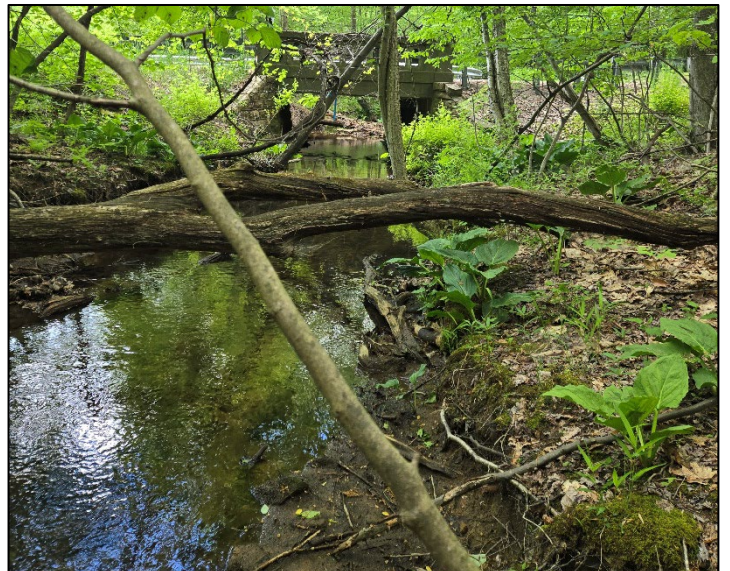
**Top Left:** Laurel Run downstream at Aulds Run Road prior to rehab (2023).

**Top Right:** An unrelated AMD discharge found along the access road downstream of the system prior to rehab (2023).

**Bottom:** Laurel Run downstream at Aulds Run Road following rehab (May 2025).

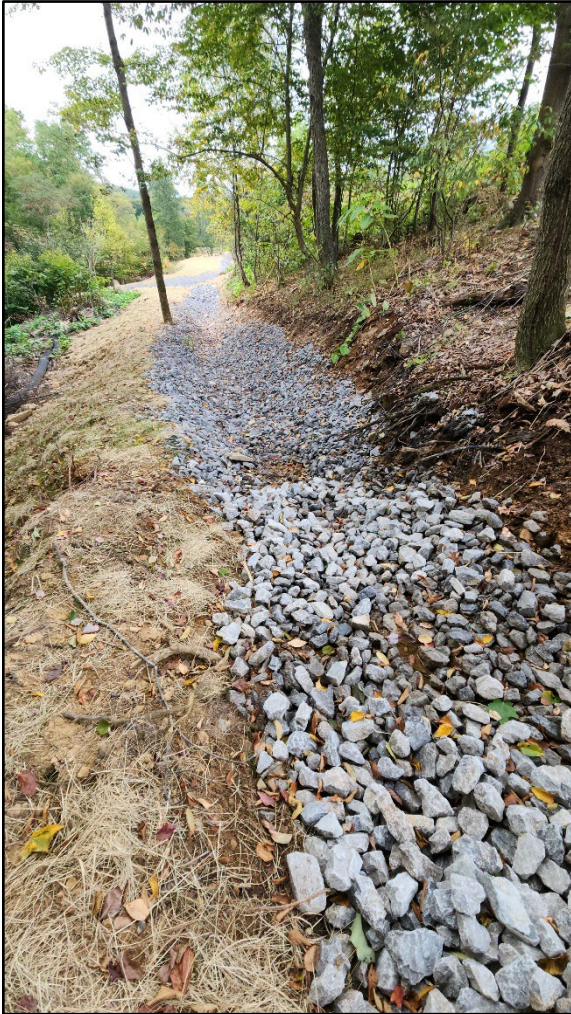
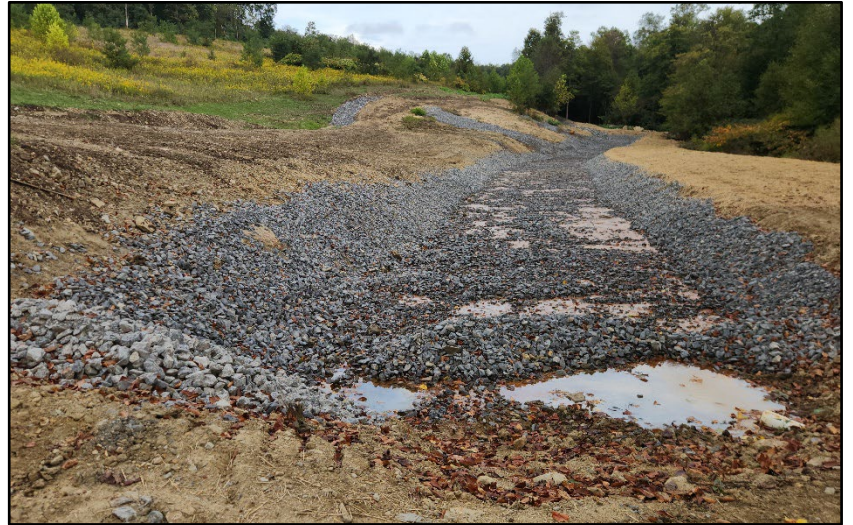
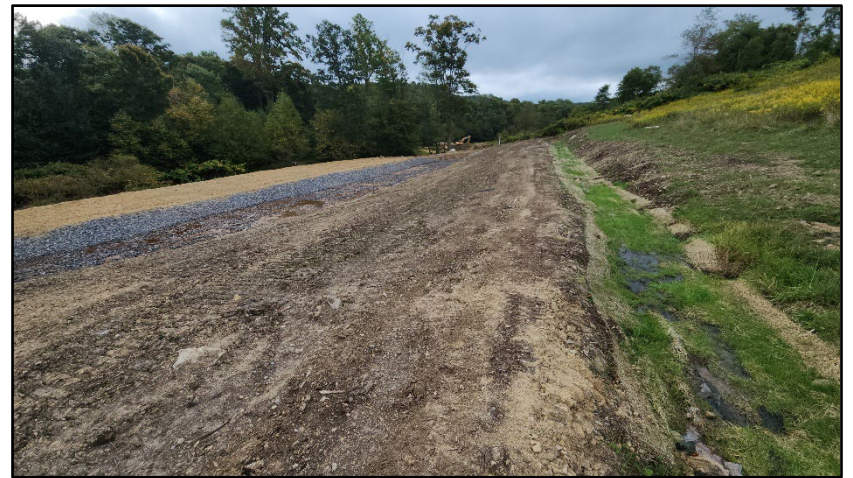
**Left:** Collection channel after initial construction.

**Top Right:** Terraced iron formation (TIF) after initial construction.

**Bottom Right:** Diversion ditch (right, on the upper slope) and the TIF (left, on the lower slope).

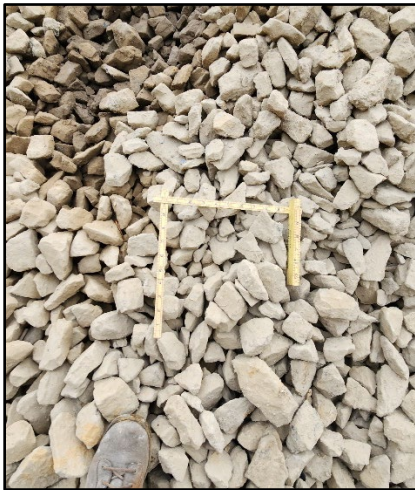
**Top Photo:** During rehabilitation, the old treatment media was washed (background) to recover the limestone. The VFPs were reconfigured over time to have more of a square shape as opposed to the previous long, narrow shape. Portion of JVFP1 new berm constructed across VFPW but incomplete with the old flush pond still intact.

**Bottom Left:** Stone recovered from the original VFPW after being washed. The engineering ruler provides scale for stone size.

**Bottom Right:** Treatment sludge and vegetation were removed from the wetland. The wetland was also utilized for temporary sludge storage while washing and recovering the limestone from the VFPs.

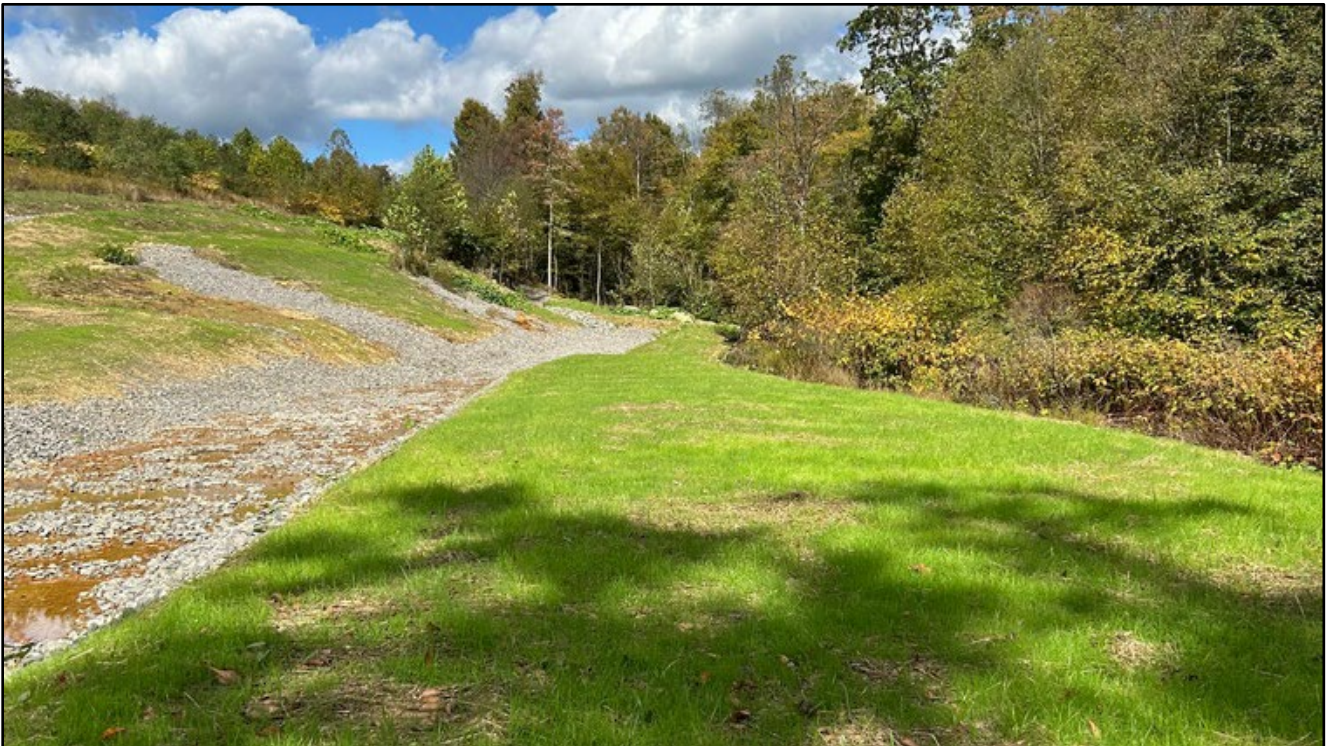
**Bottom:** Planted grass already growing next to the newly constructed TIF in fall of 2024.

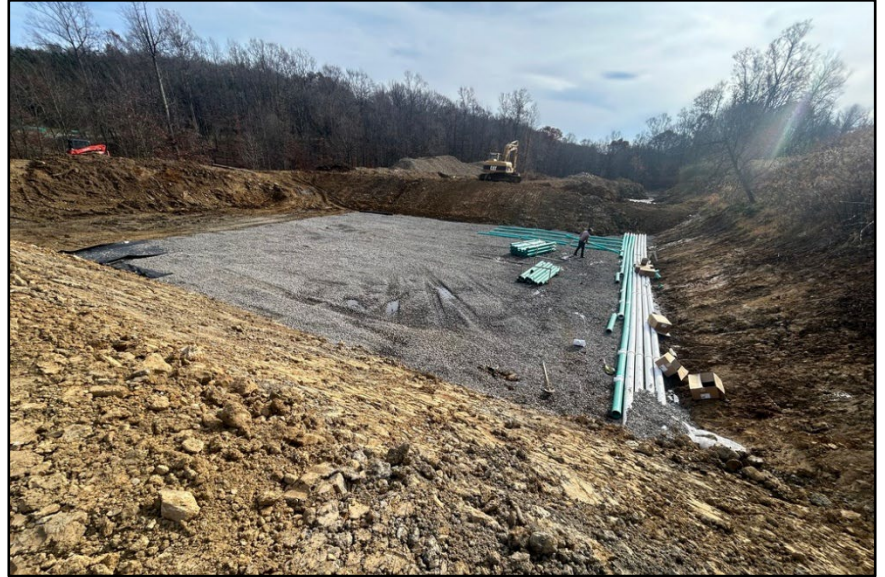
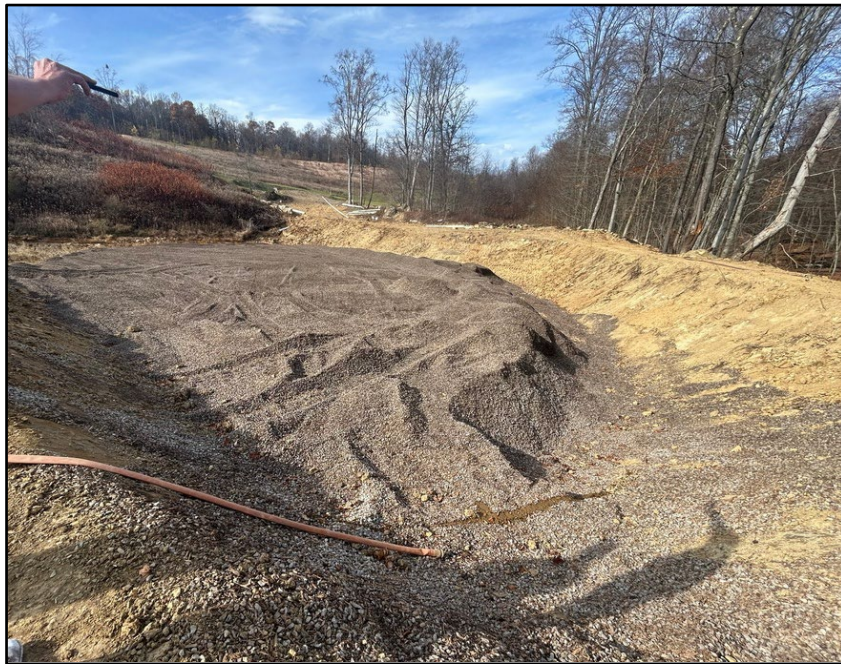
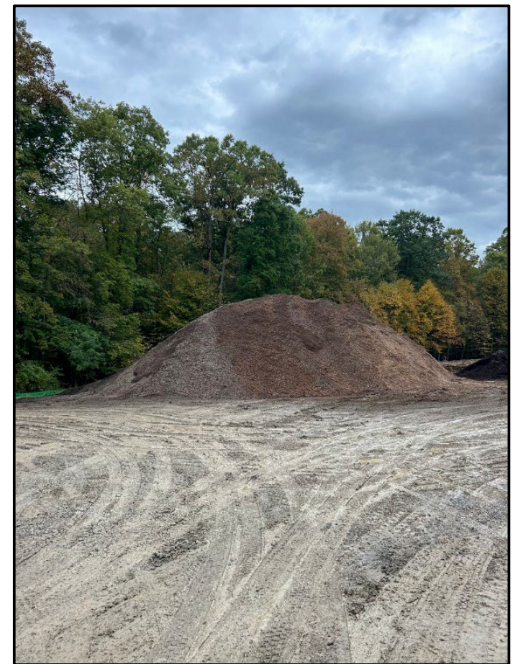
**Top Left:** Removal of piping and washing of limestone in one of the original VFPs.

**Bottom Left:** Placement of mixed media into JVFP1.

**Bottom Right:** Pile of mixed media prior to being placed into a JVFP, which included a mix of compost, woodchips, and limestone.

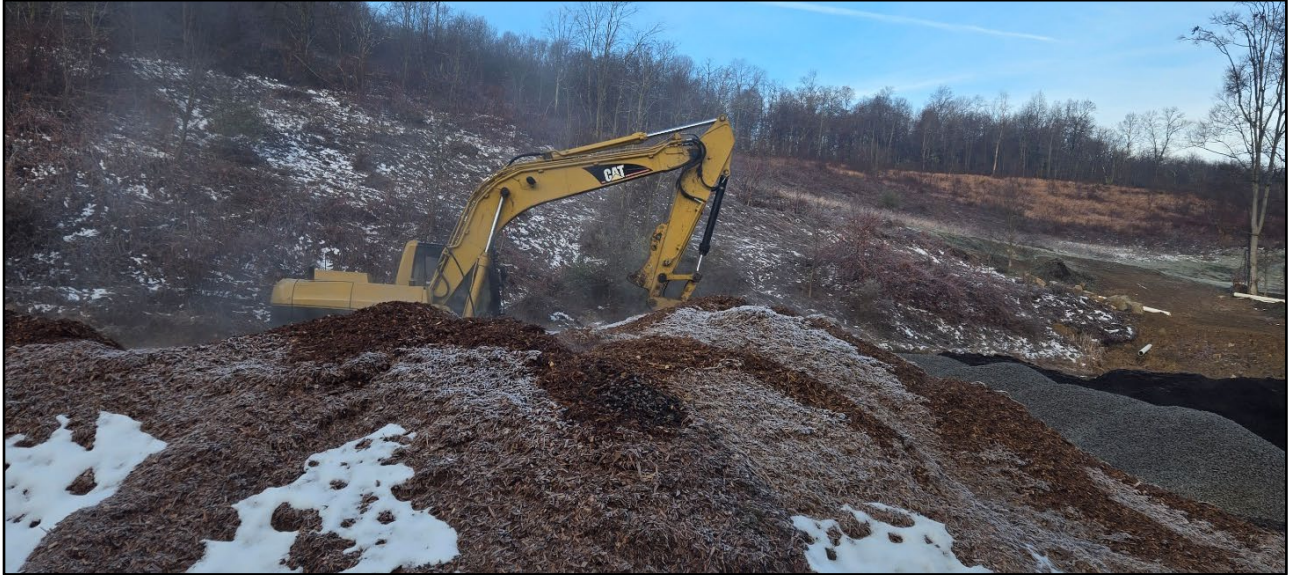
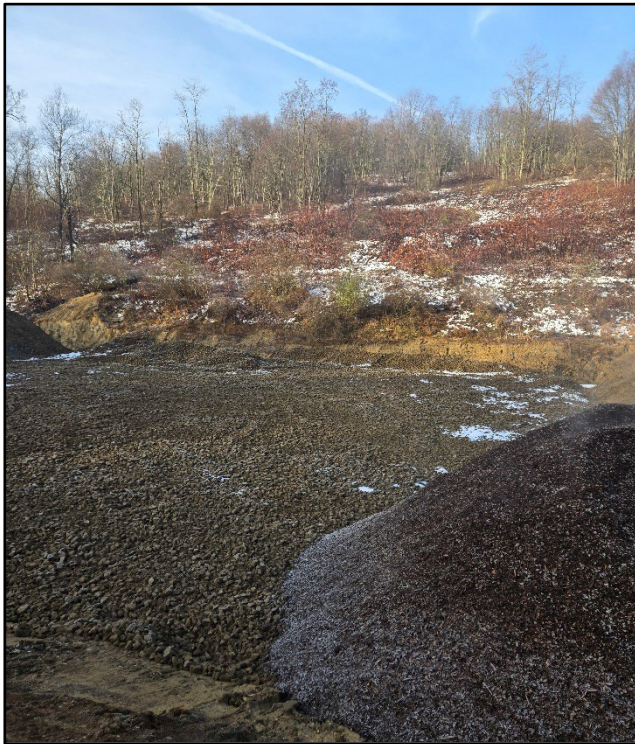
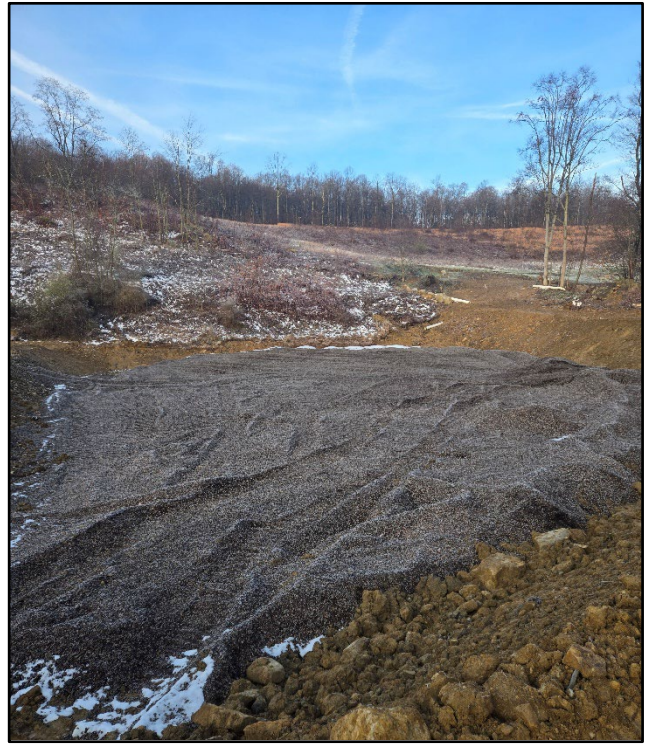
**All:** Mixing and placement of treatment media in the new JVFPs in November 2024.

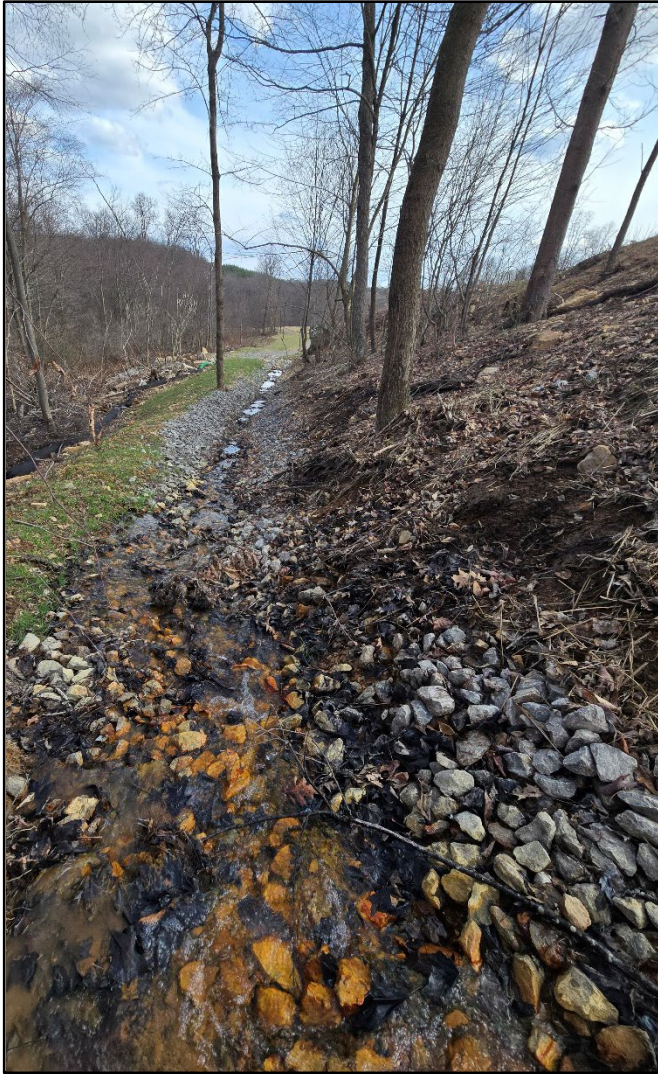
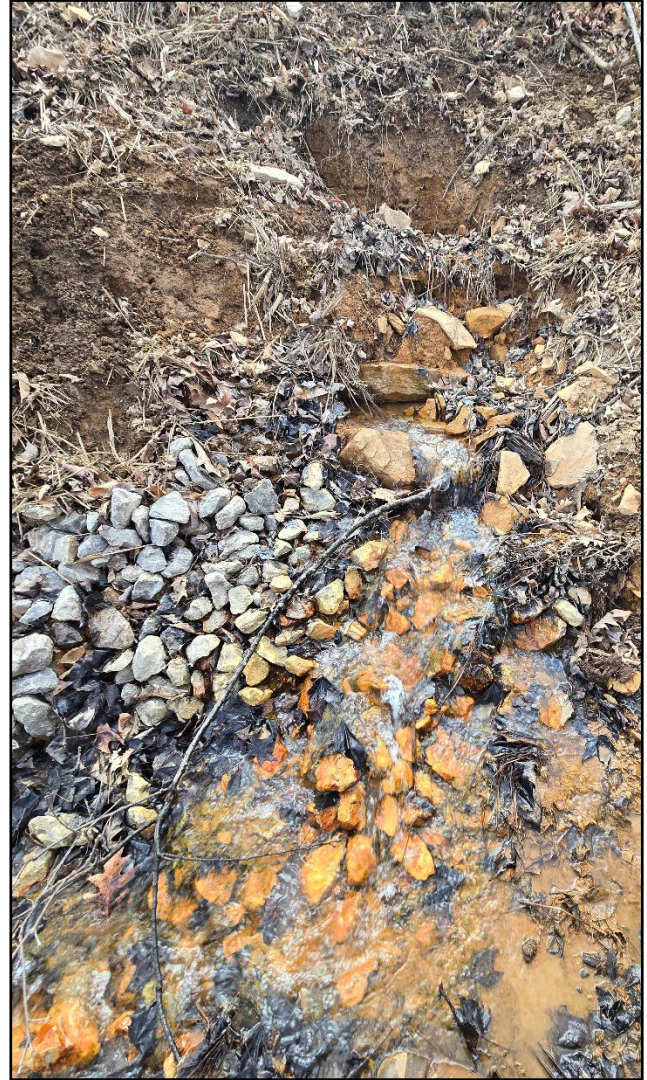
**Left:** Top of the Collection channel.

**Right:** Close-up of one of the AMD discharges that is captured by the collection channel and conveyed downhill to the TIF.

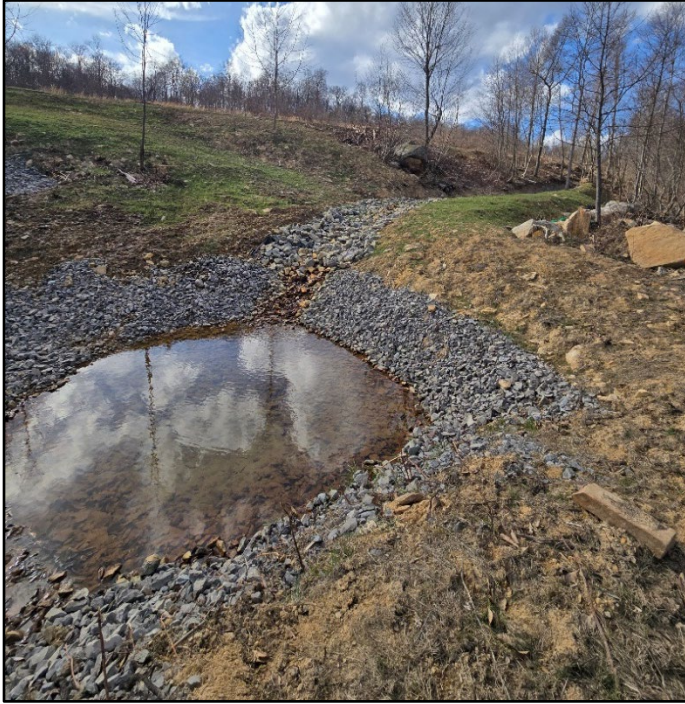
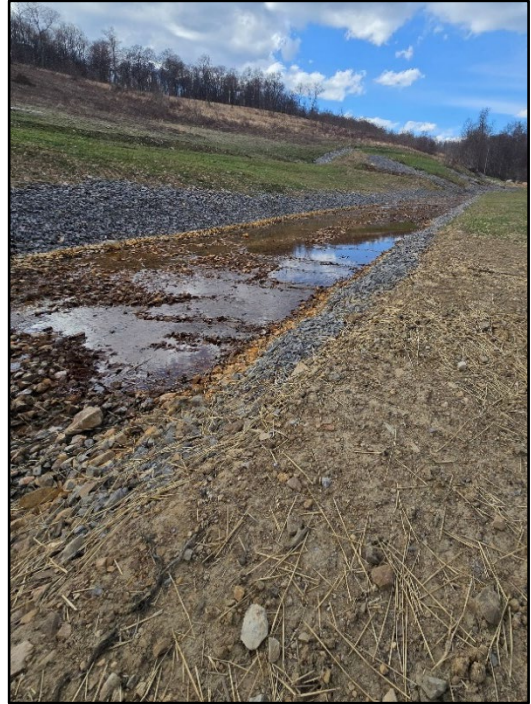
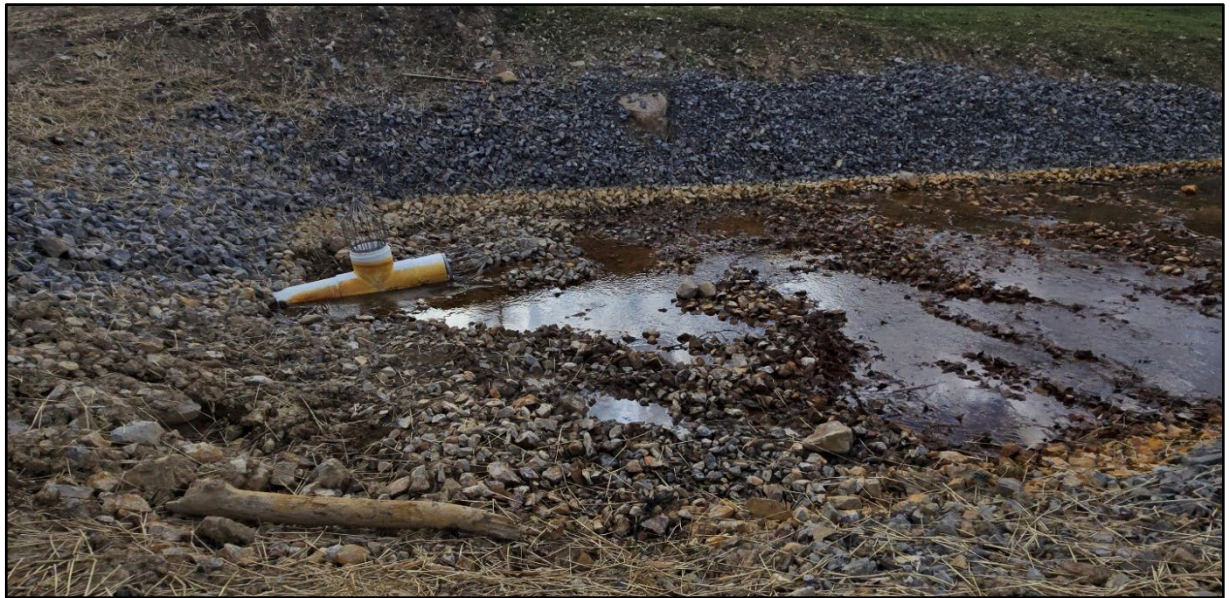
**Top Left:** Image of the end of the collection channel and another discharge entering the TIF.

**Top Right:** Terraced iron formation (TIF) after construction.

**Bottom:** End/bottom of the TIF where water pools and then flows into the pipe that conveys the AMD to the new flow splitter box.

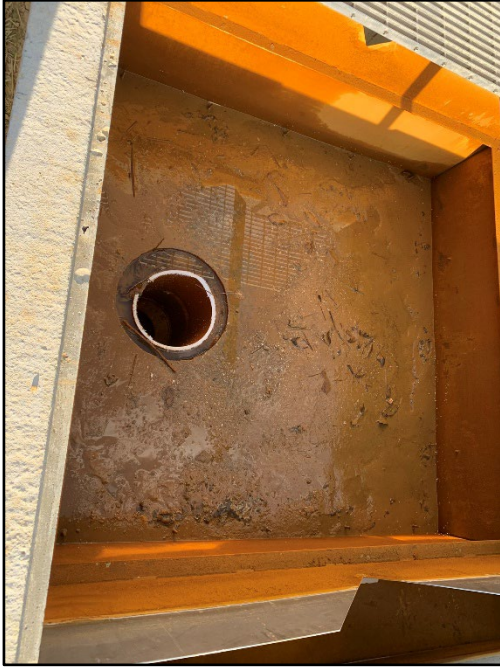
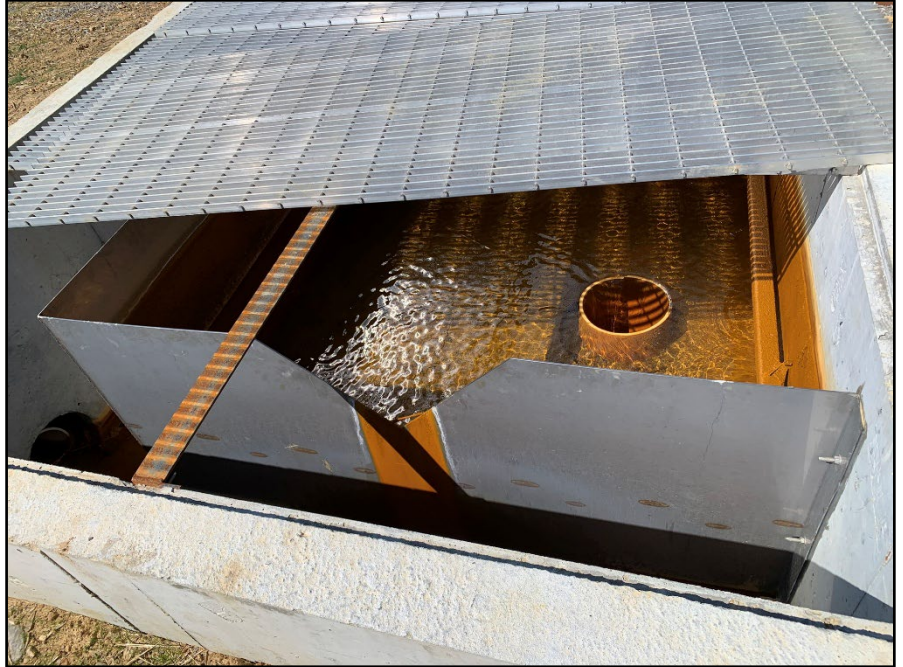
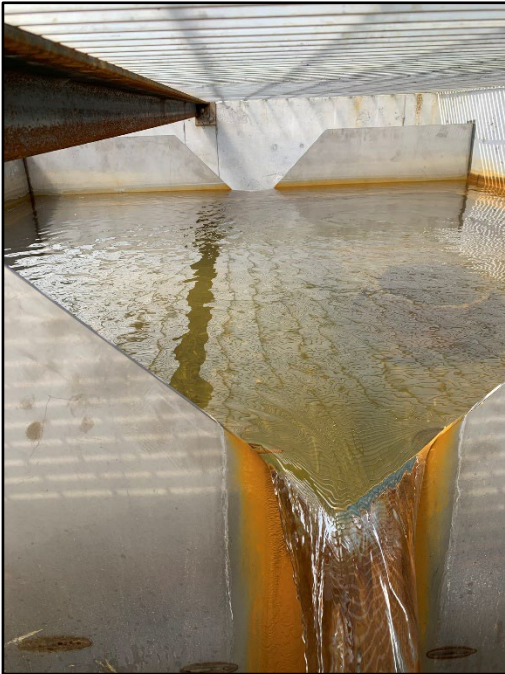
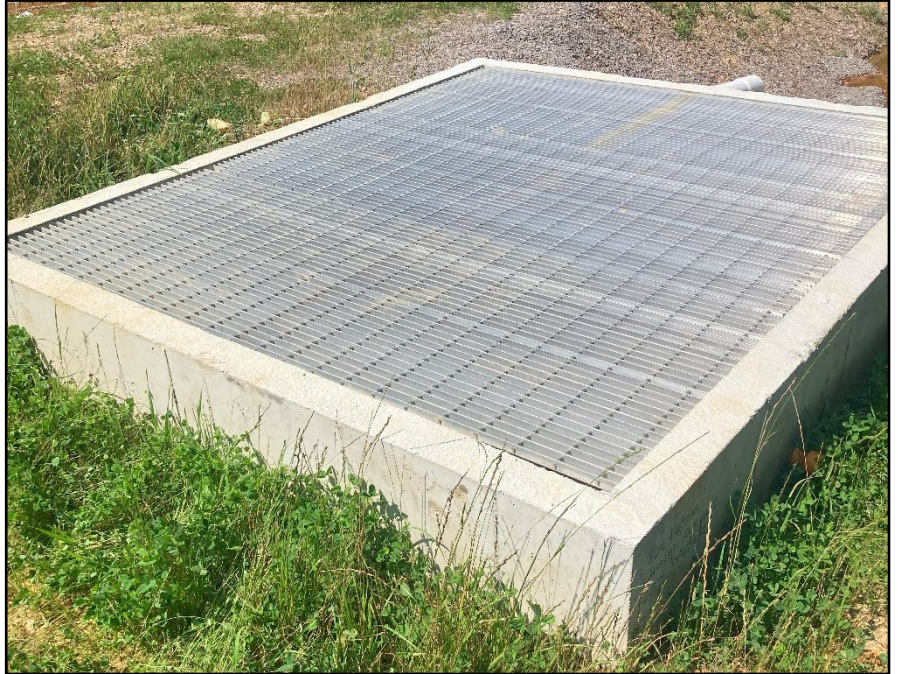
**Top Left:** Inside of flow splitter box with drain valve open and drained.

**Top Right:** Flow splitter box filling back up after valve closed.

**Bottom:** Inside of new flow splitter box (left) showing one of the V-notch weirs and outside (right) with lightweight aluminum grate cover.

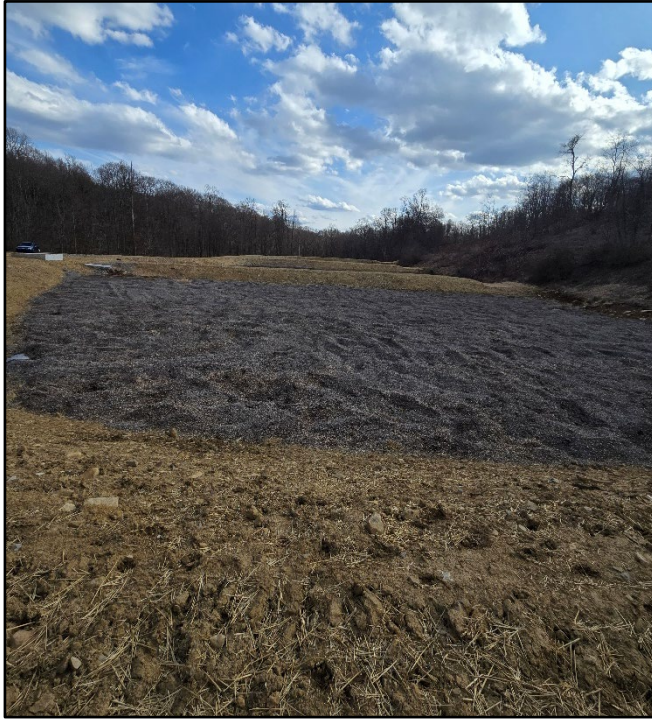
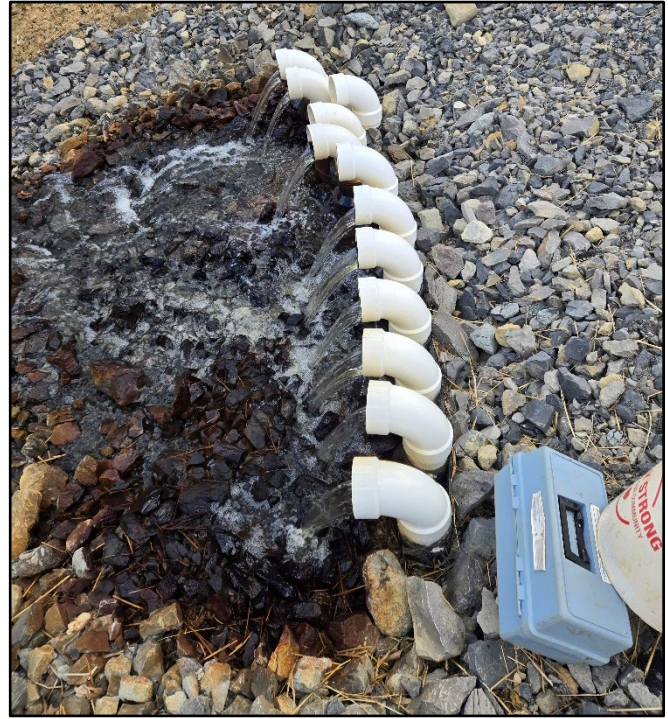
**Top Left:** JVFP1 after being online for over two months.

**Top Right:** Outlet risers of all three JVFPs discharging to the wetland.

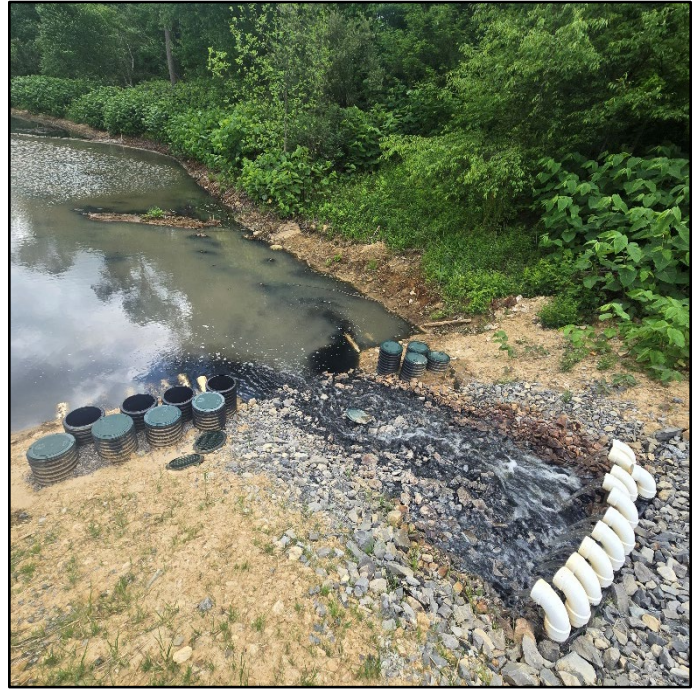
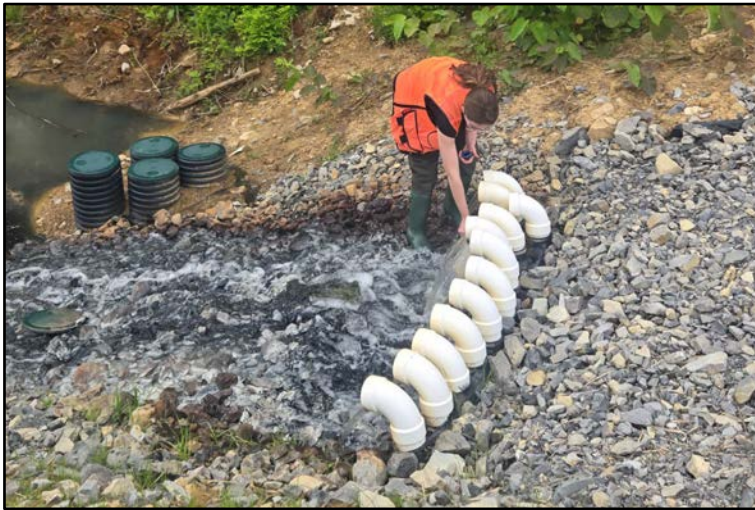
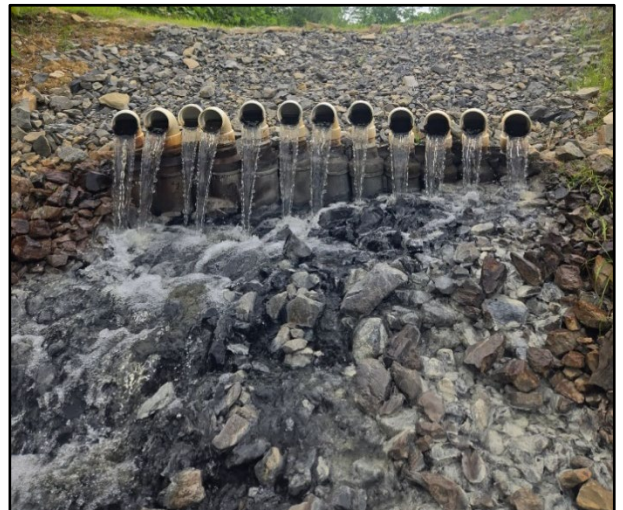
**Top Left:** Months after construction, the reconfigured JVFPs at Laurel Run #1 are working as intended. The white cloudy water on top of the JVFP1 is aluminum precipitating out of solution due to the increase in pH.

**Middle:** A rock distribution berm was installed to reduce channelization within the wetland. The second half of the wetland contains emerging wetland vegetation, such as cattails.

**Bottom:** The entire second half of the wetland now has wetland vegetation growing in it. This is expected to increase oxidation, precipitation and settling of iron.

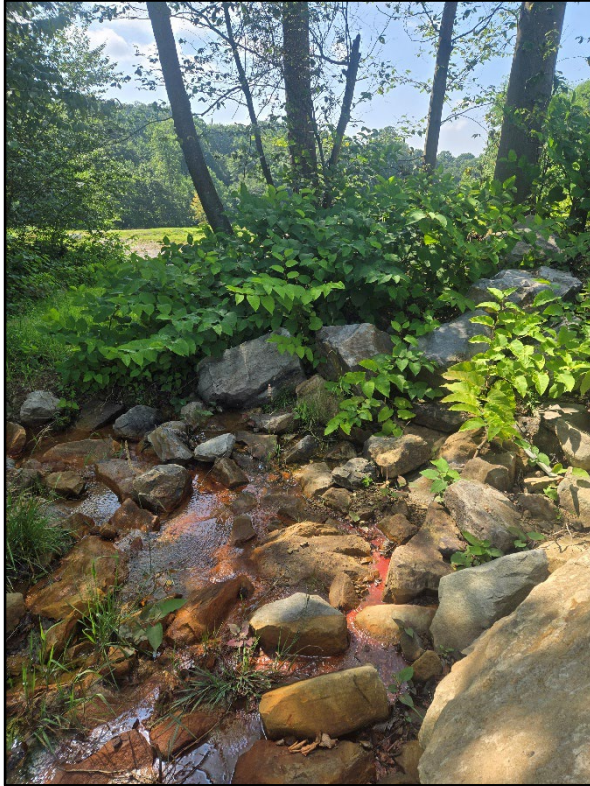
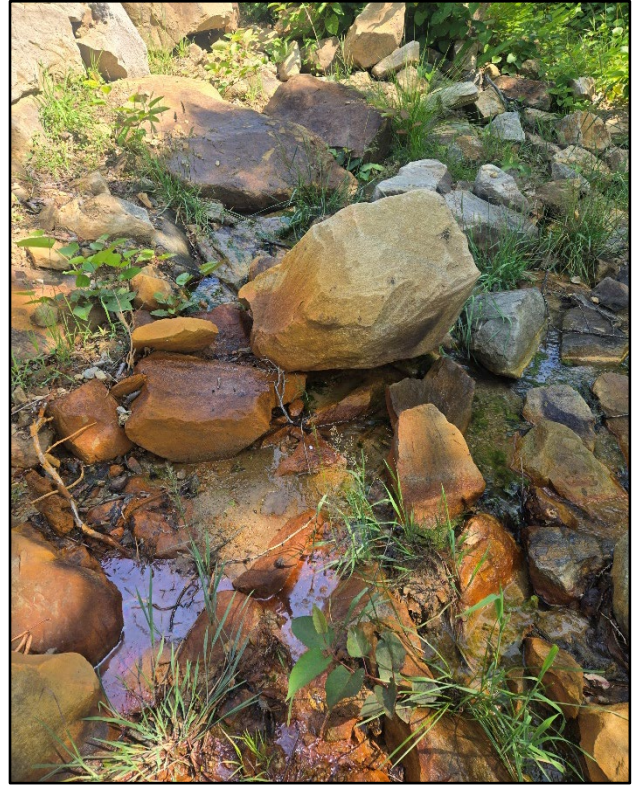
**Above:** The unnamed tributary (UNT #15) was monitored during multiple site visits using field equipment and once with laboratory analysis between March and July of 2025. The water consistently contains neutral to circumneutral pH and contained low metal concentrations (<0.1 mg/L) when assessed in May 2025. The Blacklick Creek Watershed Association reported concerns of seeing AMD flowing in the channel in June 2025 which prompted investigations by BioMost and Stream Restoration Incorporated in July 2025. Iron staining is evidence of water containing high iron content flowing through this channel at times but could partly be due to when AMD was bypassing treatment prior to rehabilitation. Field monitoring did provide some evidence of a small AMD seep entering this tributary, but it was difficult to pinpoint the exact location.

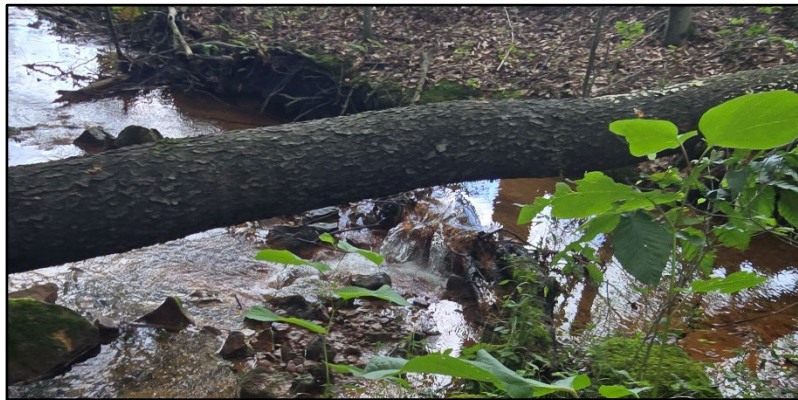
**Top:** Close up of Laurel Run (stream) located upstream near the beginning of the collection channel. Sections of the stream had significant sedimentation that had collected in small pools.

**Bottom:** Laurel Run where the LR#1 system effluent (shown on the right side with black coloration due to the VFP sulfide products) mixes with the stream. Circumneutral pH and low iron were measured at this location, despite evidence of iron staining, likely due to past conditions prior to rehabilitation.
