CAMBRIA AMD TASK FORCE  
PASSIVE TREATMENT  
SYSTEM EVALUATION

AMD 56(2524)102.1

OVEN RUN SITE "B"

KOONTZTOWN  
AMD 56(2524)102.1  
OVEN RUN SITE “B”  
MARCH 17, 2008

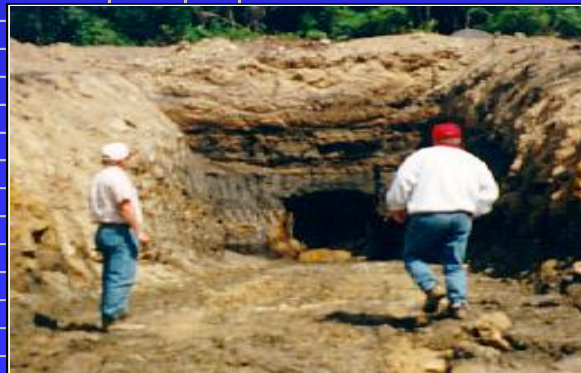
One of the three mine openings that was sealed;  
 the acid mine drainage that is collected  
 from the openings will be treated in phase 2.

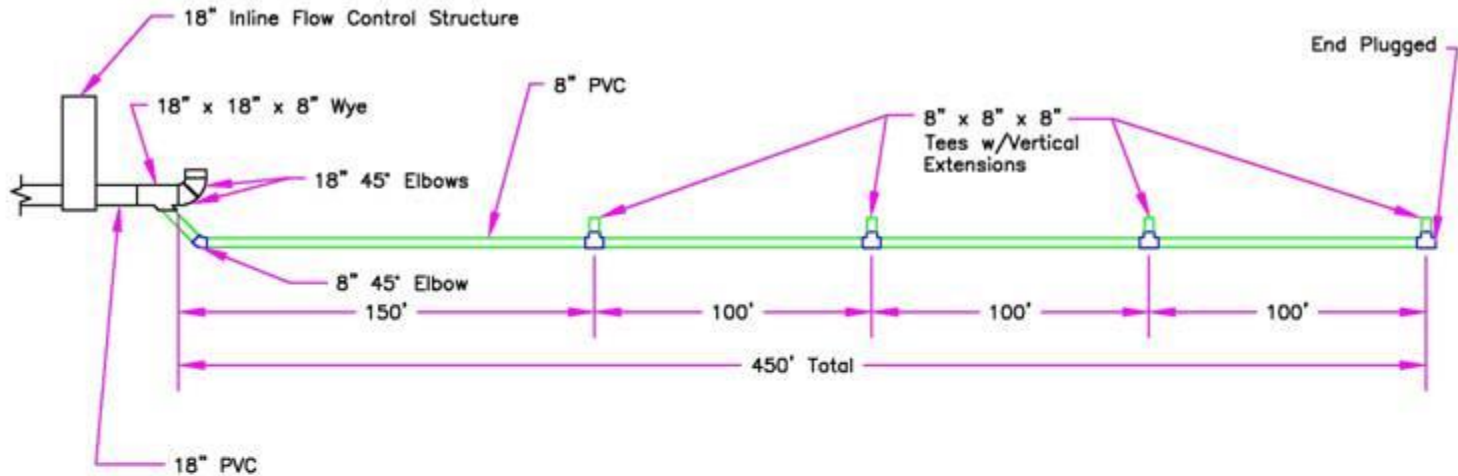
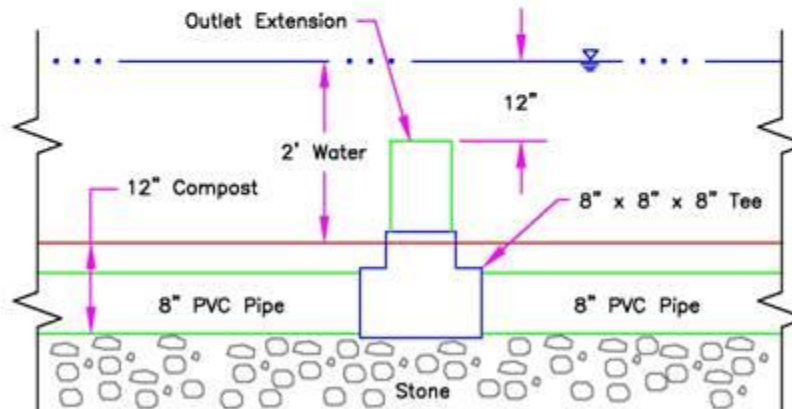
# FLOW DISTRIBUTION PIPE DETAILS

OVEN RUN SAP 1 SDR 35 PVC FLOW DISTRIBUTION PIPE
