SHEET 1 of 1 As-Built Schematic
Location Map, Legend, Plan View & Elevation Schematic

STREAM RESTORATION INCORPORATED
MCINTIRE PASSIVE TREATMENT SYSTEM
McIntire Site
SMP #3078BC12
Blacks Creek Subwatershed, Slippery Rock Creek Watershed
Marion Township, Butler County, PA
Scale: As Shown September 2012
BioMost, Inc. Mining and Reclamation Services
Mars, PA www.biomost.com

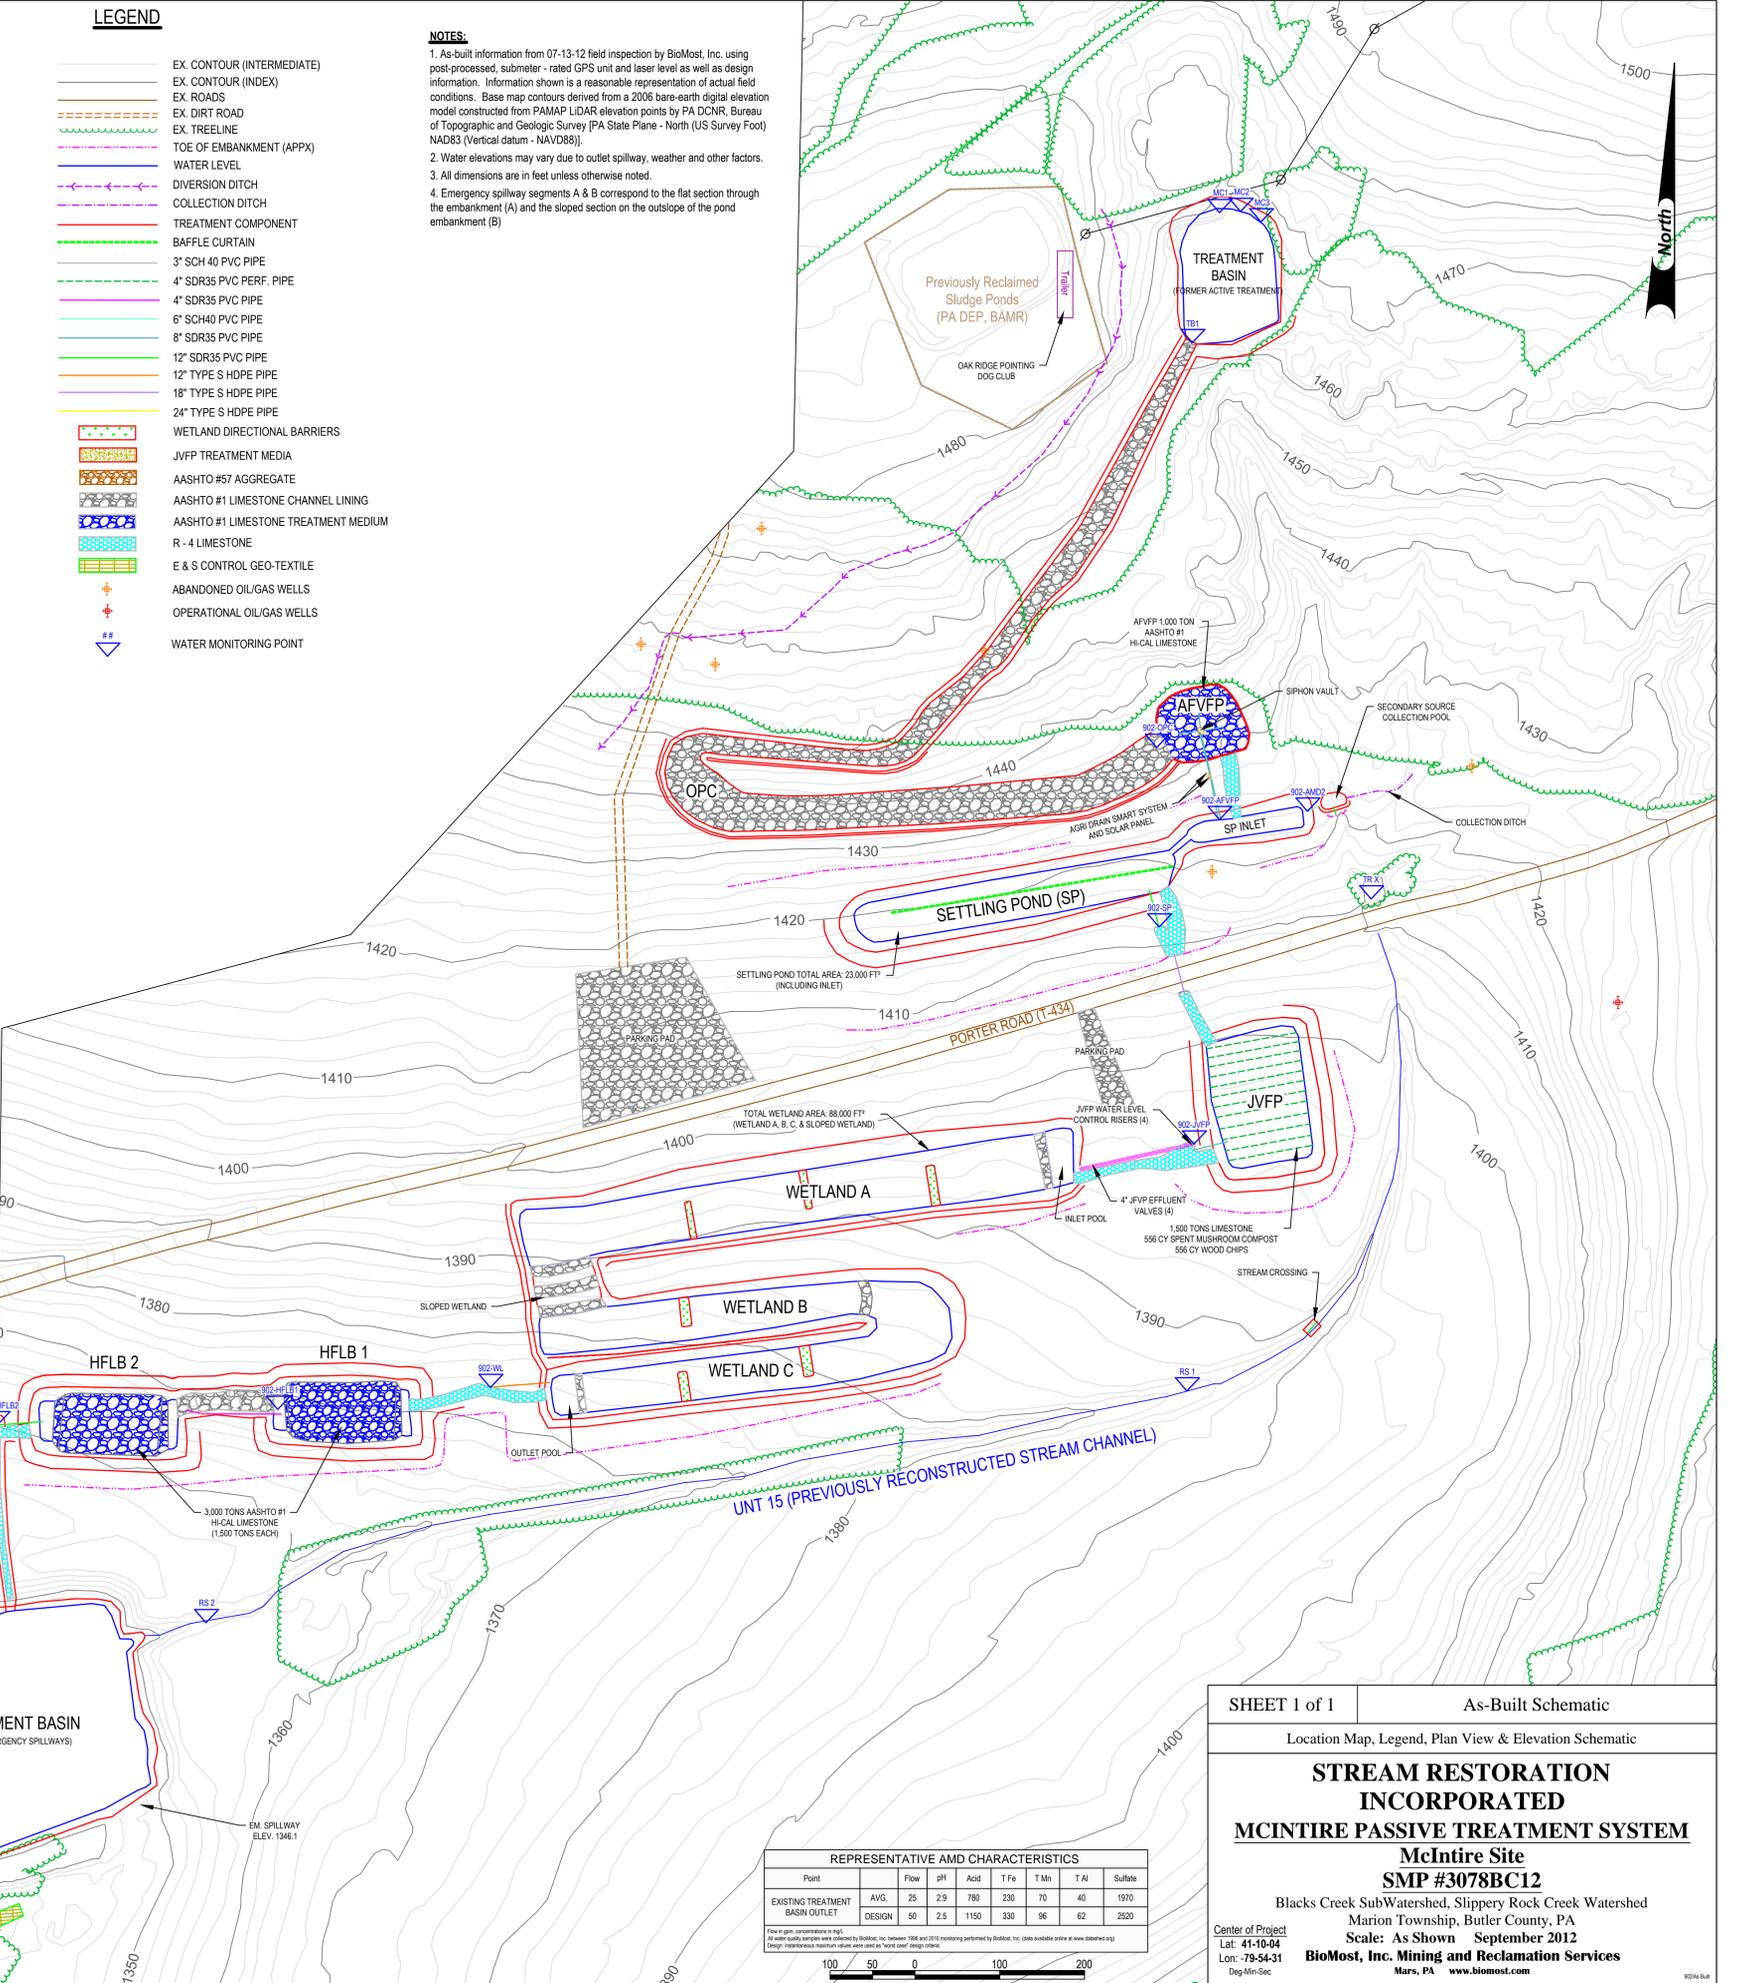
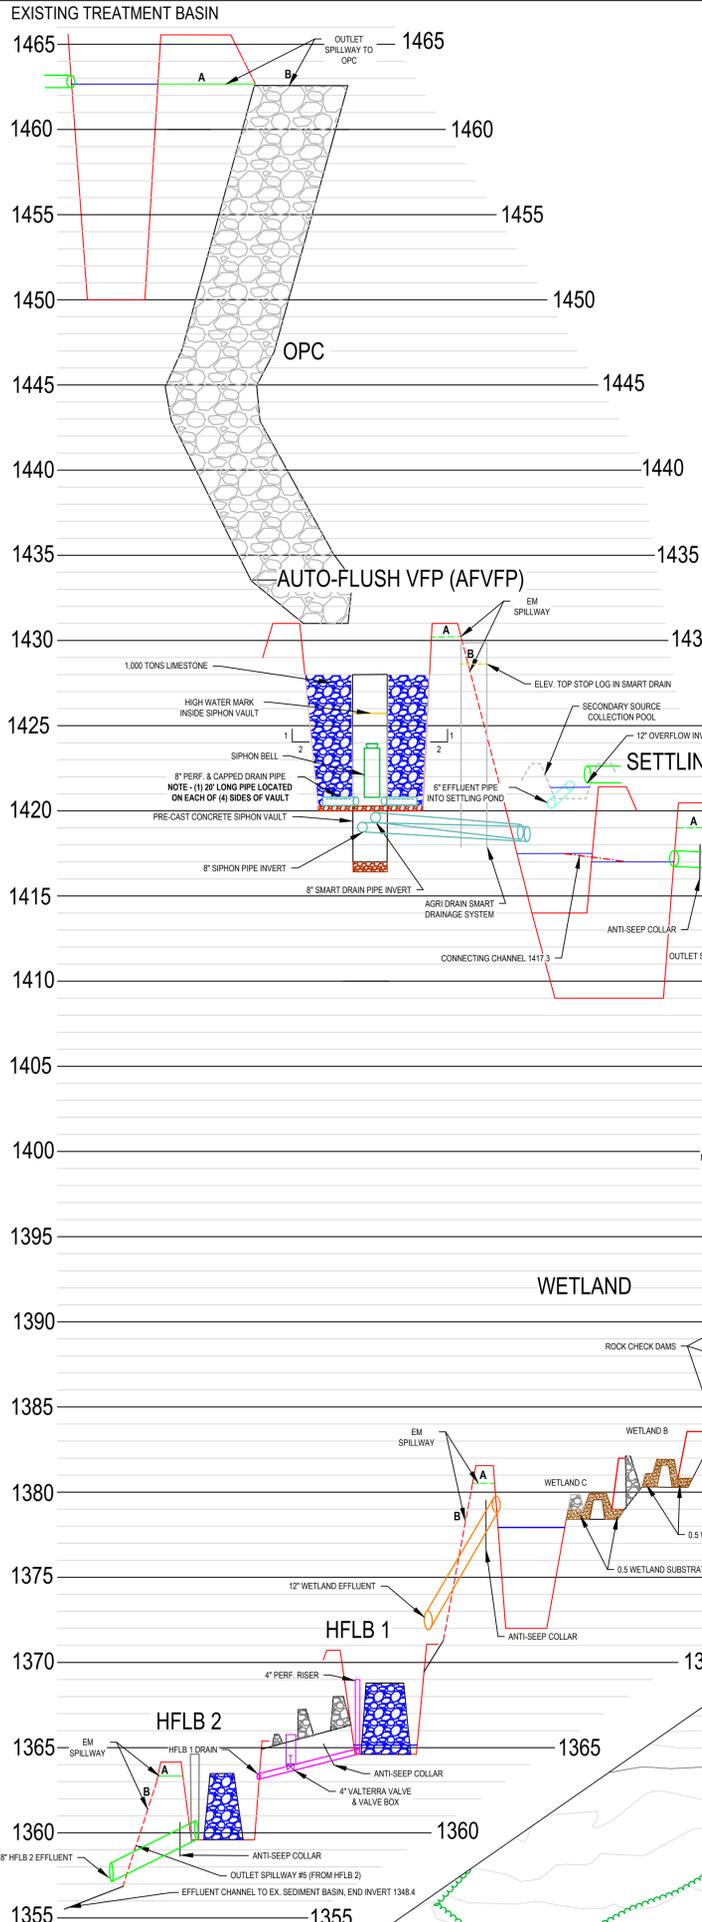
- NOTES:**
- As-built information from 07-13-12 field inspection by BioMost, Inc. using post-processed, submeter-rated GPS unit and laser level as well as design information. Information shown is a reasonable representation of actual field conditions. Base map contours derived from a 2006 bare-earth digital elevation model constructed from PAMAP LIDAR elevation points by PA DCNR, Bureau of Topographic and Geologic Survey [PA State Plane - North (US Survey Foot) NAD83 (Vertical datum - NAVD83)].
 - Water elevations may vary due to outlet spillway, weather and other factors.
 - All dimensions are in feet unless otherwise noted.
 - Emergency spillway segments A & B correspond to the flat section through the embankment (A) and the sloped section on the outside of the pond embankment (B).
