Reitz #1 Passive Treatment System
SRI O&M Project #9 Request #2
OSM PTS ID: PA-191

Requesting Organization: Shade Creek Watershed Association
Receiving Stream: Laurel Run
Watershed: Dark Shade Creek
Municipality/County: Shade Township, Somerset County
Latitude/Longitude: 40°07'04.0008"N / 78°48'11.0016"W

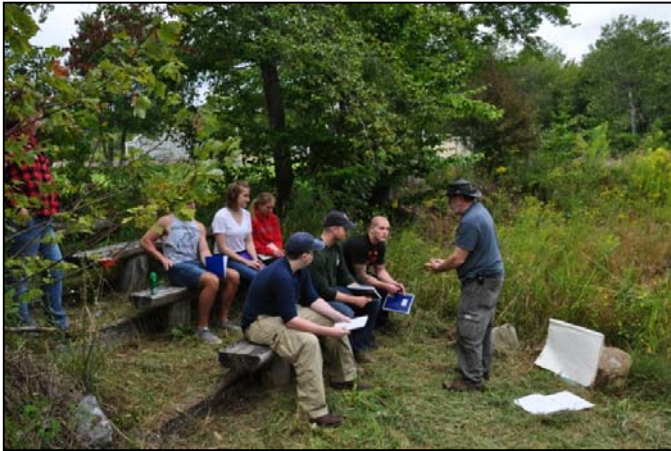
Top Left: SFU students learning about the system from Larry Hutchinson. **Top Right:** Students “fluffing” top of VFP media. **Center Left:** Bioreactor at beginning of project. Approximately 50% of the flow was being bypassed to the emergency spillway. **Center Right:** Compost island vegetated with transplanted cattails in the Bioreactor. **Bottom Left:** Large channels had formed in the rock baffles between the settling ponds and Bioreactor, preventing aeration and causing short-circuiting of the water. **Bottom Right:** Gaps were filled in and rock baffles were elevated using limestone found on site.

Upon arrival to the site on September 28, 2017, it was found that the flush valves on the Vertical Flow Pond were never closed and the substrate was mostly dry. The valves were immediately closed and while the cell was filling up, students and professors fluffed the top ~8" of material with hand tools to remove an iron oxide crust that had formed on top of the substrate. Using a raft and rakes, students also fluffed the top ~8" of the Bioreactor material. Prior to leaving the site, stop logs were removed from the Bioreactor Agri Drain to lower the water level to ~4" above the substrate in preparation for wetland construction the following week.

On October 12 and 19, the group used logs found on site to form a rectangular frame in the middle of the Bioreactor. Compost taken from a stockpile near the Vertical Flow Pond was used to build up the substrate within the rectangle and was vegetated with transplanted cattails from areas where water levels has risen due to elevating the rock baffles. All stop logs were removed from every Agri Drain within the treatment system, cleaned of built-up iron oxides to allow for easier movement in the future, and replaced.
