Booker Discharge Abandoned Mine Drainage Passive Treatment System Project

This report is submitted as required for the close out of an Office of Surface Mining grant for the construction of a Passive Treatment System for an Abandoned Mine Drainage to Carnahan Run in Parks Township Armstrong County PA. The project is on the land of Phillip Booker.

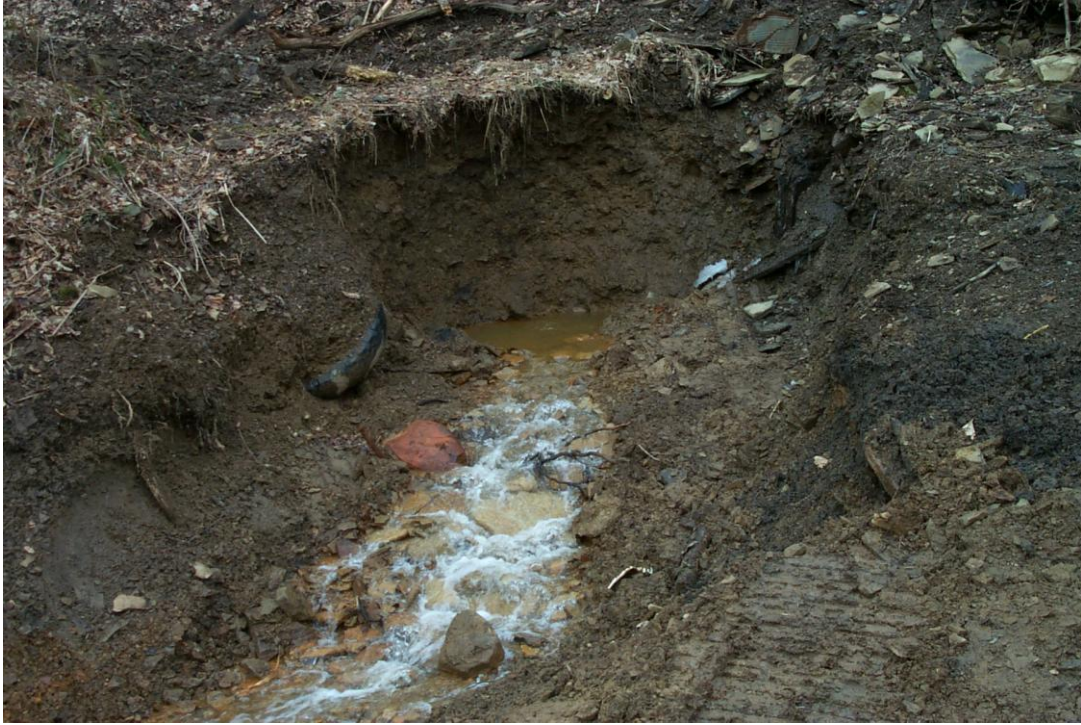
Picture 1: Opening the pit.

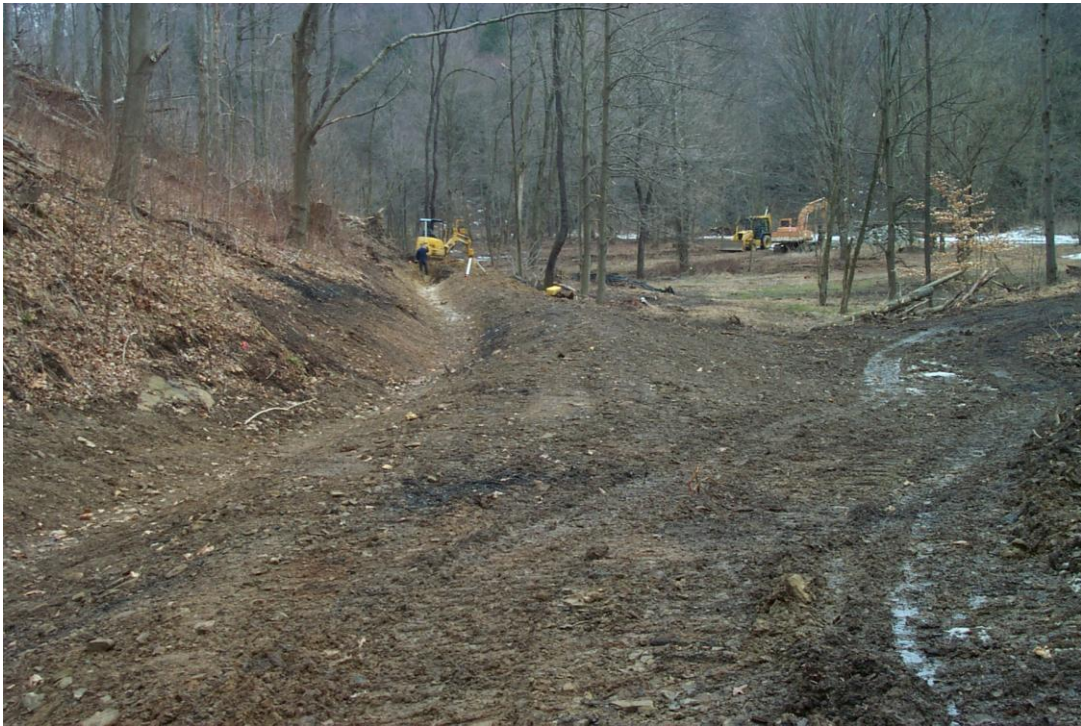
Picture 2: Construction of delivery channel

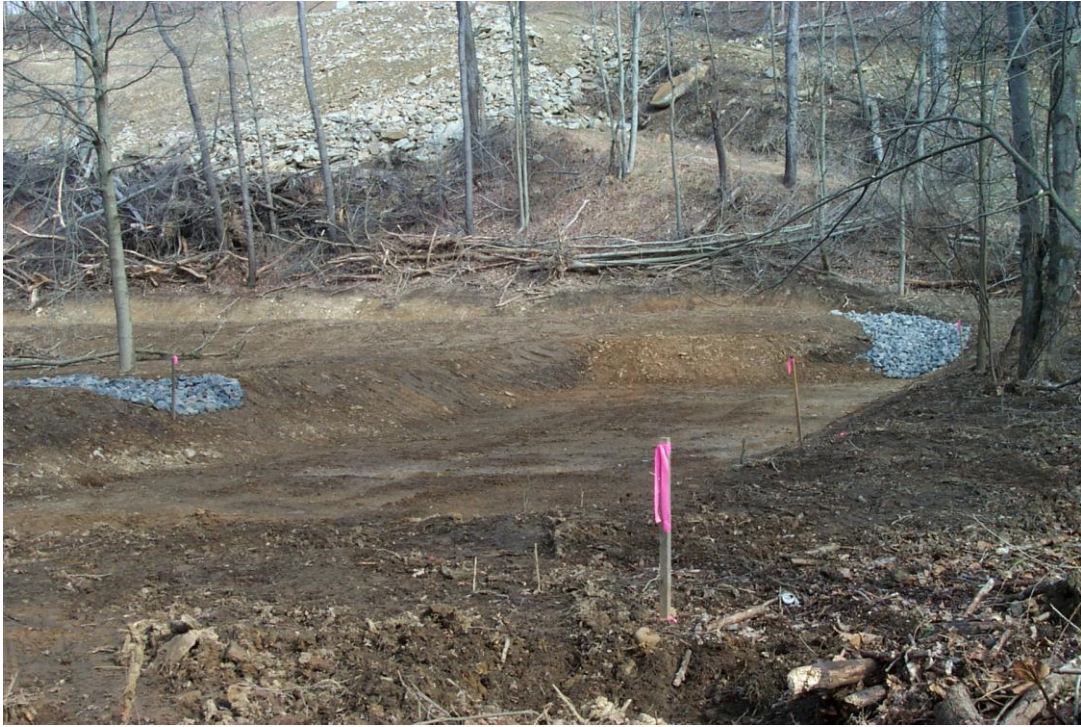
Picture 3: Construction of treatment cell 1

The first cell was constructed in such a way as to allow easy access and potential commercial recovery of the iron sludge once it fills. The third cell was constructed in such a manner as to support a bass / bluegill fishery should the landowner choose to introduce these fish.

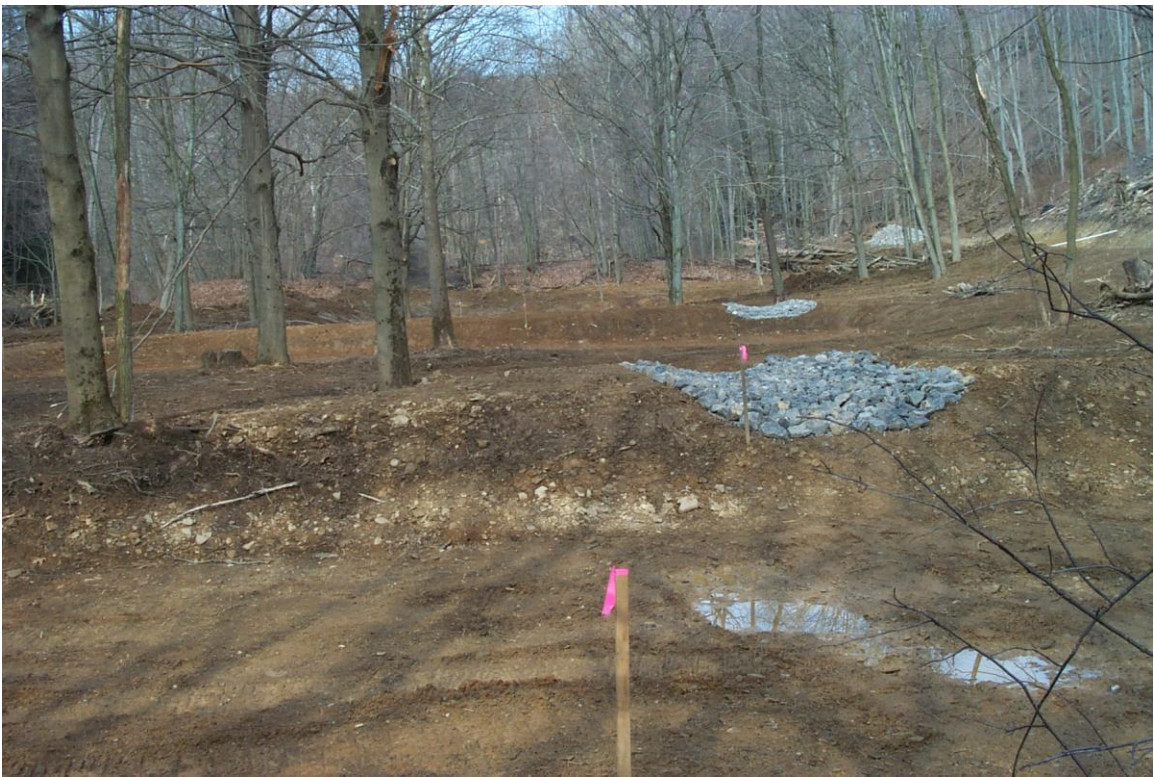
Picture 4: Construction of treatment cells showing transition channels

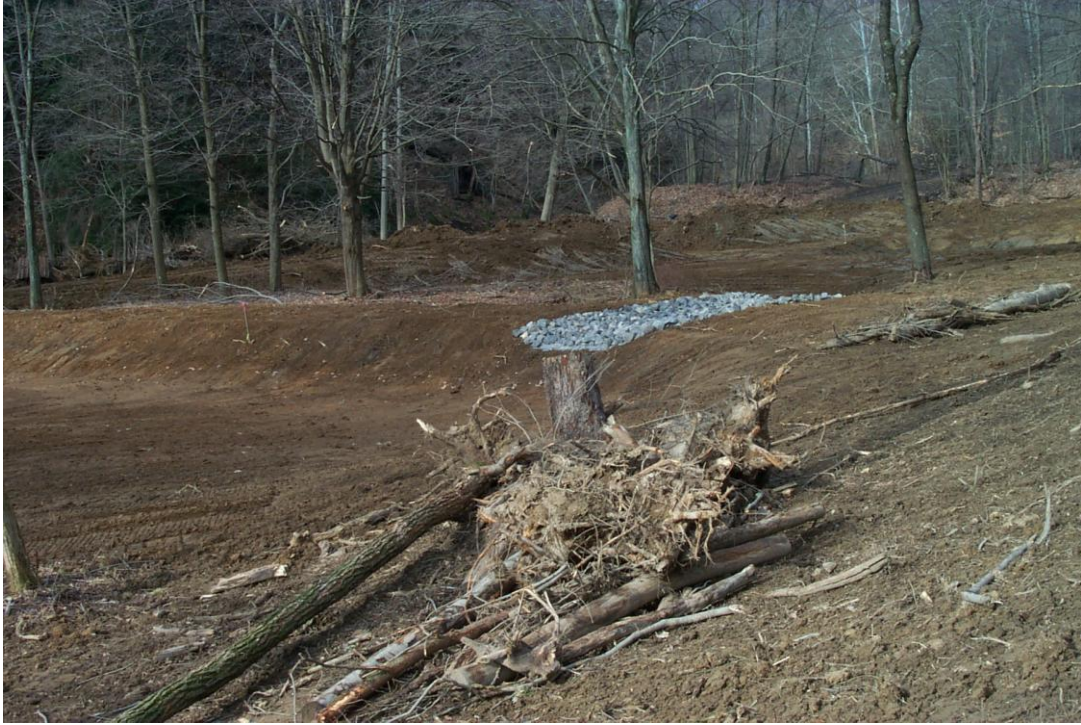
Picture 5: Transition channel from second cell to third

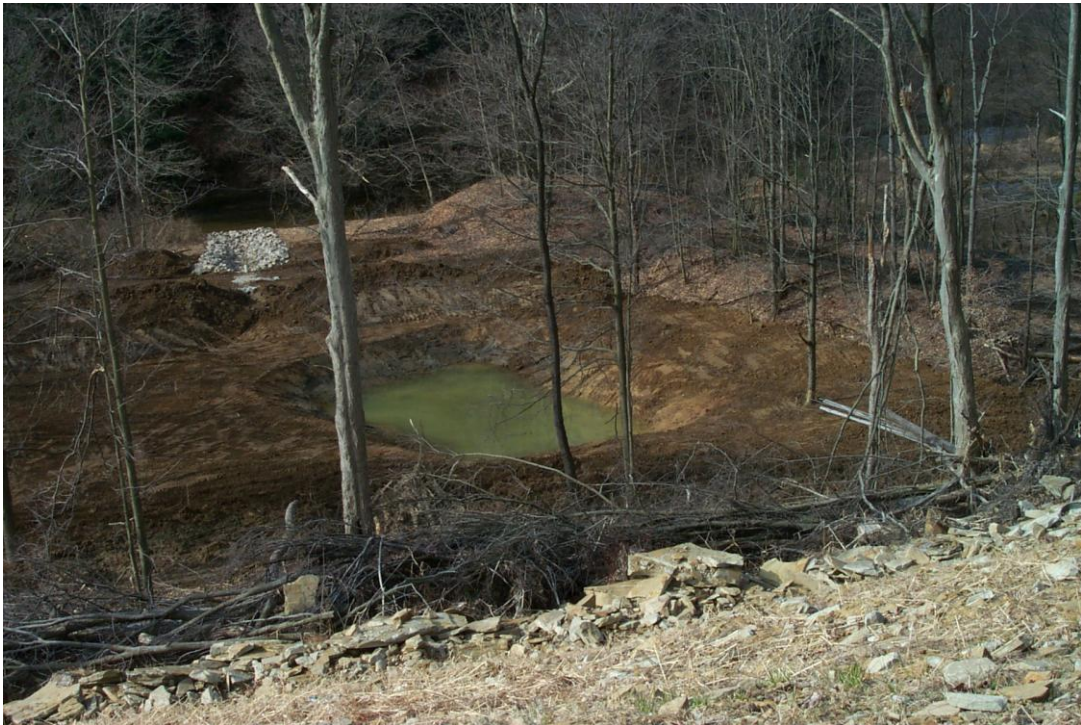
Picture 6: View of third cell showing excavated area and outflow with 24-inch CPP

The effluent was gauged at the 24" culvert pipe at the discharge from cell three to Carnahan Run. The flow on April 18, 2008 was 75 GPM. Thomas Clark sampled and field checked the iron loading on April 29, 2008. The mine discharge concentration was 18 mg/L and the treated effluent concentration was 4 mg/L. The efficiency of the system is presently 78% and is expected to improve as aquatic vegetation develops and iron-fixing bacteria become established.

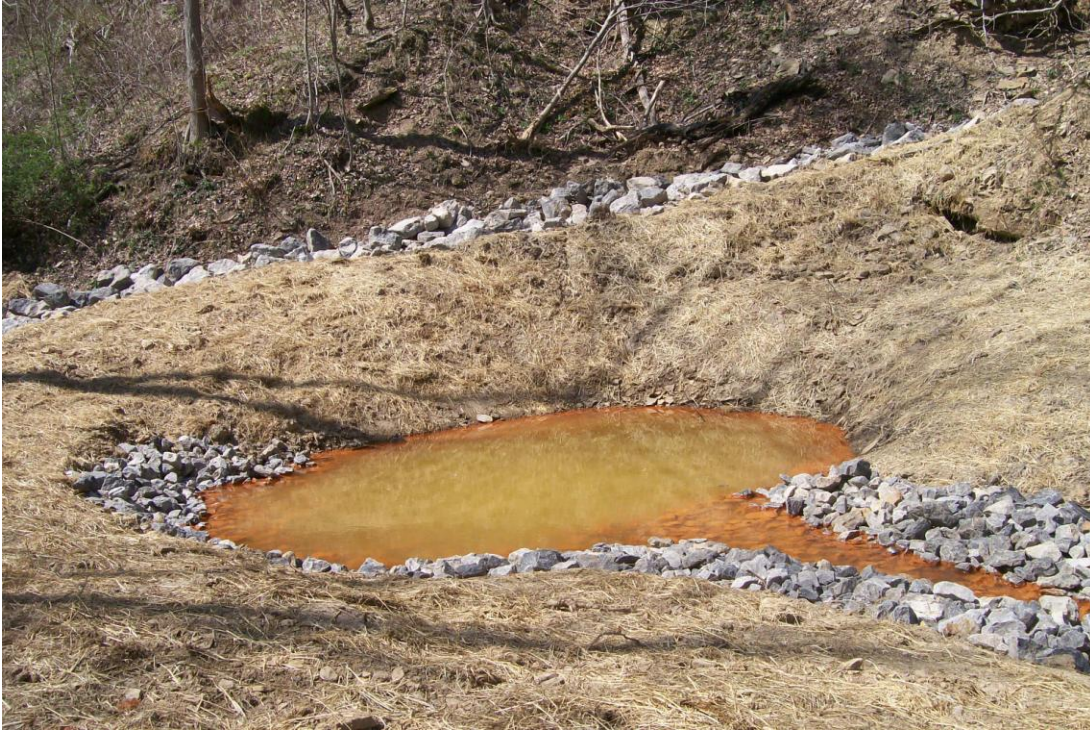
Picture 7: Completed impoundment of mine discharge and beginning of delivery channel, also showing surface water diversion channel

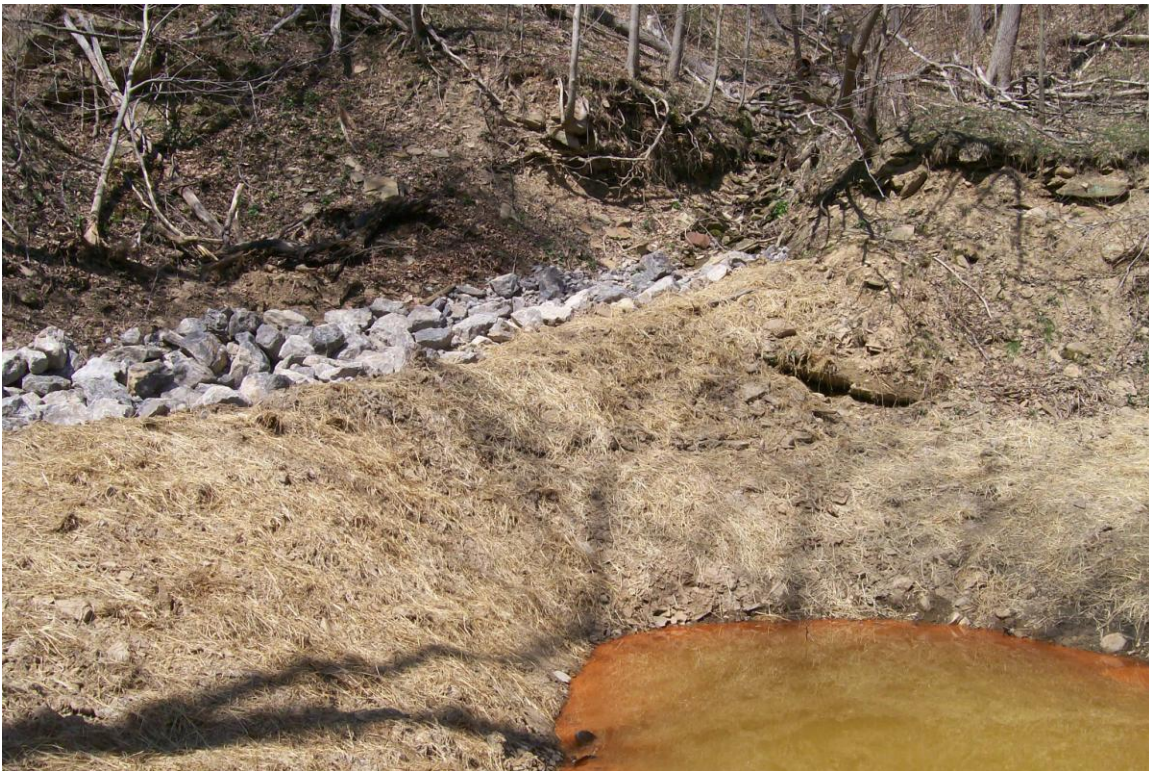
Picture 8: Surface water diversion channel

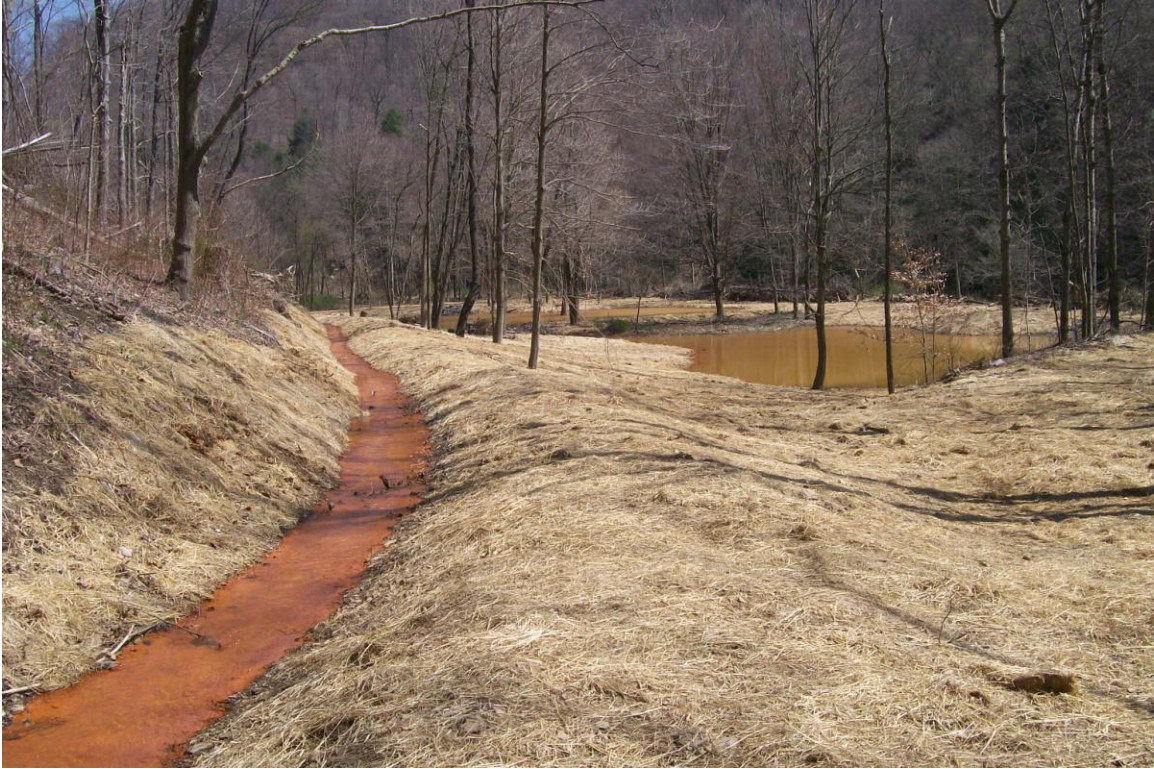
Picture 9: Delivery channel from impoundment to first cell

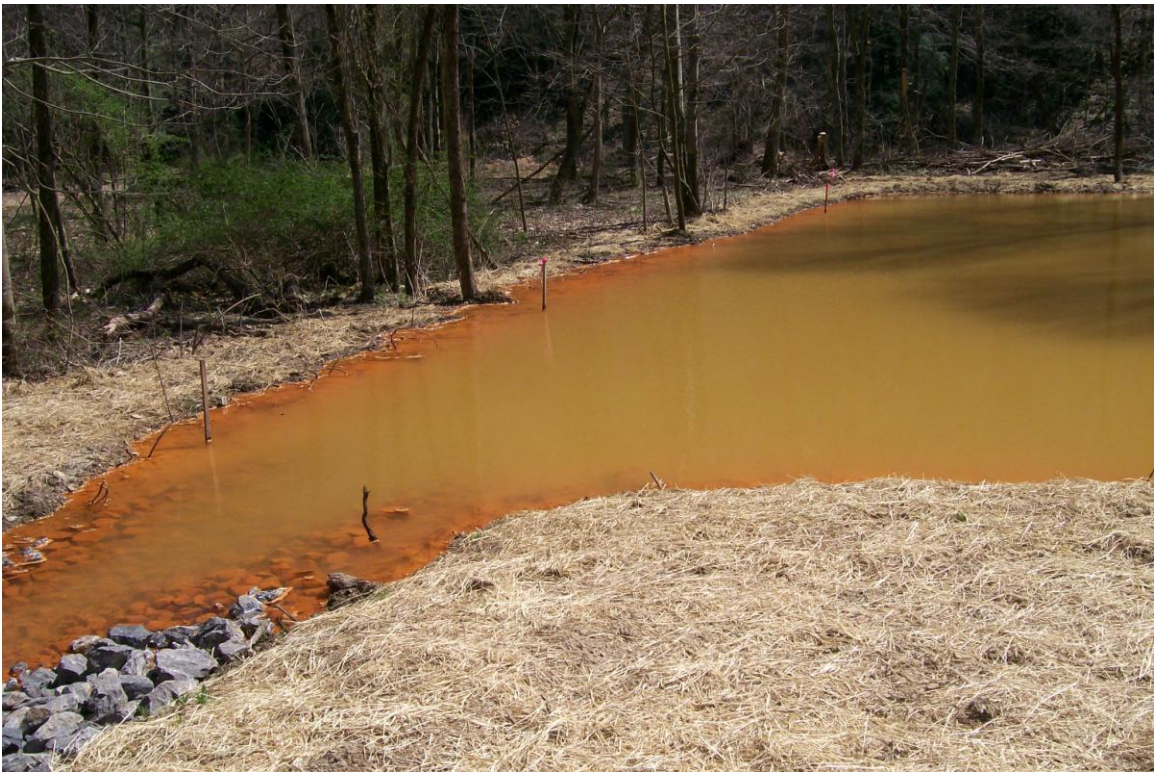
Picture 10: Delivery channel inflow to first cell

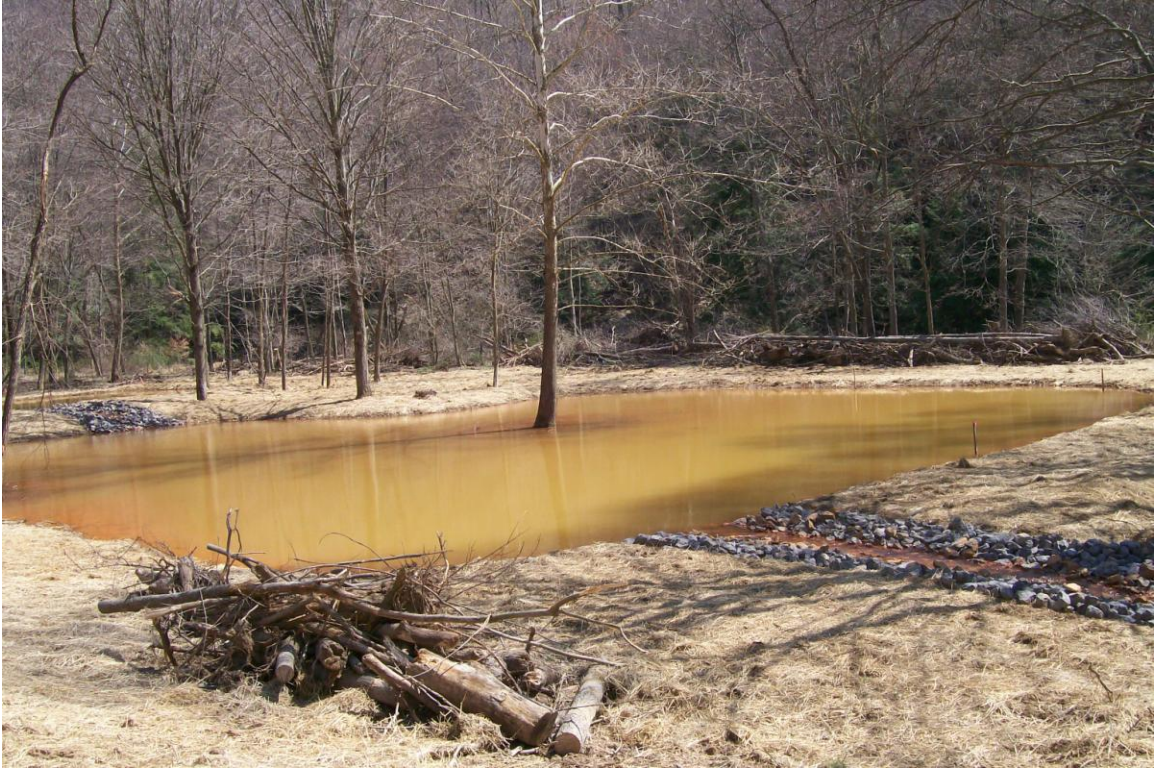
Picture 11: Finished second cell

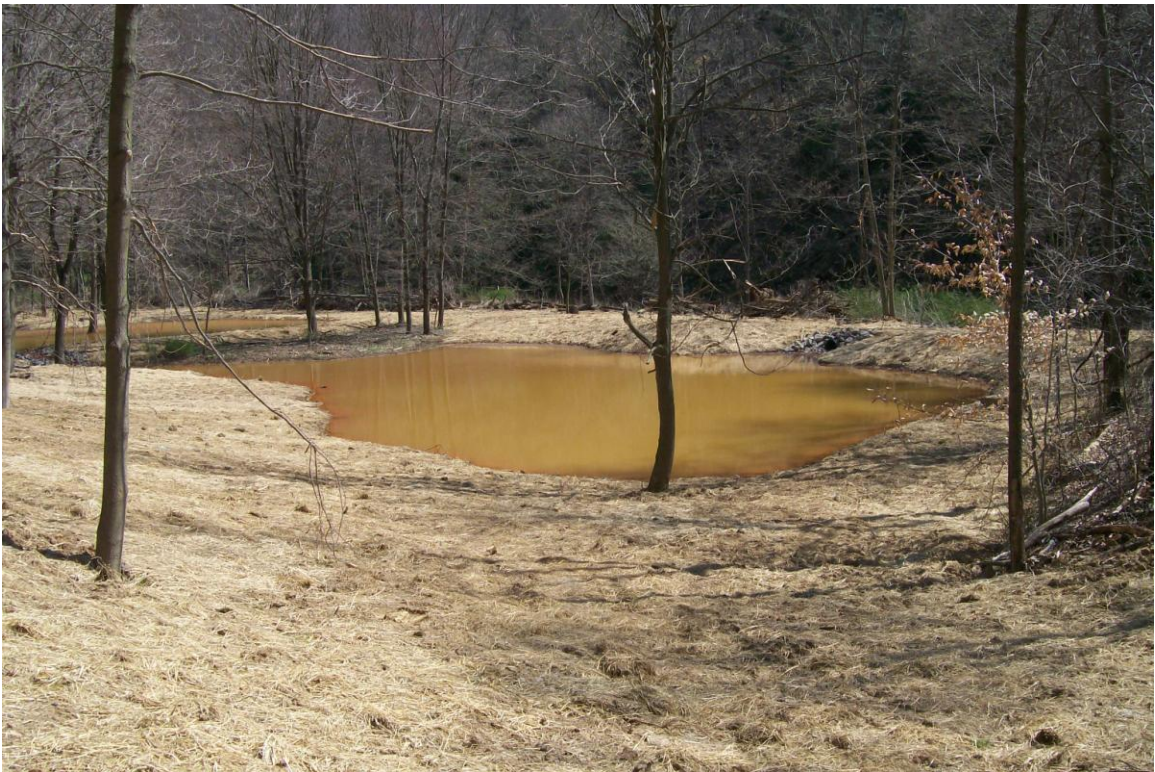
Picture 12: Finished third cell

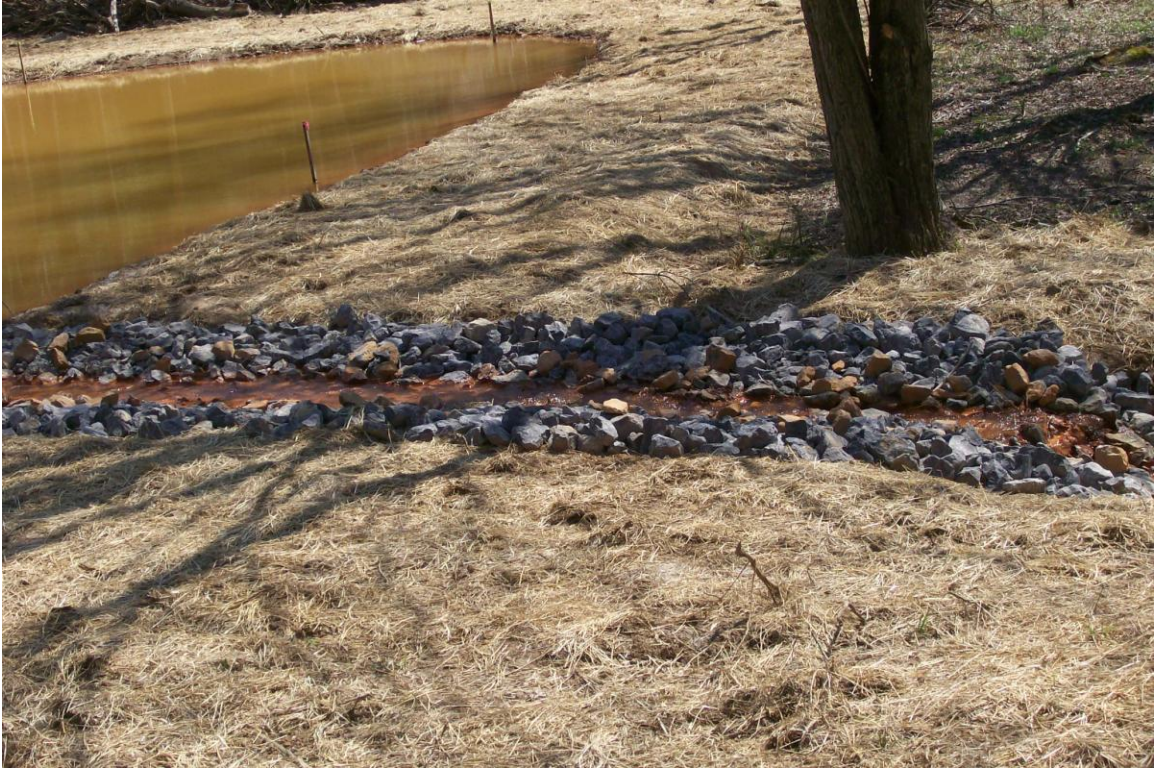
Picture 13: Detail of transition channel from second to third cell

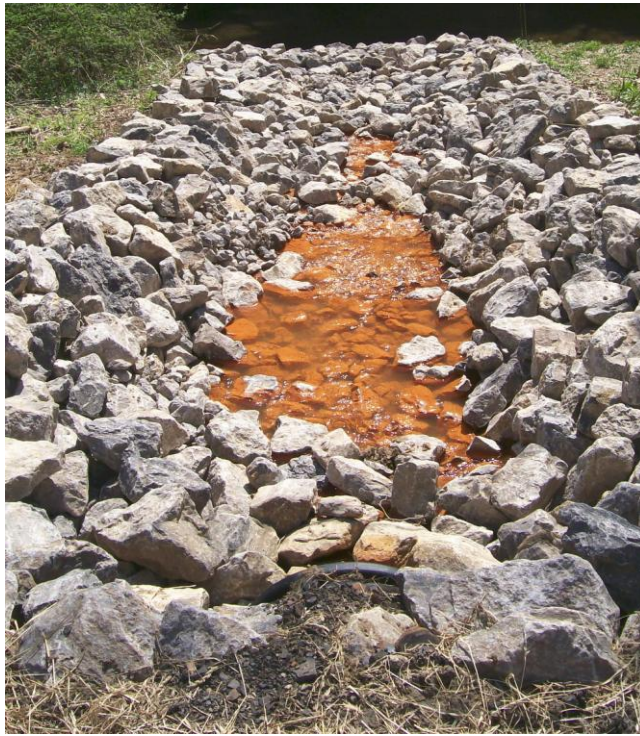
Picture 14: Detail of discharge channel to Carnahan Run

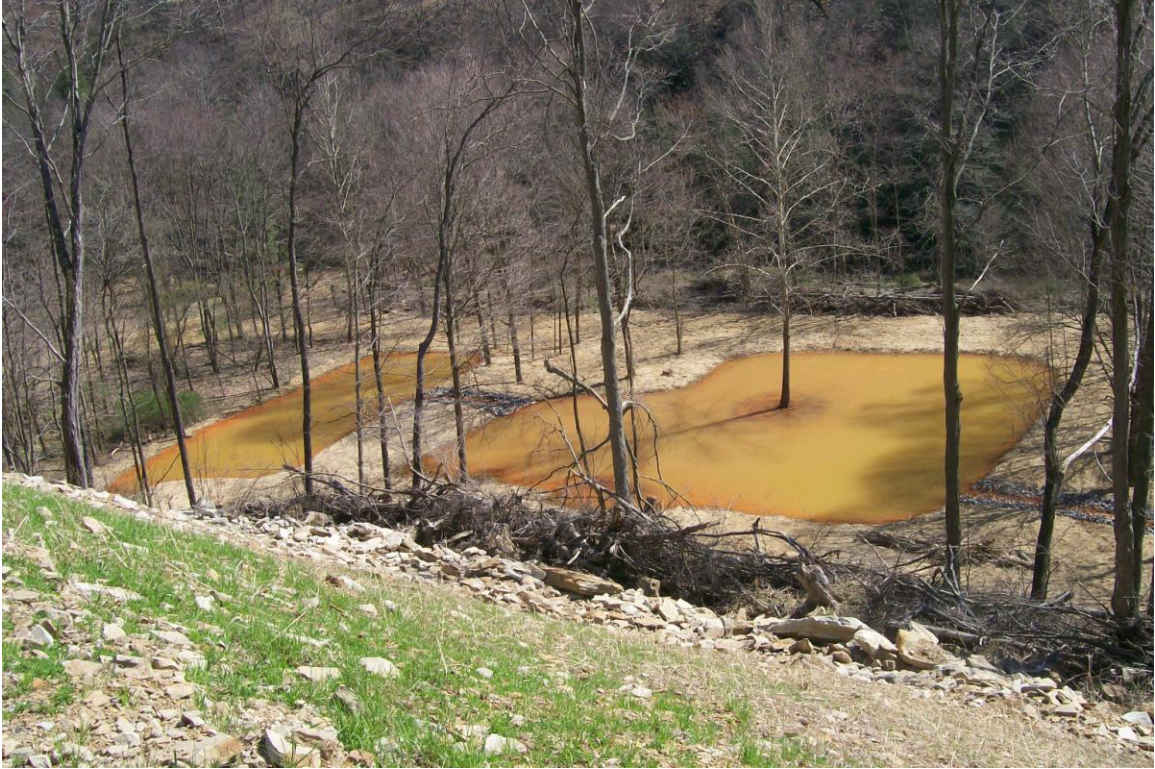
Picture 15: Picture of first and second cells

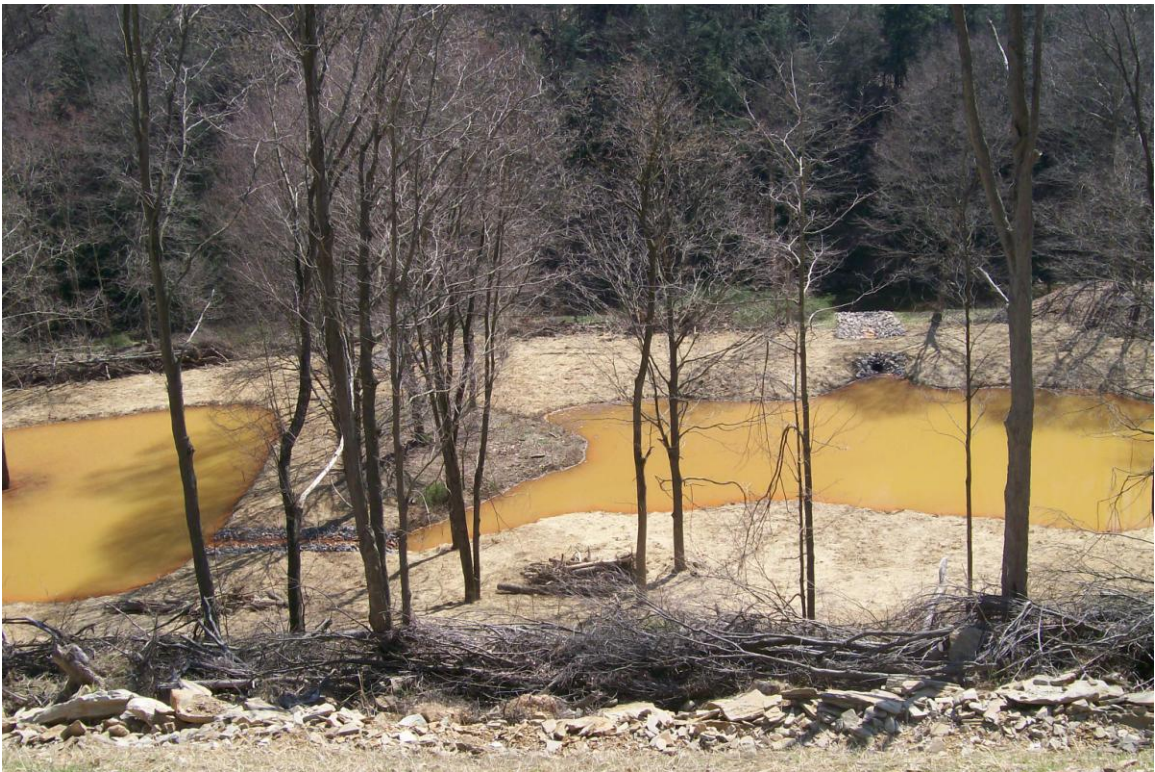
Picture 16: Picture of second and third cells
