AS-BUILT SCHEMATIC

BOYCE PARK AMD TREATMENT SYSTEM
 for
 ALLEGHENY COUNTY CONSERVATION DISTRICT
 Plum Borough, Allegheny County, Pennsylvania
 Scale: 1" = 100' September 2017
BioMost, Inc., Mars, Pennsylvania
 Mining and Reclamation Services www.biomost.com

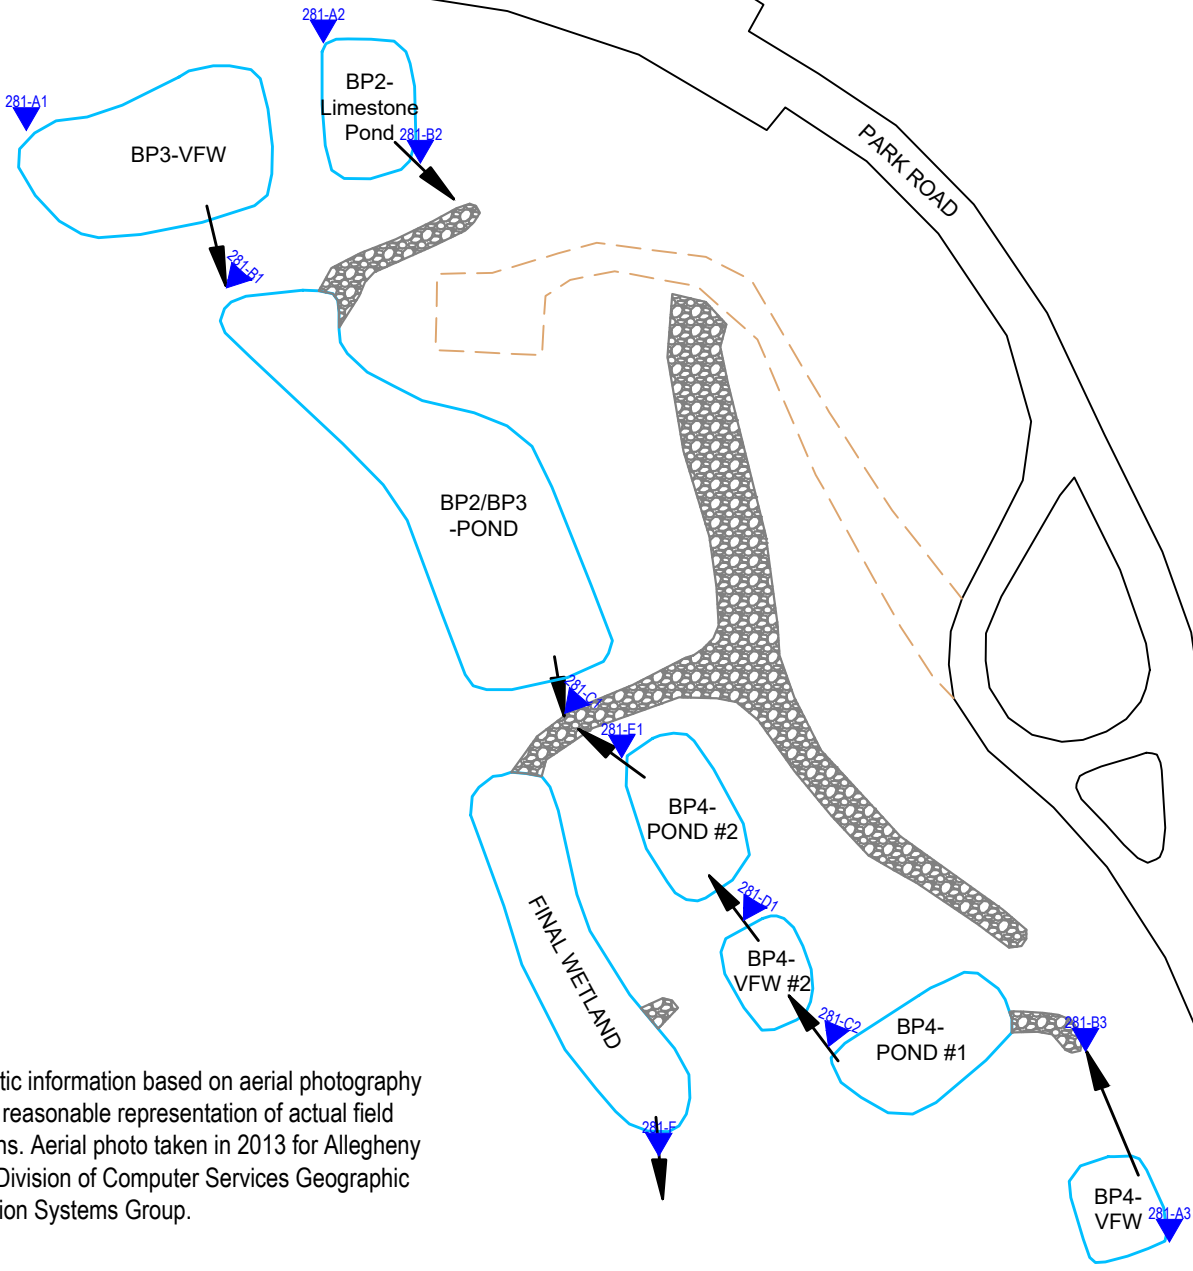
Note:
 Schematic information based on aerial photography and is a reasonable representation of actual field conditions. Aerial photo taken in 2013 for Allegheny County Division of Computer Services Geographic Information Systems Group.
