SLIPPERY ROCK WATERSHED COALITION
GOFF STATION RESTORATION PROJECT

“A Public-Private Partnership Effort”
 Venango Township, Northern Butler County, PA

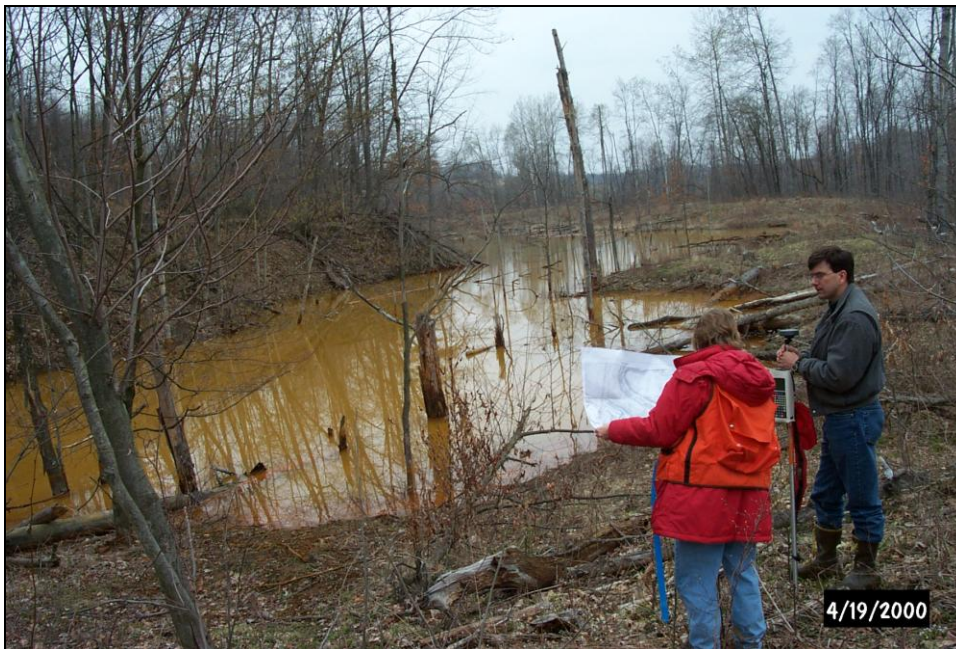
BEFORE:

Old strip pit filled with acidic, iron and aluminum-bearing mine drainage.

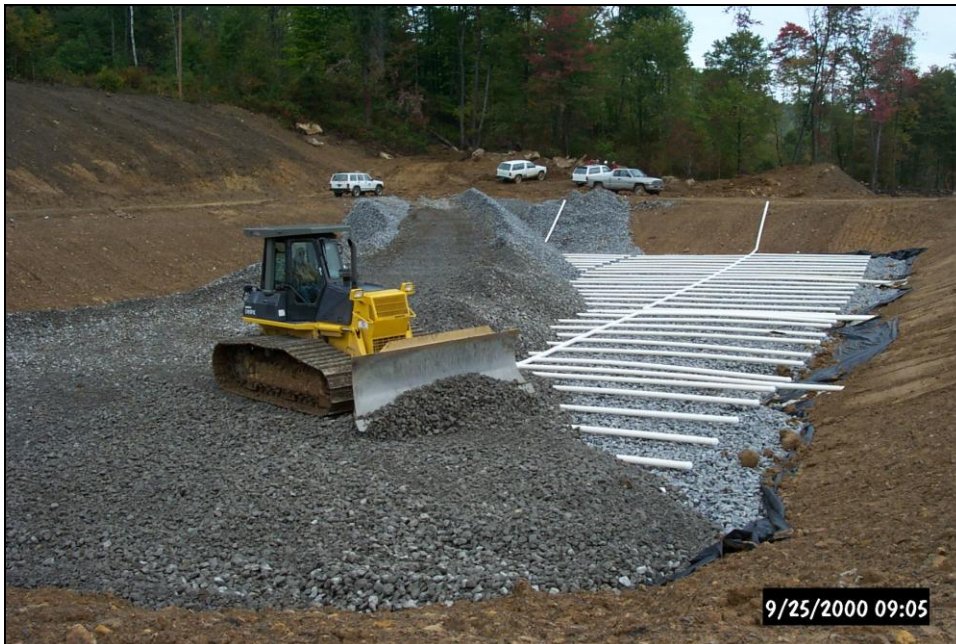
DURING:

Bulldozer spreading limestone over the pipes in a Vertical Flow Pond.

The treatment media generates alkalinity. Two tiers of perforated plastic pipe aid in flow distribution and flushing in the Vertical Flow Ponds. Treated water discharges through outlet control structures into settling or flush ponds to allow periodic flushing to remove accumulated metal precipitates (mainly iron and aluminum). The wetlands enhance wildlife habitat and facilitate additional iron oxidization and settling of metal solids.

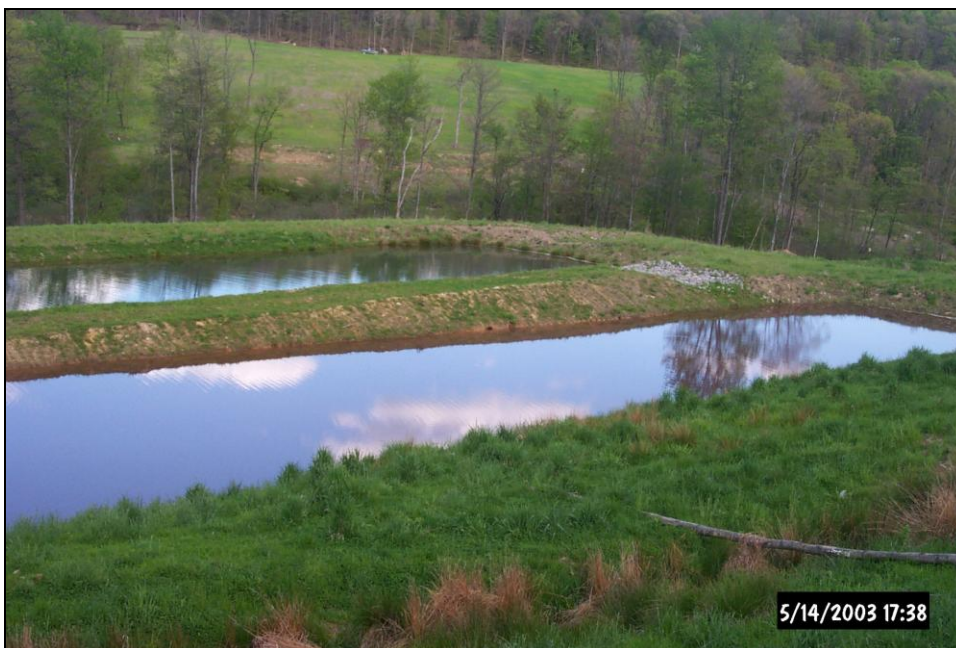
AFTER:

Completed VFP 3 AND 4 successfully treating mine discharges.
