Richards Passive Treatment System
SRI O&M TAG Project #36 Request #3
OSM PTS ID: PA-129

Requesting Organization: Blacklick Creek Watershed Association (in-kind partner)

Dates of work performed: 3/1/2023

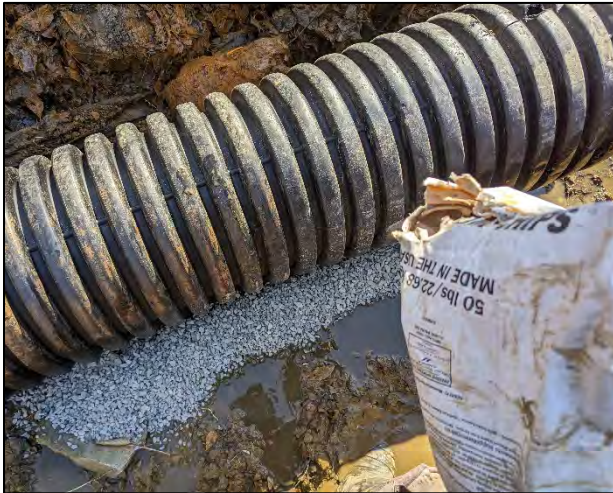
Top Left: Wetland flow monitoring pipe was bedded in bentonite (3/1/23).
Top Right: The wetland flow monitoring pipe was armored with riprap (3/1/23).
Bottom Left: Flow measurement for the seep collection drain outlet is feasible due to upgrades (3/1/23).
Bottom Right: JVFP outlets were adjusted on all three vertical flow ponds in accordance with O&M manual (3/1/23).

Work Completed: On 3/1/2023, BioMost mobilized equipment to the site. A flow measurement pipe was installed at the wetland outlet, which is the combined flow for JVFP2 and JVFP3, the existing borehole, and the seep collection drain. A 12" double-wall HDPE culvert pipe was installed through a check dam placed at the wetland outlet to measure flow. The check dam was lined with riprap. The water elevation within the wetland was kept at or below the existing water elevation.
