**Reeds Run AMD Remediation Project**  
**SRI O&M TAG Project #65 Request #1**  
**OSM PTS ID: PA-207**

Requesting Organization: Aultmans Watershed Association for Restoring the Environment (AWARE)

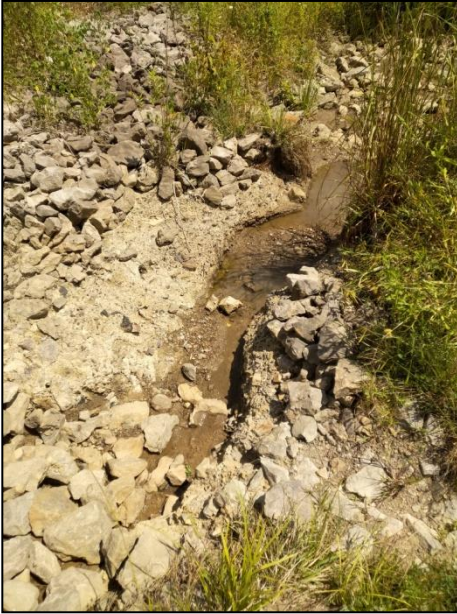
**Top Left:** Erosion of the stream channel (8/9/19).

**Bottom Left:** Riprap was placed in the eroded channel which also armored the embankments (8/9/19).

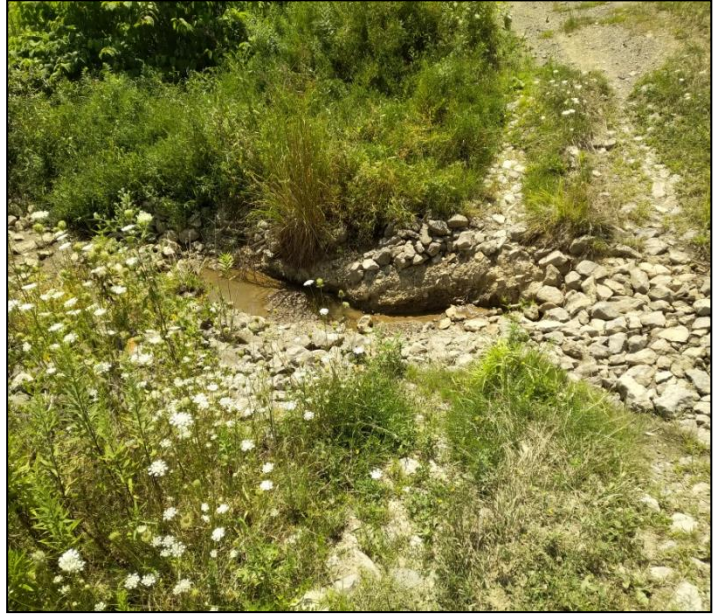
**Top Right:** Access road over-use was likely the cause of erosion (8/9/19).

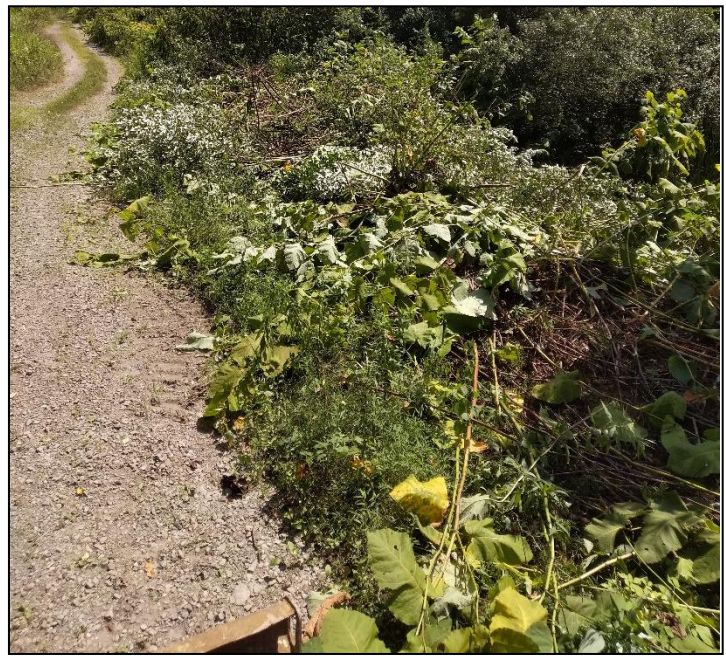
**Bottom Right:** Vegetation was removed as feasible to keep the access road passable to facilitate on going monitoring (8/9/19).

Work Completed: Unwanted vegetation near the access road and gate was cut back or removed via excavation. An eroded channel along the access road was re-graded and riprap was placed as needed. Potholes were also filled where feasible to maintain the access road. Vegetation along the access road was brushed back as feasible using both hand tools and an excavator.
