TREATMENT SYSTEM EVALUATION

SL 142-1 – PIGEON CREEK

Carroll Township
Washington County
Pennsylvania

Passive Treatment Operation & Maintenance Technical Assistance Program
Funded by Pennsylvania Department of Environmental Protection Growing Greener Grant
August 2025

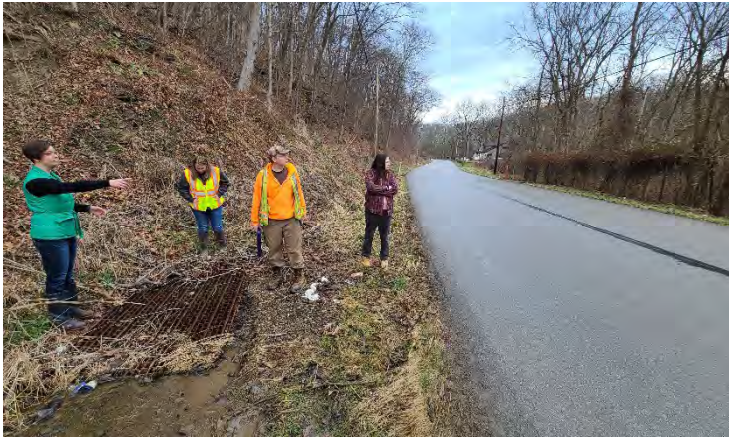
Top Left: The mine discharge is piped from a wet seal (left of photo) and into the steel grate-covered catch basin along the north side of SR-2023 (3/17/22).

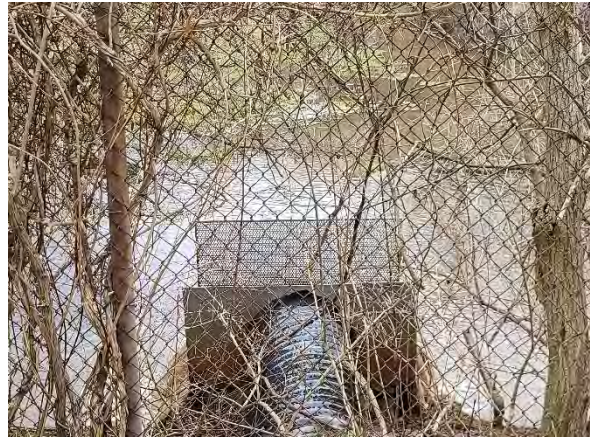
Top Right: A 24-inch corrugated metal pipe extends from the catch basin, under SR-2023 and outlets into a perforated stainless steel box (3/17/22).

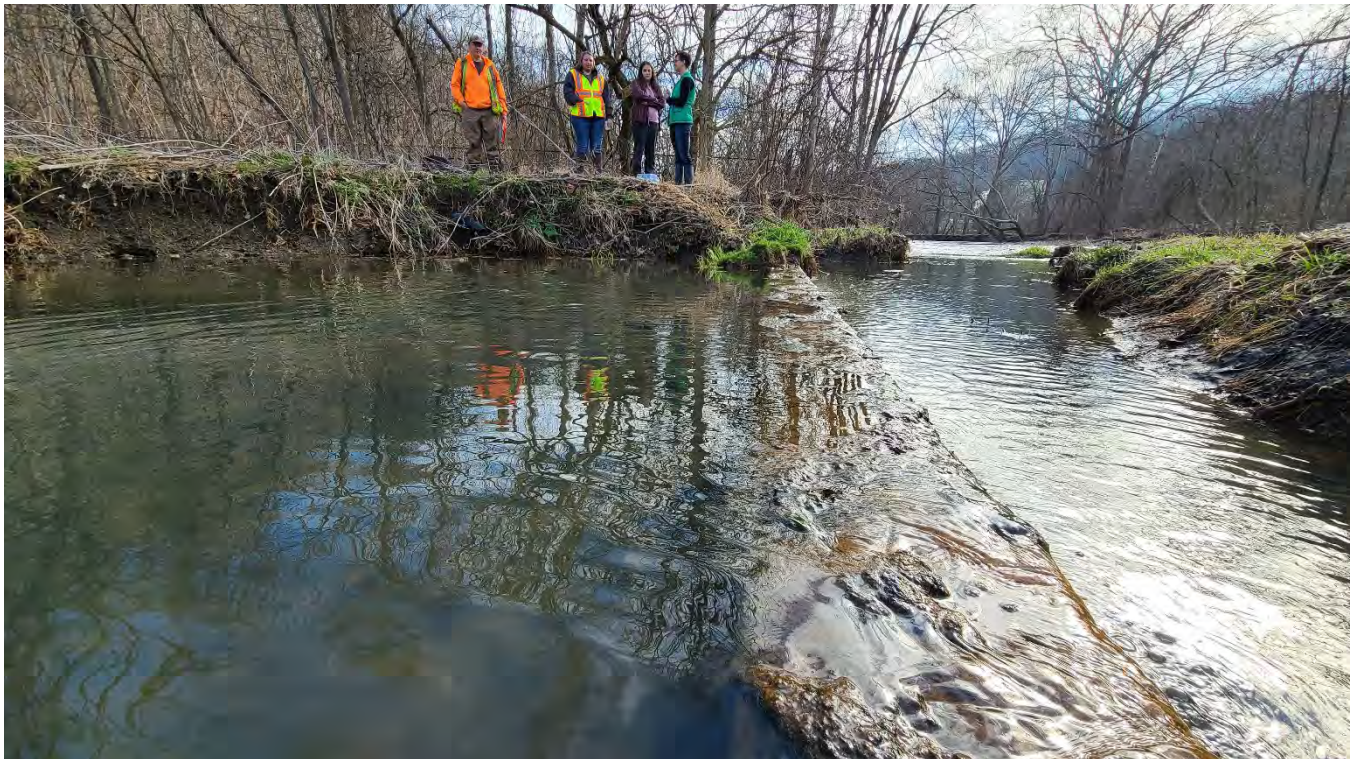
system is filled in with sediment (see photos). Even adjusting for a 50% reduced surface area, the removal rate would be no more than 0.2 g/sm/d, two orders of magnitude less than expected. Perhaps if the system aeration devices were working the system would perform better, but that would require the system to be restored to its original configuration to evaluate. This begs the question: is the system needed?

Bottom: Discharge of the system over the five-foot-high concrete dam into Pigeon Creek (right). Note that the people shown are standing on sediment that has been deposited in the settling pond, likely by Pigeon Creek during high flow events, and is above the crest elevation of the outlet dam (3/17/22).

Assuming that the system is filled with five feet of sediment it would require the removal of about 3,000 cubic yards of material that would likely need to be hauled to a landfill. Using a bulk density of 1.5 tons per cubic yard, about 4,500 tons of material would need to be removed off-site. Using an estimated disposal cost of \$100/ton for hauling and landfill fees, the disposal cost to rehabilitate the treatment system would be over \$500,000, plus other site work, design, permitting, and project management costs which would likely add an additional 50% to overall cost. Even if the system was restored to original condition, passive aeration will likely not be sufficient to achieve meaningful iron removal without powered aeration (e.g., Maelstrom oxidizer) or chemical addition (peroxide). Spending \$750,000 to restore a third-acre wetland of questionable effectiveness that is not needed to protect the aquatic resource of Pigeon Creek seems unwarranted.
