AS-BUILT DRAWING
NEAL RUN
RESTORATION PROJECT - PHASE III

PLAN VIEW

DETAILS

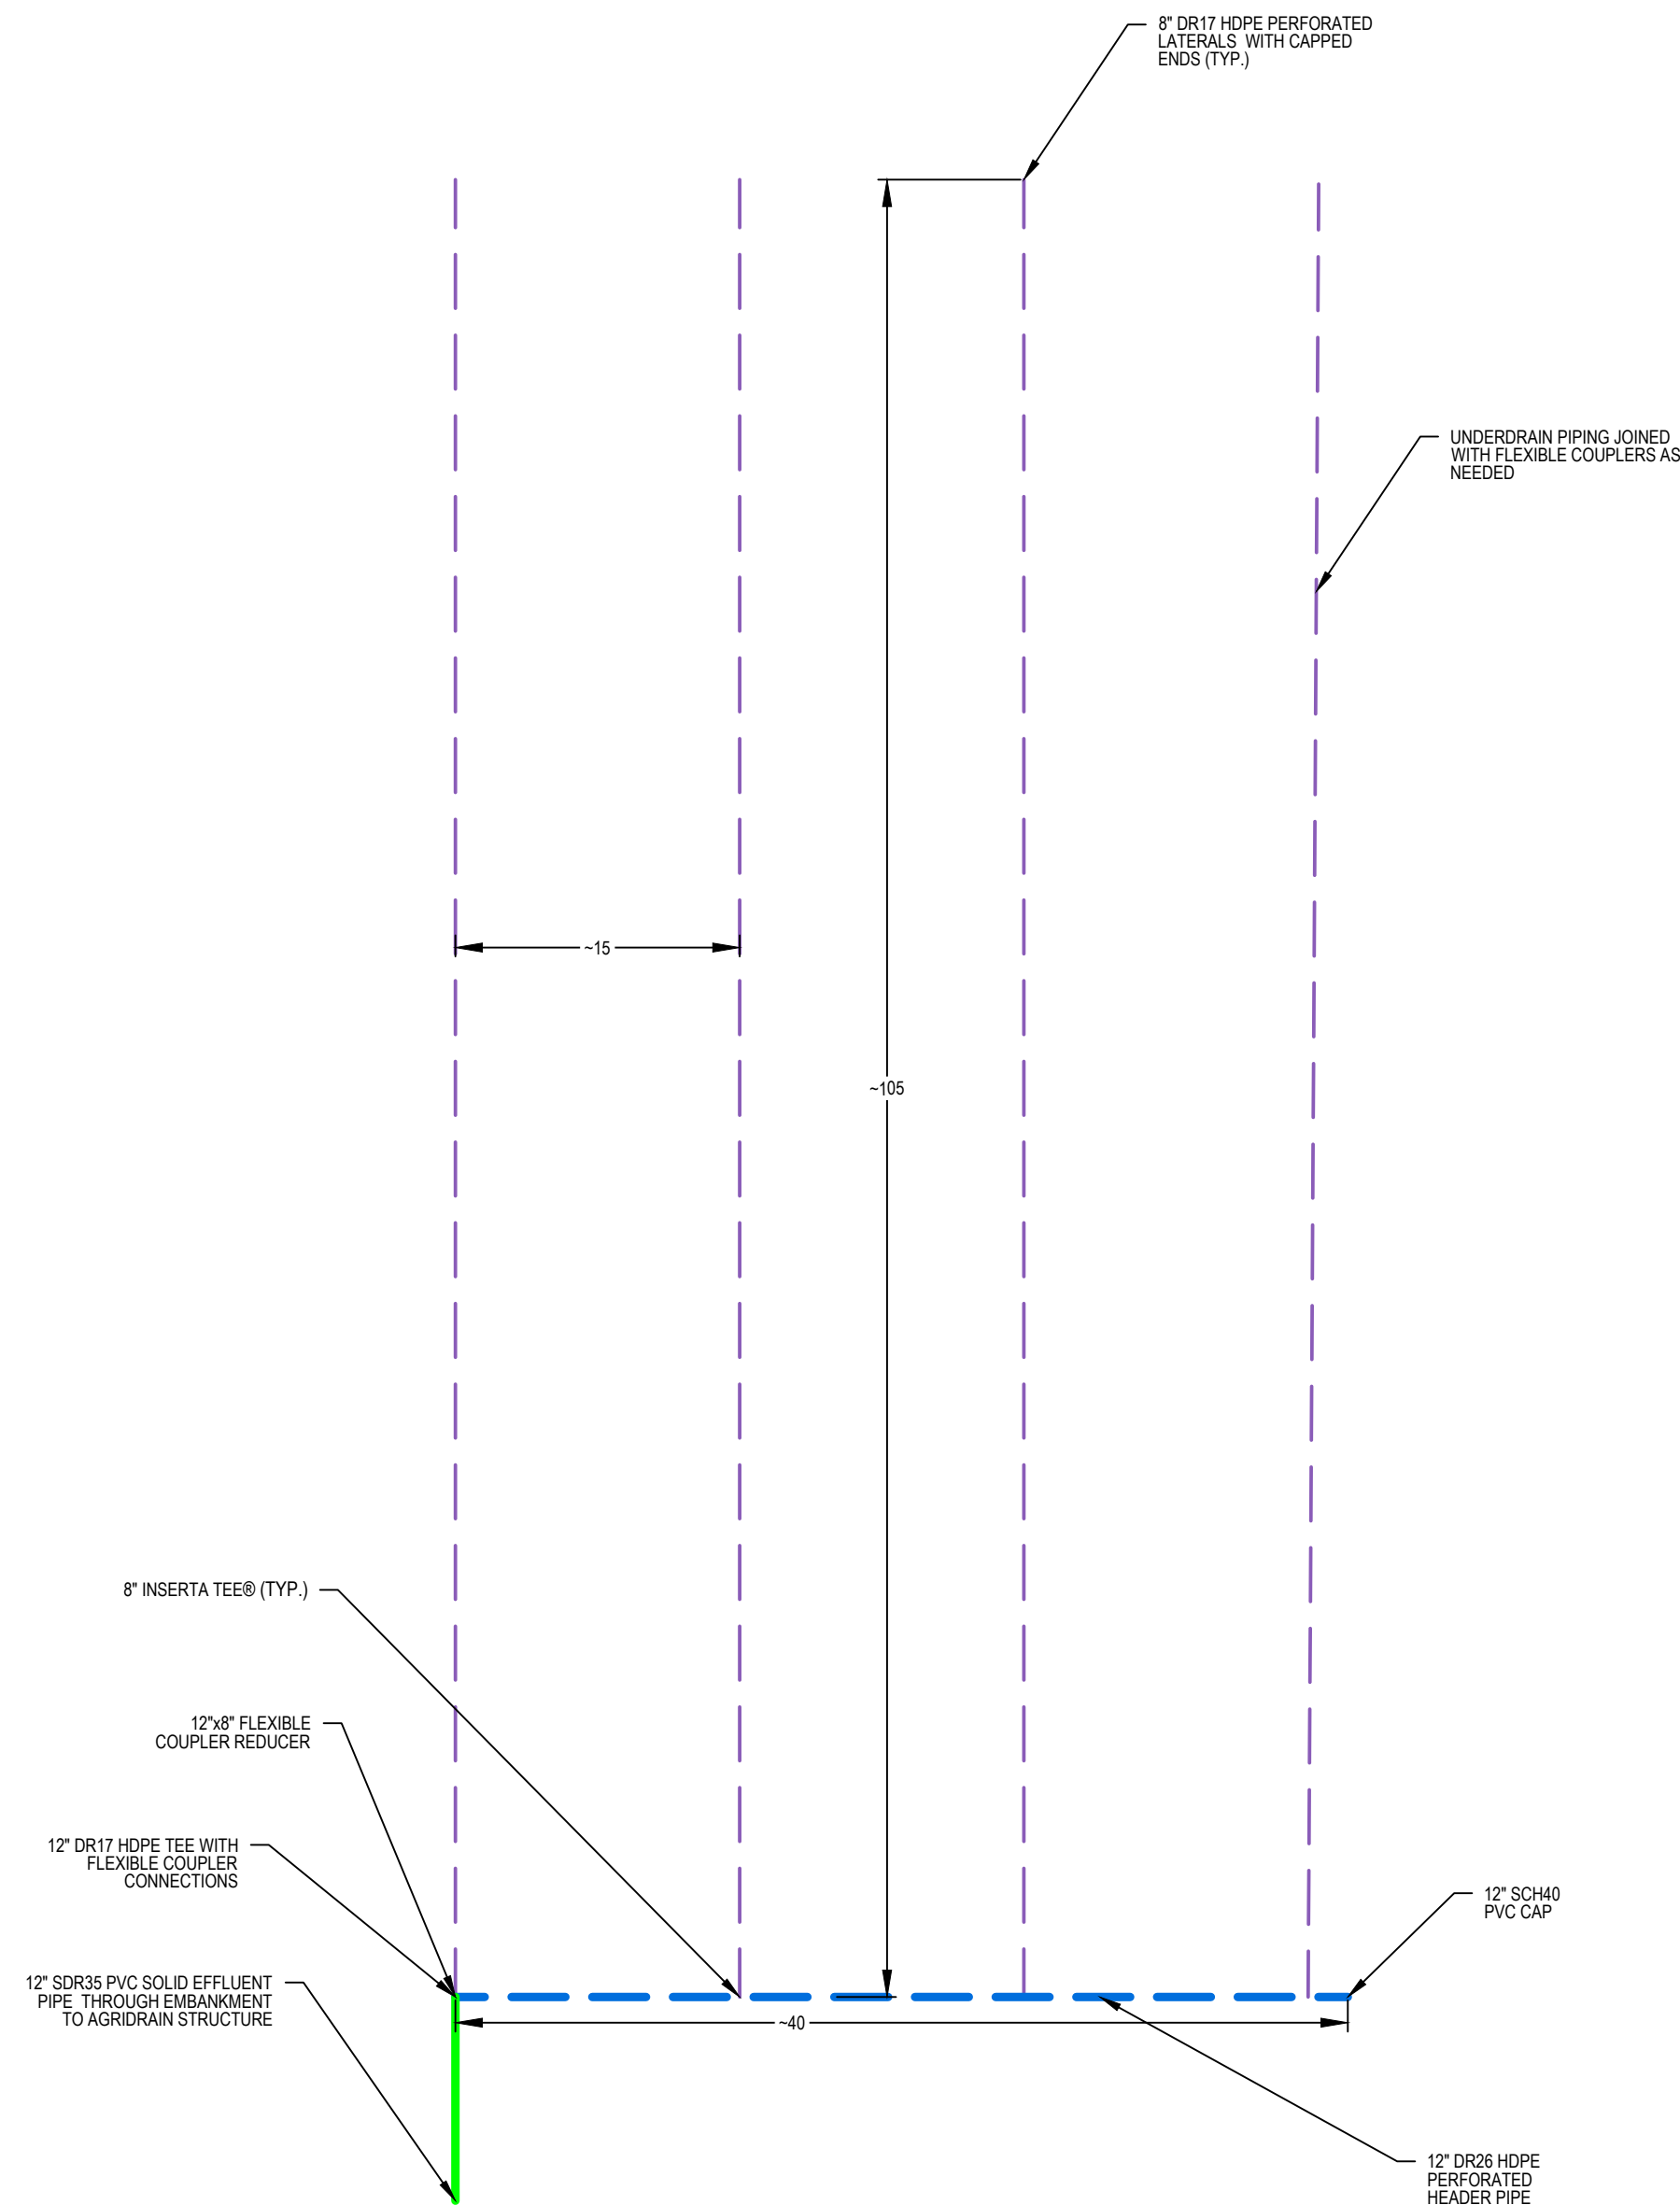
AFVFP2 UNDERDRAIN PIPE DETAIL

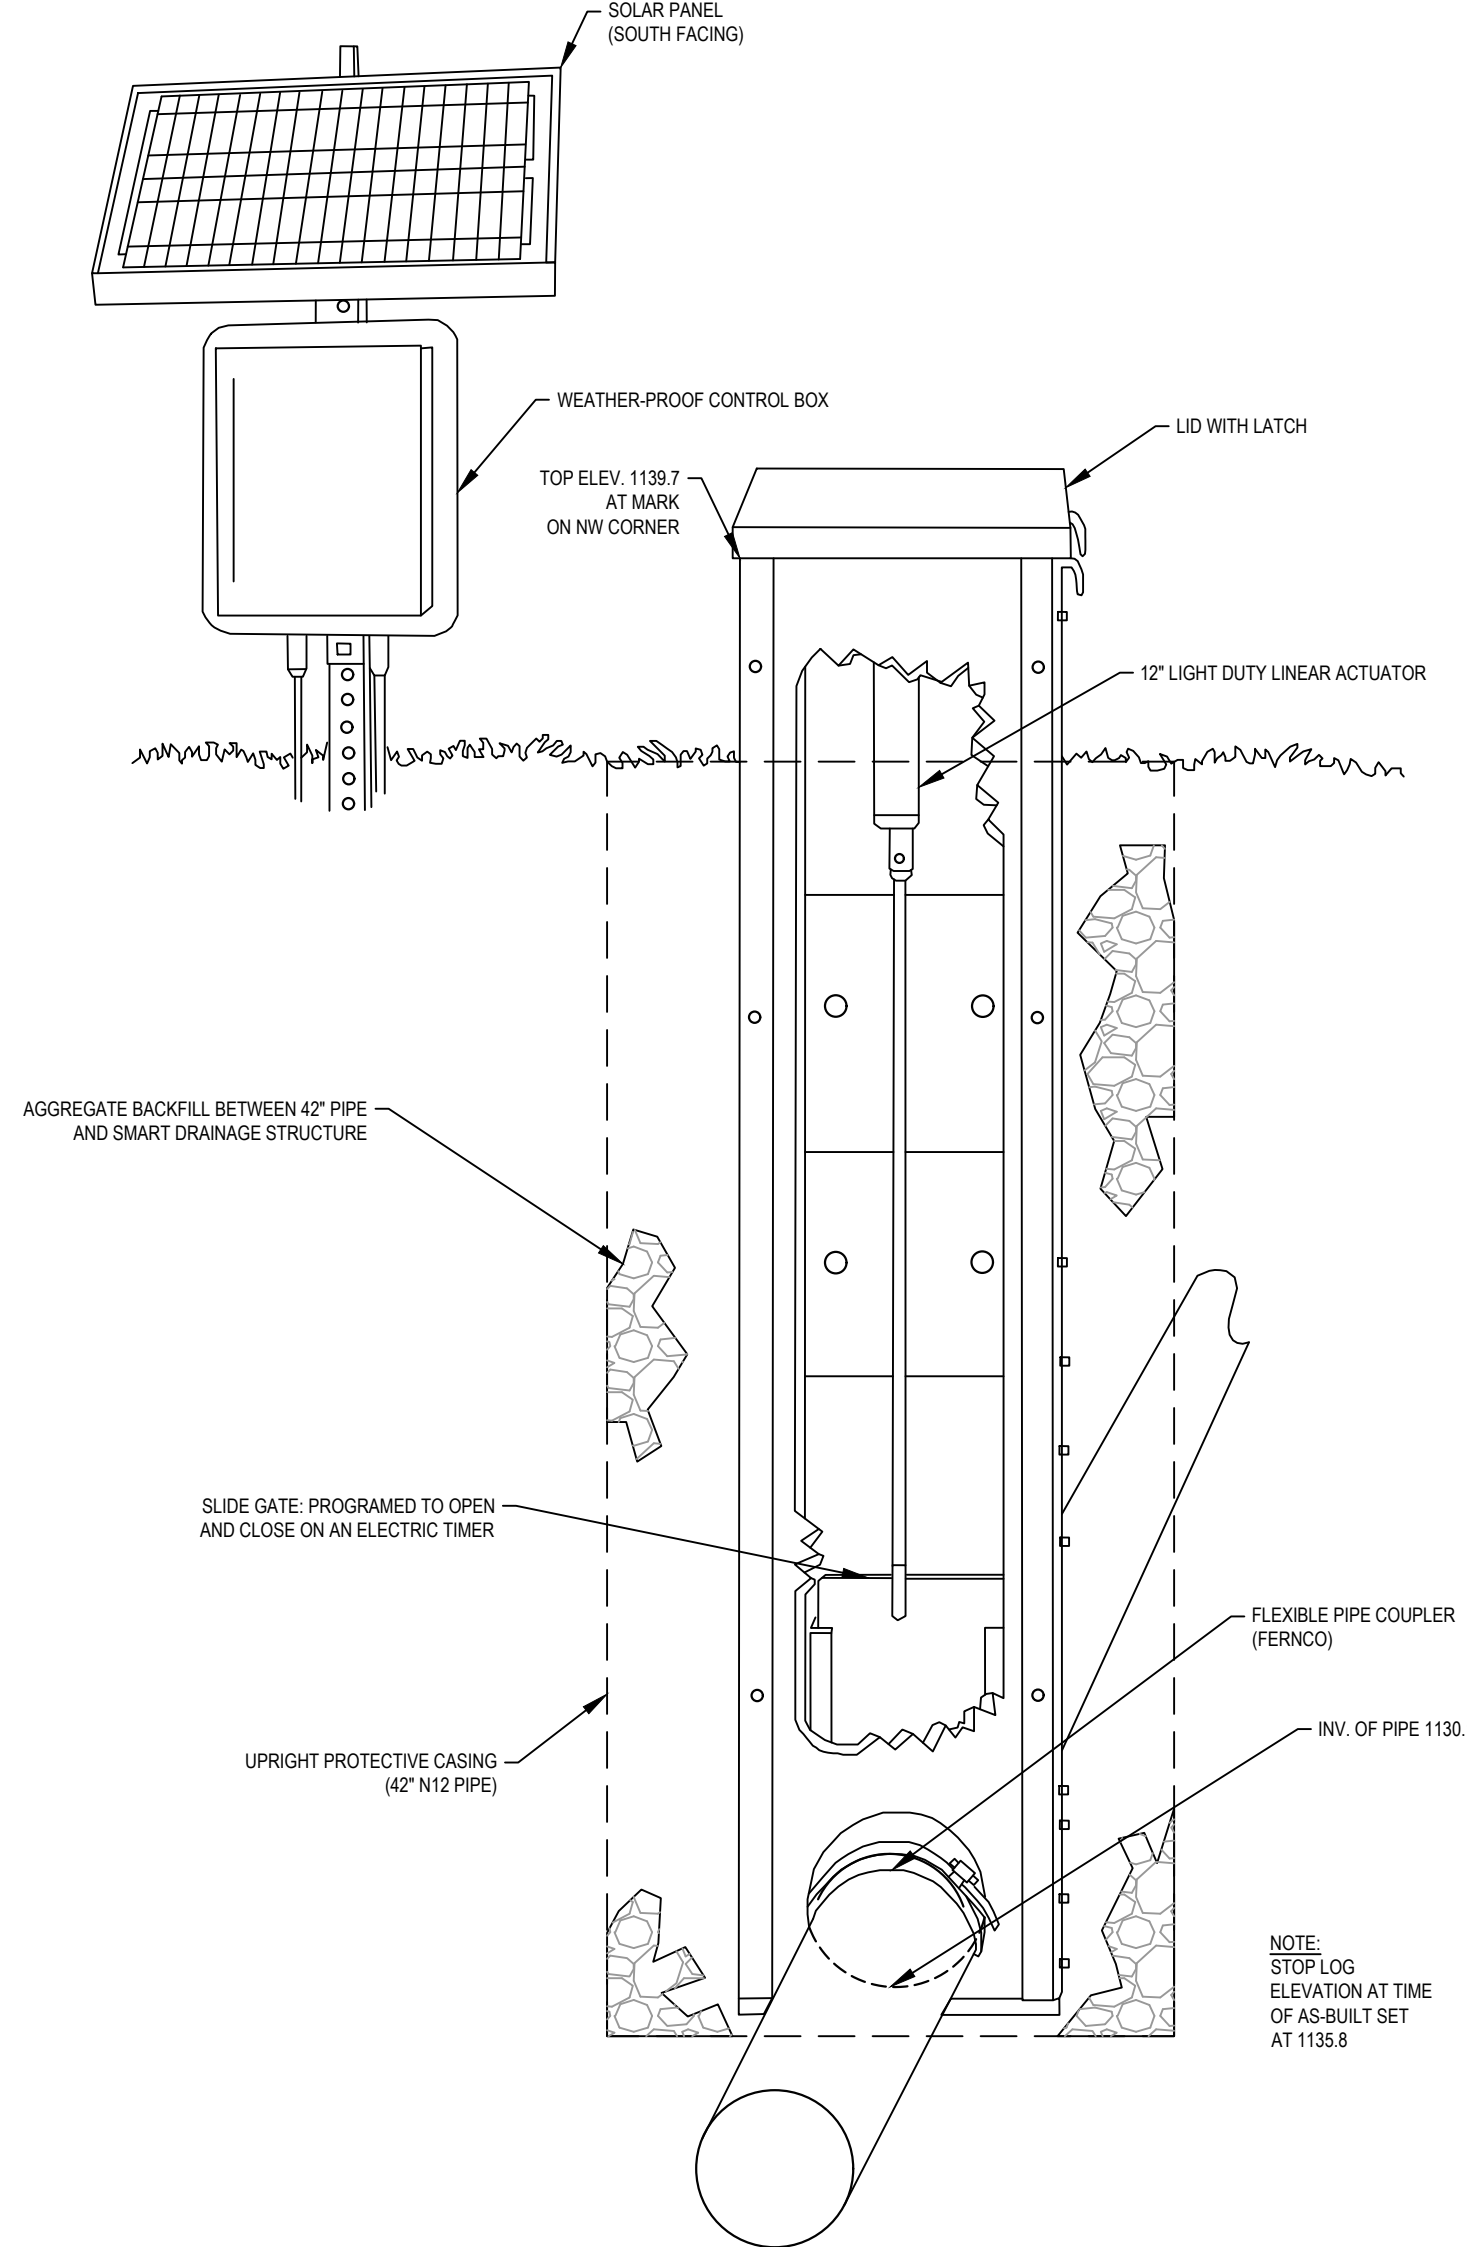
AGRI DRAIN SMART DRAINAGE SYSTEM #2

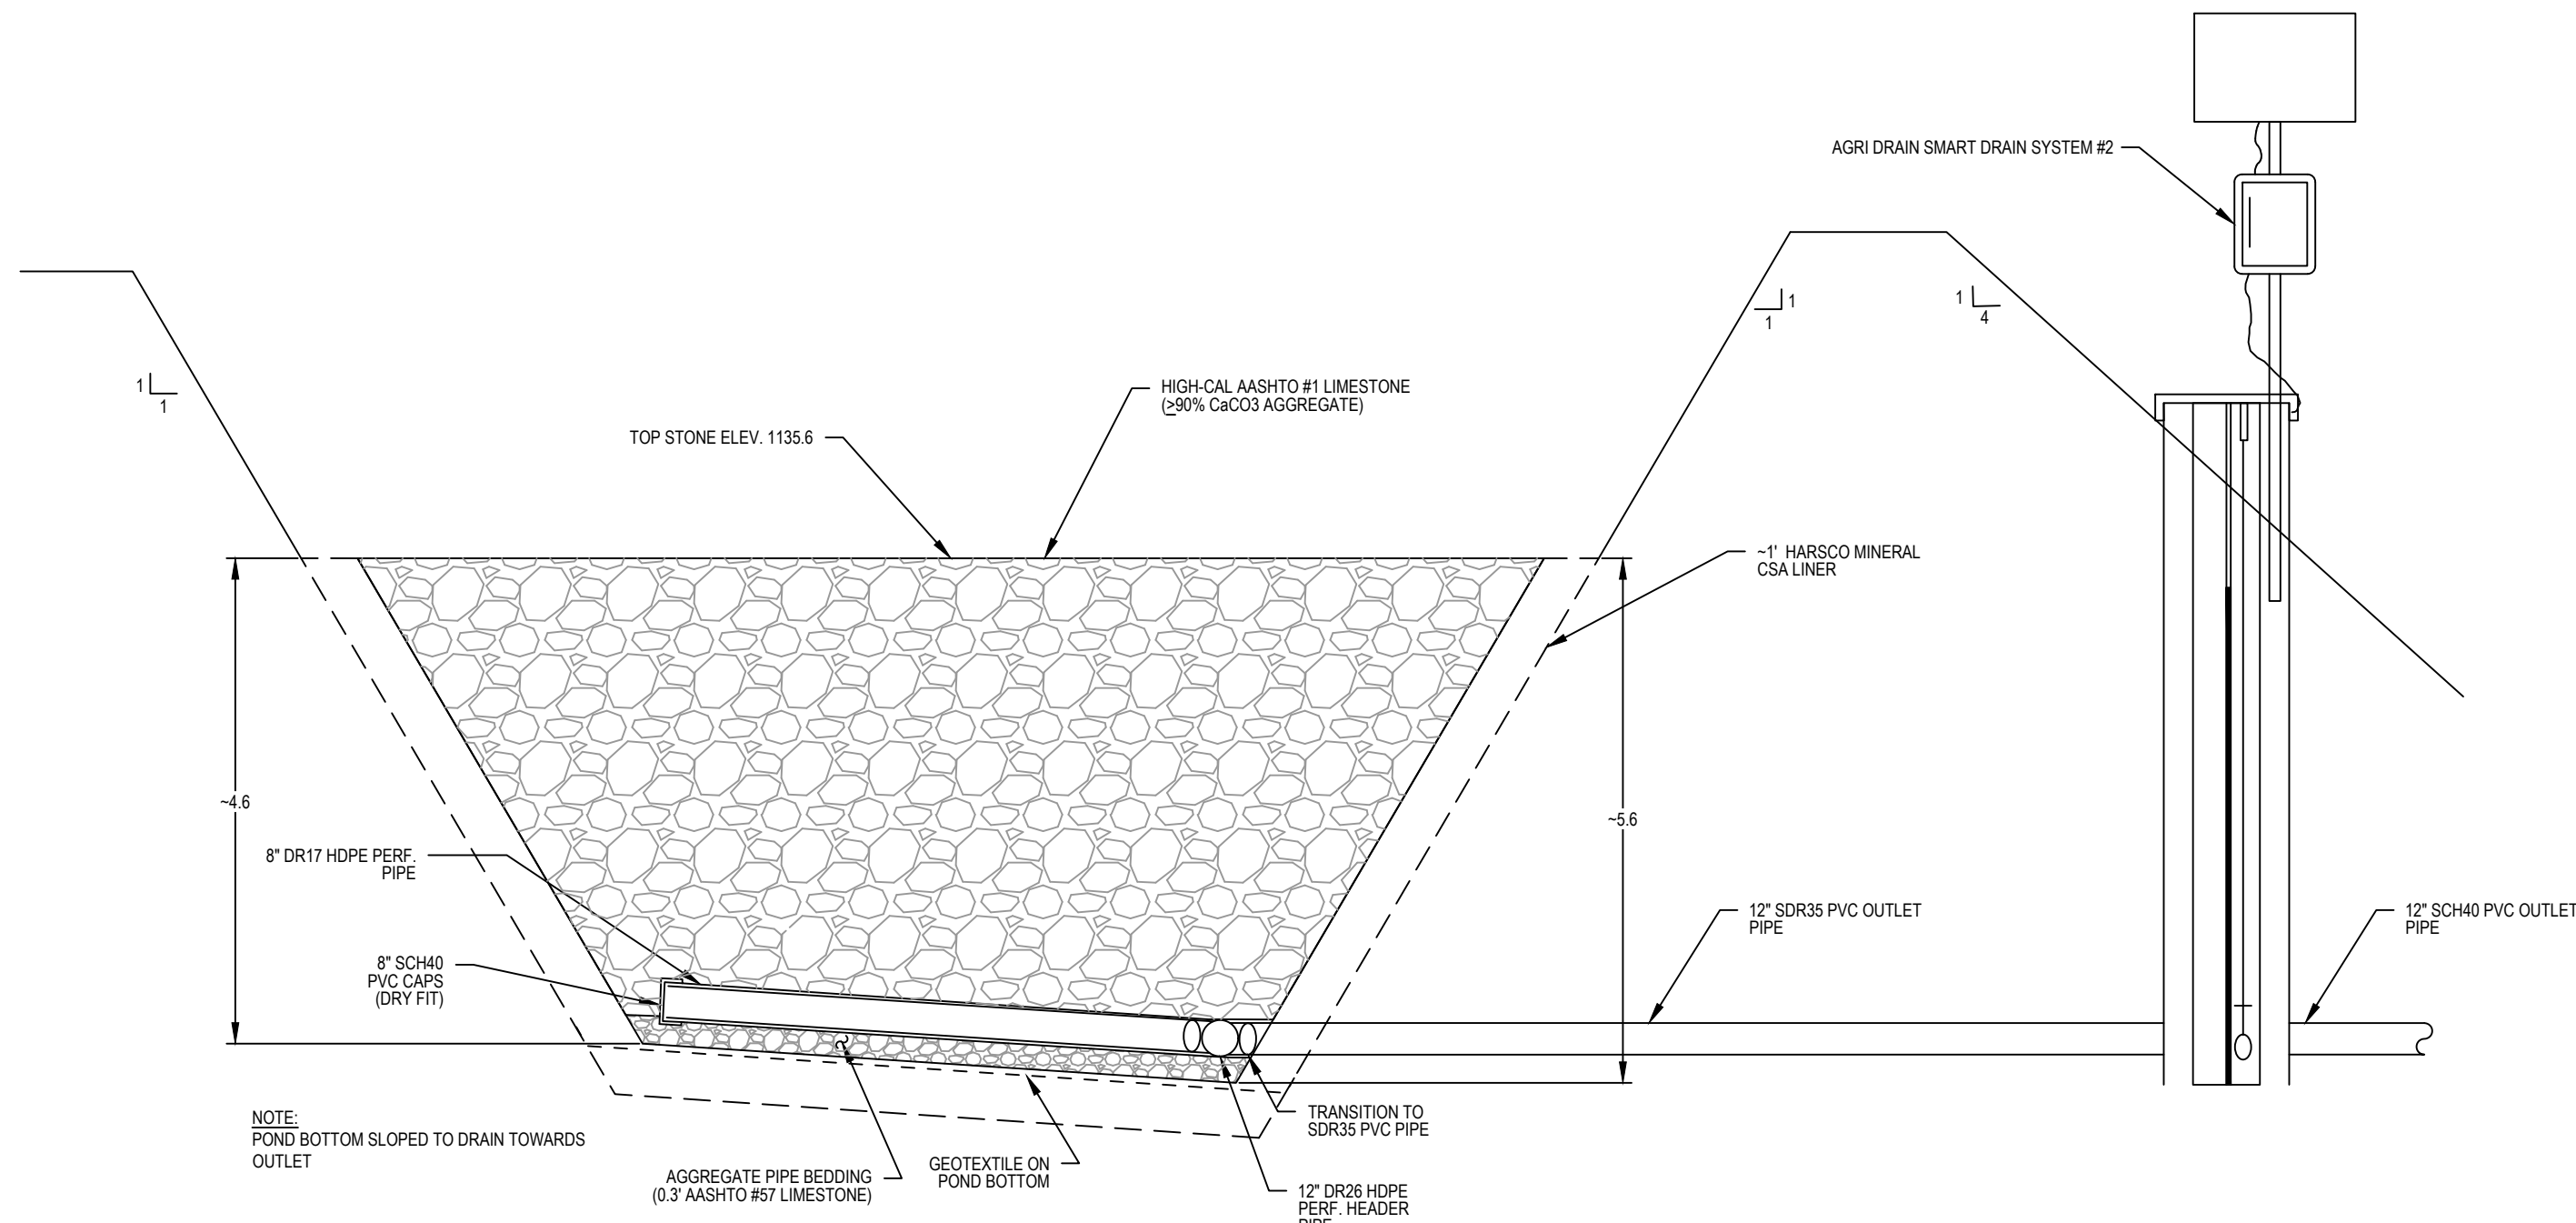
AUTO-FLUSHING VERTICAL FLOW POND #2 (AFVFP2)

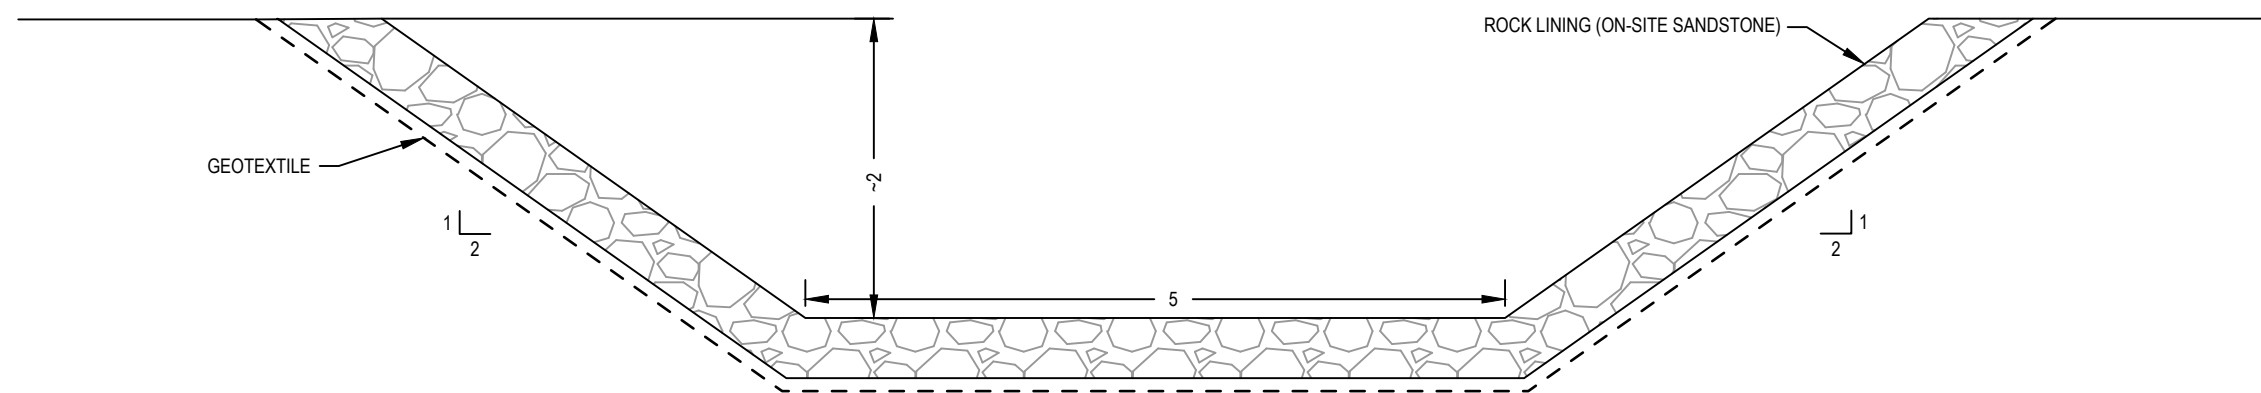
AFVFP2 EMERGENCY SPILLWAY

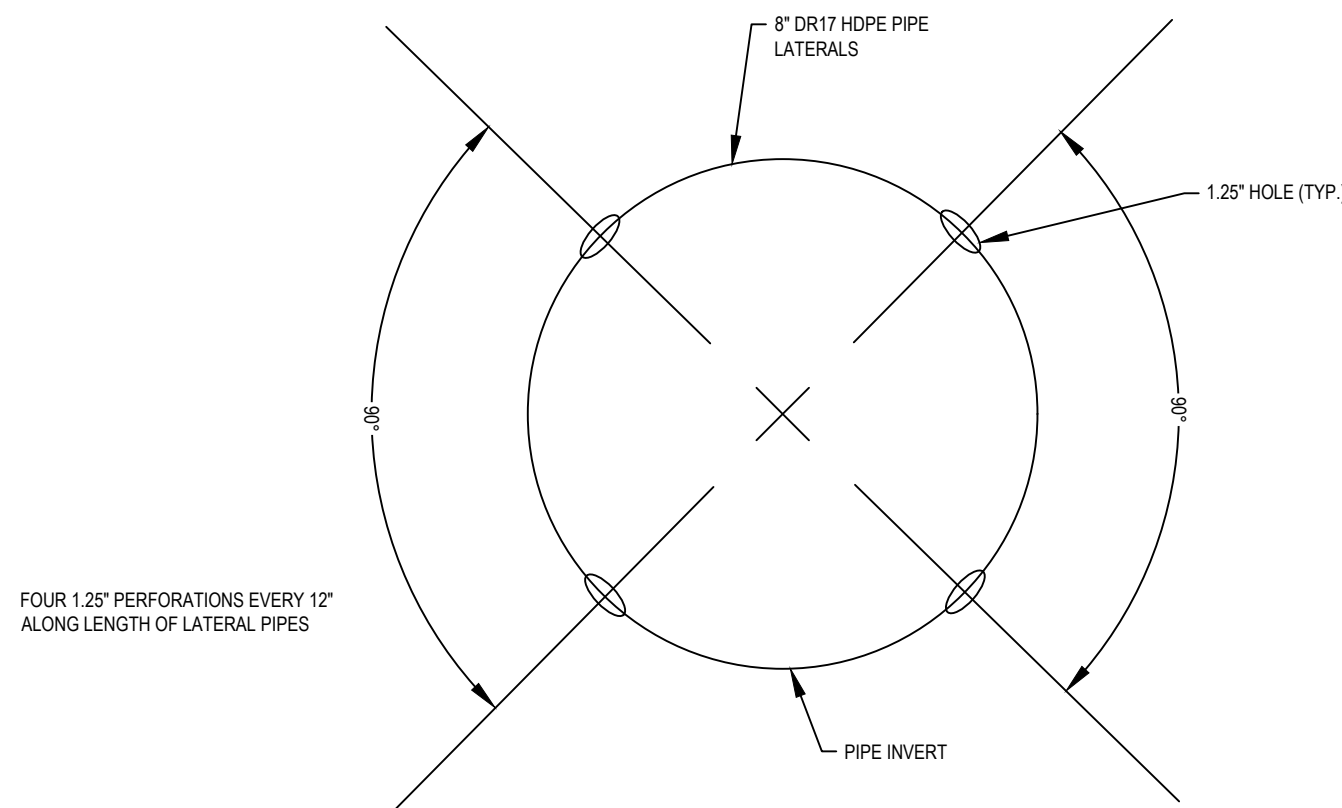
8" LATERAL PIPE PERFORATION DETAIL

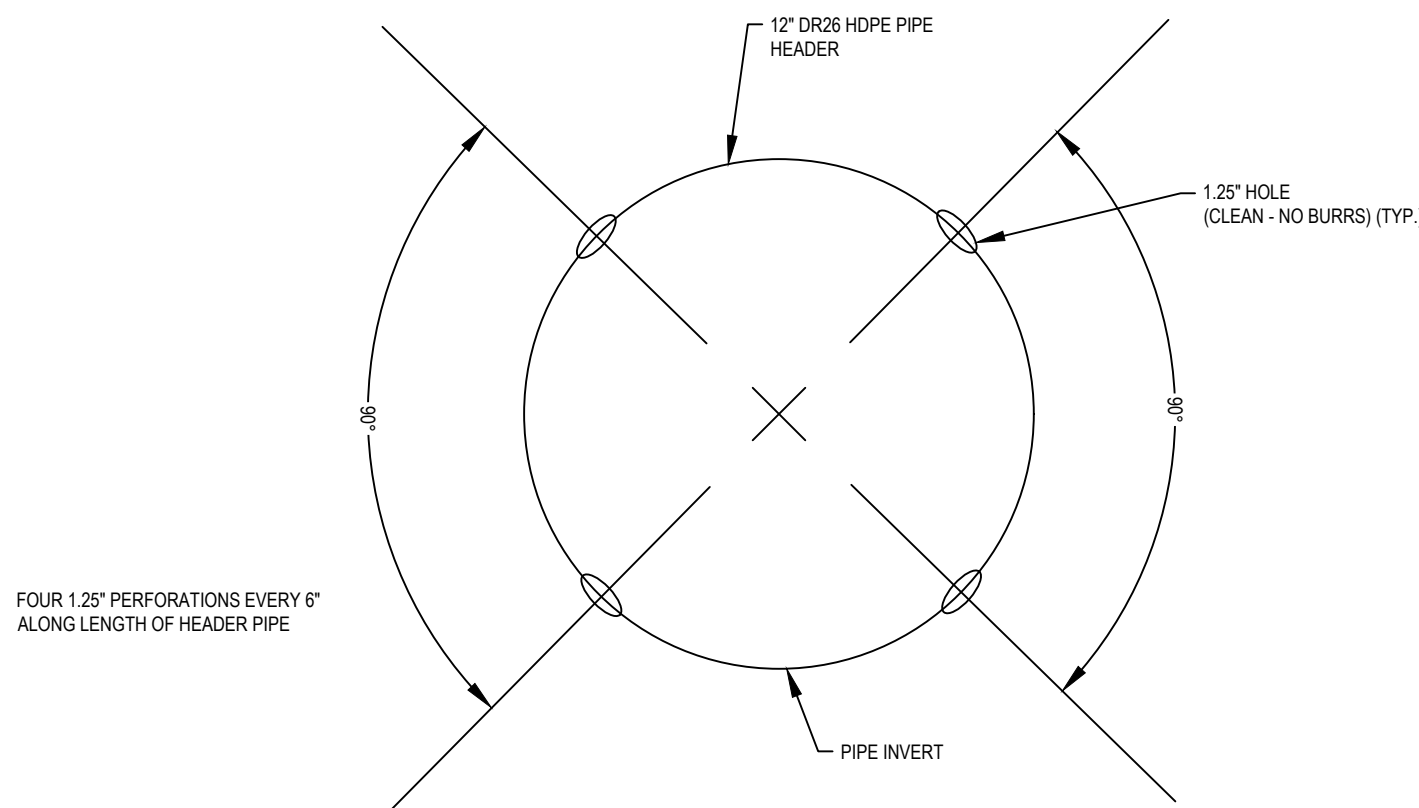
12" HEADER PIPE PERFORATION DETAIL

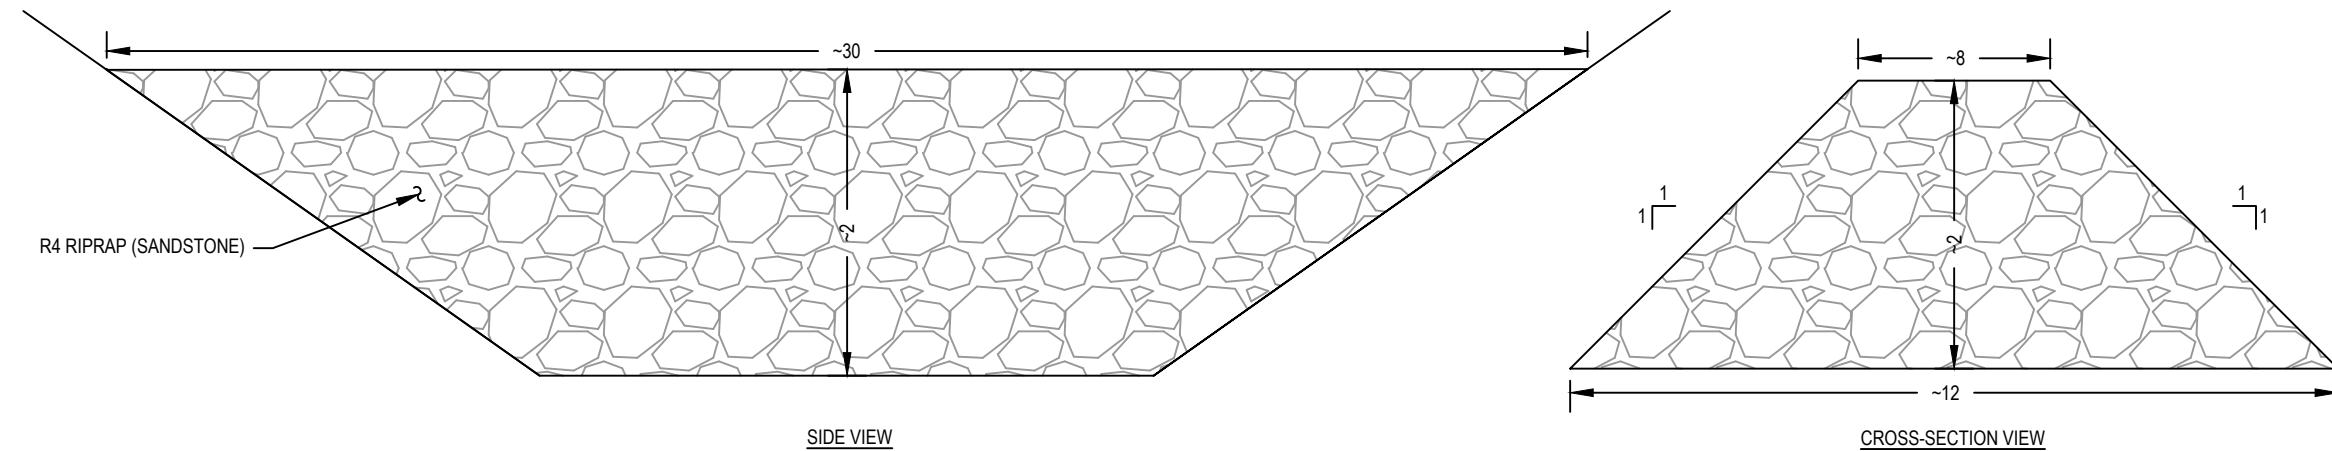
CHECK DAM
