CLIENT	STREAM RESTORATION INCORPORATED PO BOX 837 SLIPPERY ROCK, PA 16957	NO. BY DATE DESCRIPTION REVISIONS	CONTRACTOR CODY A. NEELY, P.E. PROJECT ENGINEER, PA, INC.	ALL SETTING CONDITIONS SHALL BE CHECKED AND VERIFIED AT THE SITE PRIOR TO PERFORMING ANY MAINTENANCE WORK.	DRAWING NO. SR114-As-Built-03	PROJECT NAME SR114 As-Built-03	COUNTY WASHINGTON TOWNSHIP	COUNTY BUTLER COUNTY
	PROJECT	SR114 Rehabilitation Project As-Built

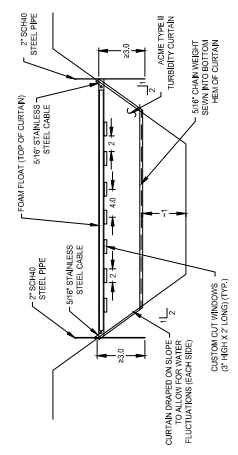
WINDOWED BAFFLE CURTAIN
Vertical Scale: None Horizontal Scale: None

Note:
1. All baffle curtain doors will have windows
out into it, and doors will extend across the entire
pond (see plan view).
