# Bear Run Watershed Renaissance Mine Drainage Restoration Project

## FINAL REPORT

Improvement of Water Quality and Biological Communities  
through Mine Land Reclamation and Mine Drainage Treatment in  
the Bear Run Watershed, Indiana County, PA

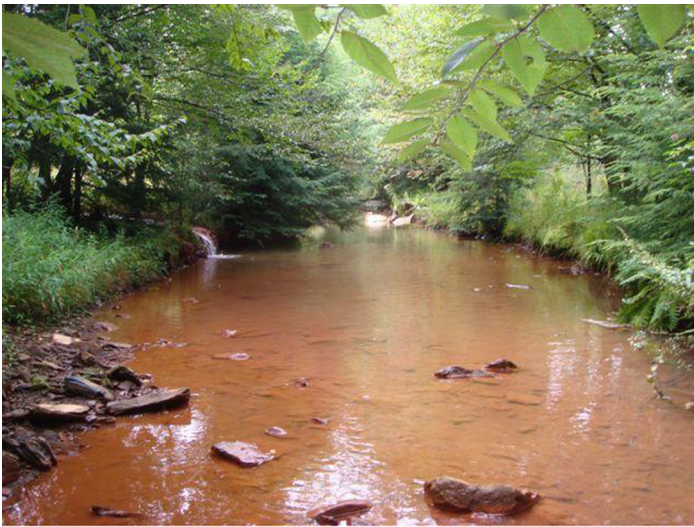
**South Branch Bear Run prior to the construction of Phase I.**

Phase I, completed in 2007, treats the discharge emanating from the Superior #3 Slope Mine using an aerobic pond and wetland passive treatment system. The Superior #3 Discharge is a moderate flow (0.512 CFS), slightly net alkaline (17.14 mg/l), and high iron (38.74 mg/l) concentrated discharge. With a daily average iron loading of 122 pounds, the Superior #3 Discharge was the largest iron input into the Bear Run Watershed.

After treatment, average effluent alkalinity concentration increased by 167 percent to 45.68 mg/l and average effluent iron concentration decreased by 91 percent to 3.44 mg/l. Average effluent pH also increased from 6.20 to 6.97.

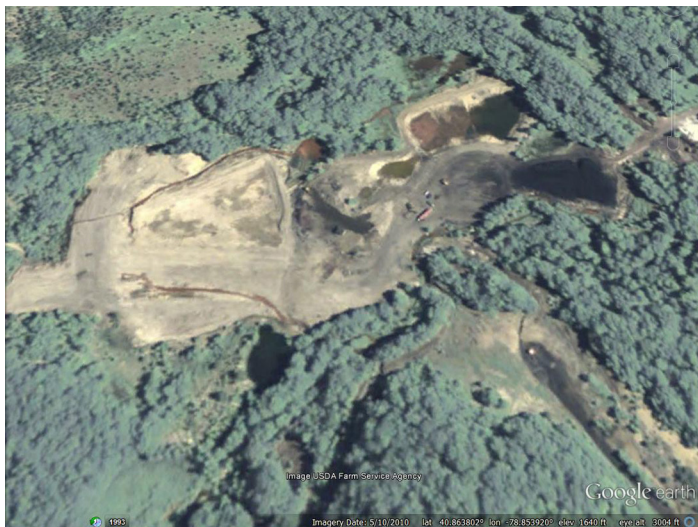
**Phase II prior to treatment and reclamation.**

Phase II, completed in 2009, treats the discharge emanating from the Bear Run #1 Drift Mine using an aerobic pond/wetland treatment system. The Bear Run #1 Discharge is a large flow (1.032 CFS), net alkaline (40.67 mg/l), and moderate iron (15.13 mg/l) concentrated discharge. With a daily average iron loading of 85 pounds, the Bear Run #1 Discharge was the second largest iron input into the Bear Run Watershed.

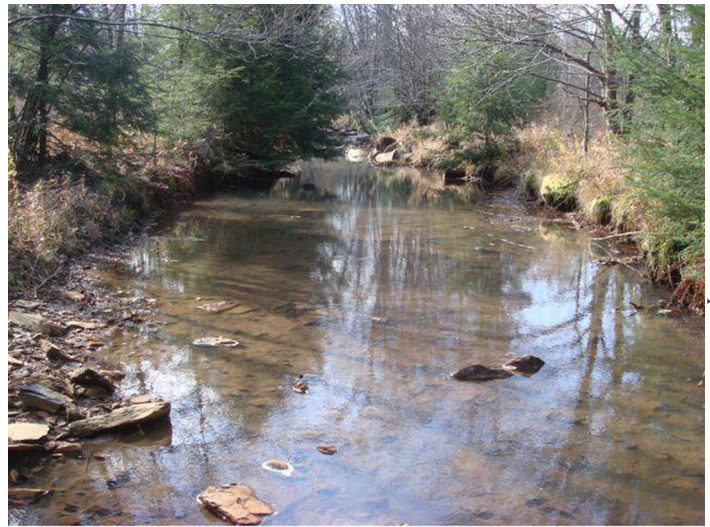
**South Branch Bear Run after the construction of Phase I.**

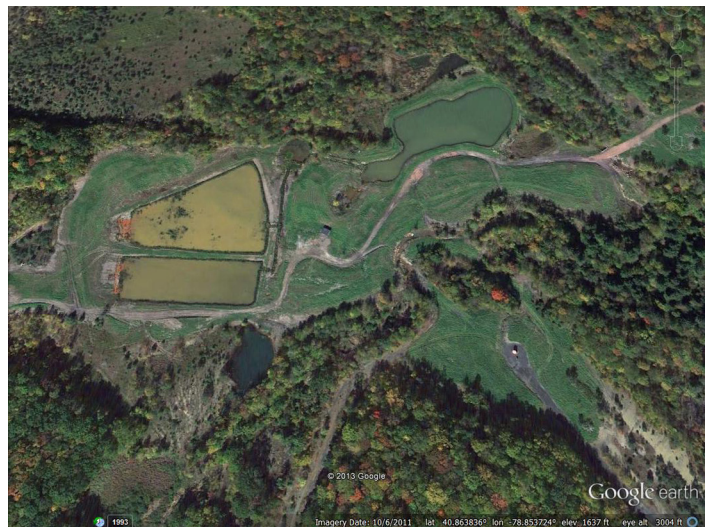
**Phase II after treatment and reclamation.**

After treatment, average effluent iron concentration decreased by 93 percent to 1.02 mg/l. Average effluent pH also increased from 6.43 to 7.06.

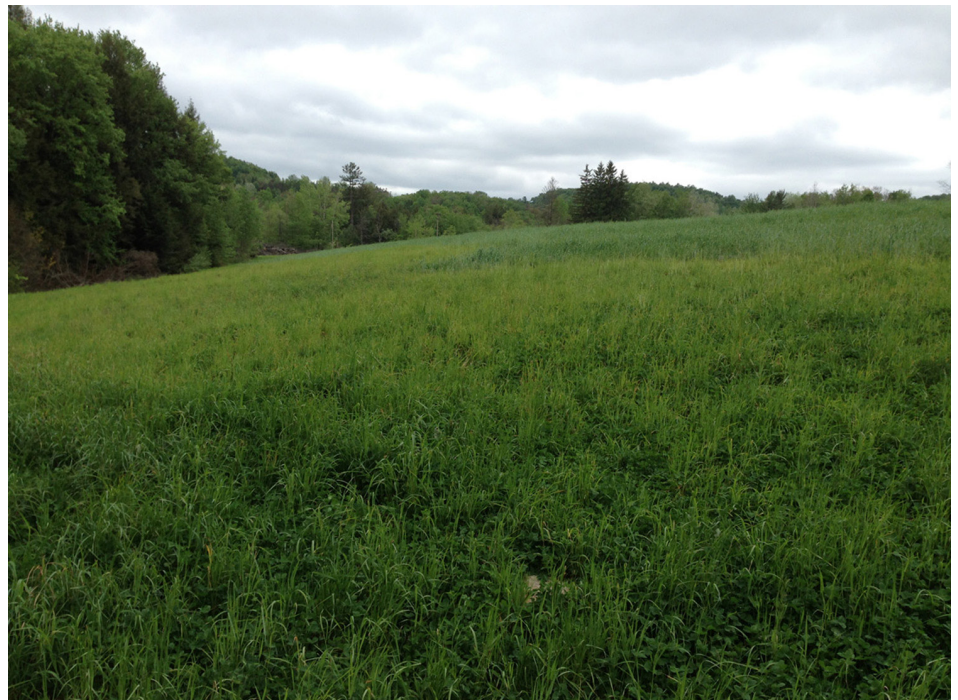
*Phase IV mine refuse post reclamation.*

included the recontouring, clay capping, and seeding of a large poor quality mine refuse dump.

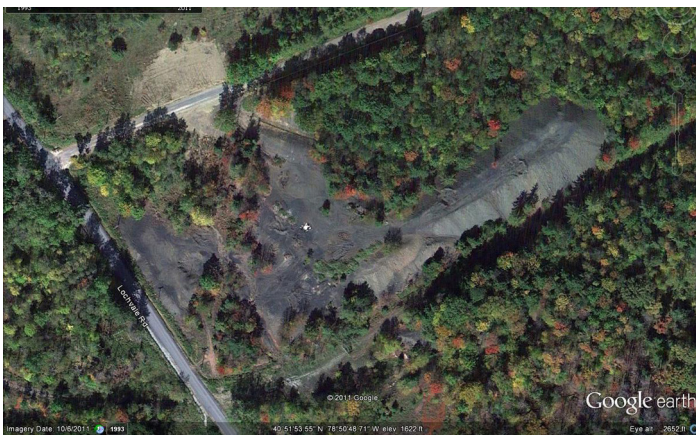
*Phase IV site just after mine pool explosion with dual pipe installed and breach reclaimed.*

Phase IV was possibly the most complex of all the Bear Run projects due to the fact that several discharges emanated from the site from an ever increasing mine pool discovered inside the Superior #1 Drift Mine. The mine pool was created due to the crushing of the mine seal drain pipe by the dumped refuse overtop. In 2011, before work began to drawdown the mine pool, pressure within the mine exploded out of the hillside above the mine seal sending millions of gallons of polluted water into the South Branch Bear Run. Consequently, Watershed Renaissance funds were utilized to install a dual pipe drain system within the mine to eliminate the mine pool, thus creating only one discharge, which was then piped to the area selected for treatment. Phase IV also

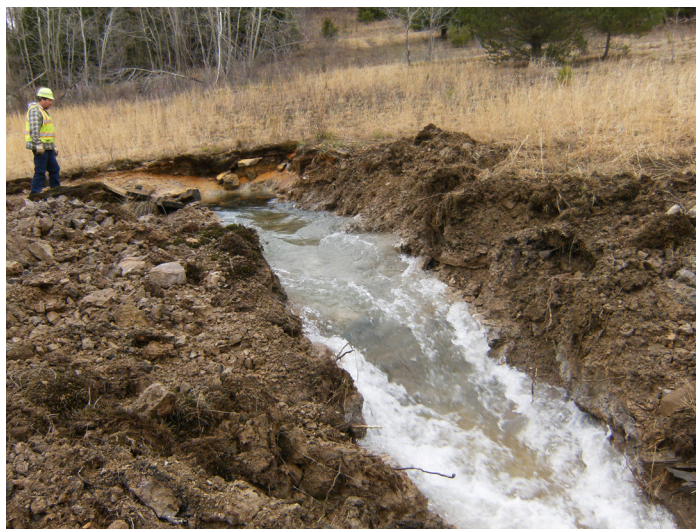
*Phase IV mine pool water exiting the breach upslope of the mine seal.*

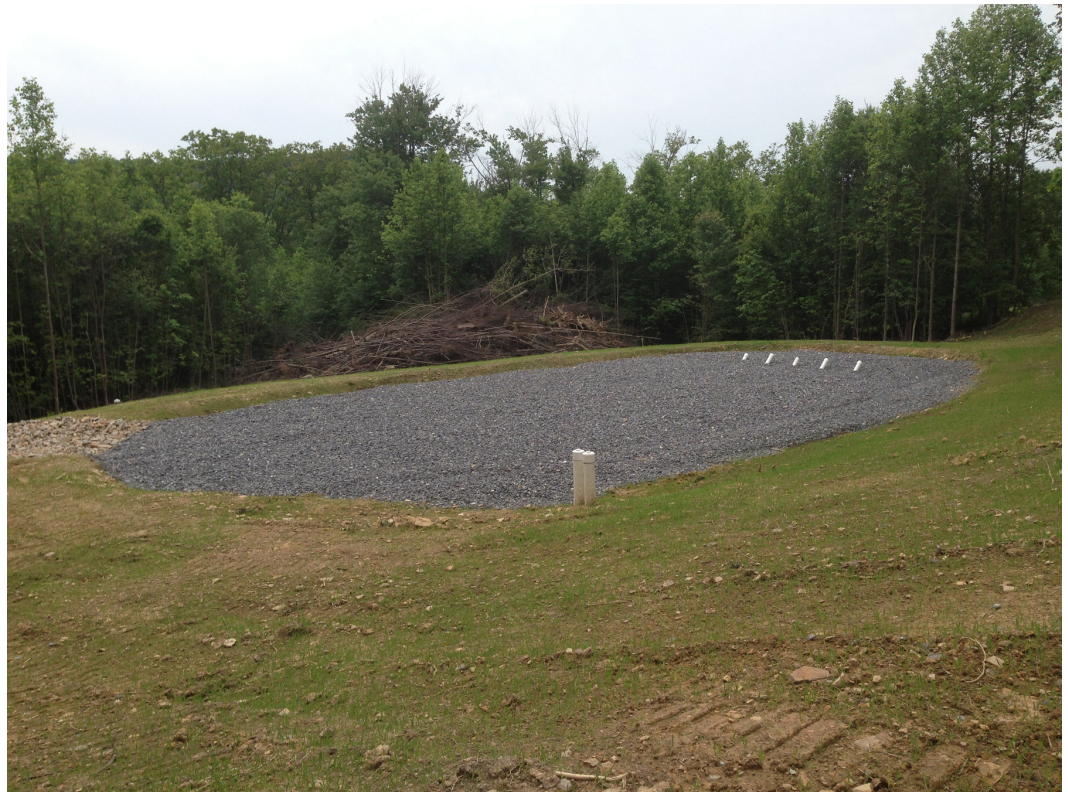
*Phase VIII up-flow, manual flush, oxic limestone drain soon after construction.*

Phase VIII, completed in 2013, utilizes an up-flow, manual flush, oxic limestone drain system for treatment. After treatment, average effluent acidity concentration decreased by 438 percent to -155.00 mg/l and average effluent aluminum concentration decreased by 97 percent to 0.11 mg/l. Average pH also increased from 3.66 to 7.4.

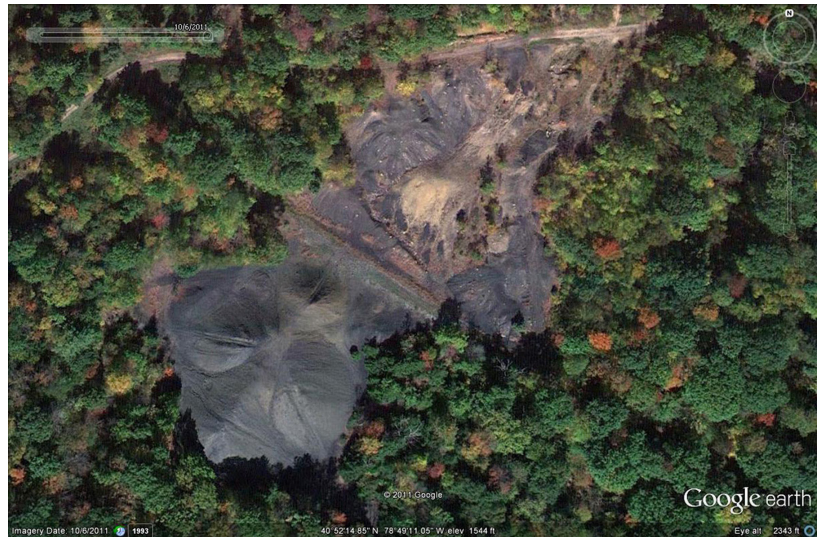
*The Banks #2 coal refuse site. Keal Run coal refuse piles will be added to this site and reclaimed in total as Phase IX.*

Due to the saving of funds on numerous phases and the combination of the originally planned Phase VI and VII into one phase, funding was available to complete a ninth phase. With additional funding from the Pennsylvania Game Commission and possibly more funding from OSM, Phase IX will entail the removal of low quality coal refuse from the banks of an unnamed tributary to the South Branch Bear Run, locally known as Keal Run. Those piles will be moved to the Banks #2 coal refuse pile about one mile downstream and cumulatively reclaimed.
